**DRAFT ADA TRANSITION PLAN UPDATE
NEIGHBORHOOD AREA 8 CHASE
SEPTEMBER 20, 2011**

CITY OF CITRUS HEIGHTS

Conditions - CHASE Area 8

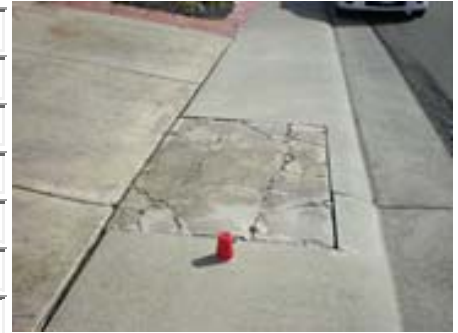
Field Date: 3/4/2011 Report Date: 3/4/2011 Barrier #: 5752B
 Location: Joshua Ct - North
 X Coordinate: -121.26996
 Y Coordinate: 38.70212
 Barrier Area: Sidewalks
 Barrier Type: Surface Condition - Damaged
 Code Ref: CBC 1133B.7.1 and ADA/ABA 302.1

As Built Meas: 8 Quantity: LF
 Description: Surface is not firm and stable (cracked, broken or loose soil, etc.)
 As Built Desc: Cracked concrete
 Solution: Repair surface to make firm and stable
 Bar. Severity: 1 Necessary Cost Estimate: \$1,000.00 Status:
 Implementation Priority: 4 Facility Function:
 Implementation Phase: Implementation Date:
 Official Responsible:

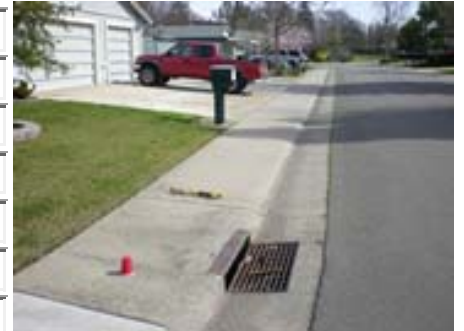
As Built Meas: 336 Quantity: LF
 Description: Cross slope exceeds 2.0% (4.1% to 4.9%)
 As Built Desc: 4.4% cross slope
 Solution: Demolish existing and construct new route
 Bar. Severity: 2 Recommended Cost Estimate: \$42,000.00 Status:
 Implementation Priority: 4 Facility Function:
 Implementation Phase: Implementation Date:
 Official Responsible:

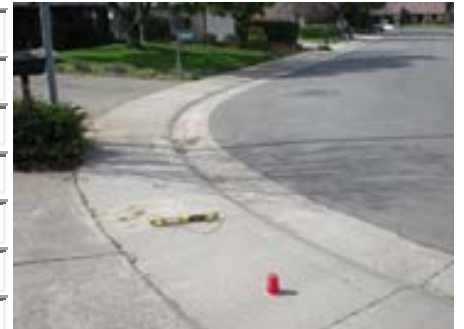
As Built Meas: 298 Quantity: LF
 Description: Cross slope exceeds 2.0% (4.1% to 4.9%)
 As Built Desc: 4.2% cross slope
 Solution: Demolish existing and construct new route
 Bar. Severity: 2 Recommended Cost Estimate: \$37,250.00 Status:
 Implementation Priority: 4 Facility Function:
 Implementation Phase: Implementation Date:
 Official Responsible:

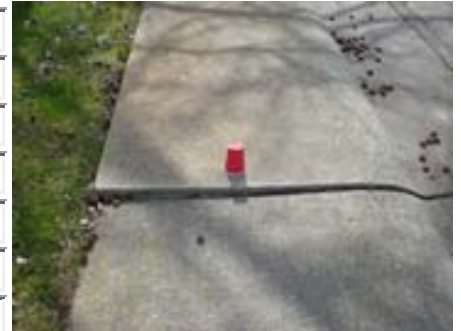
As Built Meas: 4 Quantity: LF
 Description: Change in level greater than 1/2"
 As Built Desc: 2" lip in sidewalk surface
 Solution: Grind or repair sidewalk to remove trip hazard
 Bar. Severity: 1 Necessary Cost Estimate: \$1,000.00 Status:
 Implementation Priority: 4 Facility Function:
 Implementation Phase: Implementation Date:
 Official Responsible:

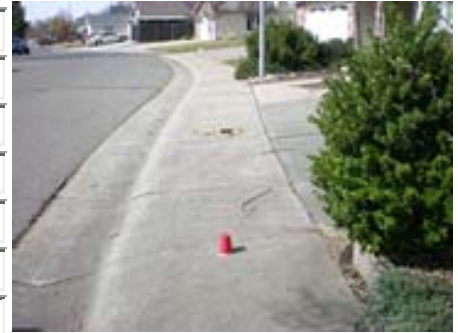
As Built Meas: 112 Quantity: LF
 Description: Cross slope exceeds 2.0% (4.1% to 4.9%)
 As Built Desc: 4.8% cross slope
 Solution: Demolish existing and construct new route
 Bar. Severity: 2 Recommended Cost Estimate: \$14,000.00 Status:
 Implementation Priority: 4 Facility Function:
 Implementation Phase: Implementation Date:
 Official Responsible:

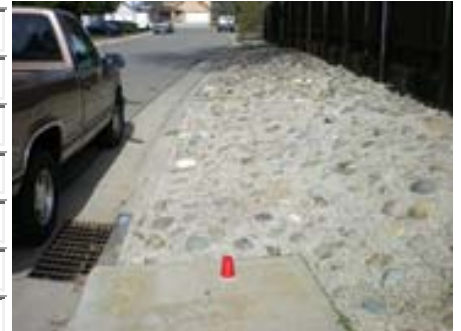
As Built Meas: 1 Quantity: JOB
 Description: No barricade provided where sidewalk ends in hazardous location
 As Built Desc: No barricade or other warning provided for the visually impaired at end of sidewalk
 Solution: Provide barricade with cane detectable warning at end of sidewalk
 Bar. Severity: 1 Necessary Cost Estimate: \$1,350.00 Status:
 Implementation Priority: 4 Facility Function:
 Implementation Phase: Implementation Date:
 Official Responsible:

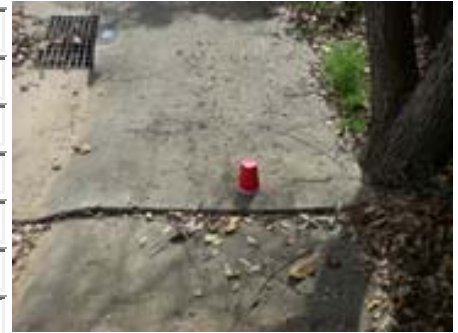
As Built Meas: 4 Quantity: LF
 Description: Change in level greater than 1/2"
 As Built Desc: 1" lip in sidewalk surface
 Solution: Grind or repair sidewalk to remove trip hazard
 Bar. Severity: 1 Necessary Cost Estimate: \$1,000.00 Status:
 Implementation Priority: 4 Facility Function:
 Implementation Phase: Implementation Date:
 Official Responsible:

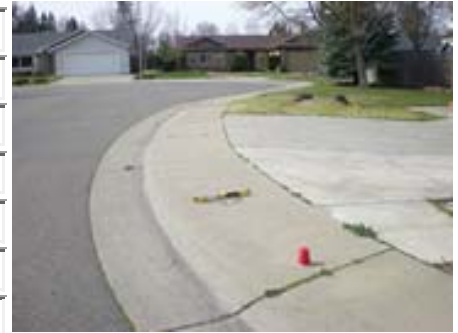
As Built Meas: 93 Quantity: LF
 Description: Cross slope exceeds 2.0% (4.1% to 4.9%)
 As Built Desc: 4.6% cross slope
 Solution: Demolish existing and construct new route
 Bar. Severity: 2 Recommended Cost Estimate: \$11,625.00 Status:
 Implementation Priority: 4 Facility Function:
 Implementation Phase: Implementation Date:
 Official Responsible:

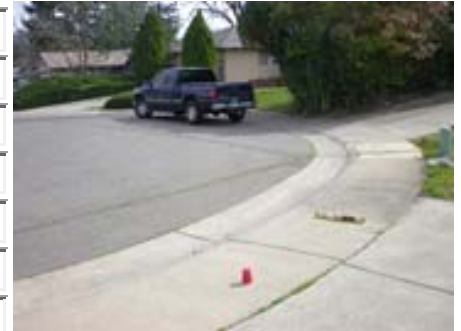
As Built Meas: 127 Quantity: LF
 Description: Cross slope exceeds 2.0% (4.1% to 4.9%)
 As Built Desc: 4.7% cross slope
 Solution: Demolish existing and construct new route
 Bar. Severity: 2 Recommended Cost Estimate: \$15,875.00 Status:
 Implementation Priority: 4 Facility Function:
 Implementation Phase: Implementation Date:
 Official Responsible:

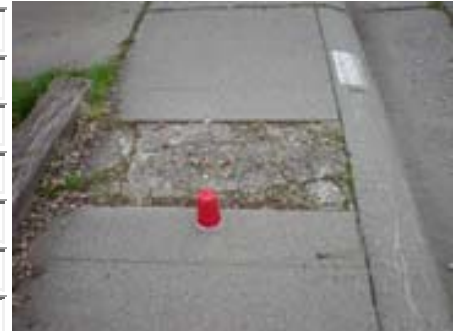
As Built Meas: 2 Quantity: LF
 Description: Surface is not firm and stable (cracked, broken or loose soil, etc.)
 As Built Desc: Cracked concrete
 Solution: Repair surface to make firm and stable
 Bar. Severity: 1 Necessary Cost Estimate: \$250.00 Status:
 Implementation Priority: 2 Facility Function:
 Implementation Phase: Implementation Date:
 Official Responsible:

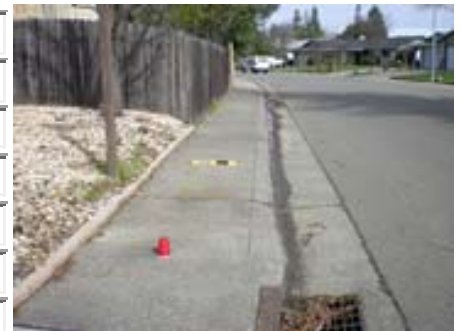
As Built Meas: 441 Quantity: LF
 Description: Cross slope exceeds 2.0% (4.1% to 4.9%)
 As Built Desc: 4.4% cross slope
 Solution: Demolish existing and construct new route
 Bar. Severity: 2 Recommended Cost Estimate: \$55,125.00 Status:
 Implementation Priority: 4 Facility Function:
 Implementation Phase: Implementation Date:
 Official Responsible:

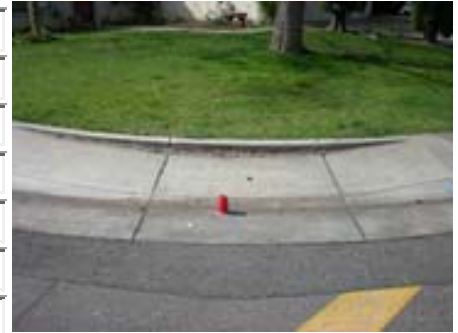
As Built Meas: 1 Quantity: EACH
 Description: No truncated domes provided at curb ramp
 As Built Desc: No detectable warnings at curb ramp
 Solution: Provide compliant truncated domes
 Bar. Severity: 2 Recommended Cost Estimate: \$1,400.00 Status:
 Implementation Priority: 2 Facility Function:
 Implementation Phase: Implementation Date:
 Official Responsible:

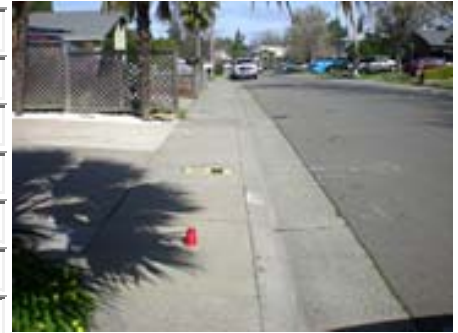
As Built Meas: 385 Quantity: LF
 Description: Cross slope exceeds 2.0% (4.1% to 4.9%)
 As Built Desc: 4.9% cross slope
 Solution: Demolish existing and construct new route
 Bar. Severity: 2 Recommended Cost Estimate: \$48,125.00 Status:
 Implementation Priority: 4 Facility Function:
 Implementation Phase: Implementation Date:
 Official Responsible:

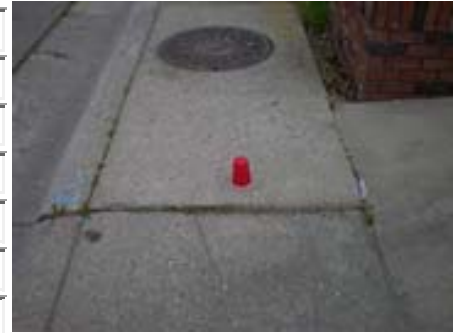
As Built Meas: 4 Quantity: LF
 Description: Change in level greater than 1/2"
 As Built Desc: 1/2" lip in sidewalk surface
 Solution: Grind or repair sidewalk to remove trip hazard
 Bar. Severity: 1 Necessary Cost Estimate: \$1,000.00 Status:
 Implementation Priority: 2 Facility Function:
 Implementation Phase: Implementation Date:
 Official Responsible:

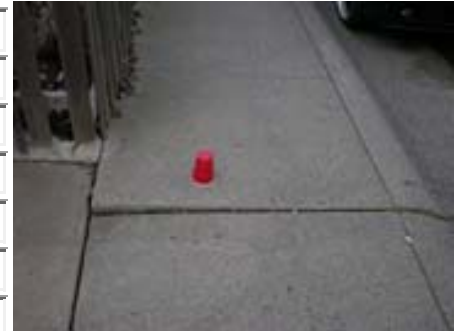
As Built Meas: 4 Quantity: LF
 Description: Change in level greater than 1/2"
 As Built Desc: 1/2" lip in sidewalk surface
 Solution: Grind or repair sidewalk to remove trip hazard
 Bar. Severity: 1 Necessary Cost Estimate: \$1,000.00 Status:
 Implementation Priority: 2 Facility Function:
 Implementation Phase: Implementation Date:
 Official Responsible:

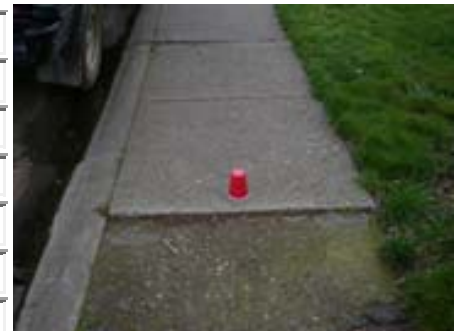
As Built Meas: 4 Quantity: LF
 Description: Change in level greater than 1/2"
 As Built Desc: 1/2" lip in sidewalk surface
 Solution: Grind or repair sidewalk to remove trip hazard
 Bar. Severity: 1 Necessary Cost Estimate: \$1,000.00 Status:
 Implementation Priority: 2 Facility Function:
 Implementation Phase: Implementation Date:
 Official Responsible:

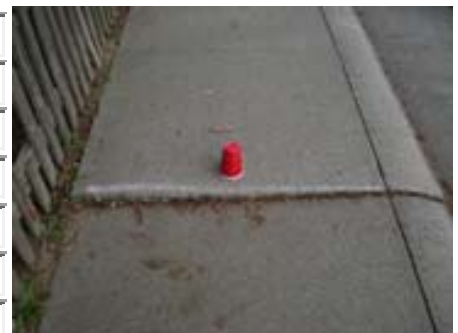
As Built Meas: 4 Quantity: LF
 Description: Change in level greater than 1/2"
 As Built Desc: 1/2" lip in sidewalk surface
 Solution: Grind or repair sidewalk to remove trip hazard
 Bar. Severity: 1 Necessary Cost Estimate: \$1,000.00 Status:
 Implementation Priority: 4 Facility Function:
 Implementation Phase: Implementation Date:
 Official Responsible:

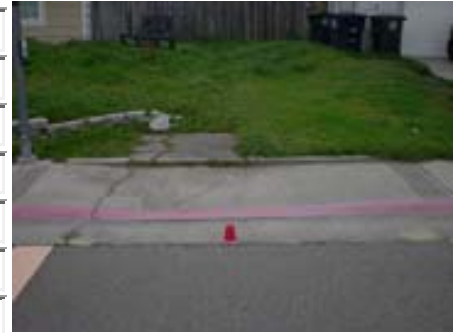
As Built Meas: 1 Quantity: EACH
 Description: No truncated domes provided at curb ramp
 As Built Desc: No detectable warnings at curb ramp
 Solution: Provide compliant truncated domes
 Bar. Severity: 2 Recommended Cost Estimate: \$1,400.00 Status:
 Implementation Priority: 2 Facility Function:
 Implementation Phase: Implementation Date:
 Official Responsible:

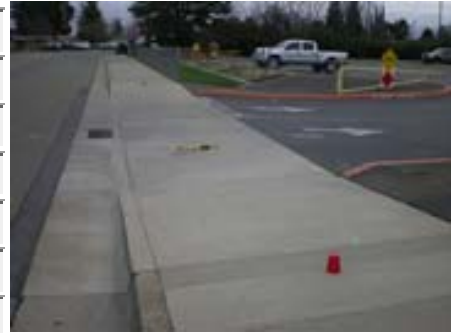
As Built Meas: 55 Quantity: LF
 Description: Driveway cross slope exceeds 2.0% (3.1% to 4.0%)
 As Built Desc: 3.4% cross slope
 Solution: Provide min. 48" wide level walkway through driveway
 Bar. Severity: 2 Recommended Cost Estimate: \$6,875.00 Status:
 Implementation Priority: 2 Facility Function:
 Implementation Phase: Implementation Date:
 Official Responsible:

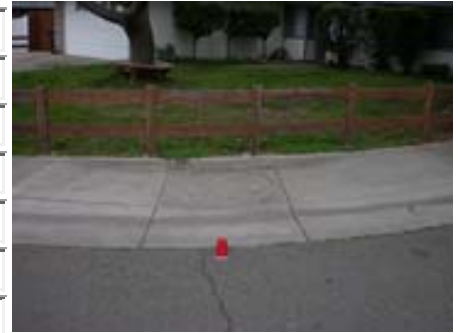
As Built Meas: 1 Quantity: EACH
 Description: No truncated domes provided at curb ramp
 As Built Desc: No detectable warnings at curb ramp
 Solution: Provide compliant truncated domes
 Bar. Severity: 2 Recommended Cost Estimate: \$1,400.00 Status:
 Implementation Priority: 2 Facility Function:
 Implementation Phase: Implementation Date:
 Official Responsible:

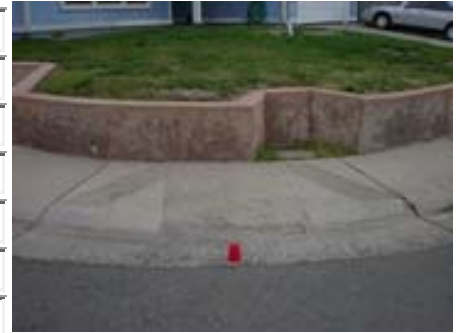
As Built Meas: 162 Quantity: LF
 Description: Cross slope exceeds 2.0% (4.1% to 4.9%)
 As Built Desc: 4.2% cross slope
 Solution: Demolish existing and construct new route
 Bar. Severity: 2 Recommended Cost Estimate: \$20,250.00 Status:
 Implementation Priority: 2 Facility Function:
 Implementation Phase: Implementation Date:
 Official Responsible:

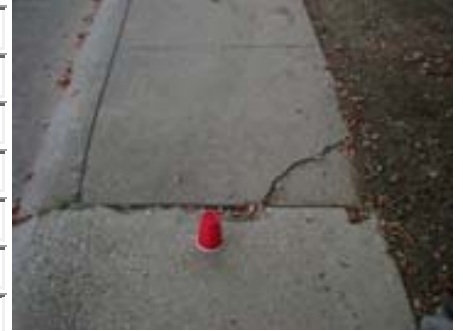
As Built Meas: 4 Quantity: LF
 Description: Surface is not firm and stable (cracked, broken or loose soil, etc.)
 As Built Desc: Cracked concrete
 Solution: Repair surface to make firm and stable
 Bar. Severity: 1 Necessary Cost Estimate: \$500.00 Status:
 Implementation Priority: 2 Facility Function:
 Implementation Phase: Implementation Date:
 Official Responsible:

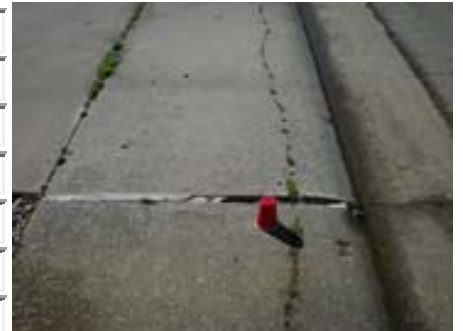
As Built Meas: 4 Quantity: LF
 Description: Surface is not firm and stable (cracked, broken or loose soil, etc.)
 As Built Desc: 2" gap in the concrete
 Solution: Repair surface to make firm and stable
 Bar. Severity: 1 Necessary Cost Estimate: \$500.00 Status:
 Implementation Priority: 3 Facility Function:
 Implementation Phase: Implementation Date:
 Official Responsible:

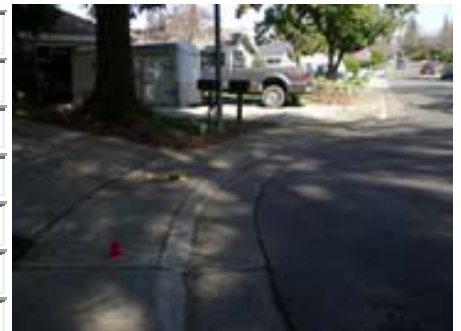
As Built Meas: 102 Quantity: LF
 Description: Cross slope exceeds 2.0% (4.1% to 4.9%)
 As Built Desc: 4.3% cross slope
 Solution: Demolish existing and construct new route
 Bar. Severity: 2 Recommended Cost Estimate: \$12,750.00 Status:
 Implementation Priority: 4 Facility Function:
 Implementation Phase: Implementation Date:
 Official Responsible:

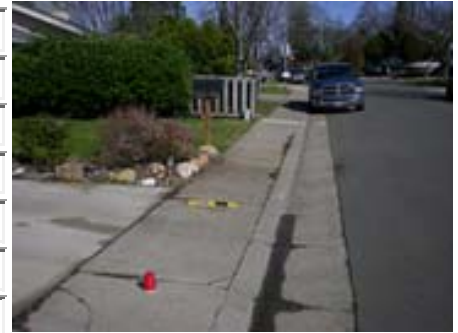
As Built Meas: 185 Quantity: LF
 Description: Cross slope exceeds 2.0% (4.1% to 4.9%)
 As Built Desc: 4.9% cross slope
 Solution: Demolish existing and construct new route
 Bar. Severity: 2 Recommended Cost Estimate: \$23,125.00 Status:
 Implementation Priority: 4 Facility Function:
 Implementation Phase: Implementation Date:
 Official Responsible:

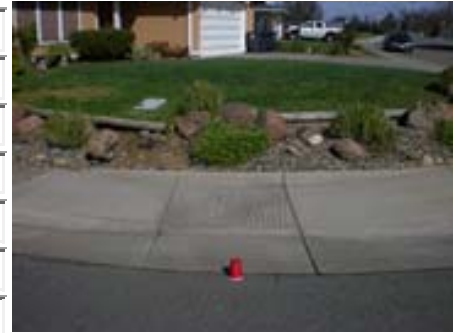
As Built Meas: 1 Quantity: EACH
 Description: No truncated domes provided at curb ramp
 As Built Desc: No detectable warnings at curb ramp
 Solution: Provide compliant truncated domes
 Bar. Severity: 2 Recommended Cost Estimate: \$1,400.00 Status:
 Implementation Priority: 3 Facility Function:
 Implementation Phase: Implementation Date:
 Official Responsible:

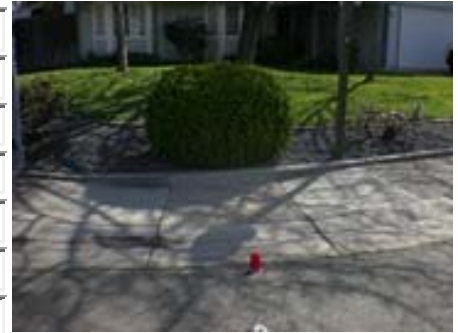
As Built Meas: 1 Quantity: EACH
 Description: No truncated domes provided at curb ramp
 As Built Desc: No detectable warnings at curb ramp
 Solution: Provide compliant truncated domes
 Bar. Severity: 2 Recommended Cost Estimate: \$1,400.00 Status:
 Implementation Priority: 3 Facility Function:
 Implementation Phase: Implementation Date:
 Official Responsible:

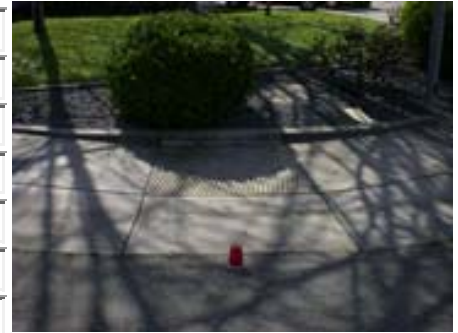
As Built Meas: 1 Quantity: EACH
 Description: No truncated domes provided at curb ramp
 As Built Desc: No detectable warnings at curb ramp
 Solution: Provide compliant truncated domes
 Bar. Severity: 2 Recommended Cost Estimate: \$1,400.00 Status:
 Implementation Priority: 3 Facility Function:
 Implementation Phase: Implementation Date:
 Official Responsible:

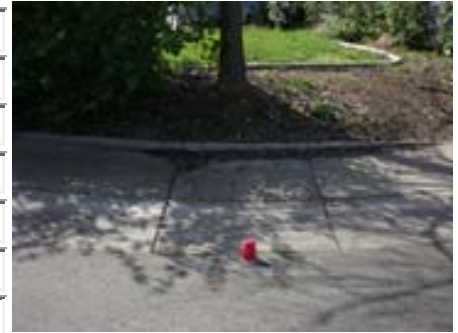
As Built Meas: 1 Quantity: EACH
 Description: No truncated domes provided at curb ramp
 As Built Desc: No detectable warnings at curb ramp
 Solution: Provide compliant truncated domes
 Bar. Severity: 2 Recommended Cost Estimate: \$1,400.00 Status:
 Implementation Priority: 3 Facility Function:
 Implementation Phase: Implementation Date:
 Official Responsible:

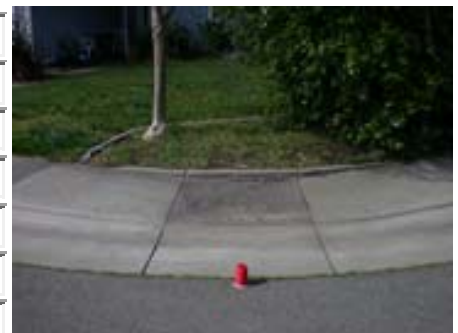
As Built Meas: 1 Quantity: EACH
 Description: 12" grooves at top of curb ramp are not level (4.1% to 4.9%)
 As Built Desc: 4.4% at 12" grooves
 Solution: Demolish existing and construct new curb ramp
 Bar. Severity: 2 Recommended Cost Estimate: \$2,500.00 Status:
 Implementation Priority: 3 Facility Function:
 Implementation Phase: Implementation Date:
 Official Responsible:

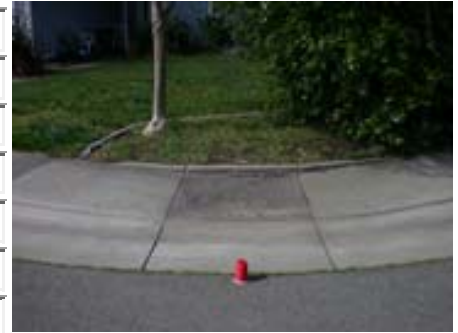
As Built Meas: 1 Quantity: EACH
 Description: No truncated domes provided at curb ramp
 As Built Desc: No detectable warnings at curb ramp
 Solution: Provide compliant truncated domes
 Bar. Severity: 2 Recommended Cost Estimate: \$1,400.00 Status:
 Implementation Priority: 3 Facility Function:
 Implementation Phase: Implementation Date:
 Official Responsible:

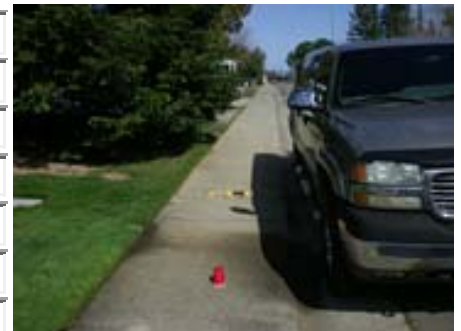
As Built Meas: 550 Quantity: LF
 Description: Cross slope exceeds 2.0% (4.1% to 4.9%)
 As Built Desc: 4.2% cross slope
 Solution: Demolish existing and construct new route
 Bar. Severity: 2 Recommended Cost Estimate: \$68,750.00 Status:
 Implementation Priority: 3 Facility Function:
 Implementation Phase: Implementation Date:
 Official Responsible:

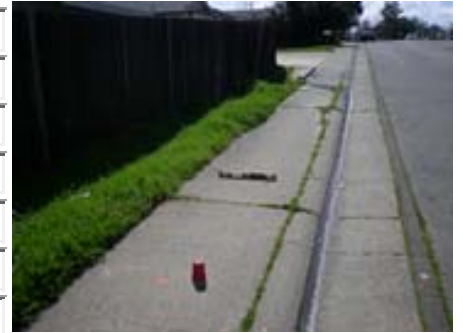
As Built Meas: 455 Quantity: LF
 Description: Cross slope exceeds 2.0% (4.1% to 4.9%)
 As Built Desc: 4.4% cross slope
 Solution: Demolish existing and construct new route
 Bar. Severity: 2 Recommended Cost Estimate: \$56,875.00 Status:
 Implementation Priority: 3 Facility Function:
 Implementation Phase: Implementation Date:
 Official Responsible:

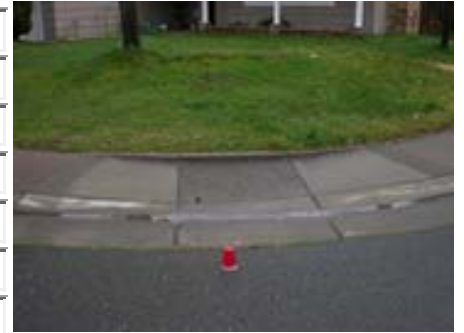
As Built Meas: 1 Quantity: EACH
 Description: No truncated domes provided at curb ramp
 As Built Desc: No detectable warnings at curb ramp
 Solution: Provide compliant truncated domes
 Bar. Severity: 2 Recommended Cost Estimate: \$1,400.00 Status:
 Implementation Priority: 3 Facility Function:
 Implementation Phase: Implementation Date:
 Official Responsible:

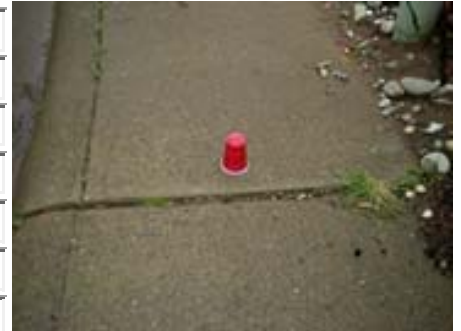
As Built Meas: 6 Quantity: LF
 Description: Change in level greater than 1/2"
 As Built Desc: 1/2" lip in sidewalk surface
 Solution: Grind or repair sidewalk to remove trip hazard
 Bar. Severity: 1 Necessary Cost Estimate: \$1,500.00 Status:
 Implementation Priority: 4 Facility Function:
 Implementation Phase: Implementation Date:
 Official Responsible:

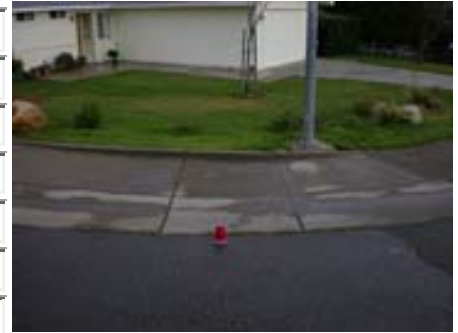
As Built Meas: 1 Quantity: EACH
 Description: No truncated domes provided at curb ramp
 As Built Desc: No detectable warnings at curb ramp
 Solution: Provide compliant truncated domes
 Bar. Severity: 2 Recommended Cost Estimate: \$1,400.00 Status:
 Implementation Priority: 3 Facility Function:
 Implementation Phase: Implementation Date:
 Official Responsible:

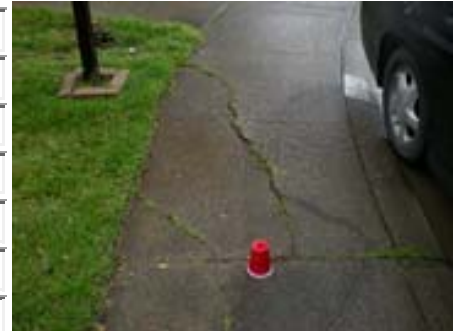
As Built Meas: 4 Quantity: LF
 Description: Surface is not firm and stable (cracked, broken or loose soil, etc.)
 As Built Desc: Cracked concrete
 Solution: Repair surface to make firm and stable
 Bar. Severity: 1 Necessary Cost Estimate: \$500.00 Status:
 Implementation Priority: 3 Facility Function:
 Implementation Phase: Implementation Date:
 Official Responsible:

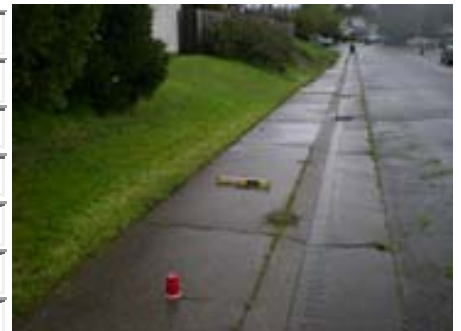
As Built Meas: 400 Quantity: LF
 Description: Cross slope exceeds 2.0% (4.1% to 4.9%)
 As Built Desc: 4.1% cross slope
 Solution: Demolish existing and construct new route
 Bar. Severity: 2 Recommended Cost Estimate: \$50,000.00 Status:
 Implementation Priority: 3 Facility Function:
 Implementation Phase: Implementation Date:
 Official Responsible:

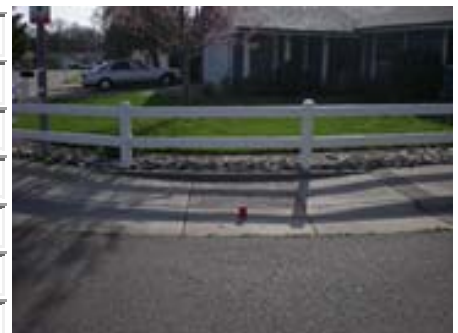
As Built Meas: 1 Quantity: EACH
 Description: No truncated domes provided at curb ramp
 As Built Desc: No detectable warnings at curb ramp
 Solution: Provide compliant truncated domes
 Bar. Severity: 2 Recommended Cost Estimate: \$1,400.00 Status:
 Implementation Priority: 3 Facility Function:
 Implementation Phase: Implementation Date:
 Official Responsible:

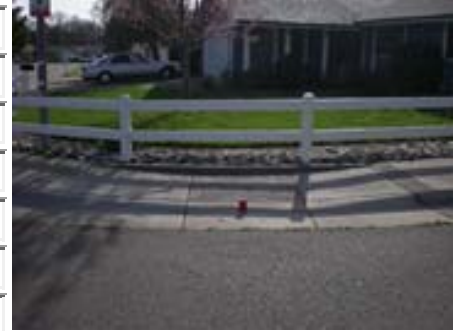
As Built Meas: 1 Quantity: SF
 Description: Gutter slope exceeds 5.0% (6.6% to 8.2%)
 As Built Desc: 6.9% gutter slope
 Solution: Demolish existing and construct new gutter
 Bar. Severity: 2 Recommended Cost Estimate: \$125.00 Status:
 Implementation Priority: 3 Facility Function:
 Implementation Phase: Implementation Date:
 Official Responsible:

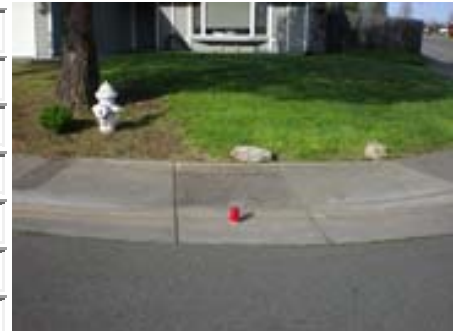
As Built Meas: 1 Quantity: EACH
 Description: 12" grooves at top of curb ramp are not level (4.1% to 4.9%)
 As Built Desc: 4.1% at 12" grooves
 Solution: Demolish existing and construct new curb ramp
 Bar. Severity: 2 Recommended Cost Estimate: \$2,500.00 Status:
 Implementation Priority: 3 Facility Function:
 Implementation Phase: Implementation Date:
 Official Responsible:

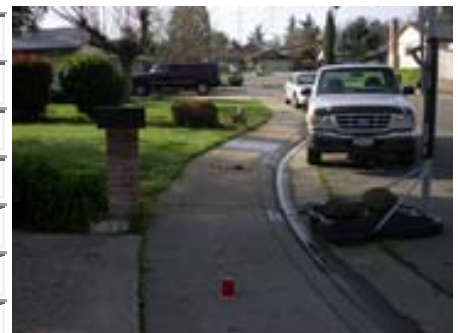
As Built Meas: 276 Quantity: LF
 Description: Cross slope exceeds 2.0% (4.1% to 4.9%)
 As Built Desc: 4.4% cross slope
 Solution: Demolish existing and construct new route
 Bar. Severity: 2 Recommended Cost Estimate: \$34,500.00 Status:
 Implementation Priority: 4 Facility Function:
 Implementation Phase: Implementation Date:
 Official Responsible:

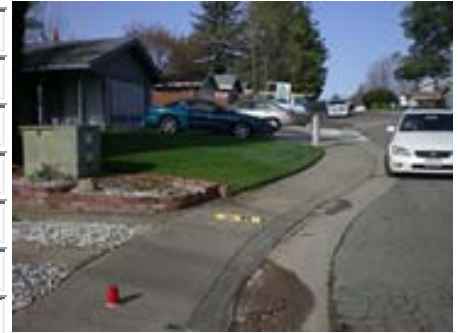
As Built Meas: 727 Quantity: LF
 Description: Cross slope exceeds 2.0% (4.1% to 4.9%)
 As Built Desc: 4.8% cross slope
 Solution: Demolish existing and construct new route
 Bar. Severity: 2 Recommended Cost Estimate: \$90,875.00 Status:
 Implementation Priority: 4 Facility Function:
 Implementation Phase: Implementation Date:
 Official Responsible:

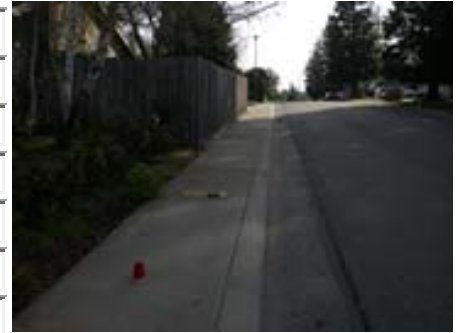
As Built Meas: 710 Quantity: LF
 Description: Cross slope exceeds 2.0% (4.1% to 4.9%)
 As Built Desc: 4.9% cross slope
 Solution: Demolish existing and construct new route
 Bar. Severity: 2 Recommended Cost Estimate: \$88,750.00 Status:
 Implementation Priority: 4 Facility Function:
 Implementation Phase: Implementation Date:
 Official Responsible:

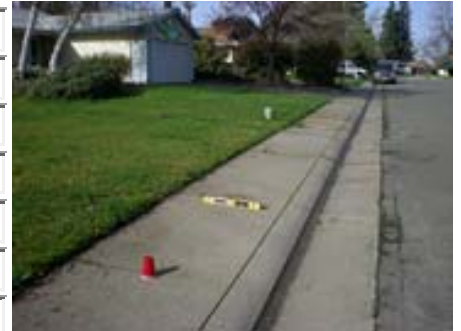
As Built Meas: 300 Quantity: LF
 Description: Cross slope exceeds 2.0% (4.1% to 4.9%)
 As Built Desc: 4.3% cross slope
 Solution: Demolish existing and construct new route
 Bar. Severity: 2 Recommended Cost Estimate: \$37,500.00 Status:
 Implementation Priority: 4 Facility Function:
 Implementation Phase: Implementation Date:
 Official Responsible:

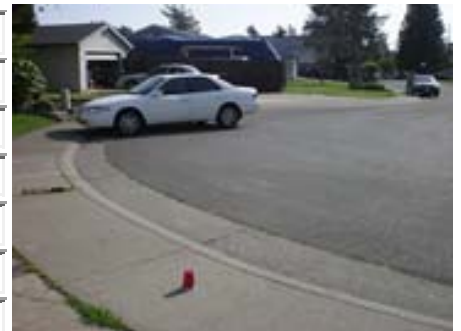
As Built Meas: 313 Quantity: LF
 Description: Cross slope exceeds 2.0% (4.1% to 4.9%)
 As Built Desc: 4.9% cross slope
 Solution: Demolish existing and construct new route
 Bar. Severity: 2 Recommended Cost Estimate: \$39,125.00 Status:
 Implementation Priority: 4 Facility Function:
 Implementation Phase: Implementation Date:
 Official Responsible:
