**DRAFT ADA TRANSITION PLAN UPDATE
NEIGHBORHOOD AREA 8 CHASE
SEPTEMBER 20, 2011**

CITY OF CITRUS HEIGHTS

Conditions - CHASE Area 8

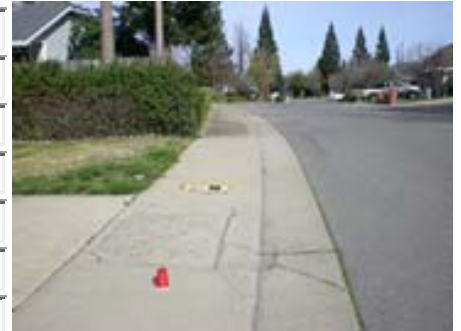
Field Date:	3/4/2011	Report Date:	3/4/2011	Barrier #:	5743
Location:	Fox Hills Dr - West				
X Coordinate:	-121.2685				
Y Coordinate:	38.70106				
Barrier Area:	Sidewalks				
Barrier Type:	Cross Slope - Existing (3.1% to 4.0%)				
Code Ref:	CBC 1133B.7.1.3 and ADA/ABA 403.3

As Built Meas:	115	Quantity:	LF
Description:	Cross slope exceeds 2.0% (3.1% to 4.0%)		
As Built Desc:	3.2% cross slope		
Solution:	Demolish existing and construct new route		
Bar. Severity:	3 Hinderance	Cost Estimate:	\$14,375.00
Implementation Priority:	4	Facility Function:	
Implementation Phase:		Implementation Date:	
Official Responsible:

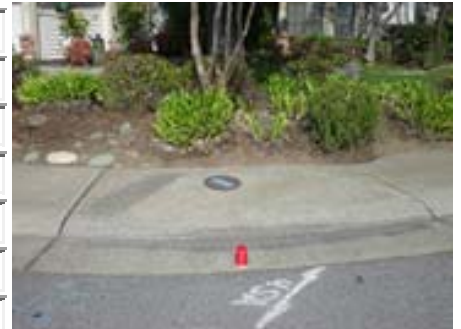
Field Date:	3/4/2011	Report Date:	3/4/2011	Barrier #:	5744
Location:	Fox Hills Dr and Kyle Ct - Corner A				
X Coordinate:	-121.26863				
Y Coordinate:	38.70152				
Barrier Area:	Curb Ramps				
Barrier Type:	No Curb Ramp - Depressed Existing Curb				
Code Ref:	CBC 1127B.5.1 and ADA/ABA 402.2

As Built Meas:	1	Quantity:	EACH
Description:	No compliant curb cut at corner (intersection)		
As Built Desc:	11.4% running slope at depressed area		
Solution:	Demolish existing and construct curb cut		
Bar. Severity:	1 Necessary	Cost Estimate:	\$2,500.00
Implementation Priority:	4	Facility Function:	
Implementation Phase:		Implementation Date:	
Official Responsible:

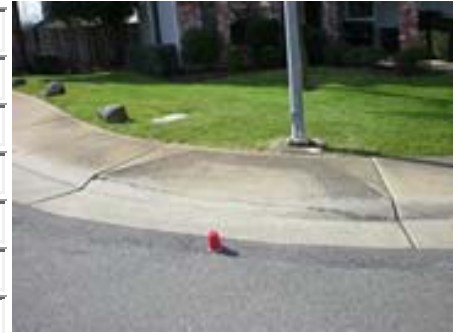
Field Date: 3/4/2011 Report Date: 3/4/2011 Barrier #: 5745
 Location: Fox Hills Dr and Kyle Ct - Corner D
 X Coordinate: -121.26859
 Y Coordinate: 38.70138
 Barrier Area: Curb Ramps
 Barrier Type: No Curb Ramp - Depressed Existing Curb
 Code Ref: CBC 1127B.5.1 and ADA/ABA 402.2

As Built Meas: 1 Quantity: EACH
 Description: No compliant curb cut at corner (intersection)
 As Built Desc: 12.7% running slope at depressed area
 Solution: Demolish existing and construct curb cut
 Bar. Severity: 1 Necessary Cost Estimate: \$2,500.00 Status:
 Implementation Priority: 4 Facility Function:
 Implementation Phase: Implementation Date:
 Official Responsible:

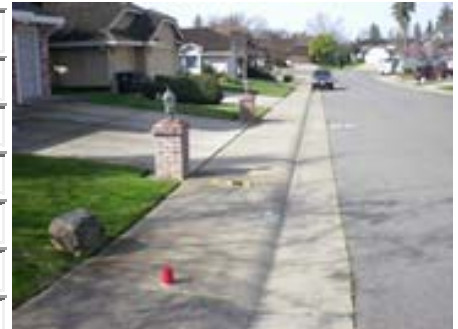
Field Date: 3/4/2011 Report Date: 3/4/2011 Barrier #: 5746
 Location: Kyle Ct - South
 X Coordinate: -121.26866
 Y Coordinate: 38.70139
 Barrier Area: Sidewalks
 Barrier Type: Cross Slope - Existing (3.1% to 4.0%)
 Code Ref: CBC 1133B.7.1.3 and ADA/ABA 403.3

As Built Meas: 85 Quantity: LF
 Description: Cross slope exceeds 2.0% (3.1% to 4.0%)
 As Built Desc: 3.6% cross slope
 Solution: Demolish existing and construct new route
 Bar. Severity: 3 Hinderance Cost Estimate: \$10,625.00 Status:
 Implementation Priority: 4 Facility Function:
 Implementation Phase: Implementation Date:
 Official Responsible:

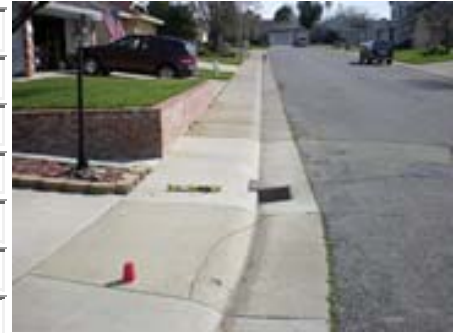
Barrier Type: Cross Slope - Existing (4.1% to 4.9%)

Code Ref: CBC 1133B.7.1.3 and ADA/ABA 403.3

As Built Meas: 255 Quantity: LF

Description: Cross slope exceeds 2.0% (4.1% to 4.9%)

Bar. Severity: 2 Recommended Cost Estimate: \$31,875.00 Status:

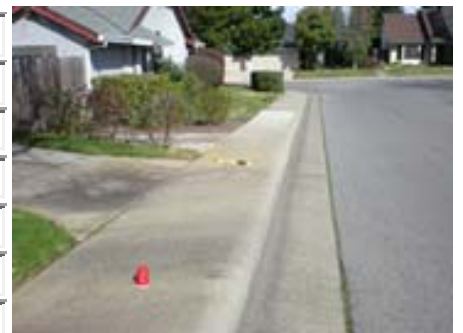
Barrier Type: Cross Slope - Existing (4.1% to 4.9%)

Code Ref: CBC 1133B.7.1.3 and ADA/ABA 403.3

As Built Meas: 110 Quantity: LF

Description: Cross slope exceeds 2.0% (4.1% to 4.9%)

Bar. Severity: 2 Recommended Cost Estimate: \$13,750.00 Status:

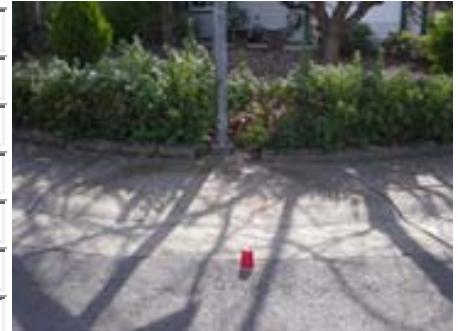
Field Date: 3/4/2011 Report Date: 3/4/2011 Barrier #: 5749
 Location: Fox Hills Dr and Joshua Ct - Corner C
 X Coordinate: -121.26846
 Y Coordinate: 38.70208
 Barrier Area: Curb Ramps
 Barrier Type: No Curb Ramp - Depressed Existing Curb
 Code Ref: CBC 1127B.5.1 and ADA/ABA 402.2

As Built Meas: 1 Quantity: EACH
 Description: No compliant curb cut at corner (intersection)
 As Built Desc: 10.5% running slope at depressed area
 Solution: Demolish existing and construct curb cut
 Bar. Severity: 1 Necessary Cost Estimate: \$2,500.00 Status:
 Implementation Priority: 4 Facility Function:
 Implementation Phase: Implementation Date:
 Official Responsible:

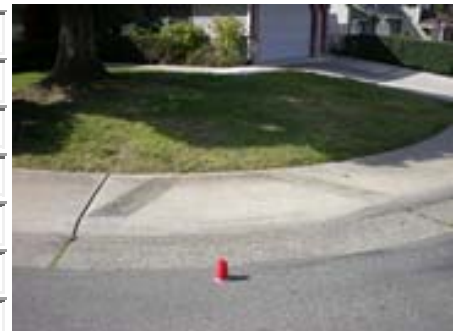
Field Date: 3/4/2011 Report Date: 3/4/2011 Barrier #: 5750
 Location: Fox Hills Dr and Joshua Ct - Corner D
 X Coordinate: -121.2686
 Y Coordinate: 38.70205
 Barrier Area: Curb Ramps
 Barrier Type: No Curb Ramp - Depressed Existing Curb
 Code Ref: CBC 1127B.5.1 and ADA/ABA 402.2

As Built Meas: 1 Quantity: EACH
 Description: No compliant curb cut at corner (intersection)
 As Built Desc: 9.8% running slope at depressed area
 Solution: Demolish existing and construct curb cut
 Bar. Severity: 1 Necessary Cost Estimate: \$2,500.00 Status:
 Implementation Priority: 4 Facility Function:
 Implementation Phase: Implementation Date:
 Official Responsible:

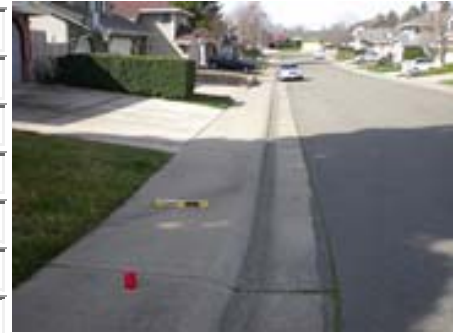
Barrier Type: Cross Slope - Existing (4.1% to 4.9%)

Code Ref: CBC 1133B.7.1.3 and ADA/ABA 403.3

As Built Meas: 477 Quantity: LF

Description: Cross slope exceeds 2.0% (4.1% to 4.9%)

Bar. Severity: 2 Recommended Cost Estimate: \$59,625.00 Status:

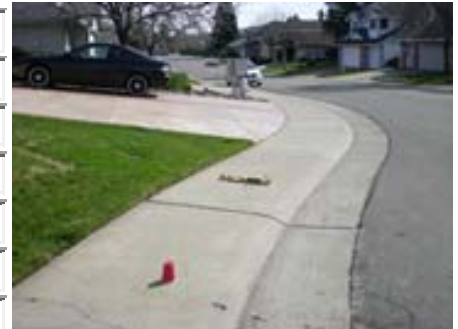
Barrier Type: Cross Slope - Existing (3.1% to 4.0%)

Code Ref: CBC 1133B.7.1.3 and ADA/ABA 403.3

As Built Meas: 451 Quantity: LF

Description: Cross slope exceeds 2.0% (3.1% to 4.0%)

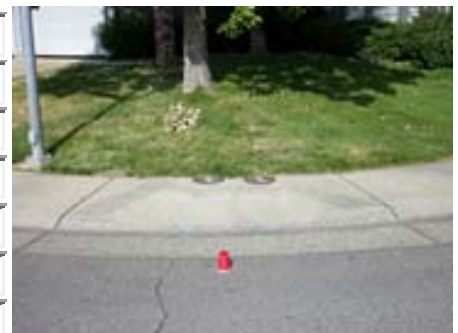
Field Date: 3/4/2011 Report Date: 3/4/2011 Barrier #: 5753
 Location: Fox Hills Dr and Saginaw Wy - Corner A
 X Coordinate: -121.26769
 Y Coordinate: 38.7022
 Barrier Area: Curb Ramps
 Barrier Type: No Curb Ramp - Depressed Existing Curb
 Code Ref: CBC 1127B.5.1 and ADA/ABA 402.2

As Built Meas: 1 Quantity: EACH
 Description: No compliant curb cut at corner (intersection)
 As Built Desc: 10.2% running slope at depressed area
 Solution: Demolish existing and construct curb cut
 Bar. Severity: 1 Necessary Cost Estimate: \$2,500.00 Status:
 Implementation Priority: 4 Facility Function:
 Implementation Phase: Implementation Date:
 Official Responsible:

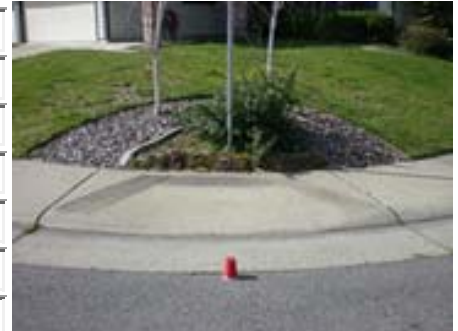
Field Date: 3/4/2011 Report Date: 3/4/2011 Barrier #: 5754
 Location: Fox Hills Dr and Saginaw Wy - Corner D
 X Coordinate: -121.26767
 Y Coordinate: 38.70206
 Barrier Area: Curb Ramps
 Barrier Type: No Curb Ramp - Depressed Existing Curb
 Code Ref: CBC 1127B.5.1 and ADA/ABA 402.2

As Built Meas: 1 Quantity: EACH
 Description: No compliant curb cut at corner (intersection)
 As Built Desc: 9.3% running slope at depressed area
 Solution: Demolish existing and construct curb cut
 Bar. Severity: 1 Necessary Cost Estimate: \$2,500.00 Status:
 Implementation Priority: 4 Facility Function:
 Implementation Phase: Implementation Date:
 Official Responsible:

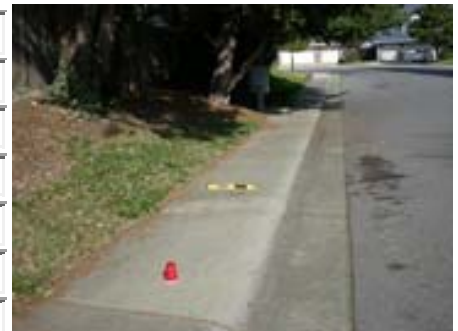
Field Date: 3/4/2011 Report Date: 3/4/2011 Barrier #: 5755
 Location: Saginaw Wy - West
 X Coordinate: -121.26767
 Y Coordinate: 38.70237
 Barrier Area: Sidewalks
 Barrier Type: Cross Slope - Existing (3.1% to 4.0%)
 Code Ref: CBC 1133B.7.1.3 and ADA/ABA 403.3

As Built Meas: 96 Quantity: LF
 Description: Cross slope exceeds 2.0% (3.1% to 4.0%)
 As Built Desc: 3.2% cross slope
 Solution: Demolish existing and construct new route
 Bar. Severity: 3 Hinderance Cost Estimate: \$12,000.00 Status:
 Implementation Priority: 4 Facility Function:
 Implementation Phase: Implementation Date:
 Official Responsible:

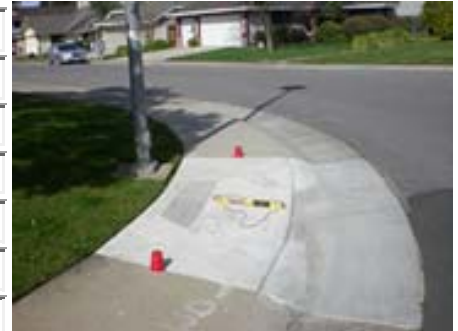
Field Date: 3/4/2011 Report Date: 3/4/2011 Barrier #: 5756
 Location: Saginaw Wy - West
 X Coordinate: -121.26769
 Y Coordinate: 38.70273
 Barrier Area: Sidewalks
 Barrier Type: Elbow in Sidewalk - Cross Slope (5.0% or more)
 Code Ref: CBC 1133B.7.1.3 and ADA/ABA 403.3

As Built Meas: 6 Quantity: LF
 Description: Cross slope at elbow exceeds 2.0% (5.0% or more)
 As Built Desc: 10.2% cross slope
 Solution: Demolish existing and construct new sidewalk without curb ramp
 Bar. Severity: 1 Necessary Cost Estimate: \$750.00 Status:
 Implementation Priority: 4 Facility Function:
 Implementation Phase: Implementation Date:
 Official Responsible:

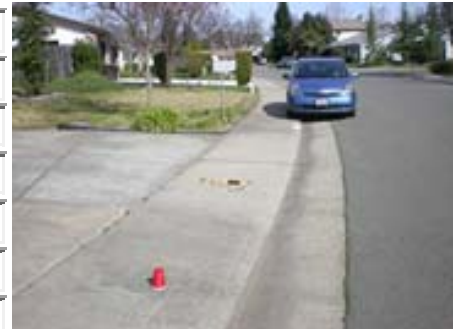
Field Date: 3/4/2011 Report Date: 3/4/2011 Barrier #: 5757
 Location: Saginaw Wy - West
 X Coordinate: -121.26905
 Y Coordinate: 38.70312
 Barrier Area: Sidewalks
 Barrier Type: Cross Slope - Existing (4.1% to 4.9%)
 Code Ref: CBC 1133B.7.1.3 and ADA/ABA 403.3

As Built Meas: 324 Quantity: LF
 Description: Cross slope exceeds 2.0% (4.1% to 4.9%)
 As Built Desc: 4.1% cross slope
 Solution: Demolish existing and construct new route
 Bar. Severity: 2 Recommended Cost Estimate: \$40,500.00 Status:
 Implementation Priority: 4 Facility Function:
 Implementation Phase: Implementation Date:
 Official Responsible:

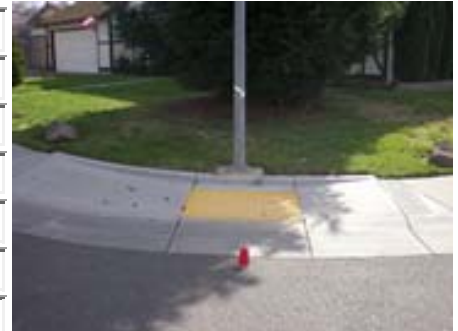
Field Date: 3/4/2011 Report Date: 3/4/2011 Barrier #: 5758A
 Location: Saginaw Wy and Soquel Wy - Corner C
 X Coordinate: -121.26878
 Y Coordinate: 38.70411
 Barrier Area: Curb Ramps
 Barrier Type: 12" Grooves - Existing (4.1% to 4.9%)
 Code Ref: CBC 1127B.5.6

As Built Meas: 1 Quantity: EACH
 Description: 12" grooves at top of curb ramp are not level (4.1% to 4.9%)
 As Built Desc: 4.4% at 12" grooves
 Solution: Demolish existing and construct new curb ramp
 Bar. Severity: 2 Recommended Cost Estimate: \$2,500.00 Status:
 Implementation Priority: 4 Facility Function:
 Implementation Phase: Implementation Date:
 Official Responsible:

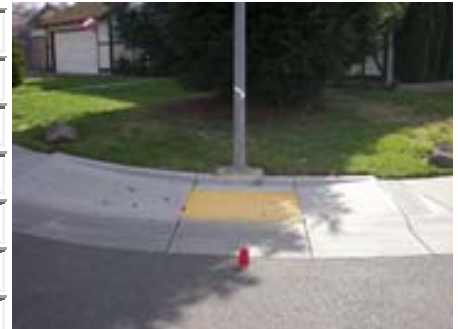
Field Date: 3/4/2011 Report Date: 3/4/2011 Barrier #: 5758B
 Location: Saginaw Wy and Soquel Wy - Corner C
 X Coordinate: -121.26878
 Y Coordinate: 38.70411
 Barrier Area: Curb Ramps
 Barrier Type: Parallel Ramp Landing - Existing (3.1% to 4.0%)
 Code Ref: CBC 1127B.5.4 and ADA/ABA 406.4

As Built Meas: 1 Quantity: EACH
 Description: Curb ramp landing or pan not level (3.1% to 4.0%)
 As Built Desc: 3.1% landing slope
 Solution: Demolish existing and construct new transition
 Bar. Severity: 3 Hindrance Cost Estimate: \$250.00 Status:
 Implementation Priority: 4 Facility Function:
 Implementation Phase: Implementation Date:
 Official Responsible:

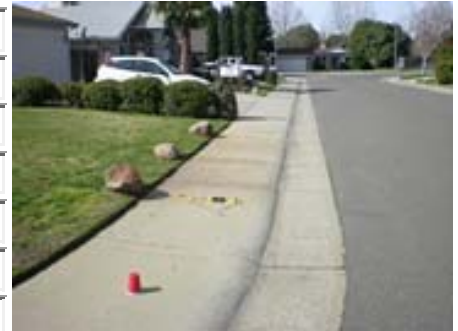
Field Date: 3/4/2011 Report Date: 3/4/2011 Barrier #: 5759
 Location: Soquel Wy - South
 X Coordinate: -121.26902
 Y Coordinate: 38.7041
 Barrier Area: Sidewalks
 Barrier Type: Cross Slope - Existing (4.1% to 4.9%)
 Code Ref: CBC 1133B.7.1.3 and ADA/ABA 403.3

As Built Meas: 178 Quantity: LF
 Description: Cross slope exceeds 2.0% (4.1% to 4.9%)
 As Built Desc: 4.4% cross slope
 Solution: Demolish existing and construct new route
 Bar. Severity: 2 Recommended Cost Estimate: \$22,250.00 Status:
 Implementation Priority: 4 Facility Function:
 Implementation Phase: Implementation Date:
 Official Responsible:

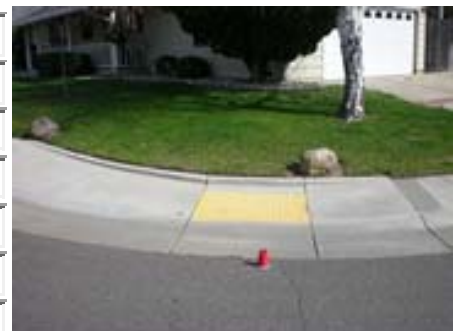
Field Date: 3/4/2011 Report Date: 3/4/2011 Barrier #: 5760A
 Location: Soquel Wy and Clovis Ct - Corner B
 X Coordinate: -121.26973
 Y Coordinate: 38.70415
 Barrier Area: Curb Ramps
 Barrier Type: 12" Grooves - Existing (4.1% to 4.9%)
 Code Ref: CBC 1127B.5.6

As Built Meas: 1 Quantity: EACH
 Description: 12" grooves at top of curb ramp are not level (4.1% to 4.9%)
 As Built Desc: 4.4% at 12" grooves
 Solution: Demolish existing and construct new curb ramp
 Bar. Severity: 2 Recommended Cost Estimate: \$2,500.00 Status:
 Implementation Priority: 4 Facility Function:
 Implementation Phase: Implementation Date:
 Official Responsible:

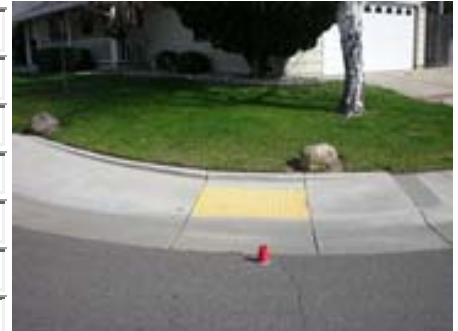
Field Date: 3/4/2011 Report Date: 3/4/2011 Barrier #: 5760B
 Location: Soquel Wy and Clovis Ct - Corner B
 X Coordinate: -121.26973
 Y Coordinate: 38.70415
 Barrier Area: Curb Ramps
 Barrier Type: Parallel Ramp Landing - Existing (4.1% to 4.9%)
 Code Ref: CBC 1127B.5.4 and ADA/ABA 406.4

As Built Meas: 1 Quantity: EACH
 Description: Curb ramp landing or pan not level(4.1% to 4.9%)
 As Built Desc: 4.1% landing slope
 Solution: Demolish existing and construct new transition
 Bar. Severity: 2 Recommended Cost Estimate: \$250.00 Status:
 Implementation Priority: 4 Facility Function:
 Implementation Phase: Implementation Date:
 Official Responsible:

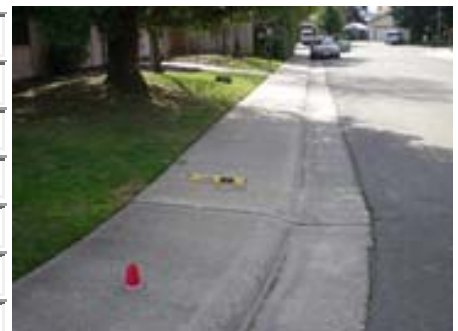
Field Date: 3/4/2011 Report Date: 3/4/2011 Barrier #: 5761
 Location: Clovis Ct - East
 X Coordinate: -121.26969
 Y Coordinate: 38.70401
 Barrier Area: Sidewalks
 Barrier Type: Cross Slope - Existing (4.1% to 4.9%)
 Code Ref: CBC 1133B.7.1.3 and ADA/ABA 403.3

As Built Meas: 343 Quantity: LF
 Description: Cross slope exceeds 2.0% (4.1% to 4.9%)
 As Built Desc: 4.5% cross slope
 Solution: Demolish existing and construct new route
 Bar. Severity: 2 Recommended Cost Estimate: \$42,875.00 Status:
 Implementation Priority: 4 Facility Function:
 Implementation Phase: Implementation Date:
 Official Responsible:

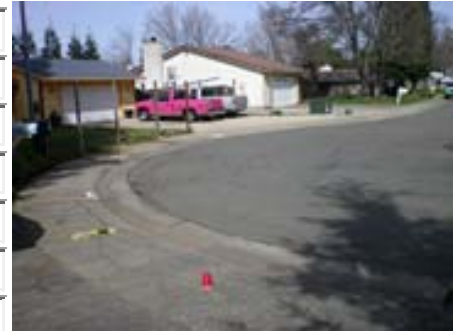
Field Date: 3/4/2011 Report Date: 3/4/2011 Barrier #: 5762A
 Location: Clovis Ct - West
 X Coordinate: -121.26984
 Y Coordinate: 38.70345
 Barrier Area: Sidewalks
 Barrier Type: Cross Slope - Existing (5.0% or more)
 Code Ref: CBC 1133B.7.1.3 and ADA/ABA 403.3

As Built Meas: 491 Quantity: LF
 Description: Cross slope exceeds 2.0% (5.0% or more)
 As Built Desc: 5.0% cross slope
 Solution: Demolish existing and construct new route
 Bar. Severity: 1 Necessary Cost Estimate: \$61,375.00 Status:
 Implementation Priority: 4 Facility Function:
 Implementation Phase: Implementation Date:
 Official Responsible:

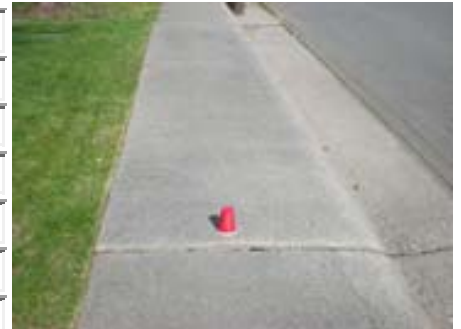
Field Date: 3/4/2011 Report Date: 3/4/2011 Barrier #: 5762B
 Location: Clovis Ct - West
 X Coordinate: -121.26986
 Y Coordinate: 38.70377
 Barrier Area: Sidewalks
 Barrier Type: Abrupt Change in Level - > 1/2"
 Code Ref: CBC 1133B.7.1 and ADA/ABA 303.3

As Built Meas: 4 Quantity: LF
 Description: Change in level greater than 1/2"
 As Built Desc: 1/2" lip in sidewalk surface
 Solution: Grind or repair sidewalk to remove trip hazard
 Bar. Severity: 1 Necessary Cost Estimate: \$1,000.00 Status:
 Implementation Priority: 4 Facility Function:
 Implementation Phase: Implementation Date:
 Official Responsible:

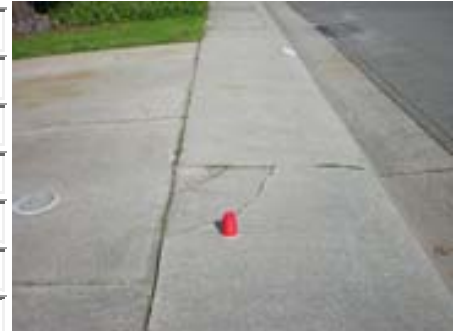
Field Date: 3/4/2011 Report Date: 3/4/2011 Barrier #: 5762C
 Location: Clovis Ct - West
 X Coordinate: -121.26985
 Y Coordinate: 38.70389
 Barrier Area: Sidewalks
 Barrier Type: Surface Condition - Damaged
 Code Ref: CBC 1133B.7.1 and ADA/ABA 302.1

As Built Meas: 4 Quantity: LF
 Description: Surface is not firm and stable (cracked, broken or loose soil, etc.)
 As Built Desc: Cracked concrete
 Solution: Repair surface to make firm and stable
 Bar. Severity: 1 Necessary Cost Estimate: \$500.00 Status:
 Implementation Priority: 4 Facility Function:
 Implementation Phase: Implementation Date:
 Official Responsible:

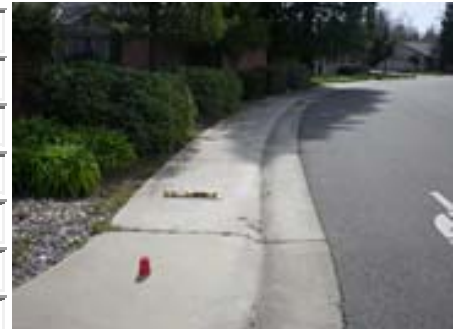
Field Date: 3/4/2011 Report Date: 3/4/2011 Barrier #: 5763
 Location: Clovis Ct - East
 X Coordinate: -121.26985
 Y Coordinate: 38.70478
 Barrier Area: Sidewalks
 Barrier Type: Cross Slope - Existing (3.1% to 4.0%)
 Code Ref: CBC 1133B.7.1.3 and ADA/ABA 403.3

As Built Meas: 46 Quantity: LF
 Description: Cross slope exceeds 2.0% (3.1% to 4.0%)
 As Built Desc: 3.1% cross slope
 Solution: Demolish existing and construct new route
 Bar. Severity: 3 Hinderance Cost Estimate: \$5,750.00 Status:
 Implementation Priority: 4 Facility Function:
 Implementation Phase: Implementation Date:
 Official Responsible:

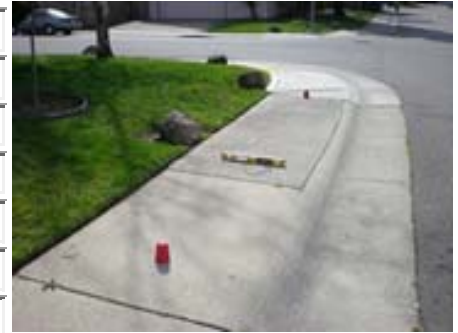
Field Date: 3/4/2011 Report Date: 3/4/2011 Barrier #: 5764
 Location: Clovis Ct - East
 X Coordinate: -121.26972
 Y Coordinate: 38.70425
 Barrier Area: Sidewalks
 Barrier Type: Cross Slope - Existing (5.0% or more)
 Code Ref: CBC 1133B.7.1.3 and ADA/ABA 403.3

As Built Meas: 14 Quantity: LF
 Description: Cross slope exceeds 2.0% (5.0% or more)
 As Built Desc: 5.6% cross slope
 Solution: Demolish existing and construct new route
 Bar. Severity: 1 Necessary Cost Estimate: \$1,750.00 Status:
 Implementation Priority: 4 Facility Function:
 Implementation Phase: Implementation Date:
 Official Responsible:

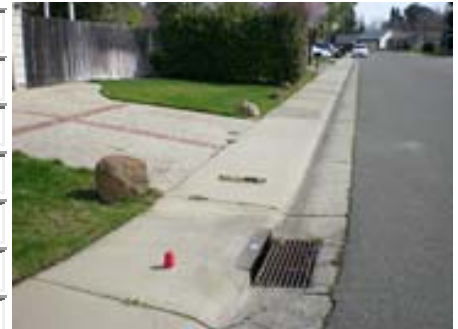
Field Date: 3/4/2011 Report Date: 3/4/2011 Barrier #: 5765
 Location: Soquel Wy - North
 X Coordinate: -121.26959
 Y Coordinate: 38.70419
 Barrier Area: Sidewalks
 Barrier Type: Cross Slope - Existing (4.1% to 4.9%)
 Code Ref: CBC 1133B.7.1.3 and ADA/ABA 403.3

As Built Meas: 352 Quantity: LF
 Description: Cross slope exceeds 2.0% (4.1% to 4.9%)
 As Built Desc: 4.6% cross slope
 Solution: Demolish existing and construct new route
 Bar. Severity: 2 Recommended Cost Estimate: \$44,000.00 Status:
 Implementation Priority: 4 Facility Function:
 Implementation Phase: Implementation Date:
 Official Responsible:

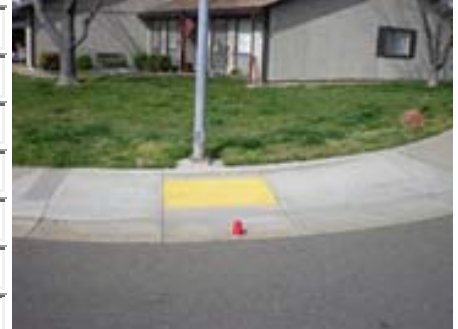
Field Date: 3/4/2011 Report Date: 3/4/2011 Barrier #: 5766A
 Location: Soquel Wy - North
 X Coordinate: -121.26845
 Y Coordinate: 38.70425
 Barrier Area: Curb Ramps
 Barrier Type: Curb Ramp at Elbow - 12" Grooves (>5.0%)
 Code Ref: CBC 1127B.5.6

As Built Meas: 1 Quantity: EACH
 Description: Elbow in roadway has 12" grooves at top of curb ramp are not level (>5.0%)
 As Built Desc: 5.1% slope at 12" grooves
 Solution: Demolish existing and construct standard sidewalk
 Bar. Severity: 1 Necessary Cost Estimate: \$2,500.00 Status:
 Implementation Priority: 4 Facility Function:
 Implementation Phase: Implementation Date:
 Official Responsible:

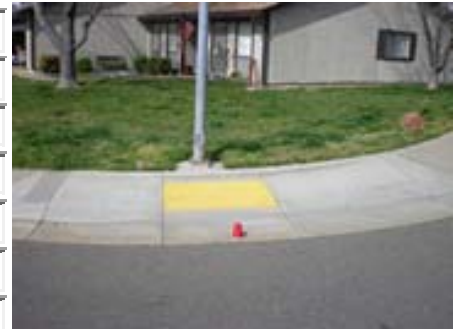
Field Date: 3/4/2011 Report Date: 3/4/2011 Barrier #: 5766B
 Location: Soquel Wy - North
 X Coordinate: -121.26845
 Y Coordinate: 38.70425
 Barrier Area: Curb Ramps
 Barrier Type: Curb Ramp at Elbow - Landing (>5.0% or more)
 Code Ref: CBC 1127B.5.4 and ADA/ABA 406.4

As Built Meas: 1 Quantity: EACH
 Description: Curb ramp landing or pan not level (>5.0% or more)
 As Built Desc: 2.7% slope at ramp landing
 Solution: Demolish existing and construct standard sidewalk
 Bar. Severity: 1 Necessary Cost Estimate: \$250.00 Status:
 Implementation Priority: 4 Facility Function:
 Implementation Phase: Implementation Date:
 Official Responsible:

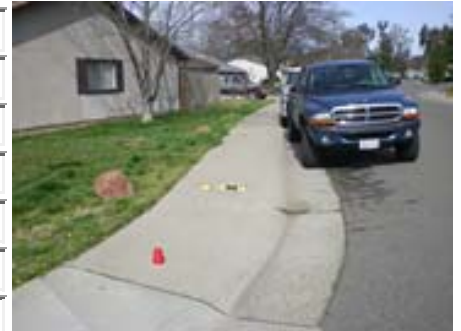
Barrier Type: Cross Slope - Existing (4.1% to 4.9%)

Code Ref: CBC 1133B.7.1.3 and ADA/ABA 403.3

As Built Meas: 291 Quantity: LF

Description: Cross slope exceeds 2.0% (4.1% to 4.9%)

Bar. Severity: 2 Recommended Cost Estimate: \$36,375.00 Status:

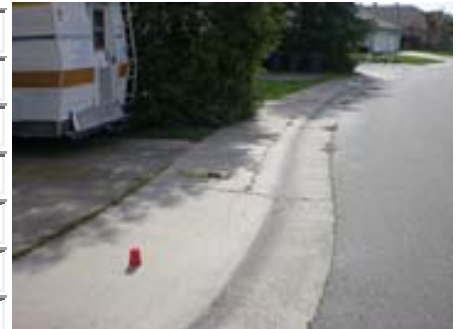
Barrier Type: Cross Slope - Existing (3.1% to 4.0%)

Code Ref: CBC 1133B.7.1.3 and ADA/ABA 403.3

As Built Meas: 81 Quantity: LF

Description: Cross slope exceeds 2.0% (3.1% to 4.0%)

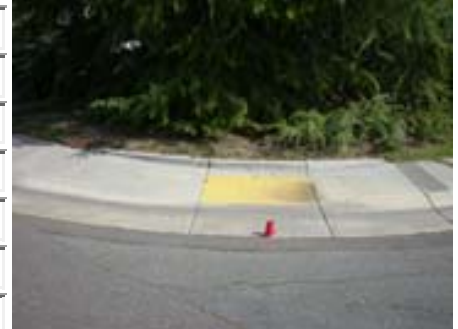
Field Date: 3/4/2011 Report Date: 3/4/2011 Barrier #: 5769A
 Location: Soquel Wy and Tomki Wy - Corner B
 X Coordinate: -121.26844
 Y Coordinate: 38.70507
 Barrier Area: Curb Ramps
 Barrier Type: 12" Grooves - Existing (3.1% to 4.0%)
 Code Ref: CBC 1127B.5.6

As Built Meas: 1 Quantity: EACH
 Description: 12" grooves at top of curb ramp are not level (3.1% to 4.0%)
 As Built Desc: 3.1% at 12" grooves
 Solution: Demolish existing and construct new curb ramp
 Bar. Severity: 3 Hindrance Cost Estimate: \$2,500.00 Status:
 Implementation Priority: 4 Facility Function:
 Implementation Phase: Implementation Date:
 Official Responsible:

Notes: Two - way intersection corners B,C. Corner C compliant

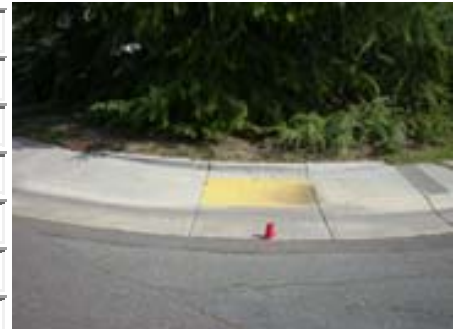
Field Date: 3/4/2011 Report Date: 3/4/2011 Barrier #: 5769B
 Location: Soquel Wy and Tomki Wy - Corner B
 X Coordinate: -121.26844
 Y Coordinate: 38.70507
 Barrier Area: Curb Ramps
 Barrier Type: Parallel Ramp Landing - Existing (3.1% to 4.0%)
 Code Ref: CBC 1127B.5.4 and ADA/ABA 406.4

As Built Meas: 1 Quantity: EACH
 Description: Curb ramp landing or pan not level (3.1% to 4.0%)
 As Built Desc: 3.4% landing slope
 Solution: Demolish existing and construct new transition
 Bar. Severity: 3 Hindrance Cost Estimate: \$250.00 Status:
 Implementation Priority: 4 Facility Function:
 Implementation Phase: Implementation Date:
 Official Responsible:

Notes: Two - way intersection corners B,C. Corner C compliant

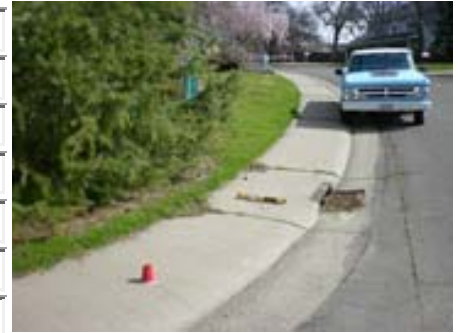
Field Date: 3/4/2011 Report Date: 3/4/2011 Barrier #: 5770A
 Location: Tomki Wy - North
 X Coordinate: -121.26835
 Y Coordinate: 38.70506
 Barrier Area: Sidewalks
 Barrier Type: Cross Slope - Existing (3.1% to 4.0%)
 Code Ref: CBC 1133B.7.1.3 and ADA/ABA 403.3

As Built Meas: 275 Quantity: LF
 Description: Cross slope exceeds 2.0% (3.1% to 4.0%)
 As Built Desc: 3.4% cross slope
 Solution: Demolish existing and construct new route
 Bar. Severity: 3 Hinderance Cost Estimate: \$34,375.00 Status:
 Implementation Priority: 4 Facility Function:
 Implementation Phase: Implementation Date:
 Official Responsible:

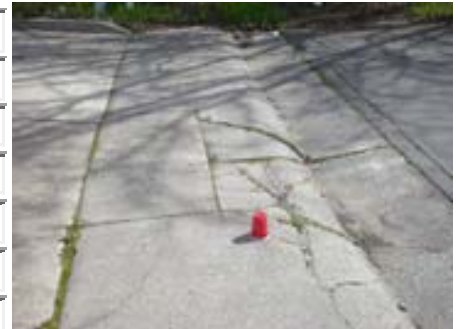
Field Date: 3/4/2011 Report Date: 3/4/2011 Barrier #: 5770B
 Location: Tomki Wy - North
 X Coordinate: -121.26764
 Y Coordinate: 38.70533
 Barrier Area: Sidewalks
 Barrier Type: Surface Condition - Damaged
 Code Ref: CBC 1133B.7.1 and ADA/ABA 302.1

As Built Meas: 4 Quantity: LF
 Description: Surface is not firm and stable (cracked, broken or loose soil, etc.)
 As Built Desc: Cracked concrete
 Solution: Repair surface to make firm and stable
 Bar. Severity: 1 Necessary Cost Estimate: \$500.00 Status:
 Implementation Priority: 4 Facility Function:
 Implementation Phase: Implementation Date:
 Official Responsible:

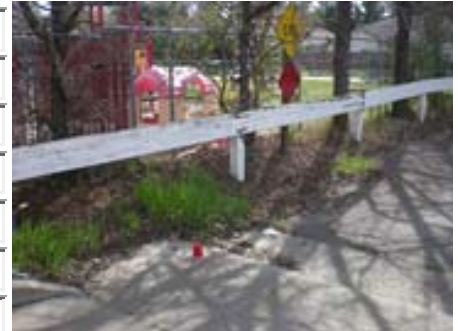
Barrier Type: No Sidewalk - No Barricade

Code Ref: MUTCD Section 6D.01

As Built Meas: 1 Quantity: JOB

Description: No barricade provided where sidewalk ends in hazardous location

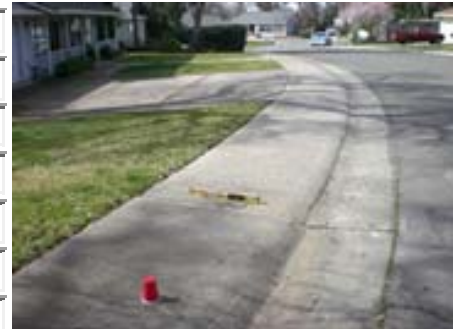
Barrier Type: Cross Slope - Existing (4.1% to 4.9%)

Code Ref: CBC 1133B.7.1.3 and ADA/ABA 403.3

As Built Meas: 268 Quantity: LF

Description: Cross slope exceeds 2.0% (4.1% to 4.9%)

Bar. Severity: 2 Recommended Cost Estimate: \$33,500.00 Status:

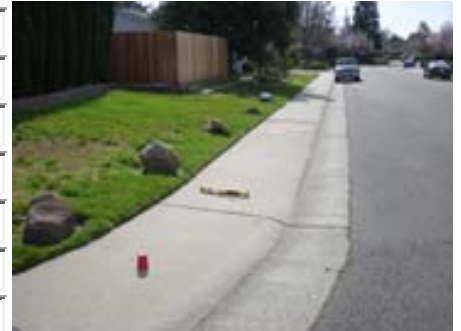
Field Date: 3/4/2011 Report Date: 3/4/2011 Barrier #: 5775
 Location: Saginaw Wy - East
 X Coordinate: -121.26884
 Y Coordinate: 38.70406
 Barrier Area: Sidewalks
 Barrier Type: Cross Slope - Existing (3.1% to 4.0%)
 Code Ref: CBC 1133B.7.1.3 and ADA/ABA 403.3

As Built Meas: 156 Quantity: LF
 Description: Cross slope exceeds 2.0% (3.1% to 4.0%)
 As Built Desc: 3.8% cross slope
 Solution: Demolish existing and construct new route
 Bar. Severity: 3 Hinderance Cost Estimate: \$19,500.00 Status:
 Implementation Priority: 4 Facility Function:
 Implementation Phase: Implementation Date:
 Official Responsible:

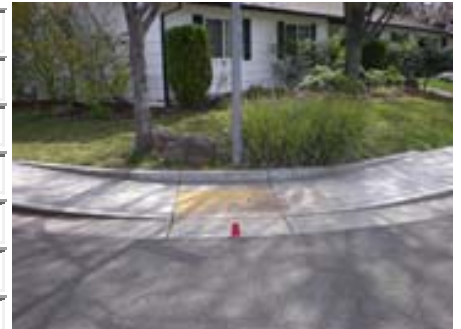
Field Date: 3/4/2011 Report Date: 3/4/2011 Barrier #: 5776
 Location: Saginaw Wy and Wapiti Pl - Corner C
 X Coordinate: -121.2688
 Y Coordinate: 38.70346
 Barrier Area: Curb Ramps
 Barrier Type: 12" Grooves - Existing (4.1% to 4.9%)
 Code Ref: CBC 1127B.5.6

As Built Meas: 1 Quantity: EACH
 Description: 12" grooves at top of curb ramp are not level (4.1% to 4.9%)
 As Built Desc: 4.7% at 12" grooves
 Solution: Demolish existing and construct new curb ramp
 Bar. Severity: 2 Recommended Cost Estimate: \$2,500.00 Status:
 Implementation Priority: 4 Facility Function:
 Implementation Phase: Implementation Date:
 Official Responsible:

Notes: Two - way intersection corners B,C. Corner B compliant

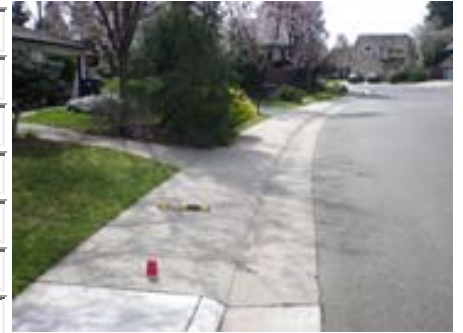
Barrier Type: Cross Slope - Existing (3.1% to 4.0%)

Code Ref: CBC 1133B.7.1.3 and ADA/ABA 403.3

As Built Meas: 176 Quantity: LF

Description: Cross slope exceeds 2.0% (3.1% to 4.0%)

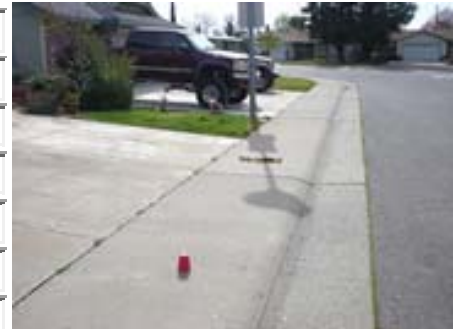
Barrier Type: Cross Slope - Existing (2.1% to 3.0%)

Code Ref: CBC 1133B.7.1.3 and ADA/ABA 403.3

As Built Meas: 200 Quantity: LF

Description: Cross slope exceeds 2.0% (2.1% to 3.0%)

Solution: Low severity barrier - no remediation recommended

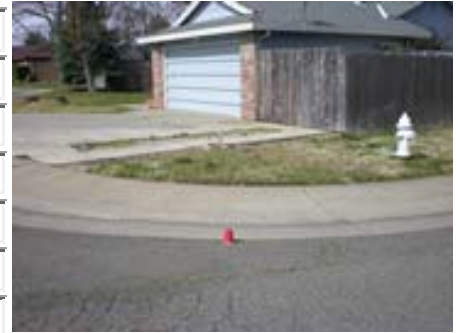
Field Date: 3/4/2011 Report Date: 3/4/2011 Barrier #: 5781
 Location: Woodchuck Wy and Woodchuck Wy Ct - Corner A
 X Coordinate: -121.2632
 Y Coordinate: 38.70443
 Barrier Area: Curb Ramps
 Barrier Type: No Curb Ramp
 Code Ref: CBC 1127B.5.1 and ADA/ABA 402.2

As Built Meas: 1 Quantity: EACH
 Description: No curb cut at corner (intersection)
 As Built Desc: No curb ramp at corner
 Solution: Demolish existing and construct curb cut
 Bar. Severity: 1 Necessary Cost Estimate: \$2,500.00 Status:
 Implementation Priority: 4 Facility Function:
 Implementation Phase: Implementation Date:
 Official Responsible:

Notes: Two - way intersection corners A,B

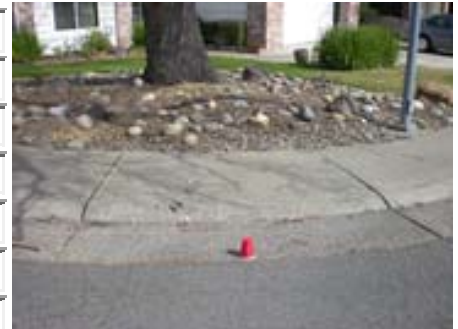
Field Date: 3/4/2011 Report Date: 3/4/2011 Barrier #: 5782
 Location: Woodchuck Wy and Woodchuck Wy Ct - Corner B
 X Coordinate: -121.26303
 Y Coordinate: 38.70447
 Barrier Area: Curb Ramps
 Barrier Type: No Curb Ramp - Depressed Existing Curb
 Code Ref: CBC 1127B.5.1 and ADA/ABA 402.2

As Built Meas: 1 Quantity: EACH
 Description: No compliant curb cut at corner (intersection)
 As Built Desc: 9.3% running slope at depressed area
 Solution: Demolish existing and construct curb cut
 Bar. Severity: 1 Necessary Cost Estimate: \$2,500.00 Status:
 Implementation Priority: 4 Facility Function:
 Implementation Phase: Implementation Date:
 Official Responsible:

Notes: Two - way intersection corners A,B

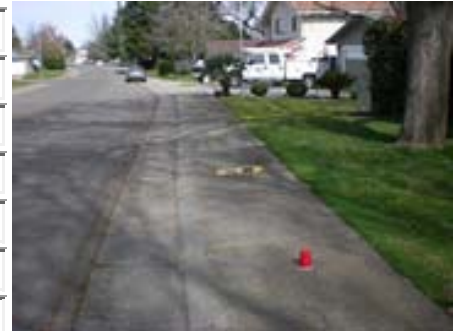
Field Date: 3/4/2011 Report Date: 3/4/2011 Barrier #: 5783A
 Location: Woodchuck Wy - East
 X Coordinate: -121.26305
 Y Coordinate: 38.70469
 Barrier Area: Sidewalks
 Barrier Type: Cross Slope - Existing (3.1% to 4.0%)
 Code Ref: CBC 1133B.7.1.3 and ADA/ABA 403.3

As Built Meas: 71 Quantity: LF
 Description: Cross slope exceeds 2.0% (3.1% to 4.0%)
 As Built Desc: 3.8% cross slope
 Solution: Demolish existing and construct new route
 Bar. Severity: 3 Hinderance Cost Estimate: \$8,875.00 Status:
 Implementation Priority: 4 Facility Function:
 Implementation Phase: Implementation Date:
 Official Responsible:

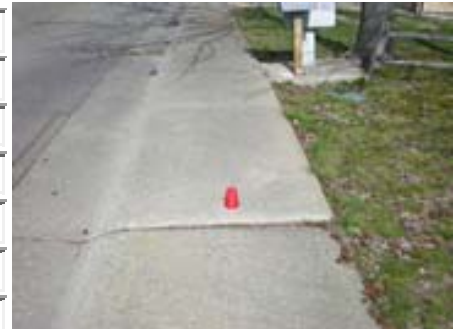
Field Date: 3/4/2011 Report Date: 3/4/2011 Barrier #: 5783B
 Location: Woodchuck Wy - East
 X Coordinate: -121.26309
 Y Coordinate: 38.70615
 Barrier Area: Sidewalks
 Barrier Type: Abrupt Change in Level - > 1/2"
 Code Ref: CBC 1133B.7.1 and ADA/ABA 303.3

As Built Meas: 4 Quantity: LF
 Description: Change in level greater than 1/2"
 As Built Desc: 1" lip in sidewalk surface
 Solution: Grind or repair sidewalk to remove trip hazard
 Bar. Severity: 1 Necessary Cost Estimate: \$1,000.00 Status:
 Implementation Priority: 4 Facility Function:
 Implementation Phase: Implementation Date:
 Official Responsible:

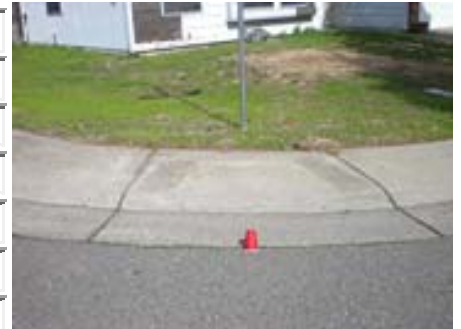
Field Date: 3/4/2011 Report Date: 3/4/2011 Barrier #: 5784
 Location: Woodchuck Wy and Chipmunk Wy - Corner B
 X Coordinate: -121.2648
 Y Coordinate: 38.70667
 Barrier Area: Curb Ramps
 Barrier Type: No Curb Ramp - Depressed Existing Curb
 Code Ref: CBC 1127B.5.1 and ADA/ABA 402.2

As Built Meas: 1 Quantity: EACH
 Description: No compliant curb cut at corner (intersection)
 As Built Desc: 7.0% running slope at depressed area
 Solution: Demolish existing and construct curb cut
 Bar. Severity: 1 Necessary Cost Estimate: \$2,500.00 Status:
 Implementation Priority: 4 Facility Function:
 Implementation Phase: Implementation Date:
 Official Responsible:

Notes: Two - way intersection corners B,C

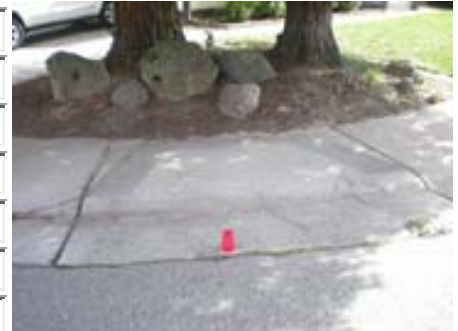
Field Date: 3/4/2011 Report Date: 3/4/2011 Barrier #: 5785
 Location: Woodchuck Wy and Chipmunk Wy - Corner C
 X Coordinate: -121.26469
 Y Coordinate: 38.70653
 Barrier Area: Curb Ramps
 Barrier Type: No Curb Ramp - Depressed Existing Curb
 Code Ref: CBC 1127B.5.1 and ADA/ABA 402.2

As Built Meas: 1 Quantity: EACH
 Description: No compliant curb cut at corner (intersection)
 As Built Desc: 10.4% running slope at depressed area
 Solution: Demolish existing and construct curb cut
 Bar. Severity: 1 Necessary Cost Estimate: \$2,500.00 Status:
 Implementation Priority: 4 Facility Function:
 Implementation Phase: Implementation Date:
 Official Responsible:

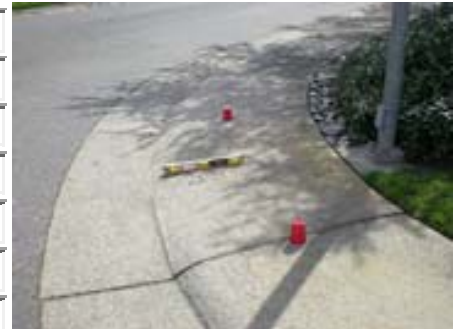
Field Date: 3/4/2011 Report Date: 3/4/2011 Barrier #: 5786
 Location: Woodchuck Wy - South
 X Coordinate: -121.26331
 Y Coordinate: 38.70668
 Barrier Area: Sidewalks
 Barrier Type: Elbow in Sidewalk - Cross Slope (5.0% or more)
 Code Ref: CBC 1133B.7.1.3 and ADA/ABA 403.3

As Built Meas: 6 Quantity: LF
 Description: Cross slope at elbow exceeds 2.0% (5.0% or more)
 As Built Desc: 11.0% cross slope
 Solution: Demolish existing and construct new sidewalk without curb ramp
 Bar. Severity: 1 Necessary Cost Estimate: \$750.00 Status:
 Implementation Priority: 4 Facility Function:
 Implementation Phase: Implementation Date:
 Official Responsible:

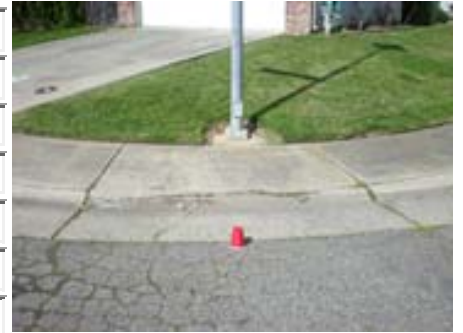
Field Date: 3/4/2011 Report Date: 3/4/2011 Barrier #: 5787
 Location: Woodchuck Wy and Blue Jay Wy - Corner A
 X Coordinate: -121.26315
 Y Coordinate: 38.70534
 Barrier Area: Curb Ramps
 Barrier Type: No Curb Ramp - Depressed Existing Curb
 Code Ref: CBC 1127B.5.1 and ADA/ABA 402.2

As Built Meas: 1 Quantity: EACH
 Description: No compliant curb cut at corner (intersection)
 As Built Desc: 11.2% running slope at depressed area
 Solution: Demolish existing and construct curb cut
 Bar. Severity: 1 Necessary Cost Estimate: \$2,500.00 Status:
 Implementation Priority: 4 Facility Function:
 Implementation Phase: Implementation Date:
 Official Responsible:

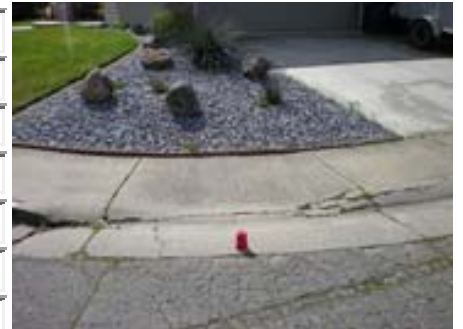
Field Date: 3/4/2011 Report Date: 3/4/2011 Barrier #: 5788
 Location: Woodchuck Wy and Blue Jay Wy - Corner D
 X Coordinate: -121.26319
 Y Coordinate: 38.70527
 Barrier Area: Curb Ramps
 Barrier Type: No Curb Ramp - Depressed Existing Curb
 Code Ref: CBC 1127B.5.1 and ADA/ABA 402.2

As Built Meas: 1 Quantity: EACH
 Description: No compliant curb cut at corner (intersection)
 As Built Desc: 10.4% running slope at depressed area
 Solution: Demolish existing and construct curb cut
 Bar. Severity: 1 Necessary Cost Estimate: \$2,500.00 Status:
 Implementation Priority: 4 Facility Function:
 Implementation Phase: Implementation Date:
 Official Responsible:

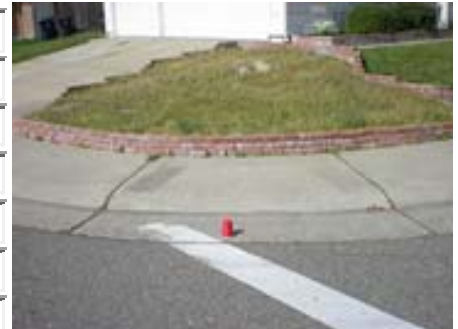
Field Date: 3/4/2011 Report Date: 3/4/2011 Barrier #: 5790
 Location: Chipmunk Wy and Blue Jay Wy - Corner A
 X Coordinate: -121.26474
 Y Coordinate: 38.7054
 Barrier Area: Curb Ramps
 Barrier Type: No Curb Ramp - Depressed Existing Curb
 Code Ref: CBC 1127B.5.1 and ADA/ABA 402.2

As Built Meas: 1 Quantity: EACH
 Description: No compliant curb cut at corner (intersection)
 As Built Desc: 8.0% running slope at depressed area
 Solution: Demolish existing and construct curb cut
 Bar. Severity: 1 Necessary Cost Estimate: \$2,500.00 Status:
 Implementation Priority: 4 Facility Function:
 Implementation Phase: Implementation Date:
 Official Responsible:

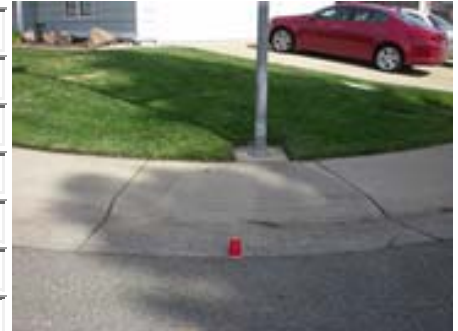
Field Date: 3/4/2011 Report Date: 3/4/2011 Barrier #: 5791
 Location: Chipmunk Wy and Blue Jay Wy - Corner B
 X Coordinate: -121.26456
 Y Coordinate: 38.70538
 Barrier Area: Curb Ramps
 Barrier Type: No Curb Ramp - Depressed Existing Curb
 Code Ref: CBC 1127B.5.1 and ADA/ABA 402.2

As Built Meas: 1 Quantity: EACH
 Description: No compliant curb cut at corner (intersection)
 As Built Desc: 11.8% running slope at depressed area
 Solution: Demolish existing and construct curb cut
 Bar. Severity: 1 Necessary Cost Estimate: \$2,500.00 Status:
 Implementation Priority: 4 Facility Function:
 Implementation Phase: Implementation Date:
 Official Responsible:

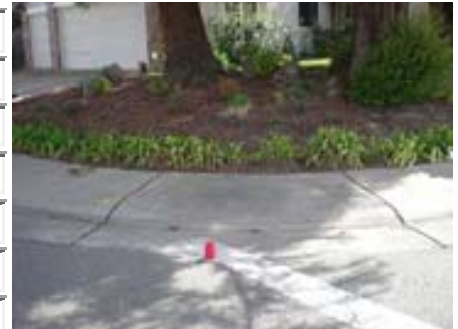
Field Date: 3/4/2011 Report Date: 3/4/2011 Barrier #: 5792
 Location: Chipmunk Wy and Blue Jay Wy - Corner C
 X Coordinate: -121.26457
 Y Coordinate: 38.70528
 Barrier Area: Curb Ramps
 Barrier Type: No Curb Ramp - Depressed Existing Curb
 Code Ref: CBC 1127B.5.1 and ADA/ABA 402.2

As Built Meas: 1 Quantity: EACH
 Description: No compliant curb cut at corner (intersection)
 As Built Desc: 10.4% running slope at depressed area
 Solution: Demolish existing and construct curb cut
 Bar. Severity: 1 Necessary Cost Estimate: \$2,500.00 Status:
 Implementation Priority: 4 Facility Function:
 Implementation Phase: Implementation Date:
 Official Responsible:

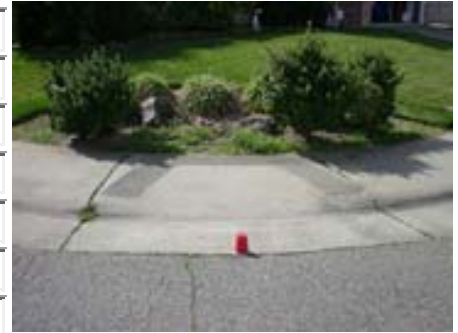
Field Date: 3/4/2011 Report Date: 3/4/2011 Barrier #: 5793
 Location: Chipmunk Wy and Blue Jay Wy - Corner D
 X Coordinate: -121.26472
 Y Coordinate: 38.70526
 Barrier Area: Curb Ramps
 Barrier Type: No Curb Ramp - Depressed Existing Curb
 Code Ref: CBC 1127B.5.1 and ADA/ABA 402.2

As Built Meas: 1 Quantity: EACH
 Description: No compliant curb cut at corner (intersection)
 As Built Desc: 8.8% running slope at depressed area
 Solution: Demolish existing and construct curb cut
 Bar. Severity: 1 Necessary Cost Estimate: \$2,500.00 Status:
 Implementation Priority: 4 Facility Function:
 Implementation Phase: Implementation Date:
 Official Responsible:

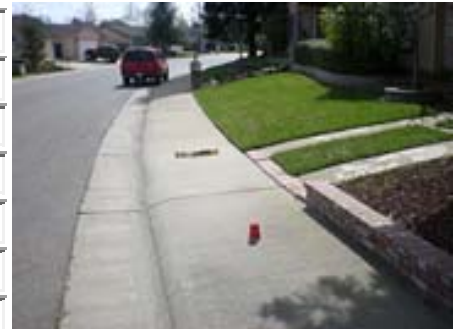
Field Date: 3/4/2011 Report Date: 3/4/2011 Barrier #: 5794
 Location: Chipmunk Wy - West
 X Coordinate: -121.26488
 Y Coordinate: 38.70658
 Barrier Area: Sidewalks
 Barrier Type: Cross Slope - Existing (3.1% to 4.0%)
 Code Ref: CBC 1133B.7.1.3 and ADA/ABA 403.3

As Built Meas: 104 Quantity: LF
 Description: Cross slope exceeds 2.0% (3.1% to 4.0%)
 As Built Desc: 3.1% cross slope
 Solution: Demolish existing and construct new route
 Bar. Severity: 3 Hinderance Cost Estimate: \$13,000.00 Status:
 Implementation Priority: 4 Facility Function:
 Implementation Phase: Implementation Date:
 Official Responsible:

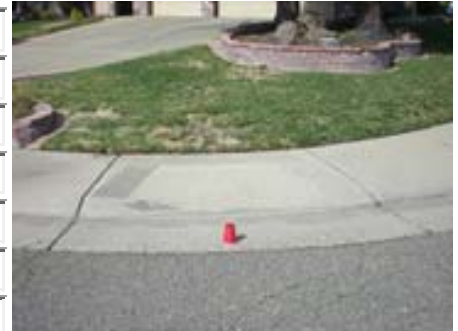
Field Date: 3/4/2011 Report Date: 3/4/2011 Barrier #: 5795
 Location: Chipmunk Wy and Chipmunk Wy Ct - Corner A
 X Coordinate: -121.26473
 Y Coordinate: 38.70614
 Barrier Area: Curb Ramps
 Barrier Type: No Curb Ramp - Depressed Existing Curb
 Code Ref: CBC 1127B.5.1 and ADA/ABA 402.2

As Built Meas: 1 Quantity: EACH
 Description: No compliant curb cut at corner (intersection)
 As Built Desc: 13.4% running slope at depressed area
 Solution: Demolish existing and construct curb cut
 Bar. Severity: 1 Necessary Cost Estimate: \$2,500.00 Status:
 Implementation Priority: 4 Facility Function:
 Implementation Phase: Implementation Date:
 Official Responsible:

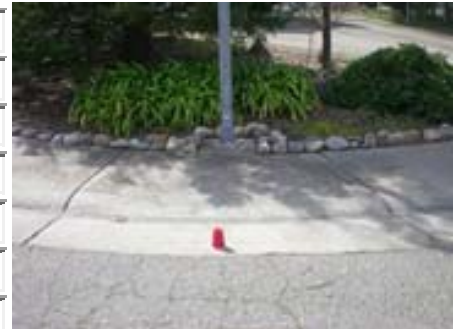
Field Date: 3/4/2011 Report Date: 3/4/2011 Barrier #: 5796
 Location: Chipmunk Wy and Chipmunk Wy Ct - Corner D
 X Coordinate: -121.26471
 Y Coordinate: 38.70606
 Barrier Area: Curb Ramps
 Barrier Type: No Curb Ramp - Depressed Existing Curb
 Code Ref: CBC 1127B.5.1 and ADA/ABA 402.2

As Built Meas: 1 Quantity: EACH
 Description: No compliant curb cut at corner (intersection)
 As Built Desc: 7.1% running slope at depressed area
 Solution: Demolish existing and construct curb cut
 Bar. Severity: 1 Necessary Cost Estimate: \$2,500.00 Status:
 Implementation Priority: 4 Facility Function:
 Implementation Phase: Implementation Date:
 Official Responsible:

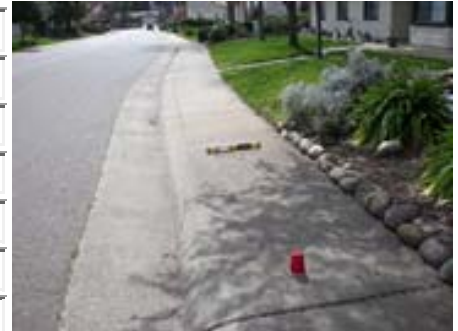
Field Date: 3/4/2011 Report Date: 3/4/2011 Barrier #: 5797
 Location: Chipmunk Wy - West
 X Coordinate: -121.26467
 Y Coordinate: 38.70593
 Barrier Area: Sidewalks
 Barrier Type: Cross Slope - Existing (3.1% to 4.0%)
 Code Ref: CBC 1133B.7.1.3 and ADA/ABA 403.3

As Built Meas: 202 Quantity: LF
 Description: Cross slope exceeds 2.0% (3.1% to 4.0%)
 As Built Desc: 3.1% cross slope
 Solution: Demolish existing and construct new route
 Bar. Severity: 3 Hinderance Cost Estimate: \$25,250.00 Status:
 Implementation Priority: 4 Facility Function:
 Implementation Phase: Implementation Date:
 Official Responsible:

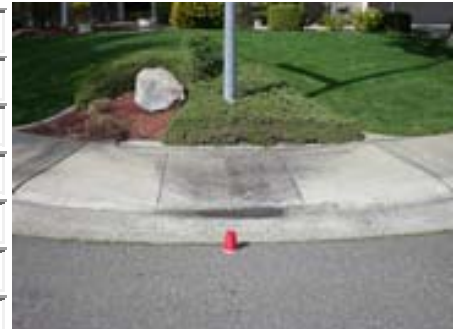
Field Date: 3/4/2011 Report Date: 3/4/2011 Barrier #: 5798A
 Location: Blue Jay Wy and Brookover Ct - Corner A
 X Coordinate: -121.26567
 Y Coordinate: 38.70547
 Barrier Area: Curb Ramps
 Barrier Type: Detectable Warnings - Truncated Domes
 Code Ref: CBC 1127B.5.7 and ADA/ABA 705.1.3

As Built Meas: 1 Quantity: EACH
 Description: No truncated domes provided at curb ramp
 As Built Desc: No detectable warnings at curb ramp
 Solution: Provide compliant truncated domes
 Bar. Severity: 2 Recommended Cost Estimate: \$1,400.00 Status:
 Implementation Priority: 4 Facility Function:
 Implementation Phase: Implementation Date:
 Official Responsible:

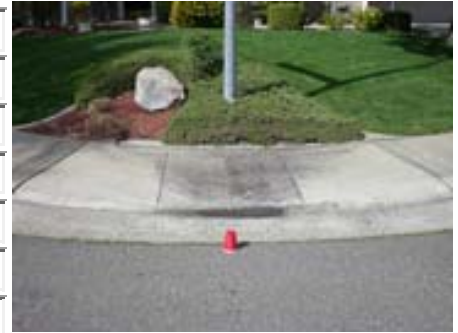
Field Date: 3/4/2011 Report Date: 3/4/2011 Barrier #: 5798B
 Location: Blue Jay Wy and Brookover Ct - Corner A
 X Coordinate: -121.26567
 Y Coordinate: 38.70547
 Barrier Area: Curb Ramps
 Barrier Type: Gutter Slope - Existing (5.1% - 5.8%)
 Code Ref: CBC 1127B.5.3 and ADA/ABA 406.2

As Built Meas: 6 Quantity: SF
 Description: Gutter slope exceeds 5.0% (5.1% - 5.8%)
 As Built Desc: 5.8% gutter slope
 Solution: Demolish existing and construct new gutter
 Bar. Severity: 4 Low Severity Cost Estimate: \$750.00 Status:
 Implementation Priority: 4 Facility Function:
 Implementation Phase: Implementation Date:
 Official Responsible:

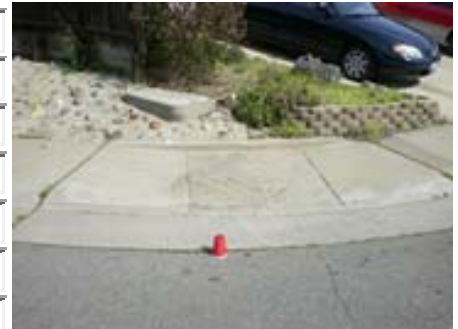
Field Date: 3/4/2011 Report Date: 3/4/2011 Barrier #: 5799
 Location: Blue Jay Wy and Brookover Ct - Corner B
 X Coordinate: -121.26549
 Y Coordinate: 38.70536
 Barrier Area: Curb Ramps
 Barrier Type: Detectable Warnings - Truncated Domes
 Code Ref: CBC 1127B.5.7 and ADA/ABA 705.1.3

As Built Meas: 1 Quantity: EACH
 Description: No truncated domes provided at curb ramp
 As Built Desc: No detectable warnings at curb ramp
 Solution: Provide compliant truncated domes
 Bar. Severity: 2 Recommended Cost Estimate: \$1,400.00 Status:
 Implementation Priority: 4 Facility Function:
 Implementation Phase: Implementation Date:
 Official Responsible:

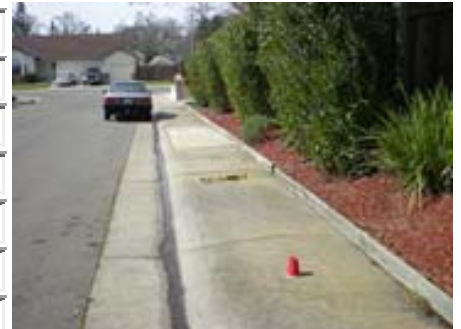
Field Date: 3/4/2011 Report Date: 3/4/2011 Barrier #: 5801
 Location: Blue Jay Wy - North
 X Coordinate: -121.26578
 Y Coordinate: 38.70534
 Barrier Area: Sidewalks
 Barrier Type: Cross Slope - Existing (5.0% or more)
 Code Ref: CBC 1133B.7.1.3 and ADA/ABA 403.3

As Built Meas: 125 Quantity: LF
 Description: Cross slope exceeds 2.0% (5.0% or more)
 As Built Desc: 5.0% cross slope
 Solution: Demolish existing and construct new route
 Bar. Severity: 1 Necessary Cost Estimate: \$15,625.00 Status:
 Implementation Priority: 4 Facility Function:
 Implementation Phase: Implementation Date:
 Official Responsible:

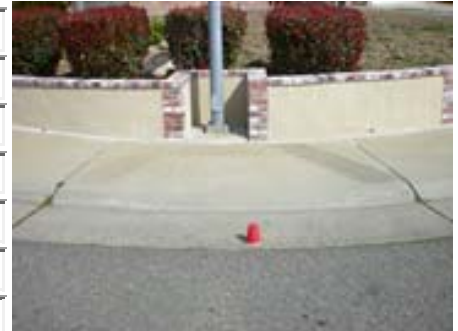
Field Date: 3/4/2011 Report Date: 3/4/2011 Barrier #: 5802
 Location: Blue Jay Wy and Glen Tree Dr - Corner B
 X Coordinate: -121.26633
 Y Coordinate: 38.70534
 Barrier Area: Curb Ramps
 Barrier Type: No Curb Ramp - Depressed Existing Curb
 Code Ref: CBC 1127B.5.1 and ADA/ABA 402.2

As Built Meas: 1 Quantity: EACH
 Description: No compliant curb cut at corner (intersection)
 As Built Desc: 10.3% running slope at depressed area
 Solution: Demolish existing and construct curb cut
 Bar. Severity: 1 Necessary Cost Estimate: \$2,500.00 Status:
 Implementation Priority: 4 Facility Function:
 Implementation Phase: Implementation Date:
 Official Responsible:

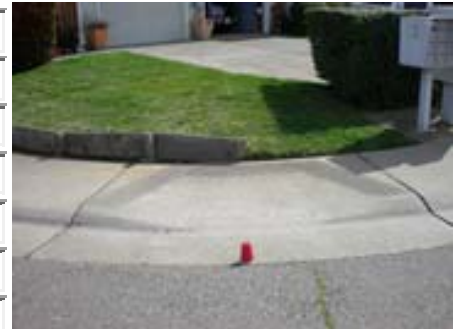
Field Date: 3/4/2011 Report Date: 3/4/2011 Barrier #: 5803
 Location: Blue Jay Wy and Glen Tree Dr - Corner C
 X Coordinate: -121.26632
 Y Coordinate: 38.70522
 Barrier Area: Curb Ramps
 Barrier Type: No Curb Ramp - Depressed Existing Curb
 Code Ref: CBC 1127B.5.1 and ADA/ABA 402.2

As Built Meas: 1 Quantity: EACH
 Description: No compliant curb cut at corner (intersection)
 As Built Desc: 7.4% running slope at depressed area
 Solution: Demolish existing and construct curb cut
 Bar. Severity: 1 Necessary Cost Estimate: \$2,500.00 Status:
 Implementation Priority: 4 Facility Function:
 Implementation Phase: Implementation Date:
 Official Responsible:

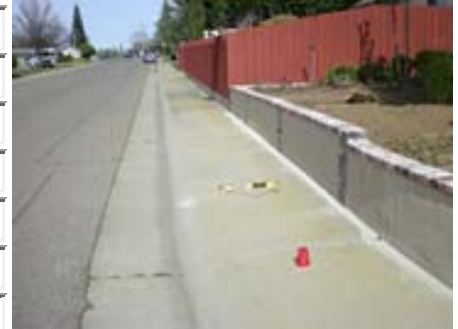
Field Date: 3/4/2011 Report Date: 3/4/2011 Barrier #: 5804
 Location: Glen Tree Dr - East
 X Coordinate: -121.26634
 Y Coordinate: 38.70539
 Barrier Area: Sidewalks
 Barrier Type: Cross Slope - Existing (4.1% to 4.9%)
 Code Ref: CBC 1133B.7.1.3 and ADA/ABA 403.3

As Built Meas: 328 Quantity: LF
 Description: Cross slope exceeds 2.0% (4.1% to 4.9%)
 As Built Desc: 4.2% cross slope
 Solution: Demolish existing and construct new route
 Bar. Severity: 2 Recommended Cost Estimate: \$41,000.00 Status:
 Implementation Priority: 4 Facility Function:
 Implementation Phase: Implementation Date:
 Official Responsible:

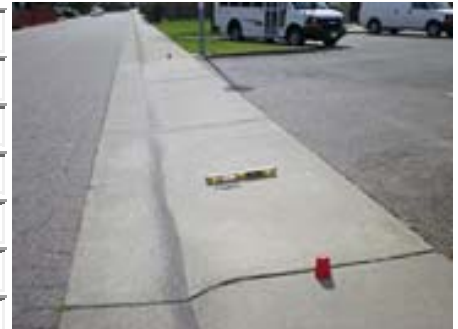
Field Date: 3/4/2011 Report Date: 3/4/2011 Barrier #: 5805
 Location: Glen Tree Dr - West
 X Coordinate: -121.26647
 Y Coordinate: 38.70613
 Barrier Area: Sidewalks
 Barrier Type: Driveway - Existing (5.0% or more)
 Code Ref: CBC 1133B.7.1.3 and ADA/ABA 403.3

As Built Meas: 40 Quantity: LF
 Description: Driveway cross slope exceeds 2.0% (5.0% or more)
 As Built Desc: 7.6% cross slope
 Solution: Provide min. 48" wide level walkway through driveway
 Bar. Severity: 4 Low Severity Cost Estimate: \$5,000.00 Status:
 Implementation Priority: 4 Facility Function:
 Implementation Phase: Implementation Date:
 Official Responsible:

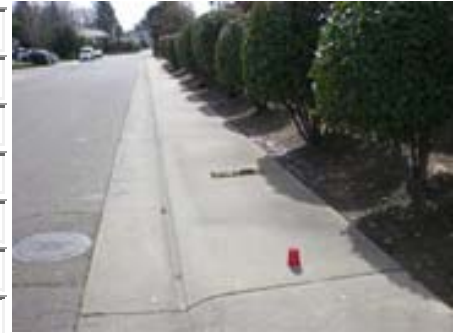
Field Date: 3/4/2011 Report Date: 3/4/2011 Barrier #: 5806
 Location: Glen Tree Dr - West
 X Coordinate: -121.26645
 Y Coordinate: 38.70573
 Barrier Area: Sidewalks
 Barrier Type: Cross Slope - Existing (3.1% to 4.0%)
 Code Ref: CBC 1133B.7.1.3 and ADA/ABA 403.3

As Built Meas: 397 Quantity: LF
 Description: Cross slope exceeds 2.0% (3.1% to 4.0%)
 As Built Desc: 3.4% cross slope
 Solution: Demolish existing and construct new route
 Bar. Severity: 3 Hinderance Cost Estimate: \$49,625.00 Status:
 Implementation Priority: 4 Facility Function:
 Implementation Phase: Implementation Date:
 Official Responsible:

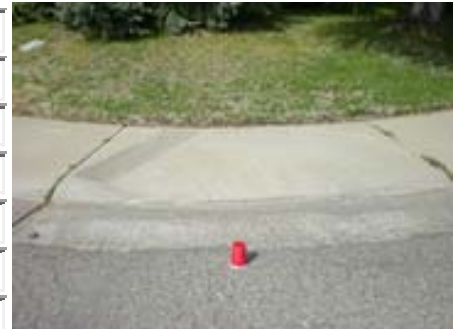
Field Date: 3/4/2011 Report Date: 3/4/2011 Barrier #: 5807
 Location: Glen Tree Dr and Chipmunk Wy - Corner A
 X Coordinate: -121.26653
 Y Coordinate: 38.70461
 Barrier Area: Curb Ramps
 Barrier Type: No Curb Ramp - Depressed Existing Curb
 Code Ref: CBC 1127B.5.1 and ADA/ABA 402.2

As Built Meas: 1 Quantity: EACH
 Description: No compliant curb cut at corner (intersection)
 As Built Desc: 9.7% running slope at depressed area
 Solution: Demolish existing and construct curb cut
 Bar. Severity: 1 Necessary Cost Estimate: \$2,500.00 Status:
 Implementation Priority: 4 Facility Function:
 Implementation Phase: Implementation Date:
 Official Responsible:

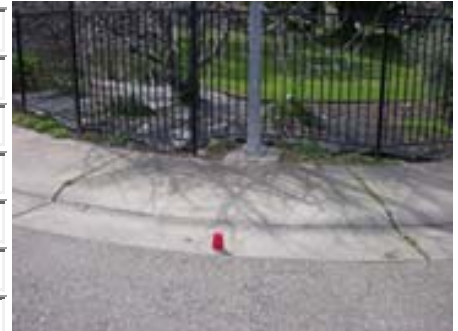
Field Date: 3/4/2011 Report Date: 3/4/2011 Barrier #: 5808
 Location: Glen Tree Dr and Chipmunk Wy - Corner D
 X Coordinate: -121.2666
 Y Coordinate: 38.70453
 Barrier Area: Curb Ramps
 Barrier Type: No Curb Ramp - Depressed Existing Curb
 Code Ref: CBC 1127B.5.1 and ADA/ABA 402.2

As Built Meas: 1 Quantity: EACH
 Description: No compliant curb cut at corner (intersection)
 As Built Desc: 8.5% running slope at depressed area
 Solution: Demolish existing and construct curb cut
 Bar. Severity: 1 Necessary Cost Estimate: \$2,500.00 Status:
 Implementation Priority: 4 Facility Function:
 Implementation Phase: Implementation Date:
 Official Responsible:

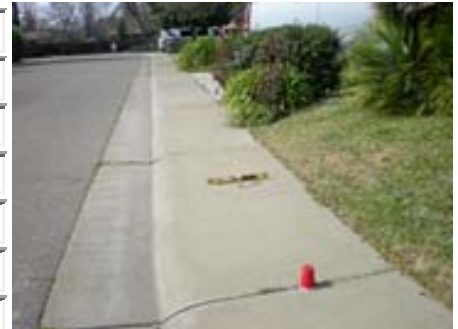
Field Date: 3/4/2011 Report Date: 3/4/2011 Barrier #: 5809
 Location: Chipmunk Wy - North
 X Coordinate: -121.26658
 Y Coordinate: 38.70466
 Barrier Area: Sidewalks
 Barrier Type: Cross Slope - Existing (4.1% to 4.9%)
 Code Ref: CBC 1133B.7.1.3 and ADA/ABA 403.3

As Built Meas: 270 Quantity: LF
 Description: Cross slope exceeds 2.0% (4.1% to 4.9%)
 As Built Desc: 4.3% cross slope
 Solution: Demolish existing and construct new route
 Bar. Severity: 2 Recommended Cost Estimate: \$33,750.00 Status:
 Implementation Priority: 4 Facility Function:
 Implementation Phase: Implementation Date:
 Official Responsible:
