**DRAFT ADA TRANSITION PLAN UPDATE
NEIGHBORHOOD AREA 8 CHASE
SEPTEMBER 20, 2011**

CITY OF CITRUS HEIGHTS

Conditions - CHASE Area 8

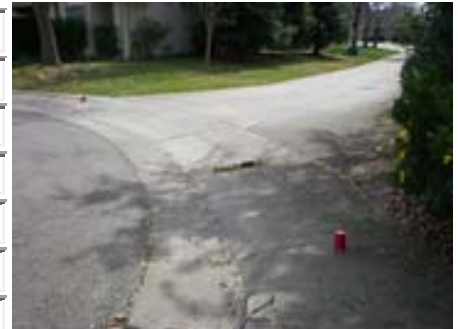
Field Date: 3/4/2011 Report Date: 3/4/2011 Barrier #: 5811
 Location: Chipmunk Wy - South
 X Coordinate: -121.26743
 Y Coordinate: 38.70447
 Barrier Area: Sidewalks
 Barrier Type: Driveway - Existing (5.0% or more)
 Code Ref: CBC 1133B.7.1.3 and ADA/ABA 403.3

As Built Meas: 29 Quantity: LF
 Description: Driveway cross slope exceeds 2.0% (5.0% or more)
 As Built Desc: 8.5% cross slope
 Solution: Provide min. 48" wide level walkway through driveway
 Bar. Severity: 4 Low Severity Cost Estimate: \$3,625.00 Status:
 Implementation Priority: 4 Facility Function:
 Implementation Phase: Implementation Date:
 Official Responsible:

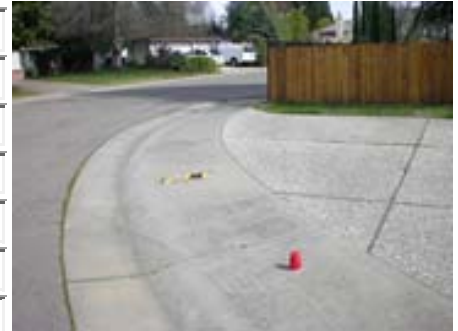
Field Date: 3/4/2011 Report Date: 3/4/2011 Barrier #: 5812
 Location: Chipmunk Wy - South
 X Coordinate: -121.26725
 Y Coordinate: 38.70451
 Barrier Area: Sidewalks
 Barrier Type: Cross Slope - Existing (3.1% to 4.0%)
 Code Ref: CBC 1133B.7.1.3 and ADA/ABA 403.3

As Built Meas: 39 Quantity: LF
 Description: Cross slope exceeds 2.0% (3.1% to 4.0%)
 As Built Desc: 3.9% cross slope
 Solution: Demolish existing and construct new route
 Bar. Severity: 3 Hinderance Cost Estimate: \$4,875.00 Status:
 Implementation Priority: 4 Facility Function:
 Implementation Phase: Implementation Date:
 Official Responsible:

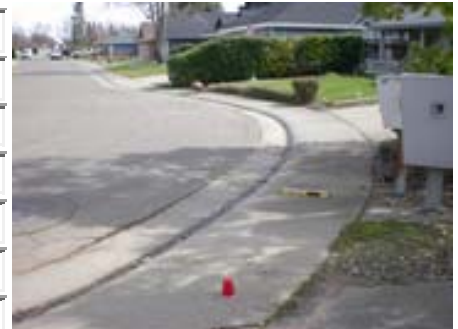
Field Date: 3/4/2011 Report Date: 3/4/2011 Barrier #: 5813
 Location: Chipmunk Wy - South
 X Coordinate: -121.26661
 Y Coordinate: 38.70436
 Barrier Area: Sidewalks
 Barrier Type: Cross Slope - Existing (3.1% to 4.0%)
 Code Ref: CBC 1133B.7.1.3 and ADA/ABA 403.3

As Built Meas: 348 Quantity: LF
 Description: Cross slope exceeds 2.0% (3.1% to 4.0%)
 As Built Desc: 3.9% cross slope
 Solution: Demolish existing and construct new route
 Bar. Severity: 3 Hinderance Cost Estimate: \$43,500.00 Status:
 Implementation Priority: 4 Facility Function:
 Implementation Phase: Implementation Date:
 Official Responsible:

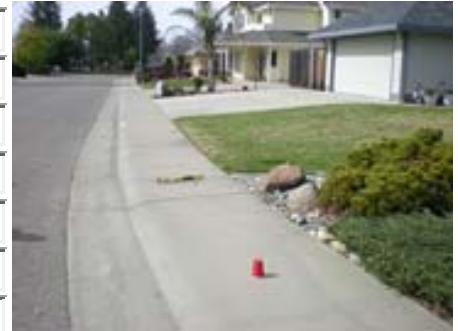
Field Date:	3/4/2011	Report Date:	3/4/2011	Barrier #:	5814
Location:	Chipmunk Wy - North				
X Coordinate:	-121.26565				
Y Coordinate:	38.70445				
Barrier Area:	Sidewalks				
Barrier Type:	Cross Slope - Existing (4.1% to 4.9%)				
Code Ref:	CBC 1133B.7.1.3 and ADA/ABA 403.3

As Built Meas:	218	Quantity:	LF
Description:	Cross slope exceeds 2.0% (4.1% to 4.9%)		
As Built Desc:	4.1% cross slope		
Solution:	Demolish existing and construct new route		
Bar. Severity:	2 Recommended	Cost Estimate:	\$27,250.00
Implementation Priority:	4	Facility Function:	
Implementation Phase:		Implementation Date:	
Official Responsible:

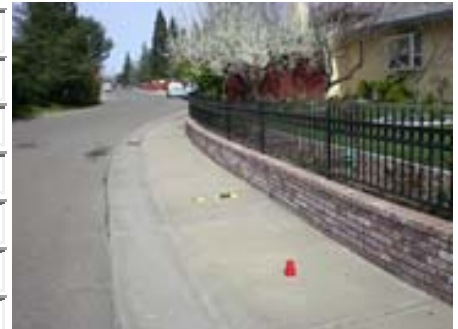
Field Date:	3/4/2011	Report Date:	3/4/2011	Barrier #:	5815
Location:	Glen Tree Dr - East				
X Coordinate:	-121.26652				
Y Coordinate:	38.70448				
Barrier Area:	Sidewalks				
Barrier Type:	Cross Slope - Existing (4.1% to 4.9%)				
Code Ref:	CBC 1133B.7.1.3 and ADA/ABA 403.3

As Built Meas:	268	Quantity:	LF
Description:	Cross slope exceeds 2.0% (4.1% to 4.9%)		
As Built Desc:	4.1% cross slope		
Solution:	Demolish existing and construct new route		
Bar. Severity:	2 Recommended	Cost Estimate:	\$33,500.00
Implementation Priority:	4	Facility Function:	
Implementation Phase:		Implementation Date:	
Official Responsible:

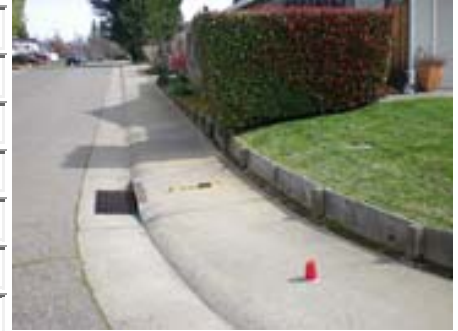
Field Date: 3/4/2011 Report Date: 3/4/2011 Barrier #: 5816
 Location: Blue Jay Wy - South
 X Coordinate: -121.26625
 Y Coordinate: 38.70522
 Barrier Area: Sidewalks
 Barrier Type: Cross Slope - Existing (4.1% to 4.9%)
 Code Ref: CBC 1133B.7.1.3 and ADA/ABA 403.3

As Built Meas: 249 Quantity: LF
 Description: Cross slope exceeds 2.0% (4.1% to 4.9%)
 As Built Desc: 4.1% cross slope
 Solution: Demolish existing and construct new route
 Bar. Severity: 2 Recommended Cost Estimate: \$31,125.00 Status:
 Implementation Priority: 4 Facility Function:
 Implementation Phase: Implementation Date:
 Official Responsible:

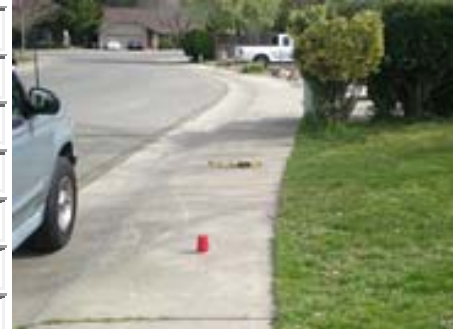
Field Date: 3/4/2011 Report Date: 3/4/2011 Barrier #: 5817
 Location: Blue Jay Wy - South
 X Coordinate: -121.26394
 Y Coordinate: 38.70531
 Barrier Area: Sidewalks
 Barrier Type: Cross Slope - Existing (3.1% to 4.0%)
 Code Ref: CBC 1133B.7.1.3 and ADA/ABA 403.3

As Built Meas: 48 Quantity: LF
 Description: Cross slope exceeds 2.0% (3.1% to 4.0%)
 As Built Desc: 4.0% cross slope
 Solution: Demolish existing and construct new route
 Bar. Severity: 3 Hinderance Cost Estimate: \$6,000.00 Status:
 Implementation Priority: 4 Facility Function:
 Implementation Phase: Implementation Date:
 Official Responsible:

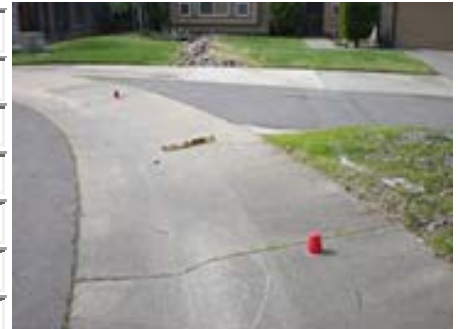
Field Date: 3/4/2011 Report Date: 3/4/2011 Barrier #: 5819
 Location: Woodchuck Wy - North
 X Coordinate: -121.26357
 Y Coordinate: 38.70449
 Barrier Area: Sidewalks
 Barrier Type: Driveway - Existing (5.0% or more)
 Code Ref: CBC 1133B.7.1.3 and ADA/ABA 403.3

As Built Meas: 21 Quantity: LF
 Description: Driveway cross slope exceeds 2.0% (5.0% or more)
 As Built Desc: 10.1% cross slope
 Solution: Provide min. 48" wide level walkway through driveway
 Bar. Severity: 4 Low Severity Cost Estimate: \$2,625.00 Status:
 Implementation Priority: 4 Facility Function:
 Implementation Phase: Implementation Date:
 Official Responsible:

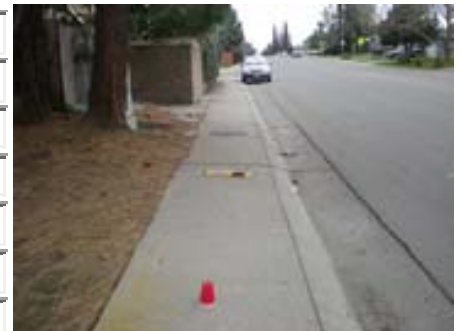
Field Date: 3/8/2011 Report Date: 3/9/2011 Barrier #: 5821
 Location: Villa Oak Dr - North
 X Coordinate: -121.26236
 Y Coordinate: 38.70603
 Barrier Area: Sidewalks
 Barrier Type: Cross Slope - Existing (5.0% or more)
 Code Ref: CBC 1133B.7.1.3 and ADA/ABA 403.3

As Built Meas: 130 Quantity: LF
 Description: Cross slope exceeds 2.0% (5.0% or more)
 As Built Desc: 8.3% cross slope
 Solution: Demolish existing and construct new route
 Bar. Severity: 1 Necessary Cost Estimate: \$16,250.00 Status:
 Implementation Priority: 2 Facility Function:
 Implementation Phase: Implementation Date:
 Official Responsible:

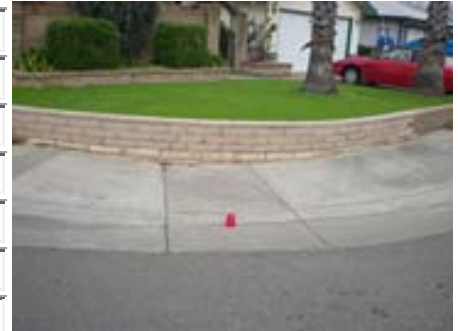
Field Date: 3/8/2011 Report Date: 3/9/2011 Barrier #: 5822
 Location: Villa Oak Dr and Ziebell Ct - Corner A
 X Coordinate: -121.2618
 Y Coordinate: 38.70601
 Barrier Area: Curb Ramps
 Barrier Type: Detectable Warnings - Truncated Domes
 Code Ref: CBC 1127B.5.7 and ADA/ABA 705.1.3

As Built Meas: 1 Quantity: EACH
 Description: No truncated domes provided at curb ramp
 As Built Desc: No detectable warnings at curb ramp
 Solution: Provide compliant truncated domes
 Bar. Severity: 2 Recommended Cost Estimate: \$1,400.00 Status:
 Implementation Priority: 2 Facility Function:
 Implementation Phase: Implementation Date:
 Official Responsible:

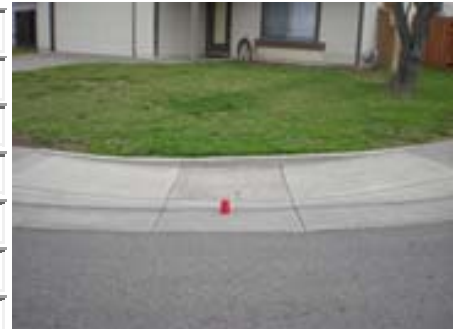
Field Date: 3/8/2011 Report Date: 3/9/2011 Barrier #: 5823
 Location: Villa Oak Dr and Ziebell Ct - Corner B
 X Coordinate: -121.26166
 Y Coordinate: 38.706
 Barrier Area: Curb Ramps
 Barrier Type: Detectable Warnings - Truncated Domes
 Code Ref: CBC 1127B.5.7 and ADA/ABA 705.1.3

As Built Meas: 1 Quantity: EACH
 Description: No truncated domes provided at curb ramp
 As Built Desc: No detectable warnings at curb ramp
 Solution: Provide compliant truncated domes
 Bar. Severity: 2 Recommended Cost Estimate: \$1,400.00 Status:
 Implementation Priority: 2 Facility Function:
 Implementation Phase: Implementation Date:
 Official Responsible:

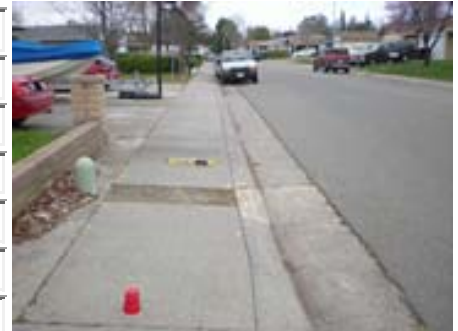
Field Date: 3/8/2011 Report Date: 3/9/2011 Barrier #: 5824A
 Location: Ziebell Ct - West
 X Coordinate: -121.26179
 Y Coordinate: 38.70606
 Barrier Area: Sidewalks
 Barrier Type: Cross Slope - Existing (5.0% or more)
 Code Ref: CBC 1133B.7.1.3 and ADA/ABA 403.3

As Built Meas: 715 Quantity: LF
 Description: Cross slope exceeds 2.0% (5.0% or more)
 As Built Desc: 6.8% cross slope
 Solution: Demolish existing and construct new route
 Bar. Severity: 1 Necessary Cost Estimate: \$89,375.00 Status:
 Implementation Priority: 4 Facility Function:
 Implementation Phase: Implementation Date:
 Official Responsible:

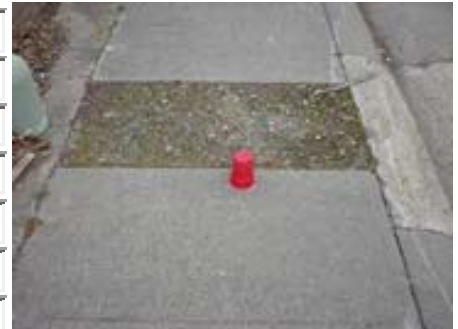
Field Date: 3/8/2011 Report Date: 3/9/2011 Barrier #: 5824B
 Location: Ziebell Ct - West
 X Coordinate: -121.2618
 Y Coordinate: 38.70607
 Barrier Area: Sidewalks
 Barrier Type: Surface Condition - Damaged
 Code Ref: CBC 1133B.7.1 and ADA/ABA 302.1

As Built Meas: 2 Quantity: LF
 Description: Surface is not firm and stable (cracked, broken or loose soil, etc.)
 As Built Desc: Cracked Concrete
 Solution: Repair surface to make firm and stable
 Bar. Severity: 1 Necessary Cost Estimate: \$250.00 Status:
 Implementation Priority: 4 Facility Function:
 Implementation Phase: Implementation Date:
 Official Responsible:

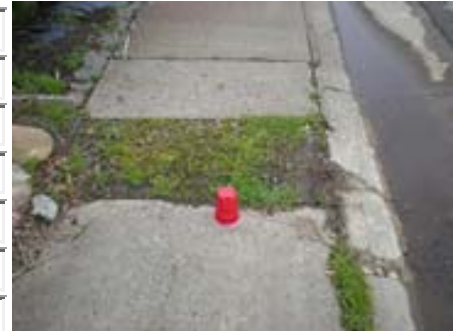
Field Date: 3/8/2011 Report Date: 3/9/2011 Barrier #: 5824C
 Location: Ziebell Ct - West
 X Coordinate: -121.26181
 Y Coordinate: 38.70656
 Barrier Area: Sidewalks
 Barrier Type: Surface Condition - Damaged
 Code Ref: CBC 1133B.7.1 and ADA/ABA 302.1

As Built Meas: 2 Quantity: LF
 Description: Surface is not firm and stable (cracked, broken or loose soil, etc.)
 As Built Desc: Cracked Concrete
 Solution: Repair surface to make firm and stable
 Bar. Severity: 1 Necessary Cost Estimate: \$250.00 Status:
 Implementation Priority: 4 Facility Function:
 Implementation Phase: Implementation Date:
 Official Responsible:

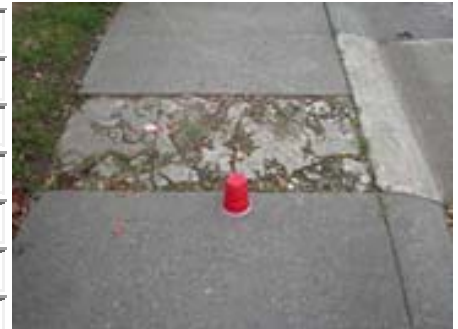
Field Date: 3/8/2011 Report Date: 3/9/2011 Barrier #: 5824D
 Location: Ziebell Ct - West
 X Coordinate: -121.26188
 Y Coordinate: 38.70748
 Barrier Area: Sidewalks
 Barrier Type: Surface Condition - Damaged
 Code Ref: CBC 1133B.7.1 and ADA/ABA 302.1

As Built Meas: 2 Quantity: LF
 Description: Surface is not firm and stable (cracked, broken or loose soil, etc.)
 As Built Desc: Cracked Concrete
 Solution: Repair surface to make firm and stable
 Bar. Severity: 1 Necessary Cost Estimate: \$250.00 Status:
 Implementation Priority: 4 Facility Function:
 Implementation Phase: Implementation Date:
 Official Responsible:

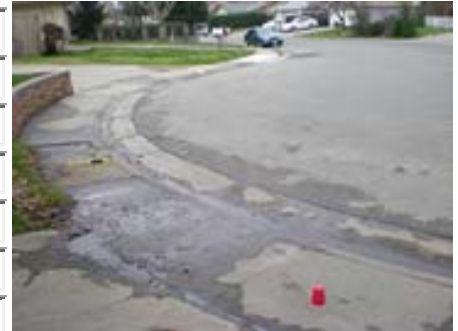
Field Date: 3/8/2011 Report Date: 3/9/2011 Barrier #: 5825
 Location: Ziebell Ct - East
 X Coordinate: -121.26163
 Y Coordinate: 38.70786
 Barrier Area: Sidewalks
 Barrier Type: Cross Slope - Existing (5.0% or more)
 Code Ref: CBC 1133B.7.1.3 and ADA/ABA 403.3

As Built Meas: 676 Quantity: LF
 Description: Cross slope exceeds 2.0% (5.0% or more)
 As Built Desc: 6.6% cross slope
 Solution: Demolish existing and construct new route
 Bar. Severity: 1 Necessary Cost Estimate: \$84,500.00 Status:
 Implementation Priority: 4 Facility Function:
 Implementation Phase: Implementation Date:
 Official Responsible:

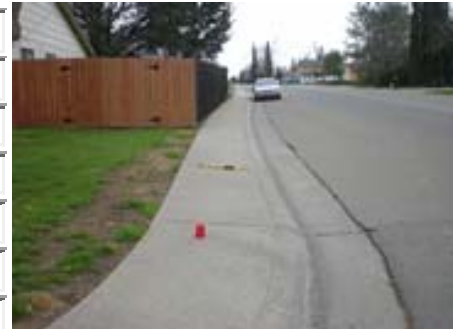
Field Date: 3/8/2011 Report Date: 3/9/2011 Barrier #: 5826
 Location: Villa Oak - North
 X Coordinate: -121.26162
 Y Coordinate: 38.70599
 Barrier Area: Sidewalks
 Barrier Type: Cross Slope - Existing (5.0% or more)
 Code Ref: CBC 1133B.7.1.3 and ADA/ABA 403.3

As Built Meas: 222 Quantity: LF
 Description: Cross slope exceeds 2.0% (5.0% or more)
 As Built Desc: 7.2% cross slope
 Solution: Demolish existing and construct new route
 Bar. Severity: 1 Necessary Cost Estimate: \$27,750.00 Status:
 Implementation Priority: 2 Facility Function:
 Implementation Phase: Implementation Date:
 Official Responsible:

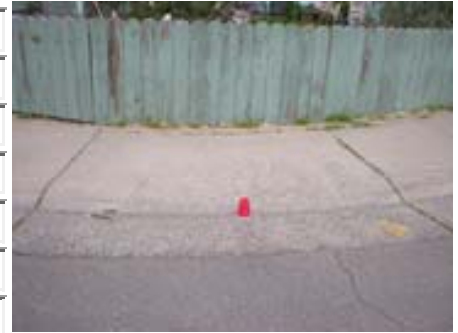
Field Date: 3/8/2011 Report Date: 3/9/2011 Barrier #: 5827
 Location: Villa Oak Dr and McConnell Dr - Corner A
 X Coordinate: -121.26078
 Y Coordinate: 38.70596
 Barrier Area: Curb Ramps
 Barrier Type: No Curb Ramp - Depressed Existing Curb
 Code Ref: CBC 1127B.5.1 and ADA/ABA 402.2

As Built Meas: 1 Quantity: EACH
 Description: No compliant curb cut at corner (intersection)
 As Built Desc: 14.3% running slope at depressed area
 Solution: Demolish existing and construct curb cut
 Bar. Severity: 1 Necessary Cost Estimate: \$2,500.00 Status:
 Implementation Priority: 2 Facility Function:
 Implementation Phase: Implementation Date:
 Official Responsible:

Notes: Four - way intersection corners A,B,C,D. Corners C,D compliant

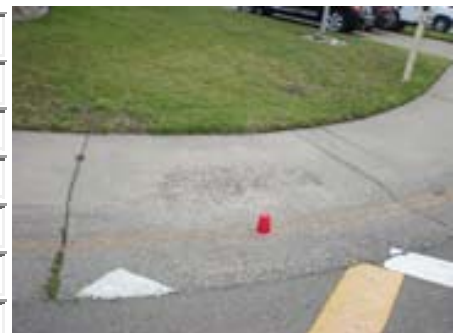
Field Date: 3/8/2011 Report Date: 3/9/2011 Barrier #: 5828
 Location: Villa Oak Dr and McConnell Dr - Corner B
 X Coordinate: -121.26063
 Y Coordinate: 38.70596
 Barrier Area: Curb Ramps
 Barrier Type: No Curb Ramp - Depressed Existing Curb
 Code Ref: CBC 1127B.5.1 and ADA/ABA 402.2

As Built Meas: 1 Quantity: EACH
 Description: No compliant curb cut at corner (intersection)
 As Built Desc: 14.1% running slope at depressed area
 Solution: Demolish existing and construct curb cut
 Bar. Severity: 1 Necessary Cost Estimate: \$2,500.00 Status:
 Implementation Priority: 2 Facility Function:
 Implementation Phase: Implementation Date:
 Official Responsible:

Notes: Four - way intersection corners A,B,C,D. Corners C,D compliant

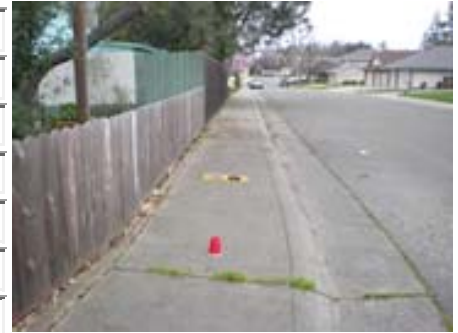
Field Date: 3/8/2011 Report Date: 3/9/2011 Barrier #: 5829
 Location: McConnell Dr - West
 X Coordinate: -121.2608
 Y Coordinate: 38.70622
 Barrier Area: Sidewalks
 Barrier Type: Cross Slope - Existing (5.0% or more)
 Code Ref: CBC 1133B.7.1.3 and ADA/ABA 403.3

As Built Meas: 345 Quantity: LF
 Description: Cross slope exceeds 2.0% (5.0% or more)
 As Built Desc: 6.2% cross slope
 Solution: Demolish existing and construct new route
 Bar. Severity: 1 Necessary Cost Estimate: \$43,125.00 Status:
 Implementation Priority: 4 Facility Function:
 Implementation Phase: Implementation Date:
 Official Responsible:

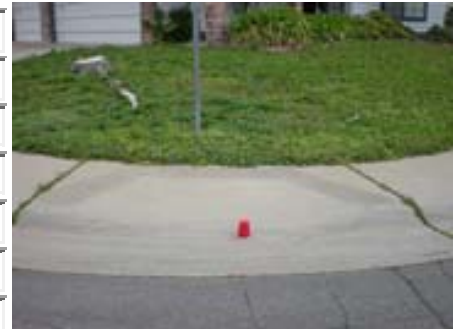
Field Date: 3/8/2011 Report Date: 3/9/2011 Barrier #: 5830
 Location: McConnell Dr and Auburn Wind Ct - Corner B
 X Coordinate: -121.26064
 Y Coordinate: 38.70759
 Barrier Area: Curb Ramps
 Barrier Type: No Curb Ramp - Depressed Existing Curb
 Code Ref: CBC 1127B.5.1 and ADA/ABA 402.2

As Built Meas: 1 Quantity: EACH
 Description: No compliant curb cut at corner (intersection)
 As Built Desc: 7.5% running slope at depressed area
 Solution: Demolish existing and construct curb cut
 Bar. Severity: 1 Necessary Cost Estimate: \$2,500.00 Status:
 Implementation Priority: 4 Facility Function:
 Implementation Phase: Implementation Date:
 Official Responsible:

Notes: Two - way intersection corners B,C

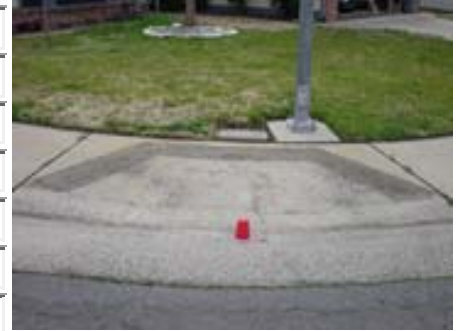
Field Date: 3/8/2011 Report Date: 3/9/2011 Barrier #: 5831
 Location: McConnell Dr and Auburn Wind Ct - Corner C
 X Coordinate: -121.26066
 Y Coordinate: 38.70744
 Barrier Area: Curb Ramps
 Barrier Type: No Curb Ramp - Depressed Existing Curb
 Code Ref: CBC 1127B.5.1 and ADA/ABA 402.2

As Built Meas: 1 Quantity: EACH
 Description: No compliant curb cut at corner (intersection)
 As Built Desc: 7.8% running slope at depressed area
 Solution: Demolish existing and construct curb cut
 Bar. Severity: 1 Necessary Cost Estimate: \$2,500.00 Status:
 Implementation Priority: 4 Facility Function:
 Implementation Phase: Implementation Date:
 Official Responsible:

Notes: Two - way intersection corners B,C

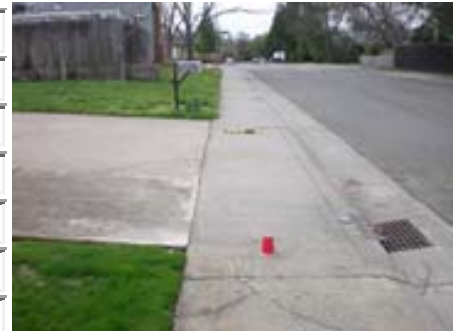
Field Date: 3/8/2011 Report Date: 3/9/2011 Barrier #: 5832
 Location: McConnell Dr - East
 X Coordinate: -121.26065
 Y Coordinate: 38.70632
 Barrier Area: Sidewalks
 Barrier Type: Cross Slope - Existing (5.0% or more)
 Code Ref: CBC 1133B.7.1.3 and ADA/ABA 403.3

As Built Meas: 148 Quantity: LF
 Description: Cross slope exceeds 2.0% (5.0% or more)
 As Built Desc: 5.1% cross slope
 Solution: Demolish existing and construct new route
 Bar. Severity: 1 Necessary Cost Estimate: \$18,500.00 Status:
 Implementation Priority: 4 Facility Function:
 Implementation Phase: Implementation Date:
 Official Responsible:

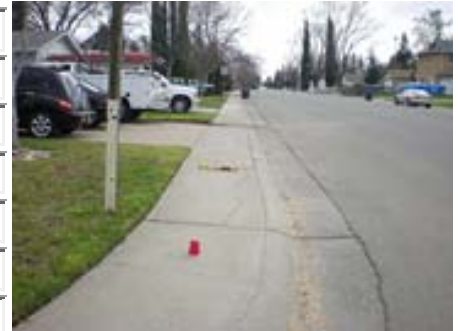
Field Date: 3/8/2011 Report Date: 3/9/2011 Barrier #: 5833
 Location: Villa Oak Dr - North
 X Coordinate: -121.2605
 Y Coordinate: 38.70594
 Barrier Area: Sidewalks
 Barrier Type: Cross Slope - Existing (5.0% or more)
 Code Ref: CBC 1133B.7.1.3 and ADA/ABA 403.3

As Built Meas: 227 Quantity: LF
 Description: Cross slope exceeds 2.0% (5.0% or more)
 As Built Desc: 5.1% cross slope
 Solution: Demolish existing and construct new route
 Bar. Severity: 1 Necessary Cost Estimate: \$28,375.00 Status:
 Implementation Priority: 2 Facility Function:
 Implementation Phase: Implementation Date:
 Official Responsible:

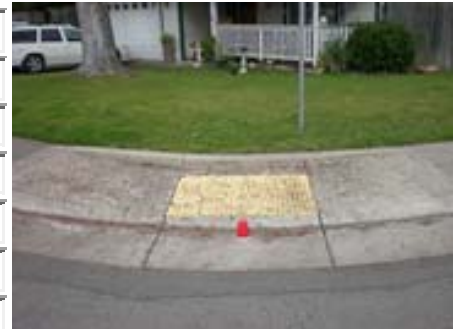
Field Date: 3/8/2011 Report Date: 3/9/2011 Barrier #: 5834
 Location: Villa Oak Dr and Teater Ct - Corner A
 X Coordinate: -121.25975
 Y Coordinate: 38.70596
 Barrier Area: Curb Ramps
 Barrier Type: 12" Grooves - Existing (2.1% to 3.0%)
 Code Ref: CBC 1127B.5.6

As Built Meas: 1 Quantity: EACH
 Description: 12" grooves at top of curb ramp are not level (2.1% to 3.0%)
 As Built Desc: 3.0% at 12" grooves
 Solution: Demolish existing and construct new curb ramp
 Bar. Severity: 4 Low Severity Cost Estimate: \$2,500.00 Status:
 Implementation Priority: 2 Facility Function:
 Implementation Phase: Implementation Date:
 Official Responsible:

Notes: Two - way intersection corners A,B

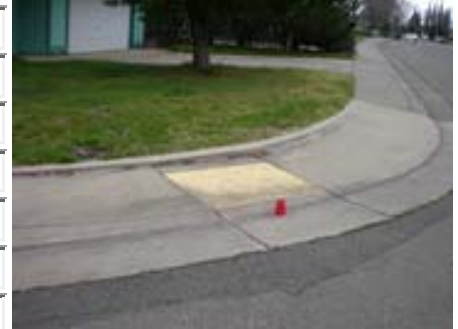
Field Date: 3/8/2011 Report Date: 3/9/2011 Barrier #: 5835
 Location: Villa Oak Dr and Teater Ct - Corner B
 X Coordinate: -121.25961
 Y Coordinate: 38.70596
 Barrier Area: Curb Ramps
 Barrier Type: 12" Grooves - Existing (3.1% to 4.0%)
 Code Ref: CBC 1127B.5.6

As Built Meas: 1 Quantity: EACH
 Description: 12" grooves at top of curb ramp are not level (3.1% to 4.0%)
 As Built Desc: 3.3% at 12" grooves
 Solution: Demolish existing and construct new curb ramp
 Bar. Severity: 3 Hindrance Cost Estimate: \$2,500.00 Status:
 Implementation Priority: 2 Facility Function:
 Implementation Phase: Implementation Date:
 Official Responsible:

Notes: Two - way intersection corners A,B

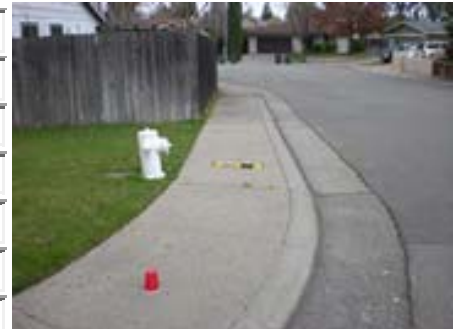
Field Date: 3/8/2011 Report Date: 3/9/2011 Barrier #: 5836
 Location: Teater Ct - West
 X Coordinate: -121.25974
 Y Coordinate: 38.70606
 Barrier Area: Sidewalks
 Barrier Type: Cross Slope - Existing (5.0% or more)
 Code Ref: CBC 1133B.7.1.3 and ADA/ABA 403.3

As Built Meas: 219 Quantity: LF
 Description: Cross slope exceeds 2.0% (5.0% or more)
 As Built Desc: 6.2% cross slope
 Solution: Demolish existing and construct new route
 Bar. Severity: 1 Necessary Cost Estimate: \$27,375.00 Status:
 Implementation Priority: 4 Facility Function:
 Implementation Phase: Implementation Date:
 Official Responsible:

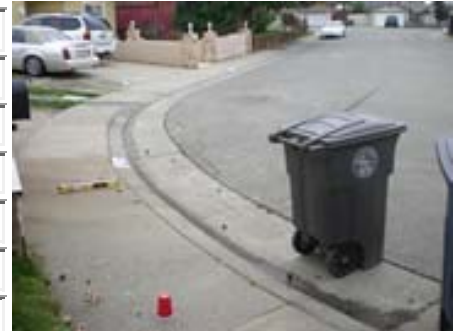
Field Date:	3/8/2011	Report Date:	3/9/2011	Barrier #:	5837
Location:	Teater Ct - East				
X Coordinate:	-121.25971				
Y Coordinate:	38.70648				
Barrier Area:	Sidewalks				
Barrier Type:	Cross Slope - Existing (4.1% to 4.9%)				
Code Ref:	CBC 1133B.7.1.3 and ADA/ABA 403.3

As Built Meas:	184	Quantity:	LF
Description:	Cross slope exceeds 2.0% (4.1% to 4.9%)		
As Built Desc:	4.9% cross slope		
Solution:	Demolish existing and construct new route		
Bar. Severity:	2 Recommended	Cost Estimate:	\$23,000.00
Implementation Priority:	4	Facility Function:	
Implementation Phase:		Implementation Date:	
Official Responsible:

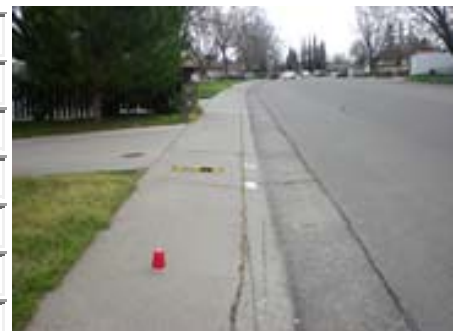
Field Date:	3/8/2011	Report Date:	3/9/2011	Barrier #:	5838A
Location:	Villa Oak Dr - North				
X Coordinate:	-121.25953				
Y Coordinate:	38.70596				
Barrier Area:	Sidewalks				
Barrier Type:	Cross Slope - Existing (5.0% or more)				
Code Ref:	CBC 1133B.7.1.3 and ADA/ABA 403.3

As Built Meas:	528	Quantity:	LF
Description:	Cross slope exceeds 2.0% (5.0% or more)		
As Built Desc:	6.3% cross slope		
Solution:	Demolish existing and construct new route		
Bar. Severity:	1 Necessary	Cost Estimate:	\$66,000.00
Implementation Priority:	2	Facility Function:	
Implementation Phase:		Implementation Date:	
Official Responsible:

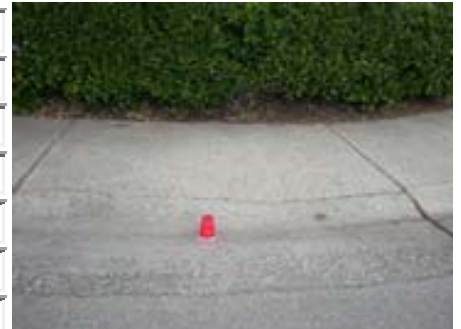
Field Date: 3/8/2011 Report Date: 3/9/2011 Barrier #: 5839
 Location: Villa Oak Dr and Smoley Wy - Corner A
 X Coordinate: -121.25778
 Y Coordinate: 38.70589
 Barrier Area: Curb Ramps
 Barrier Type: No Curb Ramp - Depressed Existing Curb
 Code Ref: CBC 1127B.5.1 and ADA/ABA 402.2

As Built Meas: 1 Quantity: EACH
 Description: No compliant curb cut at corner (intersection)
 As Built Desc: 15.2% running slope at depressed area
 Solution: Demolish existing and construct curb cut
 Bar. Severity: 1 Necessary Cost Estimate: \$2,500.00 Status:
 Implementation Priority: 2 Facility Function:
 Implementation Phase: Implementation Date:
 Official Responsible:

Notes: Two - way intersection corners A,B

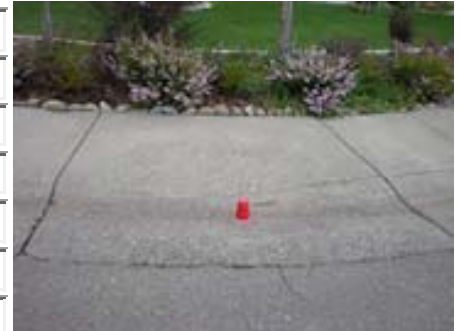
Field Date: 3/8/2011 Report Date: 3/9/2011 Barrier #: 5840
 Location: Villa Oak Dr and Smoley Wy - Corner B
 X Coordinate: -121.25755
 Y Coordinate: 38.7059
 Barrier Area: Curb Ramps
 Barrier Type: No Curb Ramp - Depressed Existing Curb
 Code Ref: CBC 1127B.5.1 and ADA/ABA 402.2

As Built Meas: 1 Quantity: EACH
 Description: No compliant curb cut at corner (intersection)
 As Built Desc: 14.8% running slope at depressed area
 Solution: Demolish existing and construct curb cut
 Bar. Severity: 1 Necessary Cost Estimate: \$2,500.00 Status:
 Implementation Priority: 2 Facility Function:
 Implementation Phase: Implementation Date:
 Official Responsible:

Notes: Two - way intersection corners A,B

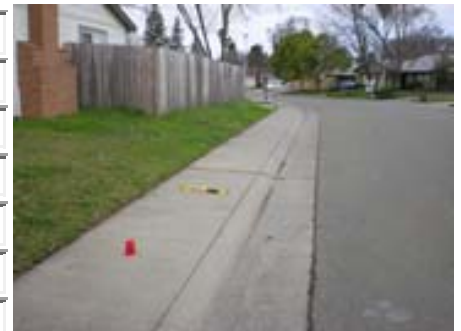
Field Date: 3/8/2011 Report Date: 3/9/2011 Barrier #: 5841
 Location: Smoley Wy - West
 X Coordinate: -121.2577
 Y Coordinate: 38.70596
 Barrier Area: Sidewalks
 Barrier Type: Cross Slope - Existing (5.0% or more)
 Code Ref: CBC 1133B.7.1.3 and ADA/ABA 403.3

As Built Meas: 296 Quantity: LF
 Description: Cross slope exceeds 2.0% (5.0% or more)
 As Built Desc: 6.6% cross slope
 Solution: Demolish existing and construct new route
 Bar. Severity: 1 Necessary Cost Estimate: \$37,000.00 Status:
 Implementation Priority: 4 Facility Function:
 Implementation Phase: Implementation Date:
 Official Responsible:

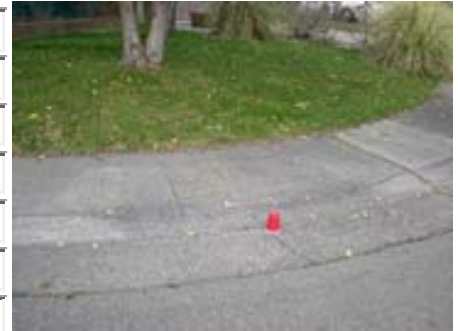
Field Date: 3/8/2011 Report Date: 3/9/2011 Barrier #: 5842
 Location: Smoley Wy and Divinda Ct - Corner A
 X Coordinate: -121.25813
 Y Coordinate: 38.70677
 Barrier Area: Curb Ramps
 Barrier Type: No Curb Ramp - Depressed Existing Curb
 Code Ref: CBC 1127B.5.1 and ADA/ABA 402.2

As Built Meas: 1 Quantity: EACH
 Description: No compliant curb cut at corner (intersection)
 As Built Desc: 12.1% running slope at depressed area
 Solution: Demolish existing and construct curb cut
 Bar. Severity: 1 Necessary Cost Estimate: \$2,500.00 Status:
 Implementation Priority: 4 Facility Function:
 Implementation Phase: Implementation Date:
 Official Responsible:

Notes: Two - way intersection corners A,D

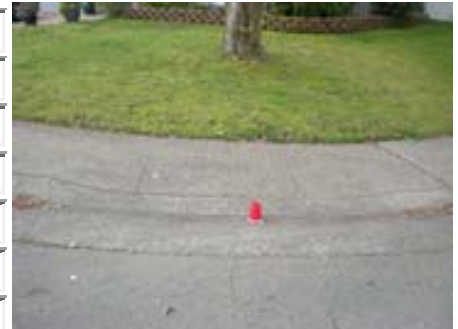
Field Date: 3/8/2011 Report Date: 3/9/2011 Barrier #: 5843
 Location: Smoley Wy and Divinda Ct - Corner D
 X Coordinate: -121.25803
 Y Coordinate: 38.70669
 Barrier Area: Curb Ramps
 Barrier Type: No Curb Ramp - Depressed Existing Curb
 Code Ref: CBC 1127B.5.1 and ADA/ABA 402.2

As Built Meas: 1 Quantity: EACH
 Description: No compliant curb cut at corner (intersection)
 As Built Desc: 12.6% running slope at depressed area
 Solution: Demolish existing and construct curb cut
 Bar. Severity: 1 Necessary Cost Estimate: \$2,500.00 Status:
 Implementation Priority: 4 Facility Function:
 Implementation Phase: Implementation Date:
 Official Responsible:

Notes: Two - way intersection corners A,D

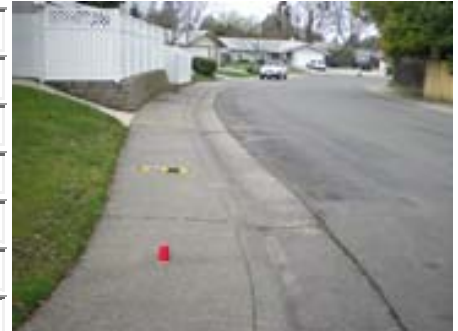
Barrier Type: Cross Slope - Existing (4.1% to 4.9%)

Code Ref: CBC 1133B.7.1.3 and ADA/ABA 403.3

As Built Meas: 282 Quantity: LF

Description: Cross slope exceeds 2.0% (4.1% to 4.9%)

Bar. Severity: 2 Recommended Cost Estimate: \$35,250.00 Status:

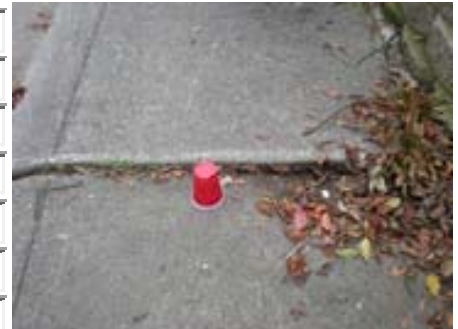
Barrier Type: Abrupt Change in Level - > 1/2"

Code Ref: CBC 1133B.7.1 and ADA/ABA 303.3

As Built Meas: 4 Quantity: LF

Description: Change in level greater than 1/2"

Solution: Grind or repair sidewalk to remove trip hazard

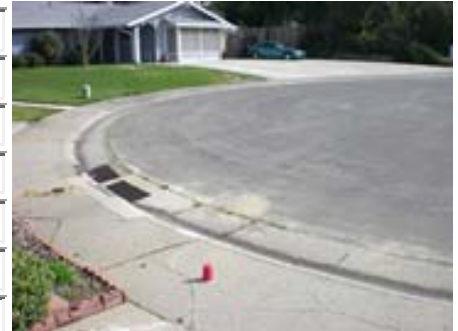
Barrier Type: Cross Slope - Existing (4.1% to 4.9%)

Code Ref: CBC 1133B.7.1.3 and ADA/ABA 403.3

As Built Meas: 283 Quantity: LF

Description: Cross slope exceeds 2.0% (4.1% to 4.9%)

Bar. Severity: 2 Recommended Cost Estimate: \$35,375.00 Status:

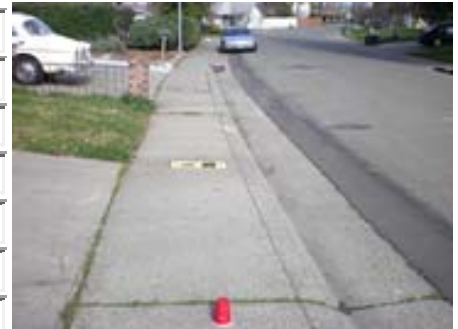
Barrier Type: Cross Slope - Existing (4.1% to 4.9%)

Code Ref: CBC 1133B.7.1.3 and ADA/ABA 403.3

As Built Meas: 189 Quantity: LF

Description: Cross slope exceeds 2.0% (4.1% to 4.9%)

Bar. Severity: 2 Recommended Cost Estimate: \$23,625.00 Status:

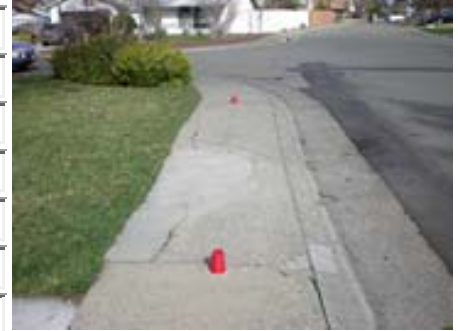
Field Date: 3/8/2011 Report Date: 3/9/2011 Barrier #: 5847B
 Location: Smoley Wy - West
 X Coordinate: -121.25848
 Y Coordinate: 38.70726
 Barrier Area: Sidewalks
 Barrier Type: Surface Condition - Damaged
 Code Ref: CBC 1133B.7.1 and ADA/ABA 302.1

As Built Meas: 20 Quantity: LF
 Description: Surface is not firm and stable (cracked, broken or loose soil, etc.)
 As Built Desc: Cracked concrete
 Solution: Repair surface to make firm and stable
 Bar. Severity: 1 Necessary Cost Estimate: \$2,500.00 Status:
 Implementation Priority: 4 Facility Function:
 Implementation Phase: Implementation Date:
 Official Responsible:

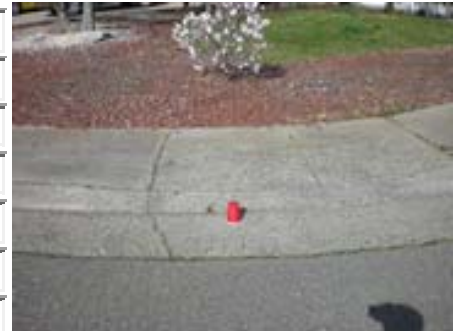
Field Date: 3/8/2011 Report Date: 3/9/2011 Barrier #: 5848
 Location: Smoley Wy and Runyon Ct -Corner A
 X Coordinate: -121.25856
 Y Coordinate: 38.70745
 Barrier Area: Curb Ramps
 Barrier Type: No Curb Ramp - Depressed Existing Curb
 Code Ref: CBC 1127B.5.1 and ADA/ABA 402.2

As Built Meas: 1 Quantity: EACH
 Description: No compliant curb cut at corner (intersection)
 As Built Desc: 13.1% running slope at depressed area
 Solution: Demolish existing and construct curb cut
 Bar. Severity: 1 Necessary Cost Estimate: \$2,500.00 Status:
 Implementation Priority: 4 Facility Function:
 Implementation Phase: Implementation Date:
 Official Responsible:

Notes: Two - way intersection corners A,D

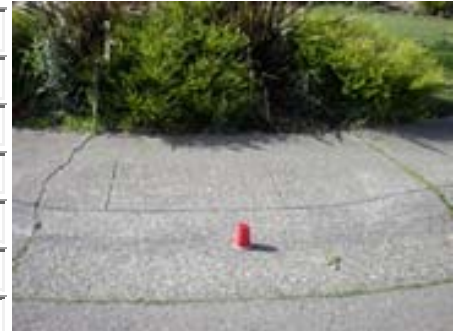
Field Date: 3/8/2011 Report Date: 3/9/2011 Barrier #: 5849
 Location: Smoley Wy and Runyon Ct -Corner D
 X Coordinate: -121.25851
 Y Coordinate: 38.70733
 Barrier Area: Curb Ramps
 Barrier Type: No Curb Ramp - Depressed Existing Curb
 Code Ref: CBC 1127B.5.1 and ADA/ABA 402.2

As Built Meas: 1 Quantity: EACH
 Description: No compliant curb cut at corner (intersection)
 As Built Desc: 11.7% running slope at depressed area
 Solution: Demolish existing and construct curb cut
 Bar. Severity: 1 Necessary Cost Estimate: \$2,500.00 Status:
 Implementation Priority: 4 Facility Function:
 Implementation Phase: Implementation Date:
 Official Responsible:

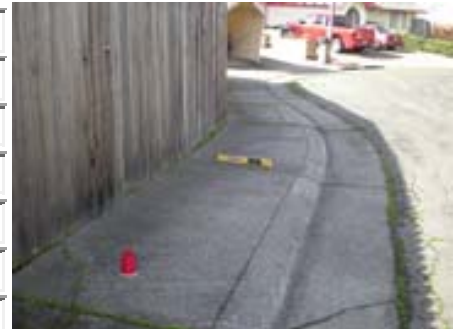
Field Date: 3/8/2011 Report Date: 3/9/2011 Barrier #: 5850
 Location: Runyon Ct - South
 X Coordinate: -121.25871
 Y Coordinate: 38.7073
 Barrier Area: Sidewalks
 Barrier Type: Cross Slope - Existing (4.1% to 4.9%)
 Code Ref: CBC 1133B.7.1.3 and ADA/ABA 403.3

As Built Meas: 126 Quantity: LF
 Description: Cross slope exceeds 2.0% (4.1% to 4.9%)
 As Built Desc: 4.2% cross slope
 Solution: Demolish existing and construct new route
 Bar. Severity: 2 Recommended Cost Estimate: \$15,750.00 Status:
 Implementation Priority: 4 Facility Function:
 Implementation Phase: Implementation Date:
 Official Responsible:

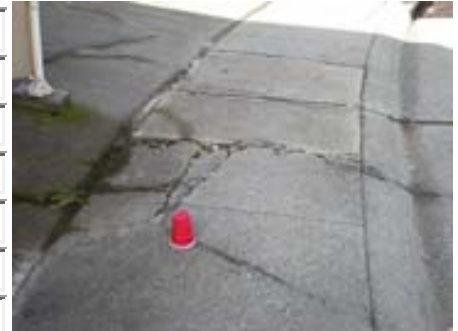
Barrier Type: Surface Condition - Damaged

Description: Surface is not firm and stable (cracked, broken or loose soil, etc.)

As Built Desc: Cracked concrete

Solution: Repair surface to make firm and stable

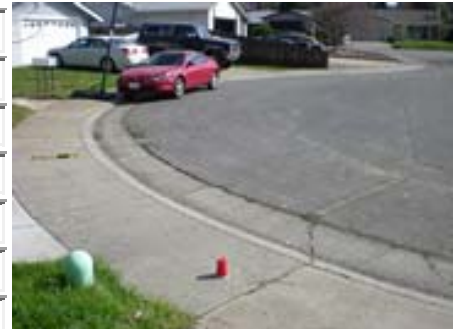
Barrier Type: Cross Slope - Existing (4.1% to 4.9%)

Description: Cross slope exceeds 2.0% (4.1% to 4.9%)

Bar. Severity: 2 Recommended Cost Estimate: \$24,500.00 Status:

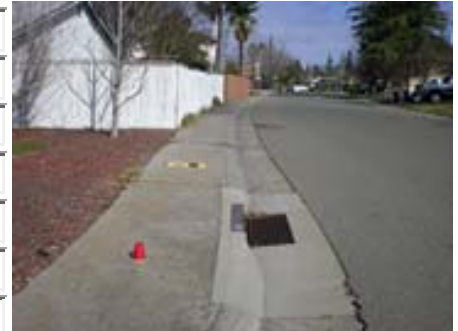
Field Date:	3/8/2011	Report Date:	3/9/2011	Barrier #:	5853
Location:	Smoley Wy - West				
X Coordinate:	-121.25853				
Y Coordinate:	38.70749				
Barrier Area:	Sidewalks				
Barrier Type:	Cross Slope - Existing (4.1% to 4.9%)				
Code Ref:	CBC 1133B.7.1.3 and ADA/ABA 403.3

As Built Meas:	189	Quantity:	LF
Description:	Cross slope exceeds 2.0% (4.1% to 4.9%)		
As Built Desc:	4.2% cross slope		
Solution:	Demolish existing and construct new route		
Bar. Severity:	2 Recommended	Cost Estimate:	\$23,625.00
Implementation Priority:	4	Facility Function:	
Implementation Phase:		Implementation Date:	
Official Responsible:

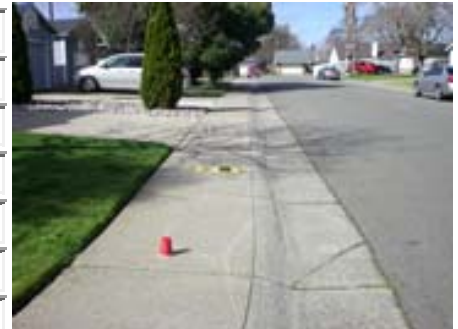
Field Date:	3/8/2011	Report Date:	3/9/2011	Barrier #:	5854
Location:	Lauralyn wy - South				
X Coordinate:	-121.25867				
Y Coordinate:	38.708				
Barrier Area:	Sidewalks				
Barrier Type:	Cross Slope - Existing (4.1% to 4.9%)				
Code Ref:	CBC 1133B.7.1.3 and ADA/ABA 403.3

As Built Meas:	306	Quantity:	LF
Description:	Cross slope exceeds 2.0% (4.1% to 4.9%)		
As Built Desc:	4.3% cross slope		
Solution:	Demolish existing and construct new route		
Bar. Severity:	2 Recommended	Cost Estimate:	\$38,250.00
Implementation Priority:	4	Facility Function:	
Implementation Phase:		Implementation Date:	
Official Responsible:

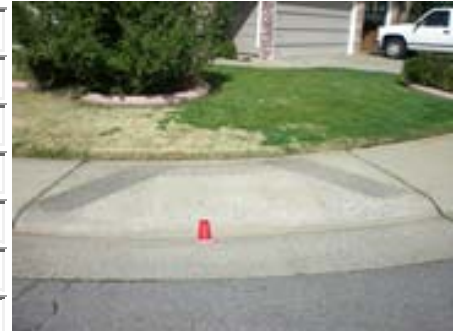
Field Date: 3/8/2011 Report Date: 3/9/2011 Barrier #: 5855
 Location: Auburn Woods Dr and Auburn Point - Corner A
 X Coordinate: -121.25998
 Y Coordinate: 38.70755
 Barrier Area: Curb Ramps
 Barrier Type: No Curb Ramp - Depressed Existing Curb
 Code Ref: CBC 1127B.5.1 and ADA/ABA 402.2

As Built Meas: 1 Quantity: EACH
 Description: No compliant curb cut at corner (intersection)
 As Built Desc: 8.5% running slope at depressed area
 Solution: Demolish existing and construct curb cut
 Bar. Severity: 1 Necessary Cost Estimate: \$2,500.00 Status:
 Implementation Priority: 4 Facility Function:
 Implementation Phase: Implementation Date:
 Official Responsible:

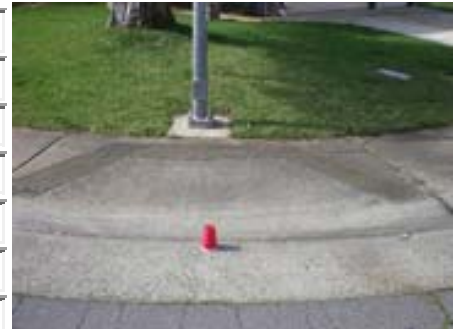
Field Date: 3/8/2011 Report Date: 3/9/2011 Barrier #: 5856
 Location: Auburn Woods Dr and Auburn Point - Corner D
 X Coordinate: -121.25998
 Y Coordinate: 38.70744
 Barrier Area: Curb Ramps
 Barrier Type: No Curb Ramp - Depressed Existing Curb
 Code Ref: CBC 1127B.5.1 and ADA/ABA 402.2

As Built Meas: 1 Quantity: EACH
 Description: No compliant curb cut at corner (intersection)
 As Built Desc: 8.8% running slope at depressed area
 Solution: Demolish existing and construct curb cut
 Bar. Severity: 1 Necessary Cost Estimate: \$2,500.00 Status:
 Implementation Priority: 4 Facility Function:
 Implementation Phase: Implementation Date:
 Official Responsible:

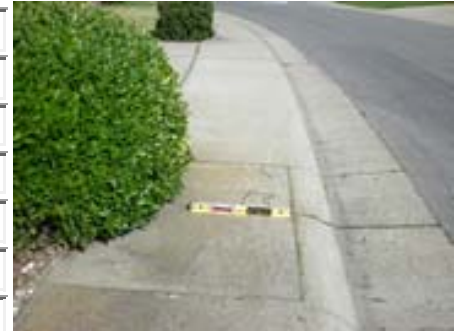
Field Date: 3/8/2011 Report Date: 3/9/2011 Barrier #: 5857
 Location: Auburn Woods Dr - West
 X Coordinate: -121.25994
 Y Coordinate: 38.7087
 Barrier Area: Sidewalks
 Barrier Type: Clear Width - Existing ($\leq 31''$ or less)
 Code Ref: CBC 1133B.7.1

As Built Meas: 1 Quantity: LF
 Description: Pedestrian route is not min. 48" wide ($\leq 31''$ or less)
 As Built Desc: 24" clear width due to foliage
 Solution: Trim foliage to provide min. 48" clear width
 Bar. Severity: 1 Necessary Cost Estimate: \$125.00 Status:
 Implementation Priority: 4 Facility Function:
 Implementation Phase: Implementation Date:
 Official Responsible:

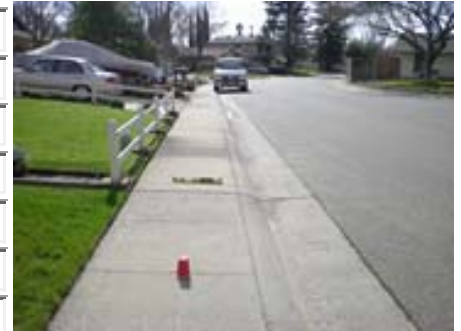
Barrier Type: Cross Slope - Existing (3.1% to 4.0%)

Description: Cross slope exceeds 2.0% (3.1% to 4.0%)

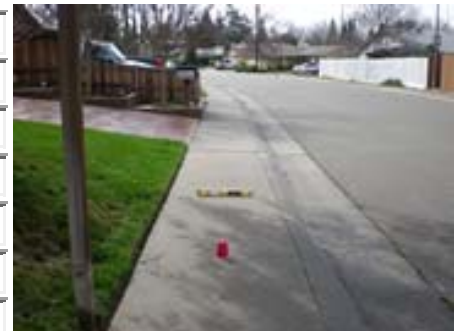
Barrier Type: Cross Slope - Existing (4.1% to 4.9%)

Description: Cross slope exceeds 2.0% (4.1% to 4.9%)

Bar. Severity: 2 Recommended Cost Estimate: \$103,250.00 Status:

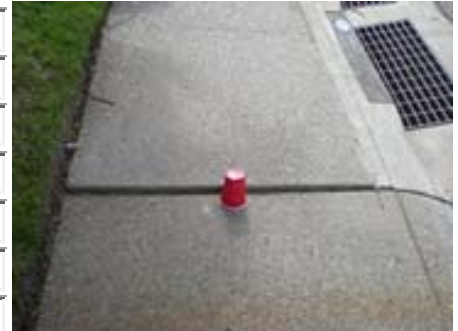
Field Date: 3/8/2011 Report Date: 3/9/2011 Barrier #: 5860B
 Location: Smoley Wy - East
 X Coordinate: -121.25812
 Y Coordinate: 38.70708
 Barrier Area: Sidewalks
 Barrier Type: Abrupt Change in Level - > 1/2"
 Code Ref: CBC 1133B.7.1 and ADA/ABA 303.3

As Built Meas: 4 Quantity: LF
 Description: Change in level greater than 1/2"
 As Built Desc: 1/2" lip in sidewalk surface
 Solution: Grind or repair sidewalk to remove trip hazard
 Bar. Severity: 1 Necessary Cost Estimate: \$1,000.00 Status:
 Implementation Priority: 4 Facility Function:
 Implementation Phase: Implementation Date:
 Official Responsible:

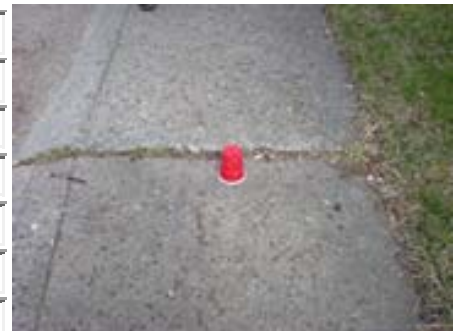
Field Date: 3/8/2011 Report Date: 3/9/2011 Barrier #: 5860C
 Location: Smoley Wy - East
 X Coordinate: -121.25761
 Y Coordinate: 38.70638
 Barrier Area: Sidewalks
 Barrier Type: Abrupt Change in Level - > 1/2"
 Code Ref: CBC 1133B.7.1 and ADA/ABA 303.3

As Built Meas: 4 Quantity: LF
 Description: Change in level greater than 1/2"
 As Built Desc: 1/2" lip in sidewalk surface
 Solution: Grind or repair sidewalk to remove trip hazard
 Bar. Severity: 1 Necessary Cost Estimate: \$1,000.00 Status:
 Implementation Priority: 4 Facility Function:
 Implementation Phase: Implementation Date:
 Official Responsible:

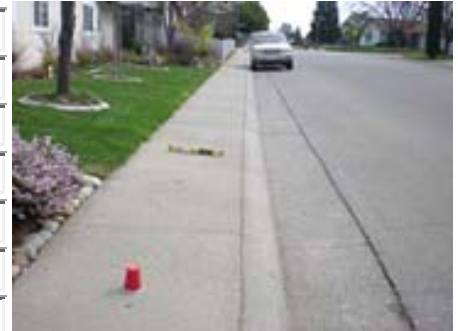
Field Date: 3/8/2011 Report Date: 3/9/2011 Barrier #: 5861
 Location: Villa Oak Dr - North
 X Coordinate: -121.2575
 Y Coordinate: 38.70588
 Barrier Area: Sidewalks
 Barrier Type: Cross Slope - Existing (5.0% or more)
 Code Ref: CBC 1133B.7.1.3 and ADA/ABA 403.3

As Built Meas: 175 Quantity: LF
 Description: Cross slope exceeds 2.0% (5.0% or more)
 As Built Desc: 5.3% cross slope
 Solution: Demolish existing and construct new route
 Bar. Severity: 1 Necessary Cost Estimate: \$21,875.00 Status:
 Implementation Priority: 2 Facility Function:
 Implementation Phase: Implementation Date:
 Official Responsible:

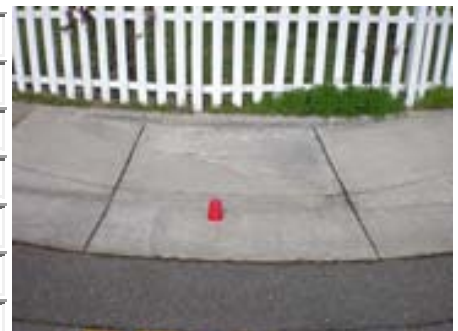
Field Date: 3/8/2011 Report Date: 3/9/2011 Barrier #: 5862
 Location: Villa Oak Dr and Wooddale Wy Corner A
 X Coordinate: -121.2569
 Y Coordinate: 38.70587
 Barrier Area: Curb Ramps
 Barrier Type: Detectable Warnings - Truncated Domes
 Code Ref: CBC 1127B.5.7 and ADA/ABA 705.1.3

As Built Meas: 1 Quantity: EACH
 Description: No truncated domes provided at curb ramp
 As Built Desc: No detectable warnings at curb ramp
 Solution: Provide compliant truncated domes
 Bar. Severity: 2 Recommended Cost Estimate: \$1,400.00 Status:
 Implementation Priority: 2 Facility Function:
 Implementation Phase: Implementation Date:
 Official Responsible:

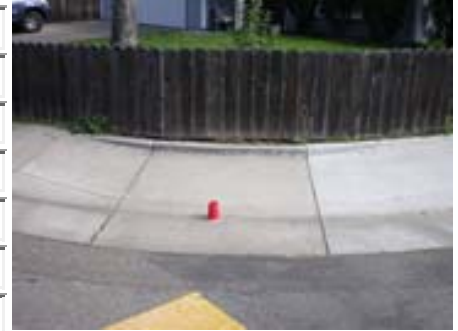
Field Date: 3/8/2011 Report Date: 3/9/2011 Barrier #: 5863
 Location: Villa Oak Dr and Wooddale Wy Corner B
 X Coordinate: -121.25674
 Y Coordinate: 38.70588
 Barrier Area: Curb Ramps
 Barrier Type: Detectable Warnings - Truncated Domes
 Code Ref: CBC 1127B.5.7 and ADA/ABA 705.1.3

As Built Meas: 1 Quantity: EACH
 Description: No truncated domes provided at curb ramp
 As Built Desc: No detectable warnings at curb ramp
 Solution: Provide compliant truncated domes
 Bar. Severity: 2 Recommended Cost Estimate: \$1,400.00 Status:
 Implementation Priority: 2 Facility Function:
 Implementation Phase: Implementation Date:
 Official Responsible:

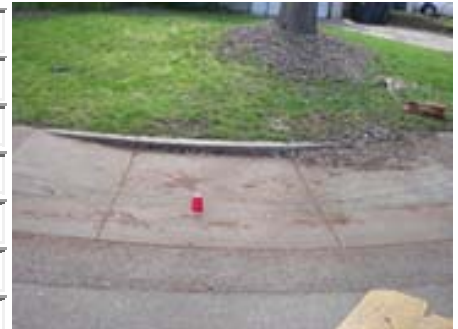
Field Date: 3/8/2011 Report Date: 3/9/2011 Barrier #: 5864
 Location: Villa Oak Dr and Wooddale Wy Corner C
 X Coordinate: -121.25673
 Y Coordinate: 38.70573
 Barrier Area: Curb Ramps
 Barrier Type: Detectable Warnings - Truncated Domes
 Code Ref: CBC 1127B.5.7 and ADA/ABA 705.1.3

As Built Meas: 1 Quantity: EACH
 Description: No truncated domes provided at curb ramp
 As Built Desc: No detectable warnings at curb ramp
 Solution: Provide compliant truncated domes
 Bar. Severity: 2 Recommended Cost Estimate: \$1,400.00 Status:
 Implementation Priority: 2 Facility Function:
 Implementation Phase: Implementation Date:
 Official Responsible:

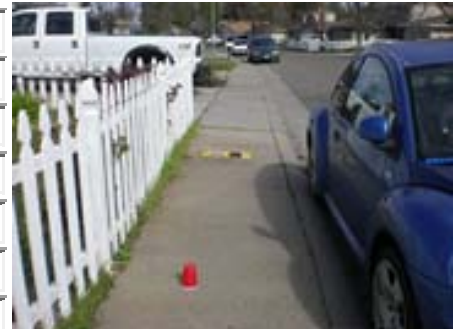
Field Date: 3/8/2011 Report Date: 3/9/2011 Barrier #: 5866
 Location: Wooddale Wy - West
 X Coordinate: -121.25685
 Y Coordinate: 38.70596
 Barrier Area: Sidewalks
 Barrier Type: Cross Slope - Existing (5.0% or more)
 Code Ref: CBC 1133B.7.1.3 and ADA/ABA 403.3

As Built Meas: 825 Quantity: LF
 Description: Cross slope exceeds 2.0% (5.0% or more)
 As Built Desc: 5.3% cross slope
 Solution: Demolish existing and construct new route
 Bar. Severity: 1 Necessary Cost Estimate: \$103,125.00 Status:
 Implementation Priority: 4 Facility Function:
 Implementation Phase: Implementation Date:
 Official Responsible:

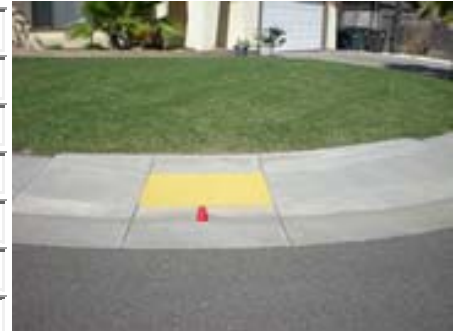
Field Date:	3/8/2011	Report Date:	3/9/2011	Barrier #:	5867A
Location:	Wooddale Wy and Lauralyn Wy - Corner A				
X Coordinate:	-121.25782				
Y Coordinate:	38.70814				
Barrier Area:	Curb Ramps				
Barrier Type:	12" Grooves - Existing (3.1% to 4.0%)				
Code Ref:	CBC 1127B.5.6

As Built Meas:	1	Quantity:	EACH		
Description:	12" grooves at top of curb ramp are not level (3.1% to 4.0%)				
As Built Desc:	4.0% at 12" grooves				
Solution:	Demolish existing and construct new curb ramp				
Bar. Severity:	3 Hindrance	Cost Estimate:	\$2,500.00	Status:	
Implementation Priority:	4	Facility Function:			
Implementation Phase:		Implementation Date:			
Official Responsible:

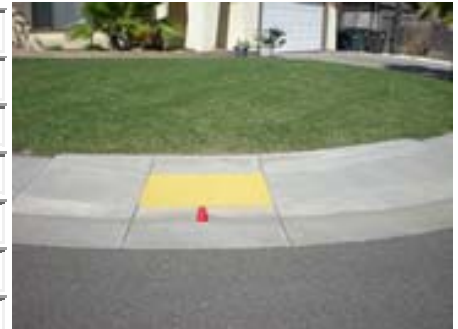
Field Date:	3/8/2011	Report Date:	3/9/2011	Barrier #:	5867B
Location:	Wooddale Wy and Lauralyn Wy - Corner A				
X Coordinate:	-121.25782				
Y Coordinate:	38.70814				
Barrier Area:	Curb Ramps				
Barrier Type:	Perpendicular Ramp Landing (3.1% to 4.0%)				
Code Ref:	CBC 1127B.5.4 and ADA/ABA 406.4

As Built Meas:	1	Quantity:	EACH		
Description:	Curb ramp top landing not level (3.1% to 4.0%)				
As Built Desc:	3.2% landing slope				
Solution:	Demolish existing and construct new transition				
Bar. Severity:	3 Hindrance	Cost Estimate:	\$250.00	Status:	
Implementation Priority:	4	Facility Function:			
Implementation Phase:		Implementation Date:			
Official Responsible:

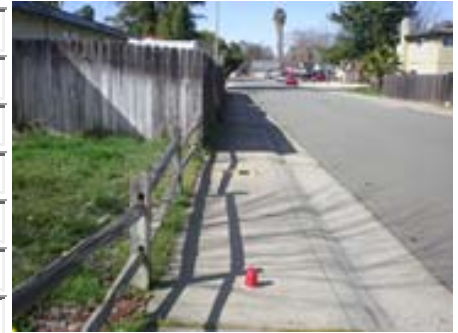
Barrier Type: Cross Slope - Existing (5.0% or more)

Description: Cross slope exceeds 2.0% (5.0% or more)

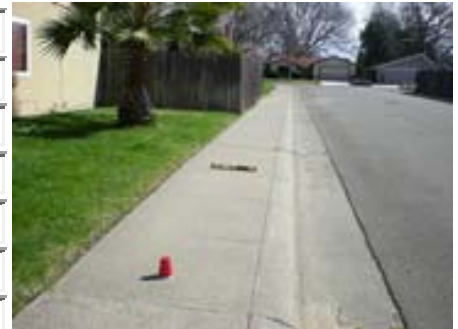
Barrier Type: Cross Slope - Existing (3.1% to 4.0%)

Description: Cross slope exceeds 2.0% (3.1% to 4.0%)

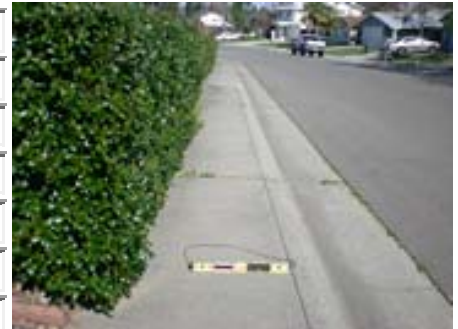
Field Date: 3/8/2011 Report Date: 3/9/2011 Barrier #: 5870B
 Location: Wooddale Wy - West
 X Coordinate: -121.25777
 Y Coordinate: 38.70886
 Barrier Area: Sidewalks
 Barrier Type: Clear Width - Existing ($\leq 31''$ or less)
 Code Ref: CBC 1133B.7.1

As Built Meas: 1 Quantity: LF
 Description: Pedestrian route is not min. 48" wide ($\leq 31''$ or less)
 As Built Desc: 37" clear width due to foliage
 Solution: Trim foliage to provide min. 48" clear width
 Bar. Severity: 1 Necessary Cost Estimate: \$125.00 Status:
 Implementation Priority: 4 Facility Function:
 Implementation Phase: Implementation Date:
 Official Responsible:

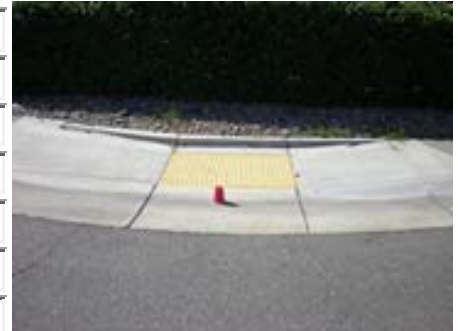
Field Date: 3/8/2011 Report Date: 3/9/2011 Barrier #: 5871A
 Location: Wooddale Wy and Wooddale Wy Ct - Corner D
 X Coordinate: -121.2578
 Y Coordinate: 38.70928
 Barrier Area: Curb Ramps
 Barrier Type: 12" Grooves - Existing (3.1% to 4.0%)
 Code Ref: CBC 1127B.5.6

As Built Meas: 1 Quantity: EACH
 Description: 12" grooves at top of curb ramp are not level (3.1% to 4.0%)
 As Built Desc: 3.8% at 12" grooves
 Solution: Demolish existing and construct new curb ramp
 Bar. Severity: 3 Hindrance Cost Estimate: \$2,500.00 Status:
 Implementation Priority: 4 Facility Function:
 Implementation Phase: Implementation Date:
 Official Responsible:

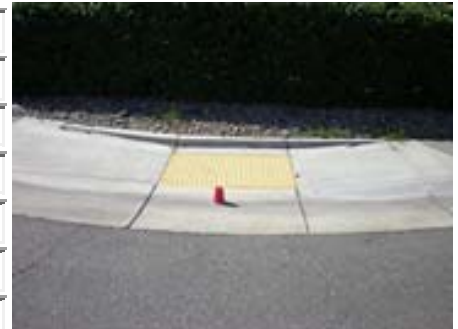
Field Date: 3/8/2011 Report Date: 3/9/2011 Barrier #: 5871B
 Location: Wooddale Wy and Wooddale Wy Ct - Corner D
 X Coordinate: -121.2578
 Y Coordinate: 38.70928
 Barrier Area: Curb Ramps
 Barrier Type: Cross Slope - Existing (2.1% to 3.0%)
 Code Ref: CBC 1127B.5.3 and ADA/ABA 406.2

As Built Meas: 1 Quantity: EACH
 Description: Ramp run cross slope exceeds 2.0% (2.1% to 3.0%)
 As Built Desc: 3.0% cross slope
 Solution: Demolish existing and construct new curb ramp
 Bar. Severity: 4 Low Severity Cost Estimate: \$2,500.00 Status:
 Implementation Priority: 4 Facility Function:
 Implementation Phase: Implementation Date:
 Official Responsible:

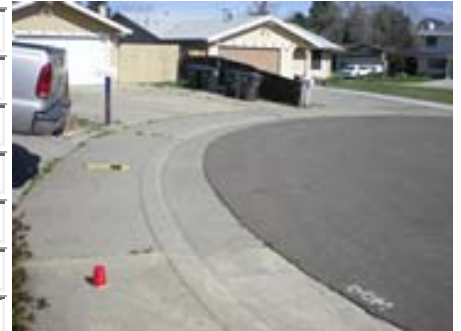
Field Date: 3/8/2011 Report Date: 3/9/2011 Barrier #: 5872
 Location: Wooddale Wy Ct - North
 X Coordinate: -121.25818
 Y Coordinate: 38.70935
 Barrier Area: Sidewalks
 Barrier Type: Cross Slope - Existing (5.0% or more)
 Code Ref: CBC 1133B.7.1.3 and ADA/ABA 403.3

As Built Meas: 150 Quantity: LF
 Description: Cross slope exceeds 2.0% (5.0% or more)
 As Built Desc: 5.0% cross slope
 Solution: Demolish existing and construct new route
 Bar. Severity: 1 Necessary Cost Estimate: \$18,750.00 Status:
 Implementation Priority: 4 Facility Function:
 Implementation Phase: Implementation Date:
 Official Responsible:

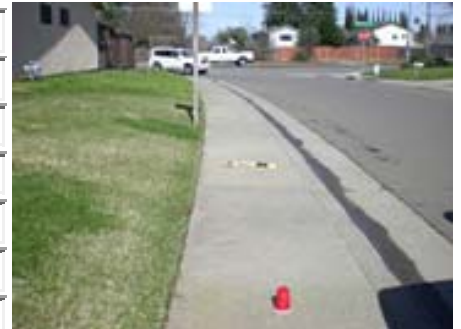
Field Date: 3/8/2011 Report Date: 3/9/2011 Barrier #: 5873
 Location: Wooddale Wy - West
 X Coordinate: -121.25783
 Y Coordinate: 38.70957
 Barrier Area: Sidewalks
 Barrier Type: Cross Slope - Existing (3.1% to 4.0%)
 Code Ref: CBC 1133B.7.1.3 and ADA/ABA 403.3

As Built Meas: 106 Quantity: LF
 Description: Cross slope exceeds 2.0% (3.1% to 4.0%)
 As Built Desc: 3.8% cross slope
 Solution: Demolish existing and construct new route
 Bar. Severity: 3 Hinderance Cost Estimate: \$13,250.00 Status:
 Implementation Priority: 4 Facility Function:
 Implementation Phase: Implementation Date:
 Official Responsible:

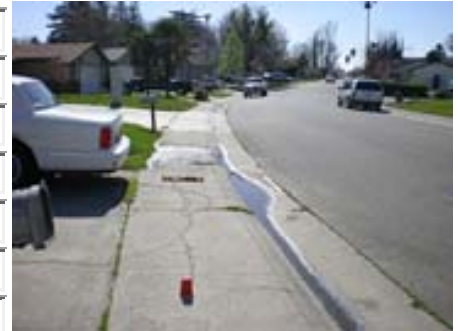
Field Date: 3/8/2011 Report Date: 3/9/2011 Barrier #: 5874A
 Location: Wooddale Wy - East
 X Coordinate: -121.25776
 Y Coordinate: 38.70982
 Barrier Area: Sidewalks
 Barrier Type: Cross Slope - Existing (4.1% to 4.9%)
 Code Ref: CBC 1133B.7.1.3 and ADA/ABA 403.3

As Built Meas: 1036 Quantity: LF
 Description: Cross slope exceeds 2.0% (4.1% to 4.9%)
 As Built Desc: 4.3% cross slope
 Solution: Demolish existing and construct new route
 Bar. Severity: 2 Recommended Cost Estimate: \$129,500.00 Status:
 Implementation Priority: 4 Facility Function:
 Implementation Phase: Implementation Date:
 Official Responsible:

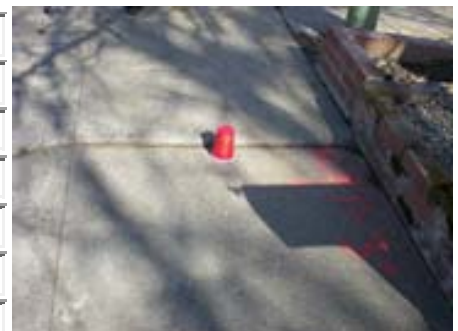
Field Date: 3/8/2011 Report Date: 3/9/2011 Barrier #: 5874B
 Location: Wooddale Wy - East
 X Coordinate: -121.25755
 Y Coordinate: 38.70835
 Barrier Area: Sidewalks
 Barrier Type: Abrupt Change in Level - > 1/2"
 Code Ref: CBC 1133B.7.1 and ADA/ABA 303.3

As Built Meas: 4 Quantity: LF
 Description: Change in level greater than 1/2"
 As Built Desc: 1/2" lip in sidewalk surface
 Solution: Grind or repair sidewalk to remove trip hazard
 Bar. Severity: 1 Necessary Cost Estimate: \$1,000.00 Status:
 Implementation Priority: 4 Facility Function:
 Implementation Phase: Implementation Date:
 Official Responsible:

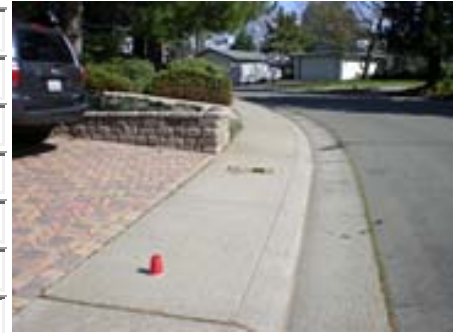
Barrier Type: Cross Slope - Existing (3.1% to 4.0%)

Code Ref: CBC 1133B.7.1.3 and ADA/ABA 403.3

As Built Meas: 243 Quantity: LF

Description: Cross slope exceeds 2.0% (3.1% to 4.0%)

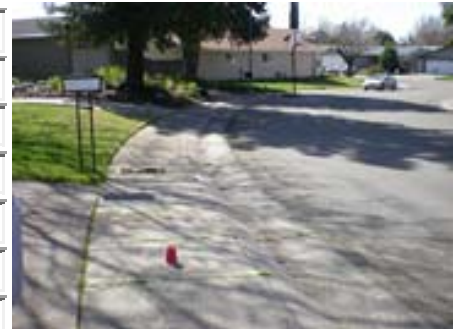
Barrier Type: Cross Slope - Existing (5.0% or more)

Code Ref: CBC 1133B.7.1.3 and ADA/ABA 403.3

As Built Meas: 192 Quantity: LF

Description: Cross slope exceeds 2.0% (5.0% or more)
