**DRAFT ADA TRANSITION PLAN UPDATE
NEIGHBORHOOD AREA 8 CHASE
SEPTEMBER 20, 2011**

CITY OF CITRUS HEIGHTS

Conditions - CHASE Area 8

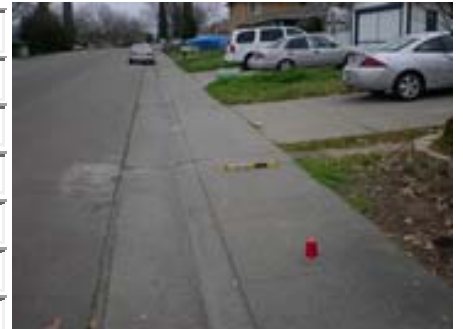
Field Date: 3/10/2011 Report Date: 3/10/2011 Barrier #: 5879A
 Location: Villa Oak Dr - South
 X Coordinate: -121.26062
 Y Coordinate: 38.70588
 Barrier Area: Sidewalks
 Barrier Type: Cross Slope - Existing (4.1% to 4.9%)
 Code Ref: CBC 1133B.7.1.3 and ADA/ABA 403.3

As Built Meas: 1050 Quantity: LF
 Description: Cross slope exceeds 2.0% (4.1% to 4.9%)
 As Built Desc: 4.9% cross slope
 Solution: Demolish existing and construct new route
 Bar. Severity: 2 Recommended Cost Estimate: \$131,250.00 Status:
 Implementation Priority: 2 Facility Function:
 Implementation Phase: Implementation Date:
 Official Responsible:

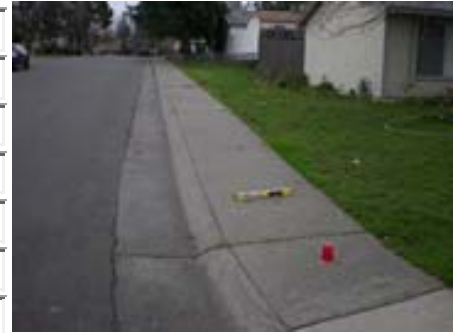
Field Date: 3/10/2011 Report Date: 3/10/2011 Barrier #: 5880A
 Location: Wooddale Wy - West
 X Coordinate: -121.25688
 Y Coordinate: 38.7057
 Barrier Area: Sidewalks
 Barrier Type: Cross Slope - Existing (5.0% or more)
 Code Ref: CBC 1133B.7.1.3 and ADA/ABA 403.3

As Built Meas: 180 Quantity: LF
 Description: Cross slope exceeds 2.0% (5.0% or more)
 As Built Desc: 5.0% cross slope
 Solution: Demolish existing and construct new route
 Bar. Severity: 1 Necessary Cost Estimate: \$22,500.00 Status:
 Implementation Priority: 4 Facility Function:
 Implementation Phase: Implementation Date:
 Official Responsible:

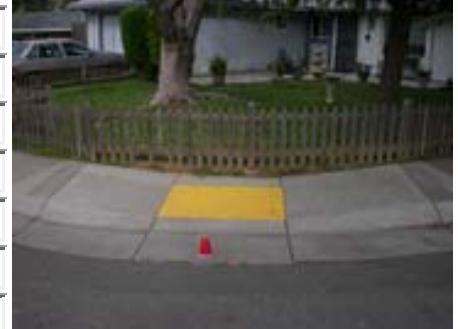
Field Date: 3/10/2011 Report Date: 3/10/2011 Barrier #: 5881
 Location: Wooddale Wy and Lin Oak Wy - Corner A
 X Coordinate: -121.25689
 Y Coordinate: 38.70518
 Barrier Area: Curb Ramps
 Barrier Type: 12" Grooves - Existing (>5.0%)
 Code Ref: CBC 1127B.5.6

As Built Meas: 1 Quantity: EACH
 Description: 12" grooves at top of curb ramp are not level (>5.0%)
 As Built Desc: 5.0% at 12" grooves
 Solution: Demolish existing and construct new curb ramp
 Bar. Severity: 1 Necessary Cost Estimate: \$2,500.00 Status:
 Implementation Priority: 4 Facility Function:
 Implementation Phase: Implementation Date:
 Official Responsible:

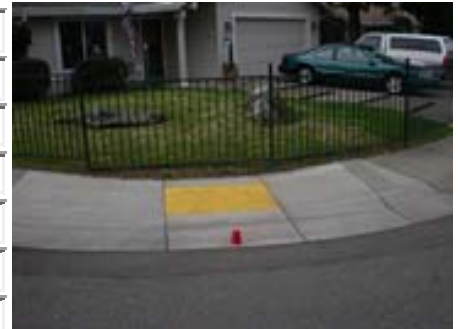
Field Date: 3/10/2011 Report Date: 3/10/2011 Barrier #: 5882
 Location: Wooddale Wy and Lin Oak Wy - Corner D
 X Coordinate: -121.25687
 Y Coordinate: 38.70506
 Barrier Area: Curb Ramps
 Barrier Type: 12" Grooves - Existing (2.1% to 3.0%)
 Code Ref: CBC 1127B.5.6

As Built Meas: 1 Quantity: EACH
 Description: 12" grooves at top of curb ramp are not level (2.1% to 3.0%)
 As Built Desc: 2.7% at 12" grooves
 Solution: Demolish existing and construct new curb ramp
 Bar. Severity: 4 Low Severity Cost Estimate: \$2,500.00 Status:
 Implementation Priority: 4 Facility Function:
 Implementation Phase: Implementation Date:
 Official Responsible:

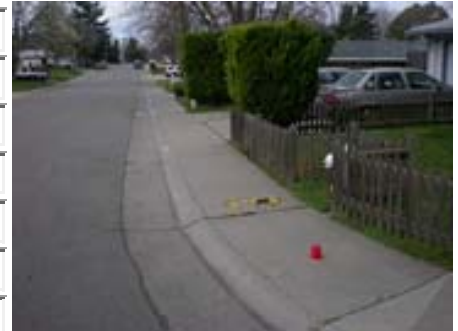
Field Date: 3/10/2011 Report Date: 3/10/2011 Barrier #: 5883A
 Location: Lin Oak Wy - North
 X Coordinate: -121.25689
 Y Coordinate: 38.70516
 Barrier Area: Sidewalks
 Barrier Type: Cross Slope - Existing (4.1% to 4.9%)
 Code Ref: CBC 1133B.7.1.3 and ADA/ABA 403.3

As Built Meas: 1050 Quantity: LF
 Description: Cross slope exceeds 2.0% (4.1% to 4.9%)
 As Built Desc: 4.6% cross slope
 Solution: Demolish existing and construct new route
 Bar. Severity: 2 Recommended Cost Estimate: \$131,250.00 Status:
 Implementation Priority: 4 Facility Function:
 Implementation Phase: Implementation Date:
 Official Responsible:

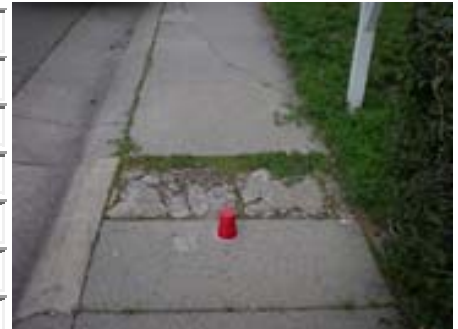
Field Date: 3/10/2011 Report Date: 3/10/2011 Barrier #: 5883B
 Location: Lin Oak Wy - North
 X Coordinate: -121.25799
 Y Coordinate: 38.70518
 Barrier Area: Sidewalks
 Barrier Type: Surface Condition - Damaged
 Code Ref: CBC 1133B.7.1 and ADA/ABA 302.1

As Built Meas: 2 Quantity: LF
 Description: Surface is not firm and stable (cracked, broken or loose soil, etc.)
 As Built Desc: Cracked concrete
 Solution: Repair surface to make firm and stable
 Bar. Severity: 1 Necessary Cost Estimate: \$250.00 Status:
 Implementation Priority: 4 Facility Function:
 Implementation Phase: Implementation Date:
 Official Responsible:

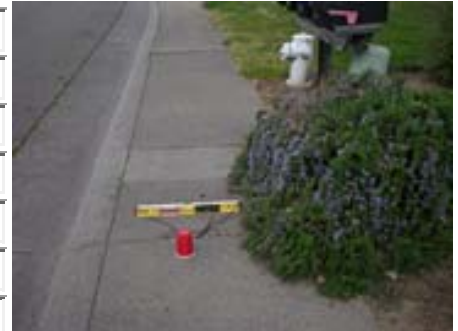
Field Date: 3/10/2011 Report Date: 3/10/2011 Barrier #: 5884
 Location: Lin Oak Wy - North
 X Coordinate: -121.25883
 Y Coordinate: 38.70521
 Barrier Area: Sidewalks
 Barrier Type: Clear Width - Existing ($\leq 31''$ or less)
 Code Ref: CBC 1133B.7.1

As Built Meas: 1 Quantity: LF
 Description: Pedestrian route is not min. 48" wide ($\leq 31''$ or less)
 As Built Desc: 30" clear width due to foliage
 Solution: Trim foliage to provide min. 48" clear width
 Bar. Severity: 1 Necessary Cost Estimate: \$125.00 Status:
 Implementation Priority: 4 Facility Function:
 Implementation Phase: Implementation Date:
 Official Responsible:

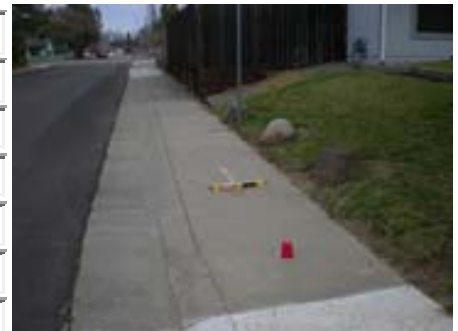
Field Date: 3/10/2011 Report Date: 3/10/2011 Barrier #: 5885
 Location: McConnel Dr - East
 X Coordinate: -121.26071
 Y Coordinate: 38.70536
 Barrier Area: Sidewalks
 Barrier Type: Cross Slope - Existing (5.0% or more)
 Code Ref: CBC 1133B.7.1.3 and ADA/ABA 403.3

As Built Meas: 91 Quantity: LF
 Description: Cross slope exceeds 2.0% (5.0% or more)
 As Built Desc: 5.5% cross slope
 Solution: Demolish existing and construct new route
 Bar. Severity: 1 Necessary Cost Estimate: \$11,375.00 Status:
 Implementation Priority: 4 Facility Function:
 Implementation Phase: Implementation Date:
 Official Responsible:

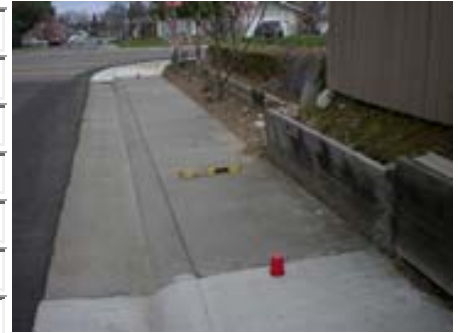
Field Date: 3/10/2011 Report Date: 3/10/2011 Barrier #: 5886
 Location: McConnel Dr - East
 X Coordinate: -121.26069
 Y Coordinate: 38.70574
 Barrier Area: Sidewalks
 Barrier Type: Cross Slope - Existing (5.0% or more)
 Code Ref: CBC 1133B.7.1.3 and ADA/ABA 403.3

As Built Meas: 40 Quantity: LF
 Description: Cross slope exceeds 2.0% (5.0% or more)
 As Built Desc: 5.0% cross slope
 Solution: Demolish existing and construct new route
 Bar. Severity: 1 Necessary Cost Estimate: \$5,000.00 Status:
 Implementation Priority: 4 Facility Function:
 Implementation Phase: Implementation Date:
 Official Responsible:

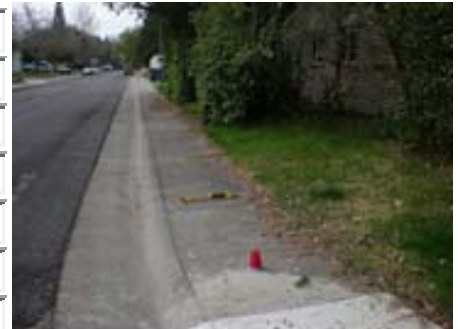
Field Date: 3/10/2011 Report Date: 3/10/2011 Barrier #: 5887A
 Location: McConnel Dr - West
 X Coordinate: -121.26078
 Y Coordinate: 38.70578
 Barrier Area: Sidewalks
 Barrier Type: Cross Slope - Existing (4.1% to 4.9%)
 Code Ref: CBC 1133B.7.1.3 and ADA/ABA 403.3

As Built Meas: 600 Quantity: LF
 Description: Cross slope exceeds 2.0% (4.1% to 4.9%)
 As Built Desc: 4.5% cross slope
 Solution: Demolish existing and construct new route
 Bar. Severity: 2 Recommended Cost Estimate: \$75,000.00 Status:
 Implementation Priority: 4 Facility Function:
 Implementation Phase: Implementation Date:
 Official Responsible:

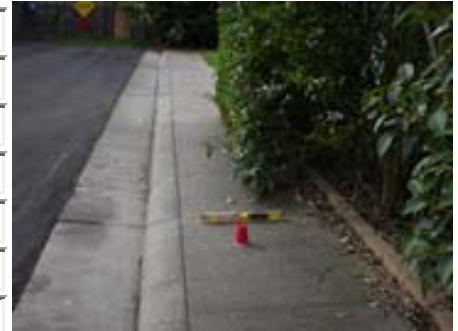
Field Date: 3/10/2011 Report Date: 3/10/2011 Barrier #: 5887B
 Location: McConnell Dr - West
 X Coordinate: -121.26077
 Y Coordinate: 38.70438
 Barrier Area: Sidewalks
 Barrier Type: Clear Width - Existing ($\leq 31''$ or less)
 Code Ref: CBC 1133B.7.1

As Built Meas: 1 Quantity: LF
 Description: Pedestrian route is not min. 48" wide ($\leq 31''$ or less)
 As Built Desc: 16" clear width due to foliage
 Solution: Trim foliage to provide min. 48" clear width
 Bar. Severity: 1 Necessary Cost Estimate: \$125.00 Status:
 Implementation Priority: 4 Facility Function:
 Implementation Phase: Implementation Date:
 Official Responsible:

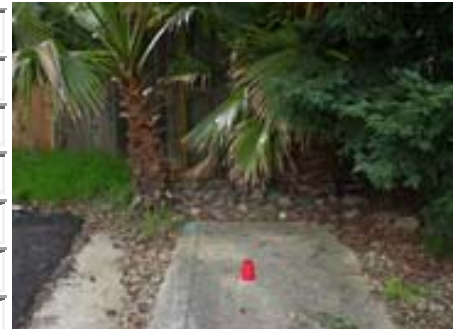
Field Date: 3/10/2011 Report Date: 3/10/2011 Barrier #: 5888
 Location: McConnell Dr - West
 X Coordinate: -121.26076
 Y Coordinate: 38.70418
 Barrier Area: Sidewalks
 Barrier Type: No Sidewalk - No Barricade
 Code Ref: MUTCD Section 6D.01

As Built Meas: 1 Quantity: JOB
 Description: No barricade provided where sidewalk ends in hazardous location
 As Built Desc: No barricade or other warning provided for the visually impaired at end of sidewalk
 Solution: Provide barricade with cane detectable warning at end of sidewalk
 Bar. Severity: 1 Necessary Cost Estimate: \$1,350.00 Status:
 Implementation Priority: 4 Facility Function:
 Implementation Phase: Implementation Date:
 Official Responsible:

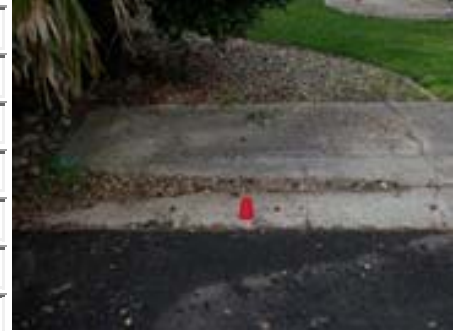
Field Date: 3/10/2011 Report Date: 3/10/2011 Barrier #: 5889
 Location: McConnel Dr - West
 X Coordinate: -121.26075
 Y Coordinate: 38.70411
 Barrier Area: Sidewalks
 Barrier Type: No Sidewalk - Transition to Shoulder
 Code Ref: CBC 1121B.2 and ADA/ABA 206.2.1

As Built Meas: 1 Quantity: JOB
 Description: Sidewalk ends and no ramp to pedestrian shoulder is provided
 As Built Desc: No ramp to shoulder to enable pedestrian travel onto existing shoulder
 Solution: Provide transition ramp to paved shoulder where no opposite sidewalk exists
 Bar. Severity: 1 Necessary Cost Estimate: \$2,500.00 Status:
 Implementation Priority: 4 Facility Function:
 Implementation Phase: Implementation Date:
 Official Responsible:

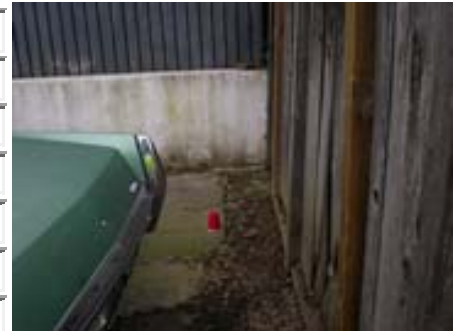
Field Date: 3/10/2011 Report Date: 3/10/2011 Barrier #: 5890
 Location: McConnel Dr - West
 X Coordinate: -121.26067
 Y Coordinate: 38.70404
 Barrier Area: Sidewalks
 Barrier Type: No Sidewalk - Transition to Shoulder
 Code Ref: CBC 1121B.2 and ADA/ABA 206.2.1

As Built Meas: 1 Quantity: JOB
 Description: Sidewalk ends and no ramp to pedestrian shoulder is provided
 As Built Desc: No ramp to shoulder to enable pedestrian travel onto existing shoulder
 Solution: Provide transition ramp to paved shoulder where no opposite sidewalk exists
 Bar. Severity: 1 Necessary Cost Estimate: \$2,500.00 Status:
 Implementation Priority: 4 Facility Function:
 Implementation Phase: Implementation Date:
 Official Responsible:

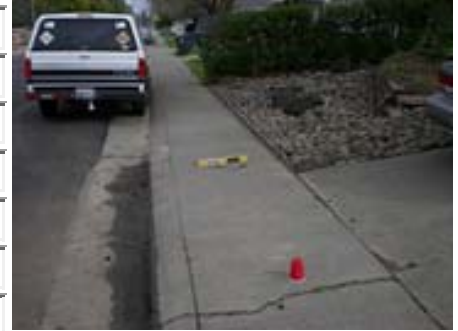
Field Date: 3/10/2011 Report Date: 3/10/2011 Barrier #: 5891
 Location: McConnel Dr - West
 X Coordinate: -121.26068
 Y Coordinate: 38.70424
 Barrier Area: Sidewalks
 Barrier Type: Cross Slope - Existing (4.1% to 4.9%)
 Code Ref: CBC 1133B.7.1.3 and ADA/ABA 403.3

As Built Meas: 290 Quantity: LF
 Description: Cross slope exceeds 2.0% (4.1% to 4.9%)
 As Built Desc: 4.5% cross slope
 Solution: Demolish existing and construct new route
 Bar. Severity: 2 Recommended Cost Estimate: \$36,250.00 Status:
 Implementation Priority: 4 Facility Function:
 Implementation Phase: Implementation Date:
 Official Responsible:

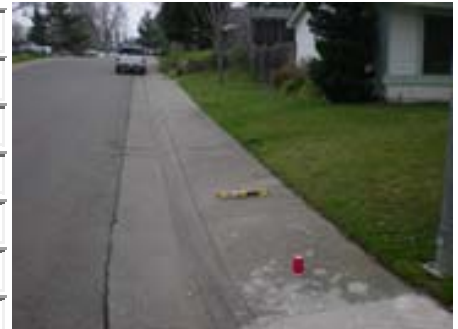
Field Date: 3/10/2011 Report Date: 3/10/2011 Barrier #: 5892A
 Location: Lin Oak Wy - South
 X Coordinate: -121.26059
 Y Coordinate: 38.70516
 Barrier Area: Sidewalks
 Barrier Type: Cross Slope - Existing (5.0% or more)
 Code Ref: CBC 1133B.7.1.3 and ADA/ABA 403.3

As Built Meas: 175 Quantity: LF
 Description: Cross slope exceeds 2.0% (5.0% or more)
 As Built Desc: 5.2% cross slope
 Solution: Demolish existing and construct new route
 Bar. Severity: 1 Necessary Cost Estimate: \$21,875.00 Status:
 Implementation Priority: 4 Facility Function:
 Implementation Phase: Implementation Date:
 Official Responsible:

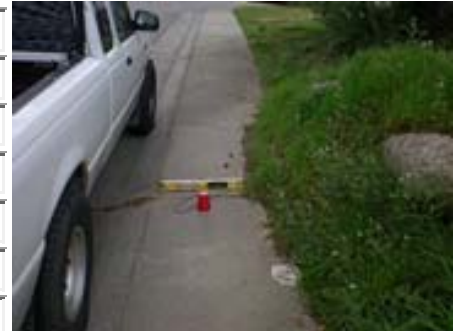
Field Date: 3/10/2011 Report Date: 3/10/2011 Barrier #: 5892B
 Location: Lin Oak Wy - South
 X Coordinate: -121.26027
 Y Coordinate: 38.70512
 Barrier Area: Sidewalks
 Barrier Type: Clear Width - Existing ($\leq 31''$ or less)
 Code Ref: CBC 1133B.7.1

As Built Meas: 4 Quantity: LF
 Description: Pedestrian route is not min. 48" wide ($\leq 31''$ or less)
 As Built Desc: 24" clear width due to dirt
 Solution: Demolish existing and construct new route
 Bar. Severity: 1 Necessary Cost Estimate: \$500.00 Status:
 Implementation Priority: 4 Facility Function:
 Implementation Phase: Implementation Date:
 Official Responsible:

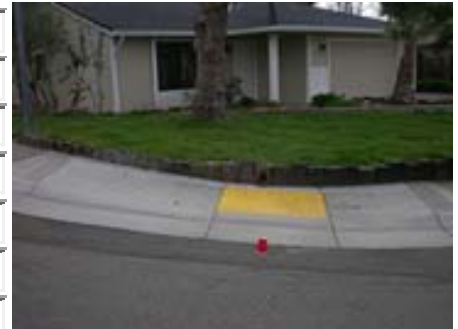
Field Date: 3/10/2011 Report Date: 3/10/2011 Barrier #: 5893A
 Location: Lin Oak Wy and Wooddale Wy - Corner C
 X Coordinate: -121.25982
 Y Coordinate: 38.70513
 Barrier Area: Curb Ramps
 Barrier Type: 12" Grooves - Existing ($> 5.0\%$)
 Code Ref: CBC 1127B.5.6

As Built Meas: 1 Quantity: EACH
 Description: 12" grooves at top of curb ramp are not level ($> 5.0\%$)
 As Built Desc: 7.4% at 12" grooves
 Solution: Demolish existing and construct new curb ramp
 Bar. Severity: 1 Necessary Cost Estimate: \$2,500.00 Status:
 Implementation Priority: 4 Facility Function:
 Implementation Phase: Implementation Date:
 Official Responsible:

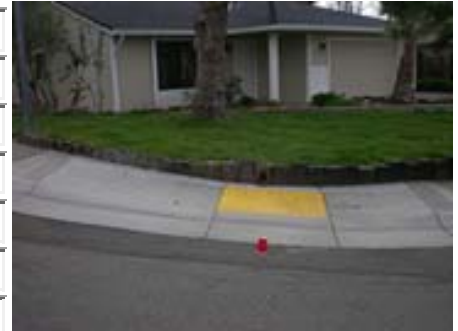
Field Date: 3/10/2011 Report Date: 3/10/2011 Barrier #: 5893B
 Location: Lin Oak Wy and Wooddale Wy - Corner C
 X Coordinate: -121.25982
 Y Coordinate: 38.70513
 Barrier Area: Curb Ramps
 Barrier Type: Cross Slope - Existing (5.0% or more)
 Code Ref: CBC 1127B.5.3 and ADA/ABA 406.2

As Built Meas: 1 Quantity: EACH
 Description: Ramp run cross slope exceeds 2.0% (5.0% or more)
 As Built Desc: 10.5% cross slope
 Solution: Demolish existing and construct new curb ramp
 Bar. Severity: 1 Necessary Cost Estimate: \$2,500.00 Status:
 Implementation Priority: 4 Facility Function:
 Implementation Phase: Implementation Date:
 Official Responsible:

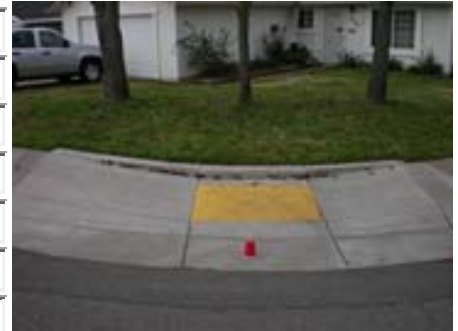
Field Date: 3/10/2011 Report Date: 3/10/2011 Barrier #: 5894
 Location: Lin Oak Wy and Wooddale Wy - Corner D
 X Coordinate: -121.25996
 Y Coordinate: 38.70513
 Barrier Area: Curb Ramps
 Barrier Type: 12" Grooves - Existing (3.1% to 4.0%)
 Code Ref: CBC 1127B.5.6

As Built Meas: 1 Quantity: EACH
 Description: 12" grooves at top of curb ramp are not level (3.1% to 4.0%)
 As Built Desc: 3.9% at 12" grooves
 Solution: Demolish existing and construct new curb ramp
 Bar. Severity: 3 Hindrance Cost Estimate: \$2,500.00 Status:
 Implementation Priority: 4 Facility Function:
 Implementation Phase: Implementation Date:
 Official Responsible:

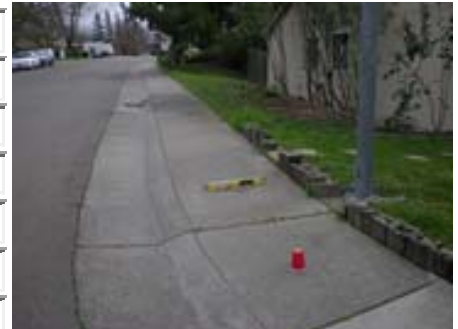
Field Date: 3/10/2011 Report Date: 3/10/2011 Barrier #: 5895A
 Location: Lin Oak Wy - South
 X Coordinate: -121.25977
 Y Coordinate: 38.70515
 Barrier Area: Sidewalks
 Barrier Type: Cross Slope - Existing (4.1% to 4.9%)
 Code Ref: CBC 1133B.7.1.3 and ADA/ABA 403.3

As Built Meas: 830 Quantity: LF
 Description: Cross slope exceeds 2.0% (4.1% to 4.9%)
 As Built Desc: 4.7% cross slope
 Solution: Demolish existing and construct new route
 Bar. Severity: 2 Recommended Cost Estimate: \$103,750.00 Status:
 Implementation Priority: 4 Facility Function:
 Implementation Phase: Implementation Date:
 Official Responsible:

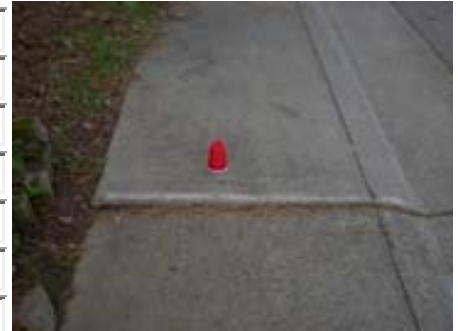
Field Date: 3/10/2011 Report Date: 3/10/2011 Barrier #: 5895B
 Location: Lin Oak Wy - South
 X Coordinate: -121.25946
 Y Coordinate: 38.70512
 Barrier Area: Sidewalks
 Barrier Type: Abrupt Change in Level - > 1/2"
 Code Ref: CBC 1133B.7.1 and ADA/ABA 303.3

As Built Meas: 4 Quantity: LF
 Description: Change in level greater than 1/2"
 As Built Desc: 1/2" lip in sidewalk surface
 Solution: Grind or repair sidewalk to remove trip hazard
 Bar. Severity: 1 Necessary Cost Estimate: \$1,000.00 Status:
 Implementation Priority: 4 Facility Function:
 Implementation Phase: Implementation Date:
 Official Responsible:

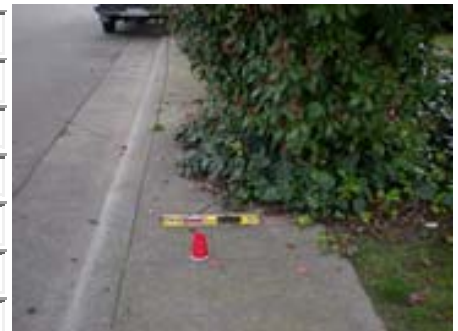
Field Date: 3/10/2011 Report Date: 3/10/2011 Barrier #: 5895C
 Location: Lin Oak Wy - South
 X Coordinate: -121.25833
 Y Coordinate: 38.70497
 Barrier Area: Sidewalks
 Barrier Type: Clear Width - Existing ($\leq 31"$ or less)
 Code Ref: CBC 1133B.7.1

As Built Meas: 1 Quantity: LF
 Description: Pedestrian route is not min. 48" wide ($\leq 31"$ or less)
 As Built Desc: 4" clear width due to foliage
 Solution: Trim foliage to provide min. 48" clear width
 Bar. Severity: 1 Necessary Cost Estimate: \$125.00 Status:
 Implementation Priority: 4 Facility Function:
 Implementation Phase: Implementation Date:
 Official Responsible:

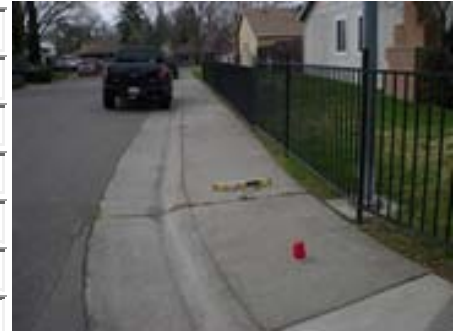
Field Date: 3/10/2011 Report Date: 3/10/2011 Barrier #: 5896
 Location: Wooddale Wy - West
 X Coordinate: -121.25684
 Y Coordinate: 38.70494
 Barrier Area: Sidewalks
 Barrier Type: Cross Slope - Existing (4.1% to 4.9%)
 Code Ref: CBC 1133B.7.1.3 and ADA/ABA 403.3

As Built Meas: 180 Quantity: LF
 Description: Cross slope exceeds 2.0% (4.1% to 4.9%)
 As Built Desc: 4.6% cross slope
 Solution: Demolish existing and construct new route
 Bar. Severity: 2 Recommended Cost Estimate: \$22,500.00 Status:
 Implementation Priority: 4 Facility Function:
 Implementation Phase: Implementation Date:
 Official Responsible:

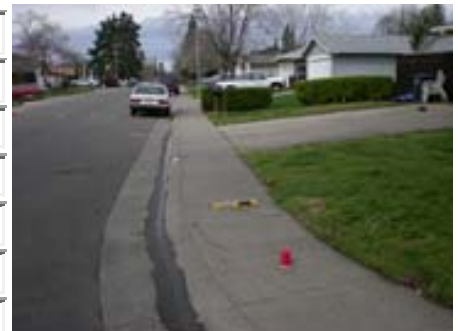
Field Date: 3/10/2011 Report Date: 3/10/2011 Barrier #: 5897
 Location: Wooddale Wy - North
 X Coordinate: -121.25688
 Y Coordinate: 38.7045
 Barrier Area: Sidewalks
 Barrier Type: Cross Slope - Existing (5.0% or more)
 Code Ref: CBC 1133B.7.1.3 and ADA/ABA 403.3

As Built Meas: 825 Quantity: LF
 Description: Cross slope exceeds 2.0% (5.0% or more)
 As Built Desc: 5.1% cross slope
 Solution: Demolish existing and construct new route
 Bar. Severity: 1 Necessary Cost Estimate: \$103,125.00 Status:
 Implementation Priority: 4 Facility Function:
 Implementation Phase: Implementation Date:
 Official Responsible:

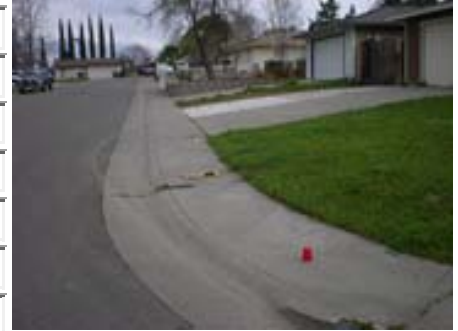
Field Date: 3/10/2011 Report Date: 3/10/2011 Barrier #: 5898
 Location: Wooddale Wy - East
 X Coordinate: -121.25983
 Y Coordinate: 38.70449
 Barrier Area: Sidewalks
 Barrier Type: Cross Slope - Existing (4.1% to 4.9%)
 Code Ref: CBC 1133B.7.1.3 and ADA/ABA 403.3

As Built Meas: 210 Quantity: LF
 Description: Cross slope exceeds 2.0% (4.1% to 4.9%)
 As Built Desc: 4.8% cross slope
 Solution: Demolish existing and construct new route
 Bar. Severity: 2 Recommended Cost Estimate: \$26,250.00 Status:
 Implementation Priority: 4 Facility Function:
 Implementation Phase: Implementation Date:
 Official Responsible:

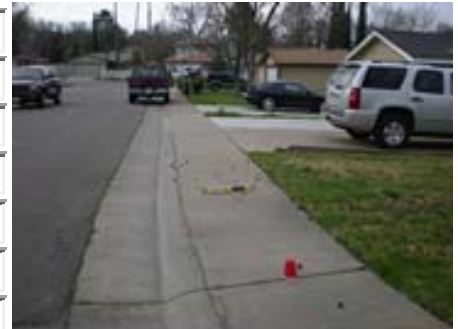
Field Date: 3/10/2011 Report Date: 3/10/2011 Barrier #: 5899
 Location: Wooddale Wy - West
 X Coordinate: -121.25994
 Y Coordinate: 38.70513
 Barrier Area: Sidewalks
 Barrier Type: Cross Slope - Existing (4.1% to 4.9%)
 Code Ref: CBC 1133B.7.1.3 and ADA/ABA 403.3

As Built Meas: 225 Quantity: LF
 Description: Cross slope exceeds 2.0% (4.1% to 4.9%)
 As Built Desc: 4.6% cross slope
 Solution: Demolish existing and construct new route
 Bar. Severity: 2 Recommended Cost Estimate: \$28,125.00 Status:
 Implementation Priority: 4 Facility Function:
 Implementation Phase: Implementation Date:
 Official Responsible:

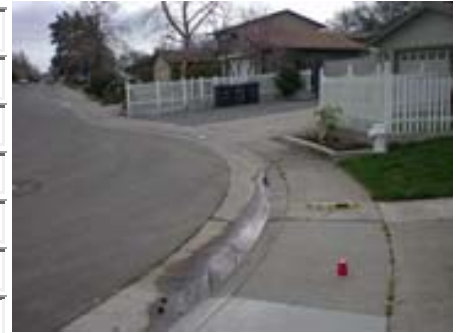
Field Date: 3/10/2011 Report Date: 3/10/2011 Barrier #: 5900
 Location: Wooddale Wy - South
 X Coordinate: -121.25991
 Y Coordinate: 38.7045
 Barrier Area: Sidewalks
 Barrier Type: Cross Slope - Existing (5.0% or more)
 Code Ref: CBC 1133B.7.1.3 and ADA/ABA 403.3

As Built Meas: 911 Quantity: LF
 Description: Cross slope exceeds 2.0% (5.0% or more)
 As Built Desc: 5.1% cross slope
 Solution: Demolish existing and construct new route
 Bar. Severity: 1 Necessary Cost Estimate: \$113,875.00 Status:
 Implementation Priority: 4 Facility Function:
 Implementation Phase: Implementation Date:
 Official Responsible:

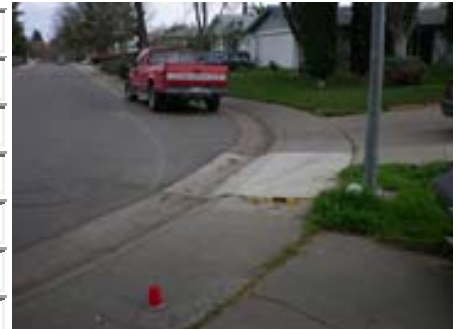
Field Date: 3/10/2011 Report Date: 3/10/2011 Barrier #: 5901
 Location: Wooddale Wy - East
 X Coordinate: -121.25678
 Y Coordinate: 38.70434
 Barrier Area: Sidewalks
 Barrier Type: Cross Slope - Existing (4.1% to 4.9%)
 Code Ref: CBC 1133B.7.1.3 and ADA/ABA 403.3

As Built Meas: 466 Quantity: LF
 Description: Cross slope exceeds 2.0% (4.1% to 4.9%)
 As Built Desc: 4.6% cross slope
 Solution: Demolish existing and construct new route
 Bar. Severity: 2 Recommended Cost Estimate: \$58,250.00 Status:
 Implementation Priority: 4 Facility Function:
 Implementation Phase: Implementation Date:
 Official Responsible:

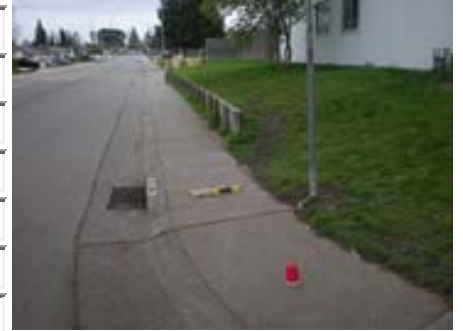
Field Date: 3/10/2011 Report Date: 3/10/2011 Barrier #: 5902
 Location: Villa Oak Dr - South
 X Coordinate: -121.25669
 Y Coordinate: 38.70573
 Barrier Area: Sidewalks
 Barrier Type: Cross Slope - Existing (5.0% or more)
 Code Ref: CBC 1133B.7.1.3 and ADA/ABA 403.3

As Built Meas: 170 Quantity: LF
 Description: Cross slope exceeds 2.0% (5.0% or more)
 As Built Desc: 5.5% cross slope
 Solution: Demolish existing and construct new route
 Bar. Severity: 1 Necessary Cost Estimate: \$21,250.00 Status:
 Implementation Priority: 2 Facility Function:
 Implementation Phase: Implementation Date:
 Official Responsible:

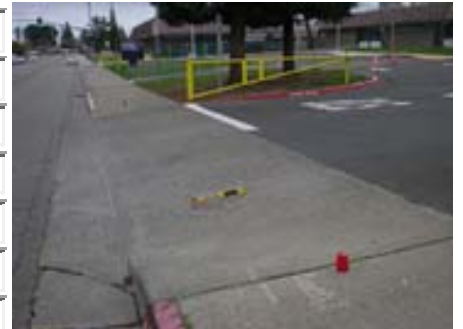
Field Date: 3/10/2011 Report Date: 3/10/2011 Barrier #: 5903
 Location: Villa Oak Dr and Woodside School Entrance
 X Coordinate: -121.25612
 Y Coordinate: 38.7057
 Barrier Area: Sidewalks
 Barrier Type: Driveway - Existing (5.0% or more)
 Code Ref: CBC 1133B.7.1.3 and ADA/ABA 403.3

As Built Meas: 41 Quantity: LF
 Description: Driveway cross slope exceeds 2.0% (5.0% or more)
 As Built Desc: 8.3% cross slope, 16.9% running slope
 Solution: Provide min. 48" wide level walkway through driveway
 Bar. Severity: 1 Necessary Cost Estimate: \$5,125.00 Status:
 Implementation Priority: 2 Facility Function:
 Implementation Phase: Implementation Date:
 Official Responsible:

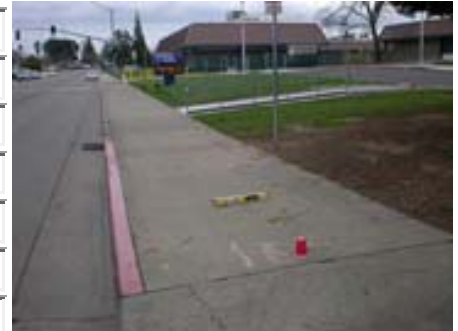
Field Date: 3/10/2011 Report Date: 3/10/2011 Barrier #: 5904
 Location: Villa Oak Dr and Woodside School Entrance
 X Coordinate: -121.25598
 Y Coordinate: 38.70569
 Barrier Area: Sidewalks
 Barrier Type: Cross Slope - Existing (5.0% or more)
 Code Ref: CBC 1133B.7.1.3 and ADA/ABA 403.3

As Built Meas: 155 Quantity: LF
 Description: Cross slope exceeds 2.0% (5.0% or more)
 As Built Desc: 5.0% cross slope
 Solution: Demolish existing and construct new route
 Bar. Severity: 1 Necessary Cost Estimate: \$19,375.00 Status:
 Implementation Priority: 2 Facility Function:
 Implementation Phase: Implementation Date:
 Official Responsible:

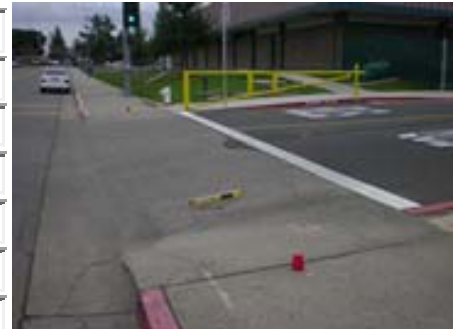
Field Date: 3/10/2011 Report Date: 3/10/2011 Barrier #: 5905
 Location: Villa Oak Dr and Woodside School Entrance
 X Coordinate: -121.25544
 Y Coordinate: 38.70566
 Barrier Area: Sidewalks
 Barrier Type: Cross Slope - Existing (5.0% or more)
 Code Ref: CBC 1133B.7.1.3 and ADA/ABA 403.3

As Built Meas: 41 Quantity: LF
 Description: Cross slope exceeds 2.0% (5.0% or more)
 As Built Desc: 9.0% cross slope, 13.0% running slope
 Solution: Demolish existing and construct new route
 Bar. Severity: 1 Necessary Cost Estimate: \$5,125.00 Status:
 Implementation Priority: 2 Facility Function:
 Implementation Phase: Implementation Date:
 Official Responsible:

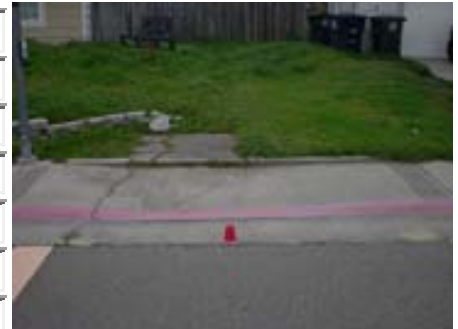
Field Date: 3/10/2011 Report Date: 3/10/2011 Barrier #: 5906B
 Location: Villa Oaks Dr - North
 X Coordinate: -121.25525
 Y Coordinate: 38.70586
 Barrier Area: Curb Ramps
 Barrier Type: Gutter Slope - Existing (8.3% or more)
 Code Ref: CBC 1127B.5.3 and ADA/ABA 406.2

As Built Meas: 6 Quantity: SF
 Description: Gutter slope exceeds 5.0% (8.3% or more)
 As Built Desc: 7.6% gutter slope
 Solution: Demolish existing and construct new gutter
 Bar. Severity: 1 Necessary Cost Estimate: \$750.00 Status:
 Implementation Priority: 2 Facility Function:
 Implementation Phase: Implementation Date:
 Official Responsible:

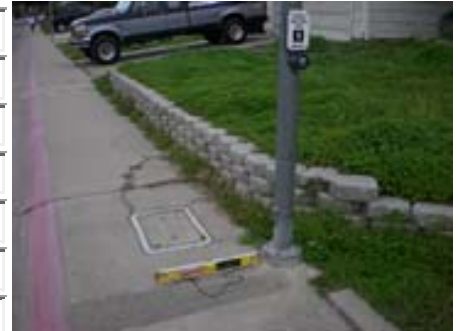
Field Date: 3/10/2011 Report Date: 3/10/2011 Barrier #: 5906C
 Location: Villa Oaks Dr - North
 X Coordinate: -121.25525
 Y Coordinate: 38.70586
 Barrier Area: Signalized Intersections
 Barrier Type: Ped Button - Landing in New Construction
 Code Ref: CBC 1118B.4

As Built Meas: 1 Quantity: JOB
 Description: Landing at pedestrian button not level ($\leq 2.0\%$)
 As Built Desc: 4.1% slope at landing
 Solution: Relocated pedestrian button to level area
 Bar. Severity: 3 Hinderance Cost Estimate: \$1,200.00 Status:
 Implementation Priority: 2 Facility Function:
 Implementation Phase: Implementation Date:
 Official Responsible:

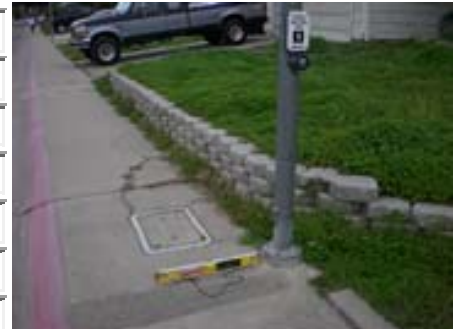
Field Date: 3/10/2011 Report Date: 3/10/2011 Barrier #: 5906D
 Location: Villa Oaks Dr - North
 X Coordinate: -121.25525
 Y Coordinate: 38.70586
 Barrier Area: Signalized Intersections
 Barrier Type: APS -Audible Ped Signal
 Code Ref: MUTCD 4E.06 & PROWAG R306.2

As Built Meas: 1 Quantity: EACH
 Description: No audible signals provided at intersection
 As Built Desc: No audible warning provided
 Solution: Provide compliant audible controls
 Bar. Severity: 1 Necessary Cost Estimate: \$7,500.00 Status:
 Implementation Priority: 2 Facility Function:
 Implementation Phase: Implementation Date:
 Official Responsible:

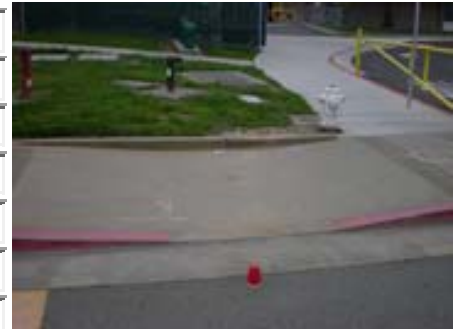
Field Date: 3/10/2011 Report Date: 3/10/2011 Barrier #: 5907A
 Location: Villa Oaks Dr - South
 X Coordinate: -121.25521
 Y Coordinate: 38.70573
 Barrier Area: Curb Ramps
 Barrier Type: 12" Grooves - Existing (>5.0%)
 Code Ref: CBC 1127B.5.6

As Built Meas: 1 Quantity: EACH
 Description: 12" grooves at top of curb ramp are not level (>5.0%)
 As Built Desc: 5.7% at 12" grooves
 Solution: Demolish existing and construct new curb ramp
 Bar. Severity: 1 Necessary Cost Estimate: \$2,500.00 Status:
 Implementation Priority: 2 Facility Function:
 Implementation Phase: Implementation Date:
 Official Responsible:

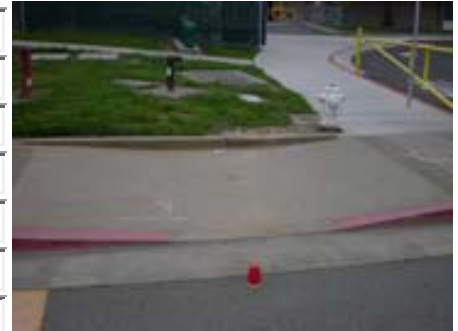
Field Date: 3/10/2011 Report Date: 3/10/2011 Barrier #: 5907B
 Location: Villa Oaks Dr - South
 X Coordinate: -121.25521
 Y Coordinate: 38.70573
 Barrier Area: Curb Ramps
 Barrier Type: Parallel Ramp Landing - Existing (3.1% to 4.0%)
 Code Ref: CBC 1127B.5.4 and ADA/ABA 406.4

As Built Meas: 1 Quantity: EACH
 Description: Curb ramp landing or pan not level (3.1% to 4.0%)
 As Built Desc: 4.0% landing slope
 Solution: Demolish existing and construct new transition
 Bar. Severity: 3 Hindrance Cost Estimate: \$250.00 Status:
 Implementation Priority: 2 Facility Function:
 Implementation Phase: Implementation Date:
 Official Responsible:

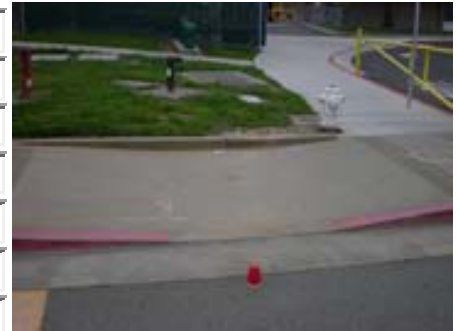
Field Date: 3/10/2011 Report Date: 3/10/2011 Barrier #: 5907C
 Location: Villa Oaks Dr - South
 X Coordinate: -121.25521
 Y Coordinate: 38.70573
 Barrier Area: Curb Ramps
 Barrier Type: Detectable Warnings - Truncated Domes
 Code Ref: CBC 1127B.5.7 and ADA/ABA 705.1.3

As Built Meas: 1 Quantity: EACH
 Description: No truncated domes provided at curb ramp
 As Built Desc: No detectable warnings at curb ramp
 Solution: Provide compliant truncated domes
 Bar. Severity: 2 Recommended Cost Estimate: \$1,400.00 Status:
 Implementation Priority: 2 Facility Function:
 Implementation Phase: Implementation Date:
 Official Responsible:

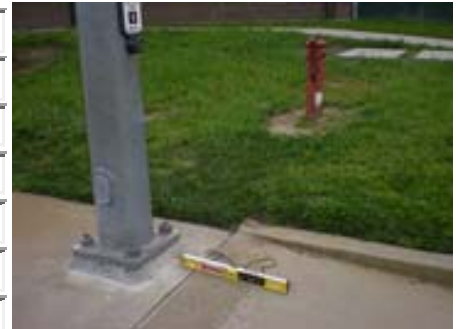
Field Date: 3/10/2011 Report Date: 3/10/2011 Barrier #: 5907E
 Location: Villa Oaks Dr - South
 X Coordinate: -121.25521
 Y Coordinate: 38.70573
 Barrier Area: Signalized Intersections
 Barrier Type: Ped Controls - Push Button
 Code Ref: CBC 1117B.6.4 & PROWAG R306.2

As Built Meas: 1 Quantity: EACH
 Description: Pedestrian control push button mechanism not operable with a fist
 As Built Desc: Control not operable with a fist
 Solution: Replace with accessible pedestrian controls
 Bar. Severity: 1 Necessary Cost Estimate: \$4,700.00 Status:
 Implementation Priority: 2 Facility Function:
 Implementation Phase: Implementation Date:
 Official Responsible:

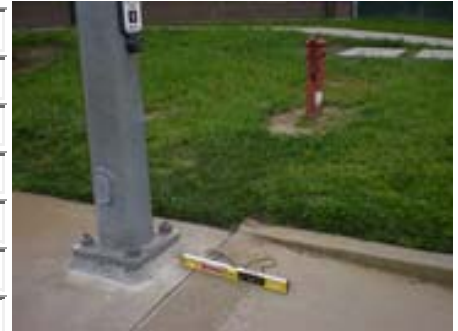
Field Date: 3/10/2011 Report Date: 3/10/2011 Barrier #: 5907F
 Location: Villa Oaks Dr - South
 X Coordinate: -121.25521
 Y Coordinate: 38.70573
 Barrier Area: Signalized Intersections
 Barrier Type: Ped Button - Existing Landing(5.0% or more)
 Code Ref: CBC 1118B.4

As Built Meas: 1 Quantity: JOB
 Description: Landing at pedestrian button not level (5.0% or more)
 As Built Desc: 5.3% slope at landing
 Solution: Relocated pedestrian button to level area
 Bar. Severity: 1 Necessary Cost Estimate: \$1,200.00 Status:
 Implementation Priority: 2 Facility Function:
 Implementation Phase: Implementation Date:
 Official Responsible:

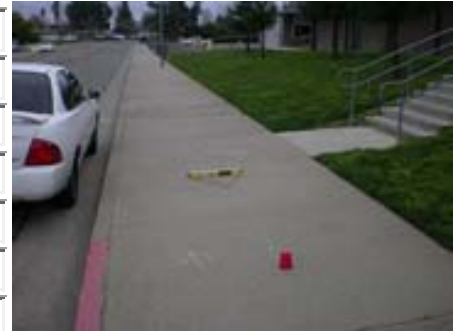
Field Date: 3/10/2011 Report Date: 3/10/2011 Barrier #: 5908
 Location: Villa Oaks Dr - South
 X Coordinate: -121.2551
 Y Coordinate: 38.70572
 Barrier Area: Sidewalks
 Barrier Type: Cross Slope - Existing (3.1% to 4.0%)
 Code Ref: CBC 1133B.7.1.3 and ADA/ABA 403.3

As Built Meas: 225 Quantity: LF
 Description: Cross slope exceeds 2.0% (3.1% to 4.0%)
 As Built Desc: 3.9% cross slope
 Solution: Demolish existing and construct new route
 Bar. Severity: 3 Hinderance Cost Estimate: \$28,125.00 Status:
 Implementation Priority: 2 Facility Function:
 Implementation Phase: Implementation Date:
 Official Responsible:

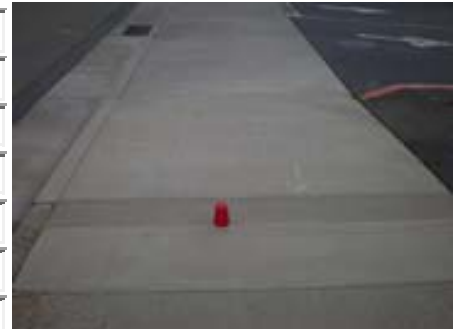
Field Date: 3/10/2011 Report Date: 3/10/2011 Barrier #: 5909
 Location: Villa Oaks Dr - South
 X Coordinate: -121.25439
 Y Coordinate: 38.70574
 Barrier Area: Sidewalks
 Barrier Type: Driveway -12" Grooves Incorrect Application
 Code Ref: CBC 1127B.5.6

As Built Meas: 1 Quantity: JOB
 Description: 12" grooves required only at curb ramps identified at transition into driveway
 As Built Desc: 12" grooves incorrectly provided where no curb ramp exists
 Solution: No remediation recommended, until new construction is performed in area
 Bar. Severity: 4 Low Severity Cost Estimate: \$0.00 Status:
 Implementation Priority: 2 Facility Function:
 Implementation Phase: Implementation Date:
 Official Responsible:

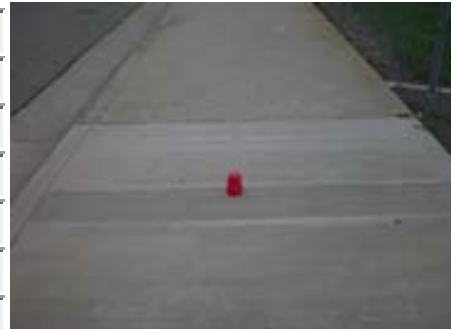
Field Date: 3/10/2011 Report Date: 3/10/2011 Barrier #: 5911
 Location: Villa Oaks Dr - South
 X Coordinate: -121.25425
 Y Coordinate: 38.70575
 Barrier Area: Sidewalks
 Barrier Type: Driveway -12" Grooves Incorrect Application
 Code Ref: CBC 1127B.5.6

As Built Meas: 1 Quantity: JOB
 Description: 12" grooves required only at curb ramps identified at transition into driveway
 As Built Desc: 12" grooves incorrectly provided where no curb ramp exists
 Solution: No remediation recommended, until new construction is performed in area
 Bar. Severity: 4 Low Severity Cost Estimate: \$0.00 Status:
 Implementation Priority: 2 Facility Function:
 Implementation Phase: Implementation Date:
 Official Responsible:

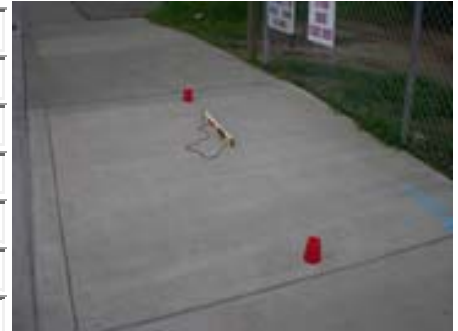
Field Date: 3/10/2011 Report Date: 3/10/2011 Barrier #: 5912
 Location: Villa Oaks Dr - South
 X Coordinate: -121.25372
 Y Coordinate: 38.70573
 Barrier Area: Sidewalks
 Barrier Type: Driveway - Running Slope in New Construction
 Code Ref: CBC 1133B.7.1.3 and ADA/ABA 403.3

As Built Meas: 9 Quantity: LF
 Description: Transition ramp into driveway not compliant (slope exceeds 8.3%)
 As Built Desc: 8.7% running slope
 Solution: Demolish existing and construct new transition ramp
 Bar. Severity: 1 Necessary Cost Estimate: \$1,125.00 Status:
 Implementation Priority: 2 Facility Function:
 Implementation Phase: Implementation Date:
 Official Responsible:

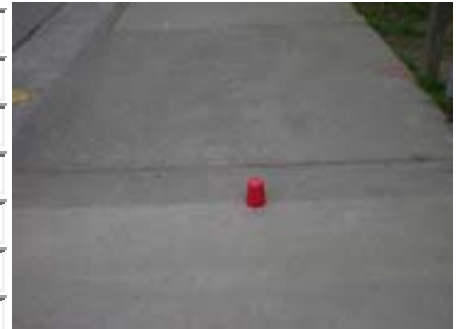
Field Date: 3/10/2011 Report Date: 3/10/2011 Barrier #: 5913
 Location: Villa Oaks Dr - South
 X Coordinate: -121.25372
 Y Coordinate: 38.70572
 Barrier Area: Sidewalks
 Barrier Type: Driveway -12" Grooves Incorrect Application
 Code Ref: CBC 1127B.5.6

As Built Meas: 1 Quantity: JOB
 Description: 12" grooves required only at curb ramps identified at transition into driveway
 As Built Desc: 12" grooves incorrectly provided where no curb ramp exists
 Solution: No remediation recommended, until new construction is performed in area
 Bar. Severity: 4 Low Severity Cost Estimate: \$0.00 Status:
 Implementation Priority: 2 Facility Function:
 Implementation Phase: Implementation Date:
 Official Responsible:

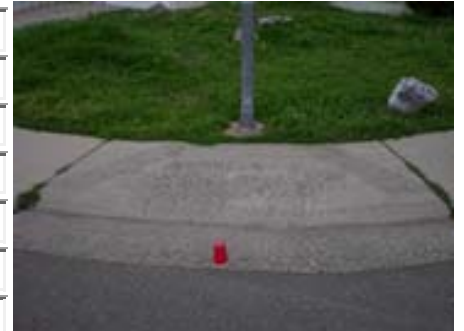
Field Date: 3/10/2011 Report Date: 3/10/2011 Barrier #: 5914
 Location: Villa Oaks Dr and Wintergreen Dr - Corner A
 X Coordinate: -121.25376
 Y Coordinate: 38.7059
 Barrier Area: Curb Ramps
 Barrier Type: No Curb Ramp - Depressed Existing Curb
 Code Ref: CBC 1127B.5.1 and ADA/ABA 402.2

As Built Meas: 1 Quantity: EACH
 Description: No compliant curb cut at corner (intersection)
 As Built Desc: 10.8% running slope at depressed area
 Solution: Demolish existing and construct curb cut
 Bar. Severity: 1 Necessary Cost Estimate: \$2,500.00 Status:
 Implementation Priority: 2 Facility Function:
 Implementation Phase: Implementation Date:
 Official Responsible:

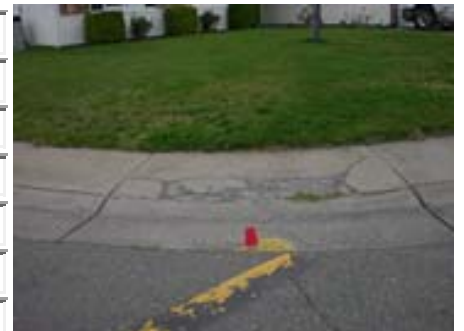
Field Date: 3/10/2011 Report Date: 3/10/2011 Barrier #: 5915
 Location: Villa Oaks Dr and Wintergreen Dr - Corner B
 X Coordinate: -121.25351
 Y Coordinate: 38.7059
 Barrier Area: Curb Ramps
 Barrier Type: No Curb Ramp - Depressed Existing Curb
 Code Ref: CBC 1127B.5.1 and ADA/ABA 402.2

As Built Meas: 1 Quantity: EACH
 Description: No compliant curb cut at corner (intersection)
 As Built Desc: 16.4% running slope at depressed area
 Solution: Demolish existing and construct curb cut
 Bar. Severity: 1 Necessary Cost Estimate: \$2,500.00 Status:
 Implementation Priority: 2 Facility Function:
 Implementation Phase: Implementation Date:
 Official Responsible:

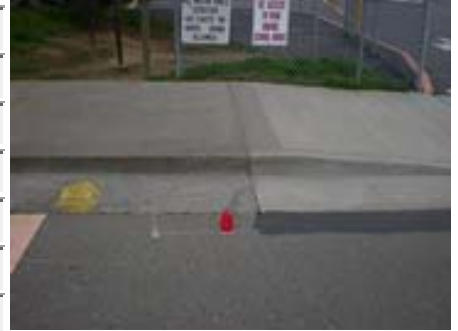
Field Date: 3/10/2011 Report Date: 3/10/2011 Barrier #: 5916
 Location: Villa Oaks Dr and Wintergreen Dr - Corner C
 X Coordinate: -121.25372
 Y Coordinate: 38.70576
 Barrier Area: Curb Ramps
 Barrier Type: No Curb Ramp
 Code Ref: CBC 1127B.5.1 and ADA/ABA 402.2

As Built Meas: 1 Quantity: EACH
 Description: No curb cut at corner (intersection)
 As Built Desc: No curb ramp at corner
 Solution: Demolish existing and construct curb cut
 Bar. Severity: 1 Necessary Cost Estimate: \$2,500.00 Status:
 Implementation Priority: 2 Facility Function:
 Implementation Phase: Implementation Date:
 Official Responsible:

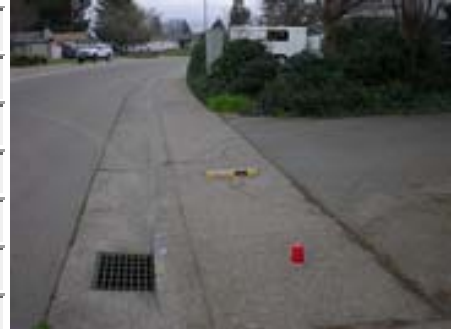
Field Date: 3/10/2011 Report Date: 3/10/2011 Barrier #: 5917A
 Location: Villa Oaks Dr - South
 X Coordinate: -121.25364
 Y Coordinate: 38.70575
 Barrier Area: Sidewalks
 Barrier Type: Cross Slope - Existing (4.1% to 4.9%)
 Code Ref: CBC 1133B.7.1.3 and ADA/ABA 403.3

As Built Meas: 700 Quantity: LF
 Description: Cross slope exceeds 2.0% (4.1% to 4.9%)
 As Built Desc: 4.7% cross slope
 Solution: Demolish existing and construct new route
 Bar. Severity: 2 Recommended Cost Estimate: \$87,500.00 Status:
 Implementation Priority: 2 Facility Function:
 Implementation Phase: Implementation Date:
 Official Responsible:

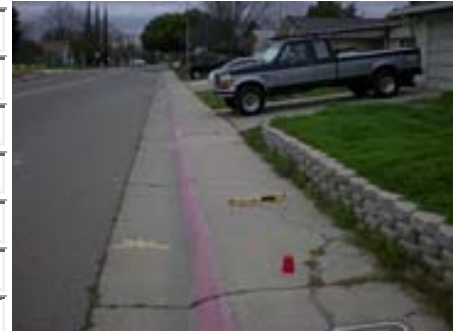
Field Date: 3/10/2011 Report Date: 3/10/2011 Barrier #: 5917B
 Location: Villa Oaks Dr - South
 X Coordinate: -121.25634
 Y Coordinate: 38.70585
 Barrier Area: Sidewalks
 Barrier Type: Surface Condition - Damaged
 Code Ref: CBC 1133B.7.1 and ADA/ABA 302.1

As Built Meas: 4 Quantity: LF
 Description: Surface is not firm and stable (cracked, broken or loose soil, etc.)
 As Built Desc: Cracked concrete
 Solution: Repair surface to make firm and stable
 Bar. Severity: 1 Necessary Cost Estimate: \$500.00 Status:
 Implementation Priority: 2 Facility Function:
 Implementation Phase: Implementation Date:
 Official Responsible:

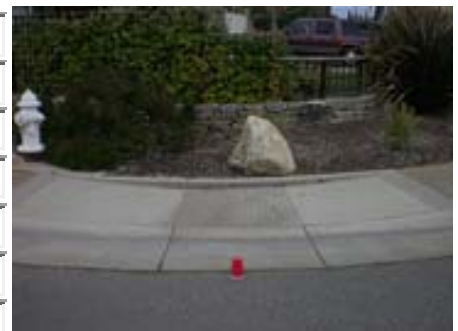
Field Date: 3/10/2011 Report Date: 3/10/2011 Barrier #: 5918A
 Location: Villa Oaks Dr and Olive Ave - Corner A
 X Coordinate: -121.25145
 Y Coordinate: 38.70482
 Barrier Area: Curb Ramps
 Barrier Type: 12" Grooves - Existing (3.1% to 4.0%)
 Code Ref: CBC 1127B.5.6

As Built Meas: 1 Quantity: EACH
 Description: 12" grooves at top of curb ramp are not level (3.1% to 4.0%)
 As Built Desc: 3.7% at 12" grooves
 Solution: Demolish existing and construct new curb ramp
 Bar. Severity: 3 Hindrance Cost Estimate: \$2,500.00 Status:
 Implementation Priority: 2 Facility Function:
 Implementation Phase: Implementation Date:
 Official Responsible:

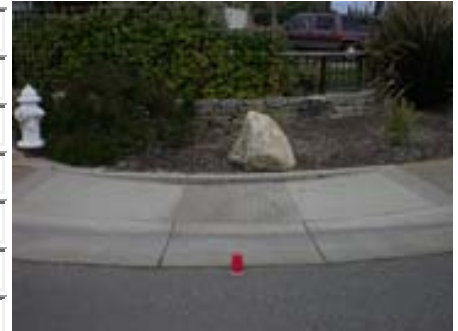
Field Date: 3/10/2011 Report Date: 3/10/2011 Barrier #: 5918B
 Location: Villa Oaks Dr and Olive Ave - Corner A
 X Coordinate: -121.25145
 Y Coordinate: 38.70482
 Barrier Area: Curb Ramps
 Barrier Type: Cross Slope - Existing (2.1% to 3.0%)
 Code Ref: CBC 1127B.5.3 and ADA/ABA 406.2

As Built Meas: 1 Quantity: EACH
 Description: Ramp run cross slope exceeds 2.0% (2.1% to 3.0%)
 As Built Desc: 3.0% cross slope
 Solution: Demolish existing and construct new curb ramp
 Bar. Severity: 4 Low Severity Cost Estimate: \$2,500.00 Status:
 Implementation Priority: 2 Facility Function:
 Implementation Phase: Implementation Date:
 Official Responsible:

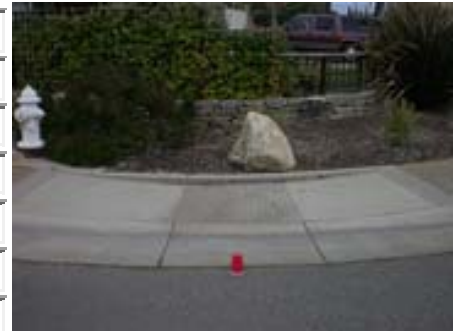
Field Date: 3/10/2011 Report Date: 3/10/2011 Barrier #: 5918C
 Location: Villa Oaks Dr and Olive Ave - Corner A
 X Coordinate: -121.25145
 Y Coordinate: 38.70482
 Barrier Area: Curb Ramps
 Barrier Type: Detectable Warnings - Truncated Domes
 Code Ref: CBC 1127B.5.7 and ADA/ABA 705.1.3

As Built Meas: 1 Quantity: EACH
 Description: No truncated domes provided at curb ramp
 As Built Desc: No detectable warnings at curb ramp
 Solution: Provide compliant truncated domes
 Bar. Severity: 2 Recommended Cost Estimate: \$1,400.00 Status:
 Implementation Priority: 2 Facility Function:
 Implementation Phase: Implementation Date:
 Official Responsible:

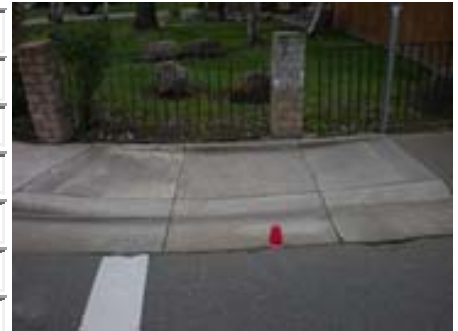
Field Date: 3/10/2011 Report Date: 3/10/2011 Barrier #: 5919A
 Location: Villa Oaks Dr and Olive Ave - Corner D
 X Coordinate: -121.25151
 Y Coordinate: 38.70473
 Barrier Area: Curb Ramps
 Barrier Type: 12" Grooves - Existing (>5.0%)
 Code Ref: CBC 1127B.5.6

As Built Meas: 1 Quantity: EACH
 Description: 12" grooves at top of curb ramp are not level (>5.0%)
 As Built Desc: 5.2% at 12" grooves
 Solution: Demolish existing and construct new curb ramp
 Bar. Severity: 1 Necessary Cost Estimate: \$2,500.00 Status:
 Implementation Priority: 2 Facility Function:
 Implementation Phase: Implementation Date:
 Official Responsible:

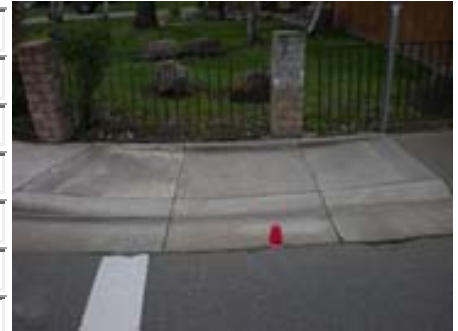
Field Date: 3/10/2011 Report Date: 3/10/2011 Barrier #: 5919B
 Location: Villa Oaks Dr and Olive Ave - Corner D
 X Coordinate: -121.25151
 Y Coordinate: 38.70473
 Barrier Area: Curb Ramps
 Barrier Type: Parallel Ramp Landing - Existing (2.1% to 3.0%)
 Code Ref: CBC 1127B.5.4 and ADA/ABA 406.4

As Built Meas: 1 Quantity: EACH
 Description: Curb ramp landing or pan not level (2.1% to 3.0%)
 As Built Desc: 3.0% landing slope
 Solution: Demolish existing and construct new transition
 Bar. Severity: 4 Low Severity Cost Estimate: \$250.00 Status:
 Implementation Priority: 2 Facility Function:
 Implementation Phase: Implementation Date:
 Official Responsible:

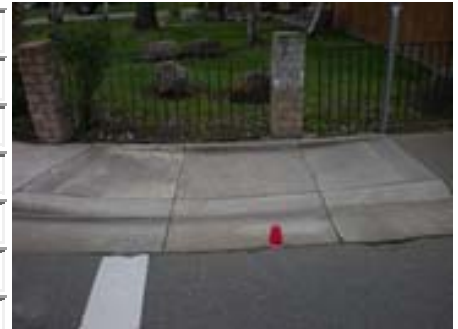
Field Date: 3/10/2011 Report Date: 3/10/2011 Barrier #: 5919C
 Location: Villa Oaks Dr and Olive Ave - Corner D
 X Coordinate: -121.25151
 Y Coordinate: 38.70473
 Barrier Area: Curb Ramps
 Barrier Type: Detectable Warnings - Truncated Domes
 Code Ref: CBC 1127B.5.7 and ADA/ABA 705.1.3

As Built Meas: 1 Quantity: EACH
 Description: No truncated domes provided at curb ramp
 As Built Desc: No detectable warnings at curb ramp
 Solution: Provide compliant truncated domes
 Bar. Severity: 2 Recommended Cost Estimate: \$1,400.00 Status:
 Implementation Priority: 2 Facility Function:
 Implementation Phase: Implementation Date:
 Official Responsible:

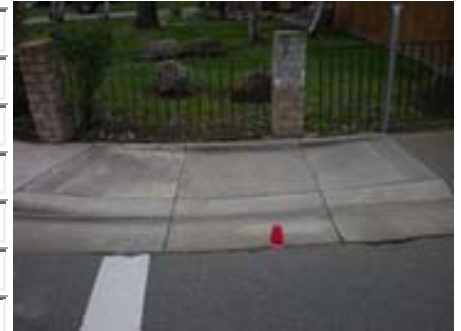
Barrier Type: Gutter Slope - Existing (8.3% or more)

Description: Gutter slope exceeds 5.0% (8.3% or more)

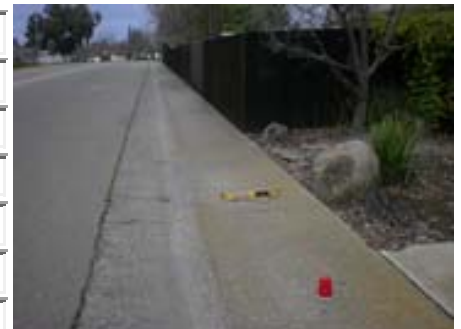
Barrier Type: Cross Slope - Existing (5.0% or more)

Description: Cross slope exceeds 2.0% (5.0% or more)

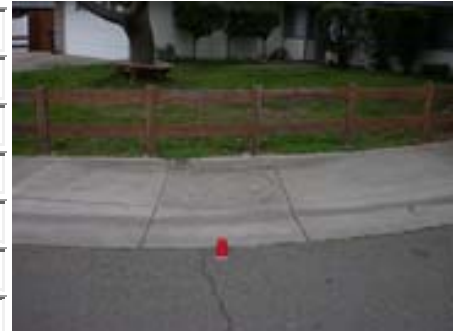
Field Date: 3/10/2011 Report Date: 3/10/2011 Barrier #: 5921A
 Location: Villa Oak Dr and Claypool Wy - Corner A
 X Coordinate: -121.25265
 Y Coordinate: 38.70569
 Barrier Area: Curb Ramps
 Barrier Type: 12" Grooves - Existing (>5.0%)
 Code Ref: CBC 1127B.5.6

As Built Meas: 1 Quantity: EACH
 Description: 12" grooves at top of curb ramp are not level (>5.0%)
 As Built Desc: 7.2% at 12" grooves
 Solution: Demolish existing and construct new curb ramp
 Bar. Severity: 1 Necessary Cost Estimate: \$2,500.00 Status:
 Implementation Priority: 2 Facility Function:
 Implementation Phase: Implementation Date:
 Official Responsible:

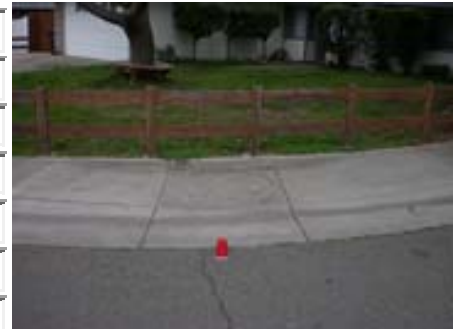
Field Date: 3/10/2011 Report Date: 3/10/2011 Barrier #: 5921B
 Location: Villa Oak Dr and Claypool Wy - Corner A
 X Coordinate: -121.25265
 Y Coordinate: 38.70569
 Barrier Area: Curb Ramps
 Barrier Type: Parallel Ramp Landing - Existing (2.1% to 3.0%)
 Code Ref: CBC 1127B.5.4 and ADA/ABA 406.4

As Built Meas: 1 Quantity: EACH
 Description: Curb ramp landing or pan not level (2.1% to 3.0%)
 As Built Desc: 2.9% landing slope
 Solution: Demolish existing and construct new transition
 Bar. Severity: 4 Low Severity Cost Estimate: \$250.00 Status:
 Implementation Priority: 2 Facility Function:
 Implementation Phase: Implementation Date:
 Official Responsible:

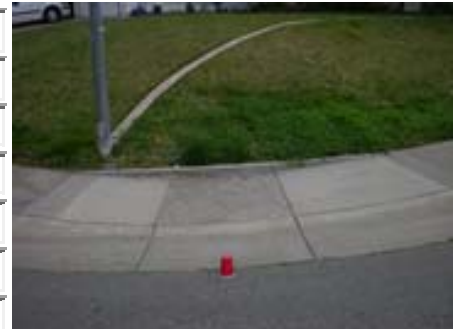
Field Date: 3/10/2011 Report Date: 3/10/2011 Barrier #: 5922A
 Location: Villa Oak Dr and Claypool Wy - Corner B
 X Coordinate: -121.25254
 Y Coordinate: 38.70563
 Barrier Area: Curb Ramps
 Barrier Type: 12" Grooves - Existing (4.1% to 4.9%)
 Code Ref: CBC 1127B.5.6

As Built Meas: 1 Quantity: EACH
 Description: 12" grooves at top of curb ramp are not level (4.1% to 4.9%)
 As Built Desc: 4.9% at 12" grooves
 Solution: Demolish existing and construct new curb ramp
 Bar. Severity: 2 Recommended Cost Estimate: \$2,500.00 Status:
 Implementation Priority: 2 Facility Function:
 Implementation Phase: Implementation Date:
 Official Responsible:

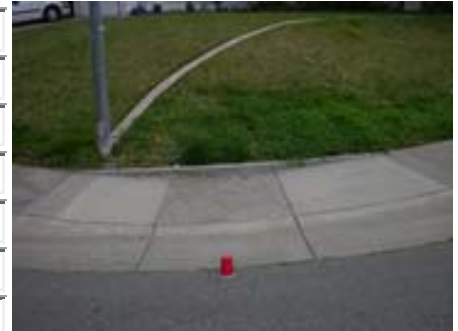
Field Date: 3/10/2011 Report Date: 3/10/2011 Barrier #: 5922B
 Location: Villa Oak Dr and Claypool Wy - Corner B
 X Coordinate: -121.25254
 Y Coordinate: 38.70563
 Barrier Area: Curb Ramps
 Barrier Type: Detectable Warnings - Truncated Domes
 Code Ref: CBC 1127B.5.7 and ADA/ABA 705.1.3

As Built Meas: 1 Quantity: EACH
 Description: No truncated domes provided at curb ramp
 As Built Desc: No detectable warnings at curb ramp
 Solution: Provide compliant truncated domes
 Bar. Severity: 2 Recommended Cost Estimate: \$1,400.00 Status:
 Implementation Priority: 2 Facility Function:
 Implementation Phase: Implementation Date:
 Official Responsible:

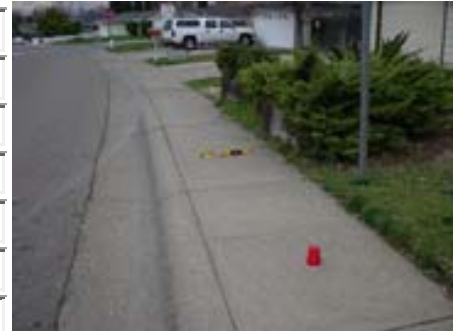
Field Date: 3/10/2011 Report Date: 3/10/2011 Barrier #: 5923
 Location: Villa Oak Dr - North
 X Coordinate: -121.25312
 Y Coordinate: 38.70583
 Barrier Area: Sidewalks
 Barrier Type: Cross Slope - Existing (3.1% to 4.0%)
 Code Ref: CBC 1133B.7.1.3 and ADA/ABA 403.3

As Built Meas: 116 Quantity: LF
 Description: Cross slope exceeds 2.0% (3.1% to 4.0%)
 As Built Desc: 3.9% cross slope
 Solution: Demolish existing and construct new route
 Bar. Severity: 3 Hinderance Cost Estimate: \$14,500.00 Status:
 Implementation Priority: 2 Facility Function:
 Implementation Phase: Implementation Date:
 Official Responsible:

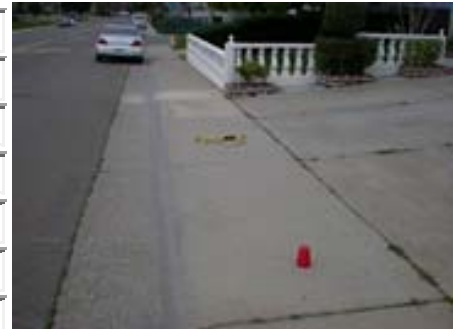
Field Date: 3/10/2011 Report Date: 3/10/2011 Barrier #: 5924
 Location: Villa Oak Dr - North
 X Coordinate: -121.25405
 Y Coordinate: 38.70588
 Barrier Area: Sidewalks
 Barrier Type: Cross Slope - Existing (3.1% to 4.0%)
 Code Ref: CBC 1133B.7.1.3 and ADA/ABA 403.3

As Built Meas: 120 Quantity: LF
 Description: Cross slope exceeds 2.0% (3.1% to 4.0%)
 As Built Desc: 3.6% cross slope
 Solution: Demolish existing and construct new route
 Bar. Severity: 3 Hinderance Cost Estimate: \$15,000.00 Status:
 Implementation Priority: 2 Facility Function:
 Implementation Phase: Implementation Date:
 Official Responsible:

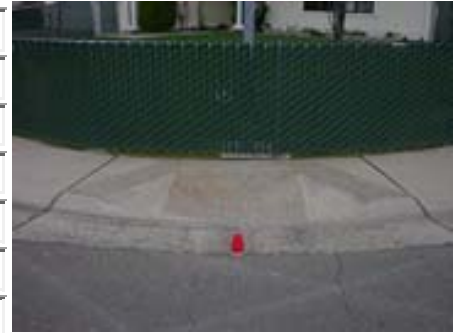
Field Date: 3/10/2011 Report Date: 3/10/2011 Barrier #: 5925
 Location: Villa Oak Dr and Sun Terrace Wy - Corner A
 X Coordinate: -121.25458
 Y Coordinate: 38.70586
 Barrier Area: Curb Ramps
 Barrier Type: No Curb Ramp - Depressed Existing Curb
 Code Ref: CBC 1127B.5.1 and ADA/ABA 402.2

As Built Meas: 1 Quantity: EACH
 Description: No compliant curb cut at corner (intersection)
 As Built Desc: 6.0% running slope at depressed area
 Solution: Demolish existing and construct curb cut
 Bar. Severity: 1 Necessary Cost Estimate: \$2,500.00 Status:
 Implementation Priority: 2 Facility Function:
 Implementation Phase: Implementation Date:
 Official Responsible:

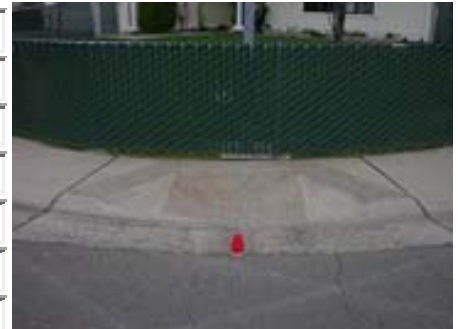
Field Date: 3/10/2011 Report Date: 3/10/2011 Barrier #: 5926
 Location: Villa Oak Dr and Sun Terrace Wy - Corner B
 X Coordinate: -121.25449
 Y Coordinate: 38.70592
 Barrier Area: Curb Ramps
 Barrier Type: No Curb Ramp - Depressed Existing Curb
 Code Ref: CBC 1127B.5.1 and ADA/ABA 402.2

As Built Meas: 1 Quantity: EACH
 Description: No compliant curb cut at corner (intersection)
 As Built Desc: 8.7% running slope at depressed area
 Solution: Demolish existing and construct curb cut
 Bar. Severity: 1 Necessary Cost Estimate: \$2,500.00 Status:
 Implementation Priority: 2 Facility Function:
 Implementation Phase: Implementation Date:
 Official Responsible:
