**DRAFT ADA TRANSITION PLAN UPDATE
NEIGHBORHOOD AREA 8 CHASE
SEPTEMBER 20, 2011**

CITY OF CITRUS HEIGHTS

Conditions - CHASE Area 8

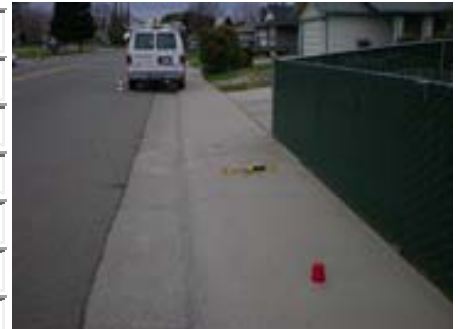
Field Date: 3/10/2011 Report Date: 3/10/2011 Barrier #: 5928
 Location: Villa Oak Dr - North
 X Coordinate: -121.25532
 Y Coordinate: 38.70587
 Barrier Area: Sidewalks
 Barrier Type: Cross Slope - Existing (4.1% to 4.9%)
 Code Ref: CBC 1133B.7.1.3 and ADA/ABA 403.3

As Built Meas: 410 Quantity: LF
 Description: Cross slope exceeds 2.0% (4.1% to 4.9%)
 As Built Desc: 4.9% cross slope
 Solution: Demolish existing and construct new route
 Bar. Severity: 2 Recommended Cost Estimate: \$51,250.00 Status:
 Implementation Priority: 2 Facility Function:
 Implementation Phase: Implementation Date:
 Official Responsible:

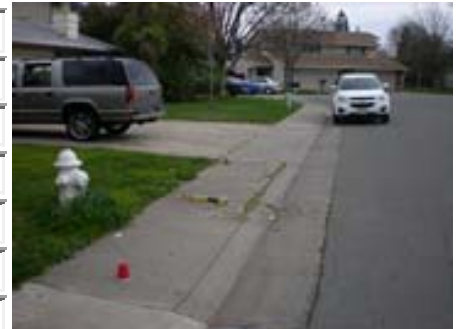
Field Date: 3/10/2011 Report Date: 3/10/2011 Barrier #: 5930
 Location: St. Philomena Way - North
 X Coordinate: -121.26221
 Y Coordinate: 38.70517
 Barrier Area: Sidewalks
 Barrier Type: Cross Slope - Existing (4.1% to 4.9%)
 Code Ref: CBC 1133B.7.1.3 and ADA/ABA 403.3

As Built Meas: 110 Quantity: LF
 Description: Cross slope exceeds 2.0% (4.1% to 4.9%)
 As Built Desc: 4.4% cross slope
 Solution: Demolish existing and construct new route
 Bar. Severity: 2 Recommended Cost Estimate: \$13,750.00 Status:
 Implementation Priority: 4 Facility Function:
 Implementation Phase: Implementation Date:
 Official Responsible:

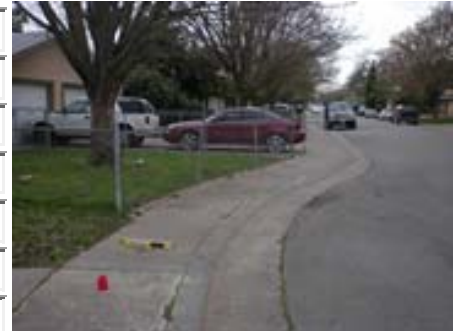
Field Date: 3/10/2011 Report Date: 3/10/2011 Barrier #: 5931A
 Location: St. Philomena Way - East
 X Coordinate: -121.2617
 Y Coordinate: 38.70503
 Barrier Area: Sidewalks
 Barrier Type: Cross Slope - Existing (4.1% to 4.9%)
 Code Ref: CBC 1133B.7.1.3 and ADA/ABA 403.3

As Built Meas: 886 Quantity: LF
 Description: Cross slope exceeds 2.0% (4.1% to 4.9%)
 As Built Desc: 4.6% cross slope
 Solution: Demolish existing and construct new route
 Bar. Severity: 2 Recommended Cost Estimate: \$110,750.00 Status:
 Implementation Priority: 4 Facility Function:
 Implementation Phase: Implementation Date:
 Official Responsible:

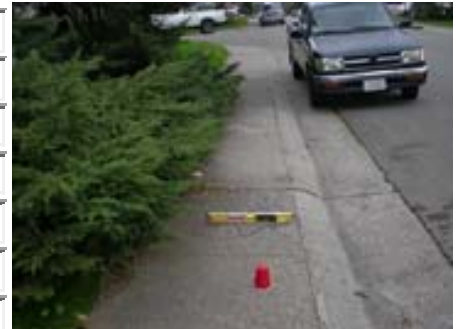
Field Date: 3/10/2011 Report Date: 3/10/2011 Barrier #: 5931B
 Location: St. Philomena Way - East
 X Coordinate: -121.26172
 Y Coordinate: 38.70282
 Barrier Area: Sidewalks
 Barrier Type: Clear Width - Existing ($\leq 31''$ or less)
 Code Ref: CBC 1133B.7.1

As Built Meas: 1 Quantity: LF
 Description: Pedestrian route is not min. 48" wide ($\leq 31''$ or less)
 As Built Desc: 24" clear width due to foliage
 Solution: Trim foliage to provide min. 48" clear width
 Bar. Severity: 1 Necessary Cost Estimate: \$125.00 Status:
 Implementation Priority: 4 Facility Function:
 Implementation Phase: Implementation Date:
 Official Responsible:

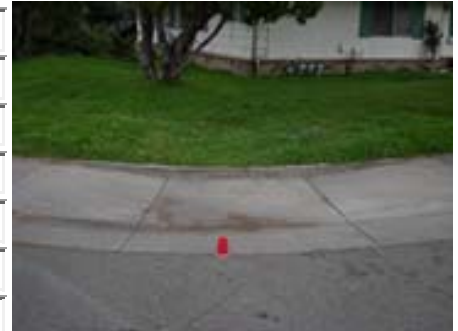
Field Date: 3/10/2011 Report Date: 3/10/2011 Barrier #: 5932A
 Location: St. Philomena Way and St. Jeanne Wy - Coner B
 X Coordinate: -121.26166
 Y Coordinate: 38.7026
 Barrier Area: Curb Ramps
 Barrier Type: Detectable Warnings - Truncated Domes
 Code Ref: CBC 1127B.5.7 and ADA/ABA 705.1.3

As Built Meas: 1 Quantity: EACH
 Description: No truncated domes provided at curb ramp
 As Built Desc: No detectable warnings at curb ramp
 Solution: Provide compliant truncated domes
 Bar. Severity: 2 Recommended Cost Estimate: \$1,400.00 Status:
 Implementation Priority: 4 Facility Function:
 Implementation Phase: Implementation Date:
 Official Responsible:

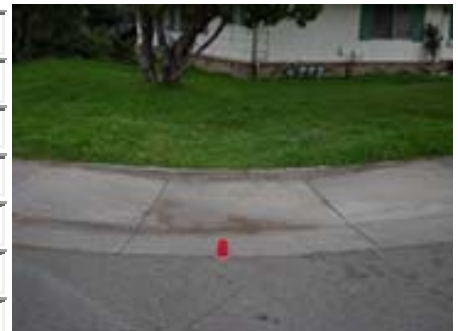
Field Date: 3/10/2011 Report Date: 3/10/2011 Barrier #: 5932B
 Location: St. Philomena Way and St. Jeanne Wy - Coner B
 X Coordinate: -121.26166
 Y Coordinate: 38.7026
 Barrier Area: Curb Ramps
 Barrier Type: Gutter Slope - Existing (8.3% or more)
 Code Ref: CBC 1127B.5.3 and ADA/ABA 406.2

As Built Meas: 6 Quantity: SF
 Description: Gutter slope exceeds 5.0% (8.3% or more)
 As Built Desc: 9.2% gutter slope
 Solution: Demolish existing and construct new gutter
 Bar. Severity: 1 Necessary Cost Estimate: \$750.00 Status:
 Implementation Priority: 4 Facility Function:
 Implementation Phase: Implementation Date:
 Official Responsible:

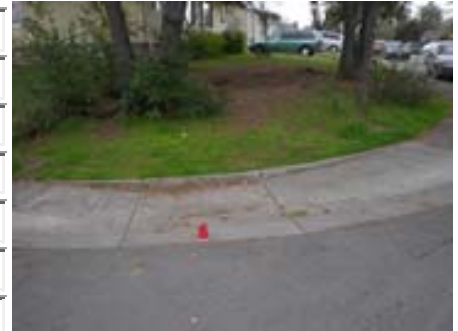
Field Date: 3/10/2011 Report Date: 3/10/2011 Barrier #: 5933A
 Location: St. Philomena Way and St. Jeanne Wy - Coner C
 X Coordinate: -121.26164
 Y Coordinate: 38.70255
 Barrier Area: Curb Ramps
 Barrier Type: Parallel Ramp Landing - Existing (4.1% to 4.9%)
 Code Ref: CBC 1127B.5.4 and ADA/ABA 406.4

As Built Meas: 1 Quantity: EACH
 Description: Curb ramp landing or pan not level(4.1% to 4.9%)
 As Built Desc: 4.3% landing slope
 Solution: Demolish existing and construct new transition
 Bar. Severity: 2 Recommended Cost Estimate: \$250.00 Status:
 Implementation Priority: 4 Facility Function:
 Implementation Phase: Implementation Date:
 Official Responsible:

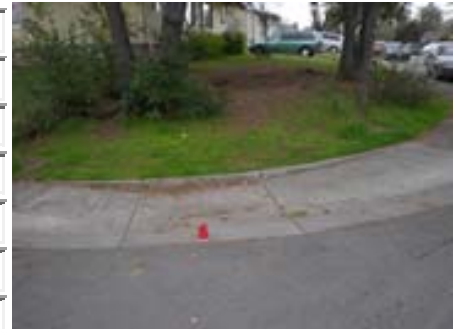
Field Date: 3/10/2011 Report Date: 3/10/2011 Barrier #: 5933B
 Location: St. Philomena Way and St. Jeanne Wy - Coner C
 X Coordinate: -121.26164
 Y Coordinate: 38.70255
 Barrier Area: Curb Ramps
 Barrier Type: Detectable Warnings - Truncated Domes
 Code Ref: CBC 1127B.5.7 and ADA/ABA 705.1.3

As Built Meas: 1 Quantity: EACH
 Description: No truncated domes provided at curb ramp
 As Built Desc: No detectable warnings at curb ramp
 Solution: Provide compliant truncated domes
 Bar. Severity: 2 Recommended Cost Estimate: \$1,400.00 Status:
 Implementation Priority: 4 Facility Function:
 Implementation Phase: Implementation Date:
 Official Responsible:

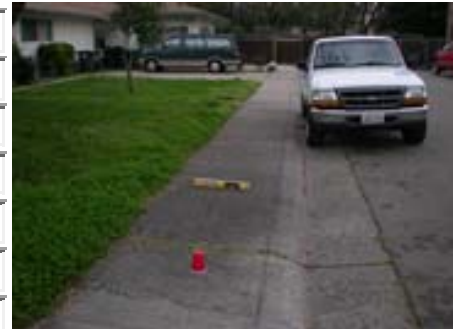
Field Date: 3/10/2011 Report Date: 3/10/2011 Barrier #: 5934
 Location: St. Jeanne Wy - North
 X Coordinate: -121.26164
 Y Coordinate: 38.70263
 Barrier Area: Sidewalks
 Barrier Type: Cross Slope - Existing (3.1% to 4.0%)
 Code Ref: CBC 1133B.7.1.3 and ADA/ABA 403.3

As Built Meas: 91 Quantity: LF
 Description: Cross slope exceeds 2.0% (3.1% to 4.0%)
 As Built Desc: 3.6% cross slope
 Solution: Demolish existing and construct new route
 Bar. Severity: 3 Hinderance Cost Estimate: \$11,375.00 Status:
 Implementation Priority: 4 Facility Function:
 Implementation Phase: Implementation Date:
 Official Responsible:

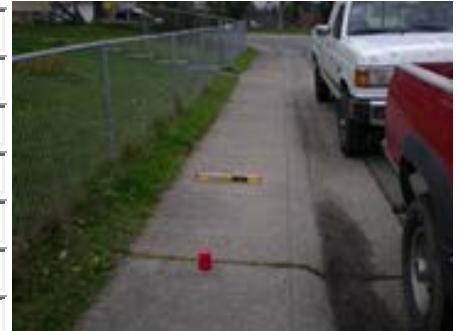
Field Date: 3/10/2011 Report Date: 3/10/2011 Barrier #: 5935
 Location: St. Jeanne Wy - South
 X Coordinate: -121.26137
 Y Coordinate: 38.70255
 Barrier Area: Sidewalks
 Barrier Type: Cross Slope - Existing (2.1% to 3.0%)
 Code Ref: CBC 1133B.7.1.3 and ADA/ABA 403.3

As Built Meas: 100 Quantity: LF
 Description: Cross slope exceeds 2.0% (2.1% to 3.0%)
 As Built Desc: 2.9% cross slope
 Solution: Low severity barrier - no remediation recommended
 Bar. Severity: 4 Low Severity Cost Estimate: \$0.00 Status:
 Implementation Priority: 4 Facility Function:
 Implementation Phase: Implementation Date:
 Official Responsible:

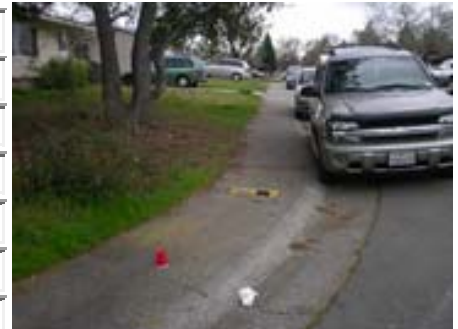
Field Date: 3/10/2011 Report Date: 3/10/2011 Barrier #: 5936A
 Location: St. Philomena Way - East
 X Coordinate: -121.26169
 Y Coordinate: 38.70251
 Barrier Area: Sidewalks
 Barrier Type: Cross Slope - Existing (4.1% to 4.9%)
 Code Ref: CBC 1133B.7.1.3 and ADA/ABA 403.3

As Built Meas: 664 Quantity: LF
 Description: Cross slope exceeds 2.0% (4.1% to 4.9%)
 As Built Desc: 4.4% cross slope
 Solution: Demolish existing and construct new route
 Bar. Severity: 2 Recommended Cost Estimate: \$83,000.00 Status:
 Implementation Priority: 4 Facility Function:
 Implementation Phase: Implementation Date:
 Official Responsible:

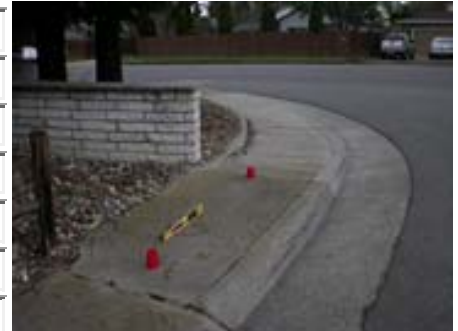
Field Date: 3/10/2011 Report Date: 3/10/2011 Barrier #: 5936B
 Location: St. Philomena Way - East
 X Coordinate: -121.2617
 Y Coordinate: 38.70066
 Barrier Area: Sidewalks
 Barrier Type: Running Slope (New Construction)
 Code Ref: CBC 1133B.7.3 and ADA/ABA 403.3

As Built Meas: 5 Quantity: LF
 Description: Running slope exceeds 5.0% where roadway slope does not
 As Built Desc: 9.2% running slope
 Solution: Demolish existing and construct new route
 Bar. Severity: 1 Necessary Cost Estimate: \$625.00 Status:
 Implementation Priority: 4 Facility Function:
 Implementation Phase: Implementation Date:
 Official Responsible:

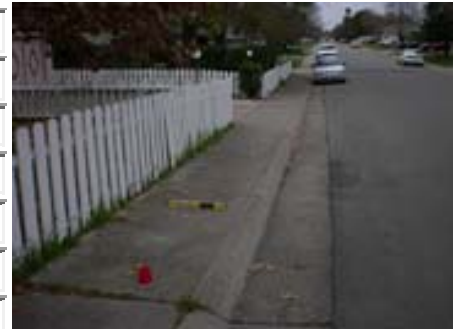
Field Date: 3/10/2011 Report Date: 3/10/2011 Barrier #: 5937
 Location: St. Philomena Way - West
 X Coordinate: -121.26181
 Y Coordinate: 38.70067
 Barrier Area: Sidewalks
 Barrier Type: Cross Slope - Existing (4.1% to 4.9%)
 Code Ref: CBC 1133B.7.1.3 and ADA/ABA 403.3

As Built Meas: 1600 Quantity: LF
 Description: Cross slope exceeds 2.0% (4.1% to 4.9%)
 As Built Desc: 4.8% cross slope
 Solution: Demolish existing and construct new route
 Bar. Severity: 2 Recommended Cost Estimate: \$200,000.00 Status:
 Implementation Priority: 4 Facility Function:
 Implementation Phase: Implementation Date:
 Official Responsible:

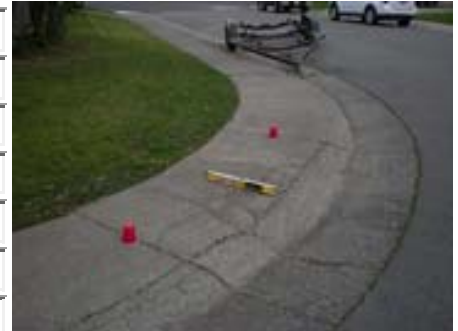
Field Date: 3/10/2011 Report Date: 3/10/2011 Barrier #: 5938
 Location: St. Philomena Way - West
 X Coordinate: -121.26186
 Y Coordinate: 38.70497
 Barrier Area: Sidewalks
 Barrier Type: Elbow in Sidewalk - Cross Slope (4.1% to 4.9%)
 Code Ref: CBC 1133B.7.1.3 and ADA/ABA 403.3

As Built Meas: 6 Quantity: LF
 Description: Cross slope at elbow exceeds 2.0% (4.1% to 4.9%)
 As Built Desc: 4.9% cross slope
 Solution: Demolish existing and construct new sidewalk without curb ramp
 Bar. Severity: 2 Recommended Cost Estimate: \$750.00 Status:
 Implementation Priority: 4 Facility Function:
 Implementation Phase: Implementation Date:
 Official Responsible:

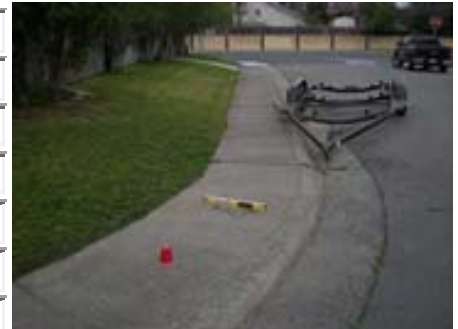
Field Date: 3/10/2011 Report Date: 3/10/2011 Barrier #: 5939
 Location: St. Philomena Way - South
 X Coordinate: -121.2619
 Y Coordinate: 38.70505
 Barrier Area: Sidewalks
 Barrier Type: Cross Slope - Existing (4.1% to 4.9%)
 Code Ref: CBC 1133B.7.1.3 and ADA/ABA 403.3

As Built Meas: 100 Quantity: LF
 Description: Cross slope exceeds 2.0% (4.1% to 4.9%)
 As Built Desc: 4.9% cross slope
 Solution: Demolish existing and construct new route
 Bar. Severity: 2 Recommended Cost Estimate: \$12,500.00 Status:
 Implementation Priority: 4 Facility Function:
 Implementation Phase: Implementation Date:
 Official Responsible:

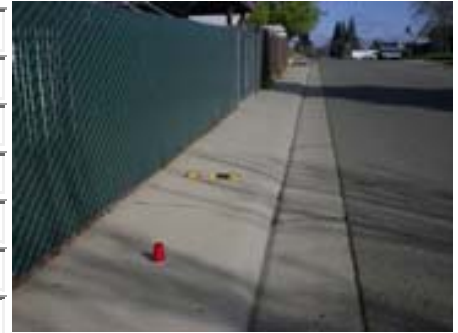
Field Date: 3/11/2011 Report Date: 3/14/2011 Barrier #: 5940
 Location: Sun Terrace Wy - West
 X Coordinate: -121.25457
 Y Coordinate: 38.70602
 Barrier Area: Sidewalks
 Barrier Type: Cross Slope - Existing (3.1% to 4.0%)
 Code Ref: CBC 1133B.7.1.3 and ADA/ABA 403.3

As Built Meas: 150 Quantity: LF
 Description: Cross slope exceeds 2.0% (3.1% to 4.0%)
 As Built Desc: 3.1% cross slope
 Solution: Demolish existing and construct new route
 Bar. Severity: 3 Hinderance Cost Estimate: \$18,750.00 Status:
 Implementation Priority: 4 Facility Function:
 Implementation Phase: Implementation Date:
 Official Responsible:

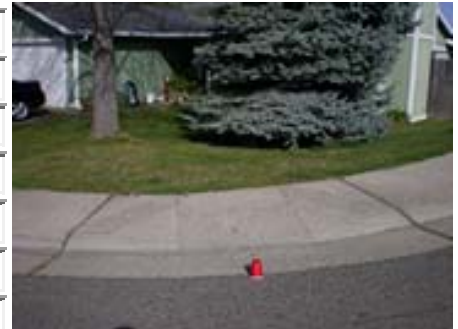
Field Date: 3/11/2011 Report Date: 3/14/2011 Barrier #: 5941
 Location: Sun Terrace Wy and Greenland Ct - Corner A
 X Coordinate: -121.25459
 Y Coordinate: 38.70654
 Barrier Area: Curb Ramps
 Barrier Type: No Curb Ramp - Depressed Existing Curb
 Code Ref: CBC 1127B.5.1 and ADA/ABA 402.2

As Built Meas: 1 Quantity: EACH
 Description: No compliant curb cut at corner (intersection)
 As Built Desc: 9.8% running slope at depressed area
 Solution: Demolish existing and construct curb cut
 Bar. Severity: 1 Necessary Cost Estimate: \$2,500.00 Status:
 Implementation Priority: 4 Facility Function:
 Implementation Phase: Implementation Date:
 Official Responsible:

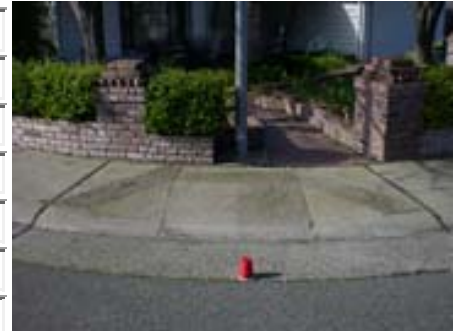
Field Date: 3/11/2011 Report Date: 3/14/2011 Barrier #: 5942
 Location: Sun Terrace Wy and Greenland Ct - Corner D
 X Coordinate: -121.25457
 Y Coordinate: 38.70645
 Barrier Area: Curb Ramps
 Barrier Type: No Curb Ramp - Depressed Existing Curb
 Code Ref: CBC 1127B.5.1 and ADA/ABA 402.2

As Built Meas: 1 Quantity: EACH
 Description: No compliant curb cut at corner (intersection)
 As Built Desc: 7.2% running slope at depressed area
 Solution: Demolish existing and construct curb cut
 Bar. Severity: 1 Necessary Cost Estimate: \$2,500.00 Status:
 Implementation Priority: 4 Facility Function:
 Implementation Phase: Implementation Date:
 Official Responsible:

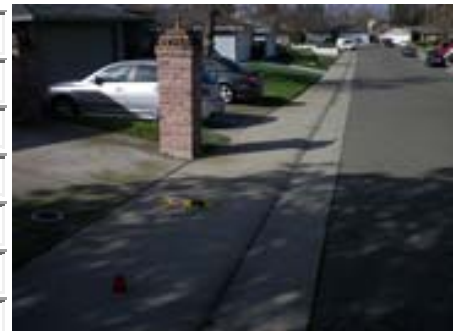
Field Date: 3/11/2011 Report Date: 3/14/2011 Barrier #: 5943
 Location: Greenland Ct - South
 X Coordinate: -121.25471
 Y Coordinate: 38.70646
 Barrier Area: Sidewalks
 Barrier Type: Cross Slope - Existing (4.1% to 4.9%)
 Code Ref: CBC 1133B.7.1.3 and ADA/ABA 403.3

As Built Meas: 300 Quantity: LF
 Description: Cross slope exceeds 2.0% (4.1% to 4.9%)
 As Built Desc: 4.4% cross slope
 Solution: Demolish existing and construct new route
 Bar. Severity: 2 Recommended Cost Estimate: \$37,500.00 Status:
 Implementation Priority: 4 Facility Function:
 Implementation Phase: Implementation Date:
 Official Responsible:

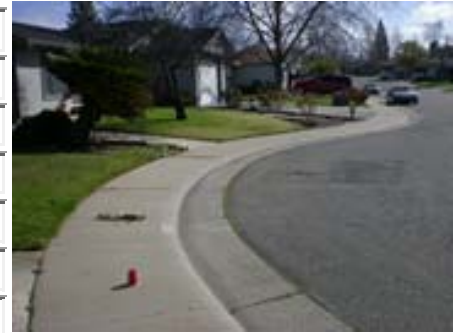
Field Date: 3/11/2011 Report Date: 3/14/2011 Barrier #: 5944
 Location: Greenland Ct - North
 X Coordinate: -121.25597
 Y Coordinate: 38.7066
 Barrier Area: Sidewalks
 Barrier Type: Cross Slope - Existing (3.1% to 4.0%)
 Code Ref: CBC 1133B.7.1.3 and ADA/ABA 403.3

As Built Meas: 390 Quantity: LF
 Description: Cross slope exceeds 2.0% (3.1% to 4.0%)
 As Built Desc: 3.9% cross slope
 Solution: Demolish existing and construct new route
 Bar. Severity: 3 Hinderance Cost Estimate: \$48,750.00 Status:
 Implementation Priority: 4 Facility Function:
 Implementation Phase: Implementation Date:
 Official Responsible:

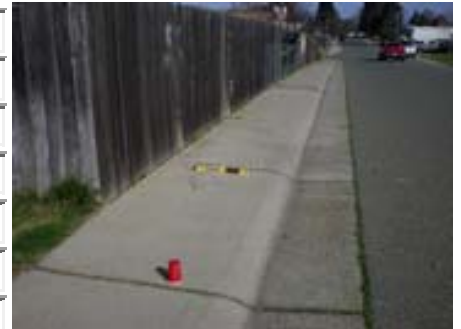
Field Date: 3/11/2011 Report Date: 3/14/2011 Barrier #: 5945
 Location: Sun Terrace Wy - West
 X Coordinate: -121.2546
 Y Coordinate: 38.70664
 Barrier Area: Sidewalks
 Barrier Type: Cross Slope - Existing (4.1% to 4.9%)
 Code Ref: CBC 1133B.7.1.3 and ADA/ABA 403.3

As Built Meas: 175 Quantity: LF
 Description: Cross slope exceeds 2.0% (4.1% to 4.9%)
 As Built Desc: 4.1% cross slope
 Solution: Demolish existing and construct new route
 Bar. Severity: 2 Recommended Cost Estimate: \$21,875.00 Status:
 Implementation Priority: 4 Facility Function:
 Implementation Phase: Implementation Date:
 Official Responsible:

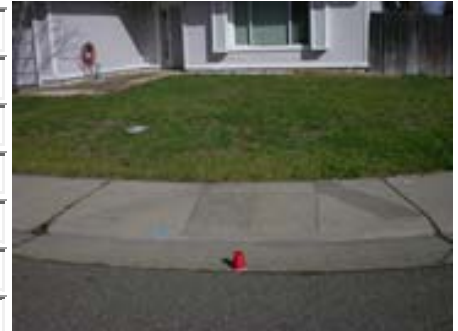
Field Date: 3/11/2011 Report Date: 3/14/2011 Barrier #: 5946
 Location: Sun Terrace Wy and Sunland Ct - Corner A
 X Coordinate: -121.25464
 Y Coordinate: 38.7073
 Barrier Area: Curb Ramps
 Barrier Type: No Curb Ramp - Depressed Existing Curb
 Code Ref: CBC 1127B.5.1 and ADA/ABA 402.2

As Built Meas: 1 Quantity: EACH
 Description: No compliant curb cut at corner (intersection)
 As Built Desc: 9.5% running slope at depressed area
 Solution: Demolish existing and construct curb cut
 Bar. Severity: 1 Necessary Cost Estimate: \$2,500.00 Status:
 Implementation Priority: 4 Facility Function:
 Implementation Phase: Implementation Date:
 Official Responsible:

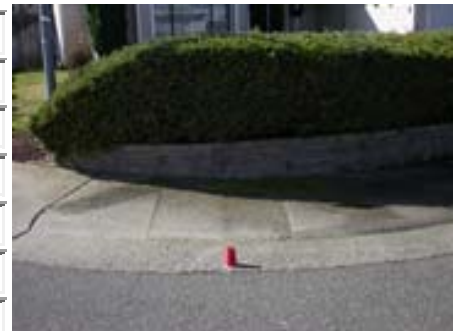
Field Date: 3/11/2011 Report Date: 3/14/2011 Barrier #: 5947
 Location: Sun Terrace Wy and Sunland Ct - Corner D
 X Coordinate: -121.2546
 Y Coordinate: 38.70722
 Barrier Area: Curb Ramps
 Barrier Type: No Curb Ramp - Depressed Existing Curb
 Code Ref: CBC 1127B.5.1 and ADA/ABA 402.2

As Built Meas: 1 Quantity: EACH
 Description: No compliant curb cut at corner (intersection)
 As Built Desc: 9.7% running slope at depressed area
 Solution: Demolish existing and construct curb cut
 Bar. Severity: 1 Necessary Cost Estimate: \$2,500.00 Status:
 Implementation Priority: 4 Facility Function:
 Implementation Phase: Implementation Date:
 Official Responsible:

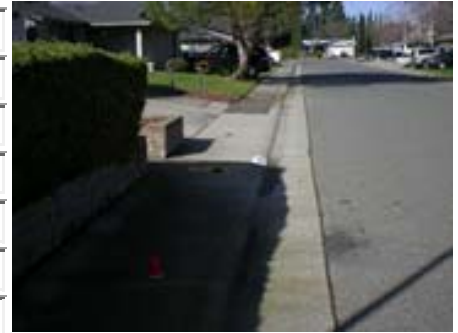
Field Date: 3/11/2011 Report Date: 3/14/2011 Barrier #: 5948
 Location: Sunland Ct - South
 X Coordinate: -121.25465
 Y Coordinate: 38.70719
 Barrier Area: Sidewalks
 Barrier Type: Cross Slope - Existing (3.1% to 4.0%)
 Code Ref: CBC 1133B.7.1.3 and ADA/ABA 403.3

As Built Meas: 180 Quantity: LF
 Description: Cross slope exceeds 2.0% (3.1% to 4.0%)
 As Built Desc: 3.6% cross slope
 Solution: Demolish existing and construct new route
 Bar. Severity: 3 Hinderance Cost Estimate: \$22,500.00 Status:
 Implementation Priority: 4 Facility Function:
 Implementation Phase: Implementation Date:
 Official Responsible:

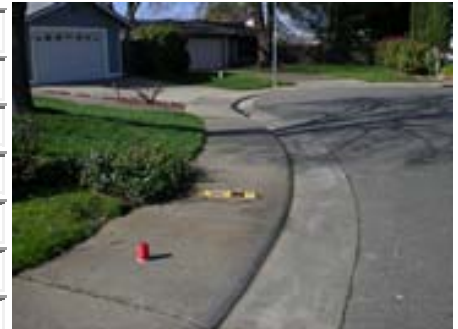
Field Date: 3/11/2011 Report Date: 3/14/2011 Barrier #: 5949
 Location: Sunland Ct - South
 X Coordinate: -121.25571
 Y Coordinate: 38.70719
 Barrier Area: Sidewalks
 Barrier Type: Cross Slope - Existing (3.1% to 4.0%)
 Code Ref: CBC 1133B.7.1.3 and ADA/ABA 403.3

As Built Meas: 54 Quantity: LF
 Description: Cross slope exceeds 2.0% (3.1% to 4.0%)
 As Built Desc: 4.0% cross slope
 Solution: Demolish existing and construct new route
 Bar. Severity: 3 Hinderance Cost Estimate: \$6,750.00 Status:
 Implementation Priority: 4 Facility Function:
 Implementation Phase: Implementation Date:
 Official Responsible:

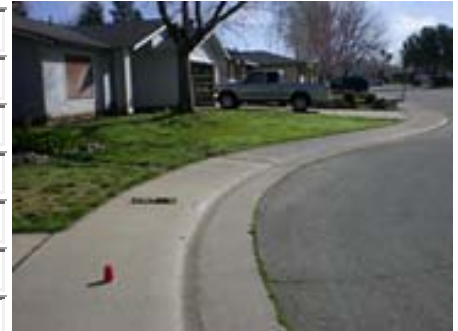
Field Date: 3/11/2011 Report Date: 3/14/2011 Barrier #: 5950
 Location: Sunland Ct - North
 X Coordinate: -121.25595
 Y Coordinate: 38.70731
 Barrier Area: Sidewalks
 Barrier Type: Cross Slope - Existing (3.1% to 4.0%)
 Code Ref: CBC 1133B.7.1.3 and ADA/ABA 403.3

As Built Meas: 100 Quantity: LF
 Description: Cross slope exceeds 2.0% (3.1% to 4.0%)
 As Built Desc: 3.5% cross slope
 Solution: Demolish existing and construct new route
 Bar. Severity: 3 Hinderance Cost Estimate: \$12,500.00 Status:
 Implementation Priority: 4 Facility Function:
 Implementation Phase: Implementation Date:
 Official Responsible:

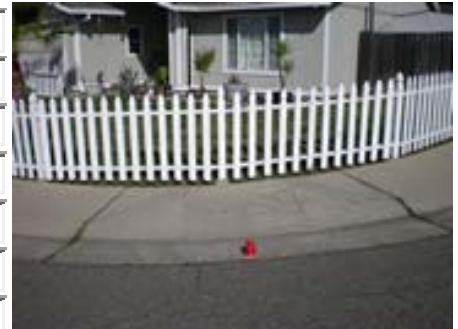
Field Date: 3/11/2011 Report Date: 3/14/2011 Barrier #: 5951
 Location: Sun Terrace Wy and Terraland Ct - Corner A
 X Coordinate: -121.25459
 Y Coordinate: 38.70799
 Barrier Area: Curb Ramps
 Barrier Type: No Curb Ramp - Depressed Existing Curb
 Code Ref: CBC 1127B.5.1 and ADA/ABA 402.2

As Built Meas: 1 Quantity: EACH
 Description: No compliant curb cut at corner (intersection)
 As Built Desc: 8.3% running slope at depressed area
 Solution: Demolish existing and construct curb cut
 Bar. Severity: 1 Necessary Cost Estimate: \$2,500.00 Status:
 Implementation Priority: 4 Facility Function:
 Implementation Phase: Implementation Date:
 Official Responsible:

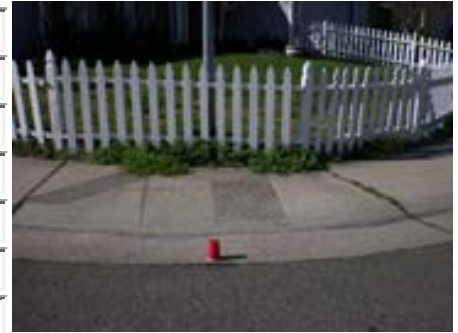
Field Date: 3/11/2011 Report Date: 3/14/2011 Barrier #: 5952
 Location: Sun Terrace Wy and Terraland Ct - Corner D
 X Coordinate: -121.25459
 Y Coordinate: 38.70787
 Barrier Area: Curb Ramps
 Barrier Type: No Curb Ramp - Depressed Existing Curb
 Code Ref: CBC 1127B.5.1 and ADA/ABA 402.2

As Built Meas: 1 Quantity: EACH
 Description: No compliant curb cut at corner (intersection)
 As Built Desc: 8.2% running slope at depressed area
 Solution: Demolish existing and construct curb cut
 Bar. Severity: 1 Necessary Cost Estimate: \$2,500.00 Status:
 Implementation Priority: 4 Facility Function:
 Implementation Phase: Implementation Date:
 Official Responsible:

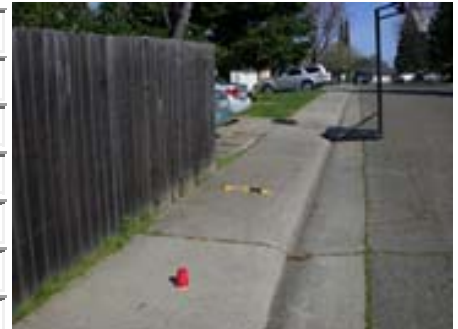
Field Date: 3/11/2011 Report Date: 3/14/2011 Barrier #: 5953
 Location: Sun Terrace Wy - West
 X Coordinate: -121.25458
 Y Coordinate: 38.70824
 Barrier Area: Sidewalks
 Barrier Type: Cross Slope - Existing (4.1% to 4.9%)
 Code Ref: CBC 1133B.7.1.3 and ADA/ABA 403.3

As Built Meas: 470 Quantity: LF
 Description: Cross slope exceeds 2.0% (4.1% to 4.9%)
 As Built Desc: 4.4% cross slope
 Solution: Demolish existing and construct new route
 Bar. Severity: 2 Recommended Cost Estimate: \$58,750.00 Status:
 Implementation Priority: 4 Facility Function:
 Implementation Phase: Implementation Date:
 Official Responsible:

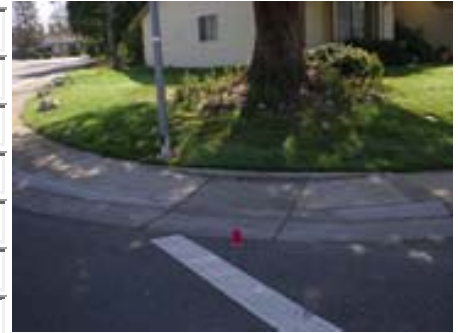
Field Date: 3/11/2011 Report Date: 3/14/2011 Barrier #: 5954A
 Location: Sun Terrace Wy and Claypool Wy - Corner C
 X Coordinate: -121.25443
 Y Coordinate: 38.70966
 Barrier Area: Curb Ramps
 Barrier Type: 12" Grooves - Existing (>5.0%)
 Code Ref: CBC 1127B.5.6

As Built Meas: 1 Quantity: EACH
 Description: 12" grooves at top of curb ramp are not level (>5.0%)
 As Built Desc: 7.1% at 12" grooves
 Solution: Demolish existing and construct new curb ramp
 Bar. Severity: 1 Necessary Cost Estimate: \$2,500.00 Status:
 Implementation Priority: 4 Facility Function:
 Implementation Phase: Implementation Date:
 Official Responsible:

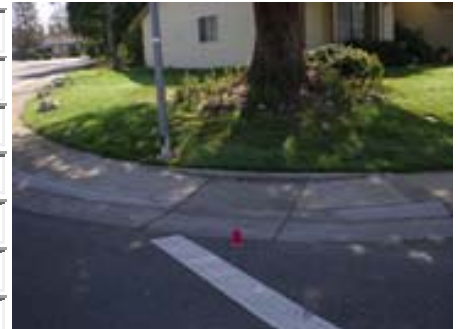
Field Date: 3/11/2011 Report Date: 3/14/2011 Barrier #: 5954B
 Location: Sun Terrace Wy and Claypool Wy - Corner C
 X Coordinate: -121.25443
 Y Coordinate: 38.70966
 Barrier Area: Curb Ramps
 Barrier Type: Parallel Ramp Landing - Existing (>5.0% or more)
 Code Ref: CBC 1127B.5.4 and ADA/ABA 406.4

As Built Meas: 1 Quantity: EACH
 Description: Curb ramp landing or pan not level (>5.0% or more)
 As Built Desc: 5.1% landing slope
 Solution: Demolish existing and construct new transition
 Bar. Severity: 1 Necessary Cost Estimate: \$250.00 Status:
 Implementation Priority: 4 Facility Function:
 Implementation Phase: Implementation Date:
 Official Responsible:

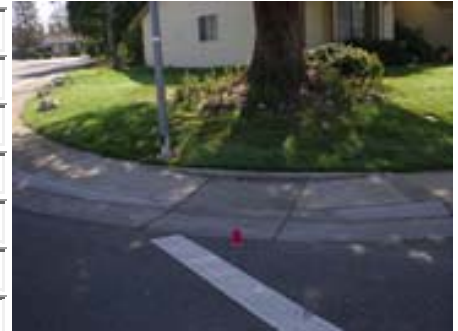
Field Date: 3/11/2011 Report Date: 3/14/2011 Barrier #: 5954C
 Location: Sun Terrace Wy and Claypool Wy - Corner C
 X Coordinate: -121.25443
 Y Coordinate: 38.70966
 Barrier Area: Curb Ramps
 Barrier Type: Detectable Warnings - Truncated Domes
 Code Ref: CBC 1127B.5.7 and ADA/ABA 705.1.3

As Built Meas: 1 Quantity: EACH
 Description: No truncated domes provided at curb ramp
 As Built Desc: No detectable warnings at curb ramp
 Solution: Provide compliant truncated domes
 Bar. Severity: 2 Recommended Cost Estimate: \$1,400.00 Status:
 Implementation Priority: 4 Facility Function:
 Implementation Phase: Implementation Date:
 Official Responsible:

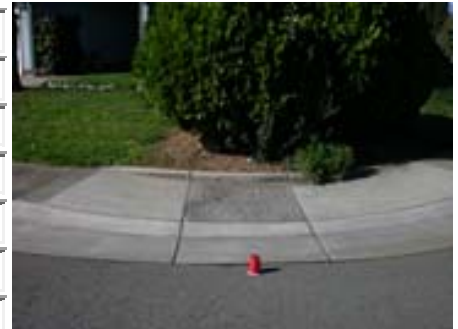
Field Date: 3/11/2011 Report Date: 3/14/2011 Barrier #: 5955A
 Location: Sun Terrace Wy and Claypool Wy - Corner D
 X Coordinate: -121.25456
 Y Coordinate: 38.70966
 Barrier Area: Curb Ramps
 Barrier Type: Detectable Warnings - Truncated Domes
 Code Ref: CBC 1127B.5.7 and ADA/ABA 705.1.3

As Built Meas: 1 Quantity: EACH
 Description: No truncated domes provided at curb ramp
 As Built Desc: No detectable warnings at curb ramp
 Solution: Provide compliant truncated domes
 Bar. Severity: 2 Recommended Cost Estimate: \$1,400.00 Status:
 Implementation Priority: 4 Facility Function:
 Implementation Phase: Implementation Date:
 Official Responsible:

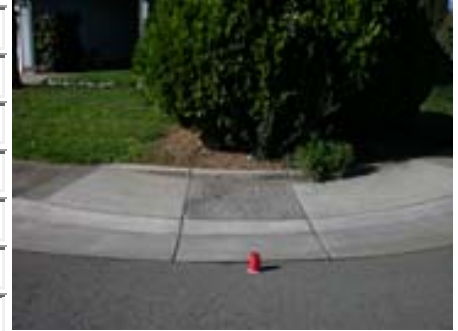
Field Date: 3/11/2011 Report Date: 3/14/2011 Barrier #: 5955B
 Location: Sun Terrace Wy and Claypool Wy - Corner D
 X Coordinate: -121.25456
 Y Coordinate: 38.70966
 Barrier Area: Curb Ramps
 Barrier Type: Gutter Slope - Existing (6.6% to 8.2%)
 Code Ref: CBC 1127B.5.3 and ADA/ABA 406.2

As Built Meas: 6 Quantity: SF
 Description: Gutter slope exceeds 5.0% (6.6% to 8.2%)
 As Built Desc: 7.3% gutter slope
 Solution: Demolish existing and construct new gutter
 Bar. Severity: 2 Recommended Cost Estimate: \$750.00 Status:
 Implementation Priority: 4 Facility Function:
 Implementation Phase: Implementation Date:
 Official Responsible:

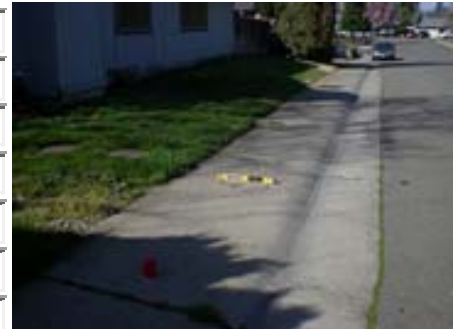
Field Date: 3/11/2011 Report Date: 3/14/2011 Barrier #: 5956
 Location: Claypool Wy - South
 X Coordinate: -121.25464
 Y Coordinate: 38.70965
 Barrier Area: Sidewalks
 Barrier Type: Cross Slope - Existing (2.1% to 3.0%)
 Code Ref: CBC 1133B.7.1.3 and ADA/ABA 403.3

As Built Meas: 82 Quantity: LF
 Description: Cross slope exceeds 2.0% (2.1% to 3.0%)
 As Built Desc: 3.0% cross slope
 Solution: Low severity barrier - no remediation recommended
 Bar. Severity: 4 Low Severity Cost Estimate: \$0.00 Status:
 Implementation Priority: 3 Facility Function:
 Implementation Phase: Implementation Date:
 Official Responsible:

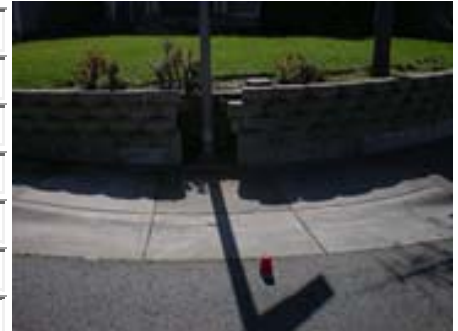
Field Date: 3/11/2011 Report Date: 3/14/2011 Barrier #: 5957A
 Location: Claypool Wy and Wetzle Ct - Corner C
 X Coordinate: -121.25521
 Y Coordinate: 38.70965
 Barrier Area: Curb Ramps
 Barrier Type: 12" Grooves - Existing (4.1% to 4.9%)
 Code Ref: CBC 1127B.5.6

As Built Meas: 1 Quantity: EACH
 Description: 12" grooves at top of curb ramp are not level (4.1% to 4.9%)
 As Built Desc: 4.3% at 12" grooves
 Solution: Demolish existing and construct new curb ramp
 Bar. Severity: 2 Recommended Cost Estimate: \$2,500.00 Status:
 Implementation Priority: 3 Facility Function:
 Implementation Phase: Implementation Date:
 Official Responsible:

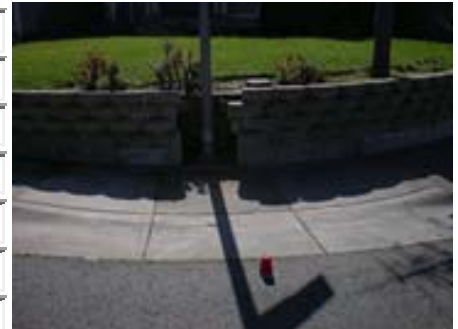
Field Date: 3/11/2011 Report Date: 3/14/2011 Barrier #: 5957B
 Location: Claypool Wy and Wetzle Ct - Corner C
 X Coordinate: -121.25521
 Y Coordinate: 38.70965
 Barrier Area: Curb Ramps
 Barrier Type: Detectable Warnings - Truncated Domes
 Code Ref: CBC 1127B.5.7 and ADA/ABA 705.1.3

As Built Meas: 1 Quantity: EACH
 Description: No truncated domes provided at curb ramp
 As Built Desc: No detectable warnings at curb ramp
 Solution: Provide compliant truncated domes
 Bar. Severity: 2 Recommended Cost Estimate: \$1,400.00 Status:
 Implementation Priority: 3 Facility Function:
 Implementation Phase: Implementation Date:
 Official Responsible:

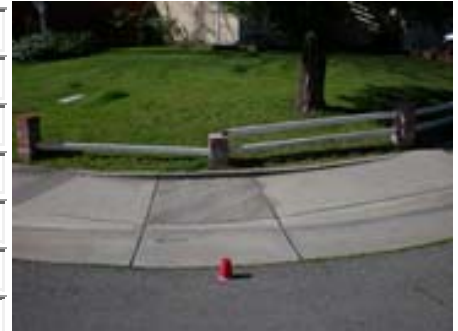
Field Date: 3/11/2011 Report Date: 3/14/2011 Barrier #: 5958A
 Location: Claypool Wy and Wetzle Ct - Corner D
 X Coordinate: -121.25535
 Y Coordinate: 38.70966
 Barrier Area: Curb Ramps
 Barrier Type: 12" Grooves - Existing (>5.0%)
 Code Ref: CBC 1127B.5.6

As Built Meas: 1 Quantity: EACH
 Description: 12" grooves at top of curb ramp are not level (>5.0%)
 As Built Desc: 6.7% at 12" grooves
 Solution: Demolish existing and construct new curb ramp
 Bar. Severity: 1 Necessary Cost Estimate: \$2,500.00 Status:
 Implementation Priority: 3 Facility Function:
 Implementation Phase: Implementation Date:
 Official Responsible:

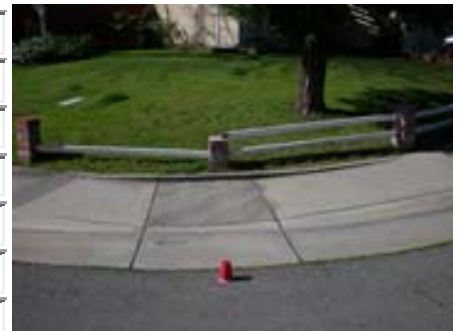
Field Date: 3/11/2011 Report Date: 3/14/2011 Barrier #: 5958B
 Location: Claypool Wy and Wetzle Ct - Corner D
 X Coordinate: -121.25535
 Y Coordinate: 38.70966
 Barrier Area: Curb Ramps
 Barrier Type: Parallel Ramp Landing - Existing (>5.0% or more)
 Code Ref: CBC 1127B.5.4 and ADA/ABA 406.4

As Built Meas: 1 Quantity: EACH
 Description: Curb ramp landing or pan not level (>5.0% or more)
 As Built Desc: 5.1% landing slope
 Solution: Demolish existing and construct new transition
 Bar. Severity: 1 Necessary Cost Estimate: \$250.00 Status:
 Implementation Priority: 3 Facility Function:
 Implementation Phase: Implementation Date:
 Official Responsible:

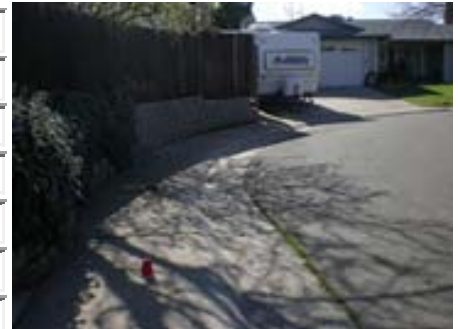
Field Date: 3/11/2011 Report Date: 3/14/2011 Barrier #: 5959
 Location: Wetzle Ct - East
 X Coordinate: -121.25523
 Y Coordinate: 38.70952
 Barrier Area: Sidewalks
 Barrier Type: Cross Slope - Existing (2.1% to 3.0%)
 Code Ref: CBC 1133B.7.1.3 and ADA/ABA 403.3

As Built Meas: 45 Quantity: LF
 Description: Cross slope exceeds 2.0% (2.1% to 3.0%)
 As Built Desc: 3.1.% cross slope
 Solution: Low severity barrier - no remediation recommended
 Bar. Severity: 4 Low Severity Cost Estimate: \$0.00 Status:
 Implementation Priority: 4 Facility Function:
 Implementation Phase: Implementation Date:
 Official Responsible:

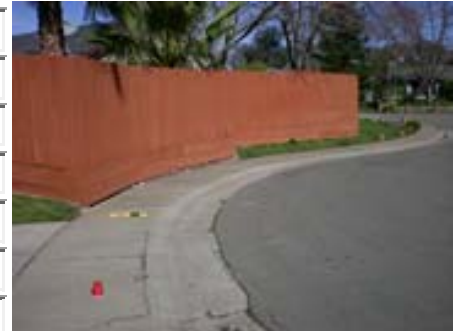
Field Date: 3/11/2011 Report Date: 3/14/2011 Barrier #: 5960
 Location: Wetzle Ct - West
 X Coordinate: -121.25539
 Y Coordinate: 38.70937
 Barrier Area: Sidewalks
 Barrier Type: Cross Slope - Existing (2.1% to 3.0%)
 Code Ref: CBC 1133B.7.1.3 and ADA/ABA 403.3

As Built Meas: 90 Quantity: LF
 Description: Cross slope exceeds 2.0% (2.1% to 3.0%)
 As Built Desc: 3.0% cross slope
 Solution: Low severity barrier - no remediation recommended
 Bar. Severity: 4 Low Severity Cost Estimate: \$0.00 Status:
 Implementation Priority: 4 Facility Function:
 Implementation Phase: Implementation Date:
 Official Responsible:

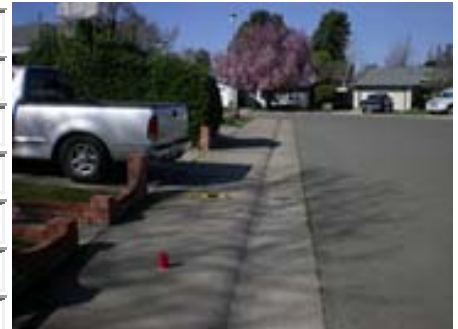
Field Date: 3/11/2011 Report Date: 3/14/2011 Barrier #: 5961
 Location: Claypool Wy - South
 X Coordinate: -121.25549
 Y Coordinate: 38.70966
 Barrier Area: Sidewalks
 Barrier Type: Cross Slope - Existing (2.1% to 3.0%)
 Code Ref: CBC 1133B.7.1.3 and ADA/ABA 403.3

As Built Meas: 93 Quantity: LF
 Description: Cross slope exceeds 2.0% (2.1% to 3.0%)
 As Built Desc: 3.0% cross slope
 Solution: Low severity barrier - no remediation recommended
 Bar. Severity: 4 Low Severity Cost Estimate: \$0.00 Status:
 Implementation Priority: 3 Facility Function:
 Implementation Phase: Implementation Date:
 Official Responsible:

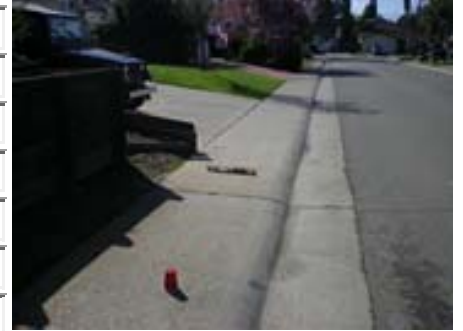
Field Date: 3/11/2011 Report Date: 3/14/2011 Barrier #: 5962A
 Location: Claypool Wy - East
 X Coordinate: -121.25592
 Y Coordinate: 38.70942
 Barrier Area: Sidewalks
 Barrier Type: Cross Slope - Existing (3.1% to 4.0%)
 Code Ref: CBC 1133B.7.1.3 and ADA/ABA 403.3

As Built Meas: 240 Quantity: LF
 Description: Cross slope exceeds 2.0% (3.1% to 4.0%)
 As Built Desc: 3.5% cross slope
 Solution: Demolish existing and construct new route
 Bar. Severity: 3 Hinderance Cost Estimate: \$30,000.00 Status:
 Implementation Priority: 3 Facility Function:
 Implementation Phase: Implementation Date:
 Official Responsible:

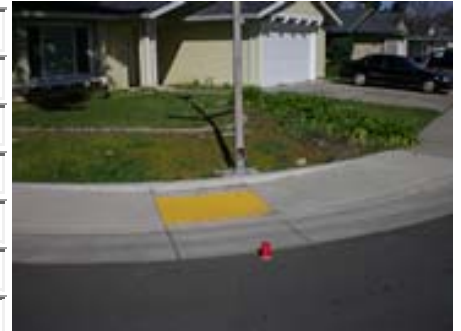
Field Date: 3/11/2011 Report Date: 3/14/2011 Barrier #: 5963
 Location: Claypool Wy and Daffodil Wy - Corner A
 X Coordinate: -121.25602
 Y Coordinate: 38.70867
 Barrier Area: Curb Ramps
 Barrier Type: No Curb Ramp - Depressed Existing Curb
 Code Ref: CBC 1127B.5.1 and ADA/ABA 402.2

As Built Meas: 1 Quantity: EACH
 Description: No compliant curb cut at corner (intersection)
 As Built Desc: 4.3% running slope at depressed area
 Solution: Demolish existing and construct curb cut
 Bar. Severity: 1 Necessary Cost Estimate: \$2,500.00 Status:
 Implementation Priority: 3 Facility Function:
 Implementation Phase: Implementation Date:
 Official Responsible:

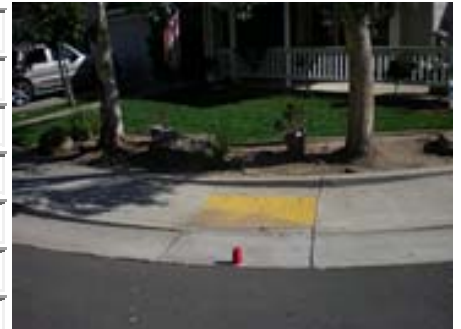
Field Date: 3/11/2011 Report Date: 3/14/2011 Barrier #: 5964
 Location: Claypool Wy and Daffodil Wy - Corner B
 X Coordinate: -121.25591
 Y Coordinate: 38.70869
 Barrier Area: Curb Ramps
 Barrier Type: No Curb Ramp - Depressed Existing Curb
 Code Ref: CBC 1127B.5.1 and ADA/ABA 402.2

As Built Meas: 1 Quantity: EACH
 Description: No compliant curb cut at corner (intersection)
 As Built Desc: 5.8% running slope at depressed area
 Solution: Demolish existing and construct curb cut
 Bar. Severity: 1 Necessary Cost Estimate: \$2,500.00 Status:
 Implementation Priority: 3 Facility Function:
 Implementation Phase: Implementation Date:
 Official Responsible:

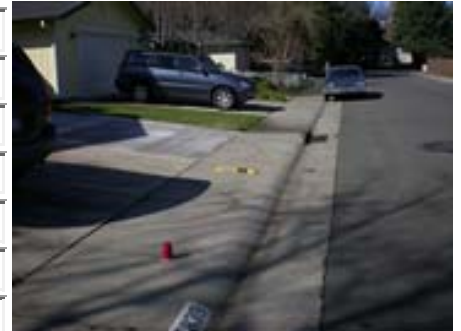
Barrier Type: Cross Slope - Existing (3.1% to 4.0%)

Description: Cross slope exceeds 2.0% (3.1% to 4.0%)

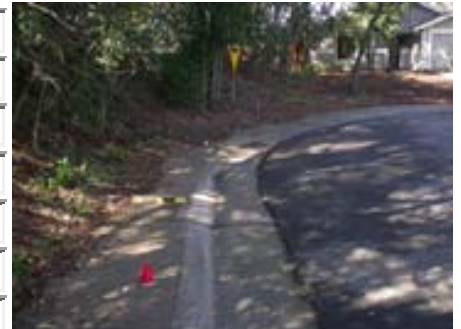
Barrier Type: Cross Slope - Existing (4.1% to 4.9%)

Description: Cross slope exceeds 2.0% (4.1% to 4.9%)

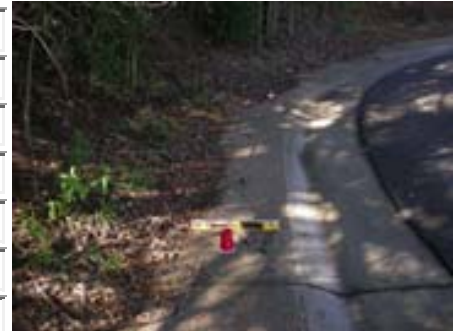
Field Date: 3/11/2011 Report Date: 3/14/2011 Barrier #: 5966B
 Location: Daffodil Wy - South
 X Coordinate: -121.25673
 Y Coordinate: 38.70856
 Barrier Area: Sidewalks
 Barrier Type: Clear Width - Existing ($\leq 31''$ or less)
 Code Ref: CBC 1133B.7.1

As Built Meas: 1 Quantity: LF
 Description: Pedestrian route is not min. 48" wide ($\leq 31''$ or less)
 As Built Desc: 10" clear width dirt and foliage
 Solution: Trim foliage to provide min. 48" clear width
 Bar. Severity: 1 Necessary Cost Estimate: \$125.00 Status:
 Implementation Priority: 4 Facility Function:
 Implementation Phase: Implementation Date:
 Official Responsible:

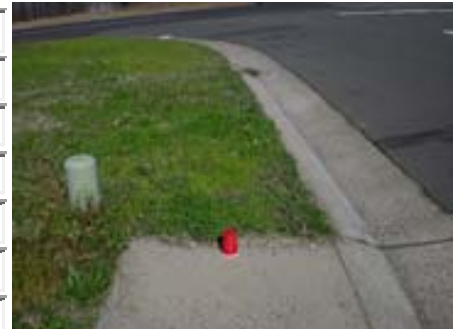
Field Date: 3/11/2011 Report Date: 3/14/2011 Barrier #: 5969
 Location: Daffodil Wy - West
 X Coordinate: -121.2569
 Y Coordinate: 38.71021
 Barrier Area: Sidewalks
 Barrier Type: No Sidewalk - No Barricade
 Code Ref: MUTCD Section 6D.01

As Built Meas: 1 Quantity: JOB
 Description: No barricade provided where sidewalk ends in hazardous location
 As Built Desc: No barricade or other warning provided for the visually impaired at end of sidewalk
 Solution: Provide barricade with cane detectable warning at end of sidewalk
 Bar. Severity: 1 Necessary Cost Estimate: \$1,350.00 Status:
 Implementation Priority: 4 Facility Function:
 Implementation Phase: Implementation Date:
 Official Responsible:

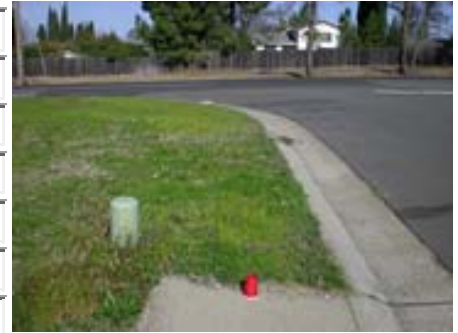
Field Date: 3/11/2011 Report Date: 3/14/2011 Barrier #: 5970
 Location: Daffodil Wy - West
 X Coordinate: -121.2569
 Y Coordinate: 38.71023
 Barrier Area: Sidewalks
 Barrier Type: No sidewalk
 Code Ref: CBC 1127B.1 and ADA/ABA 206.2.1

As Built Meas: 50 Quantity: LF
 Description: No pedestrian route provided
 As Built Desc: No sidewalk provided
 Solution: Construct new firm and stable pedestrian route
 Bar. Severity: 1 Necessary Cost Estimate: \$5,000.00 Status:
 Implementation Priority: 4 Facility Function:
 Implementation Phase: Implementation Date:
 Official Responsible:

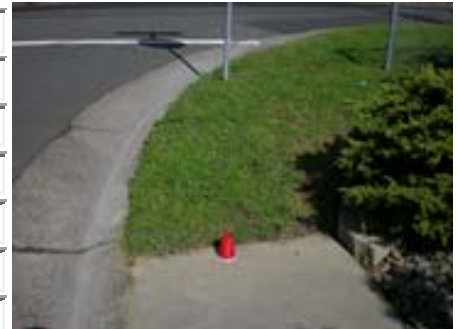
Field Date: 3/11/2011 Report Date: 3/14/2011 Barrier #: 5971
 Location: Daffodil Wy - East
 X Coordinate: -121.25684
 Y Coordinate: 38.71032
 Barrier Area: Sidewalks
 Barrier Type: No Sidewalk - No Barricade
 Code Ref: MUTCD Section 6D.01

As Built Meas: 1 Quantity: JOB
 Description: No barricade provided where sidewalk ends in hazardous location
 As Built Desc: No barricade or other warning provided for the visually impaired at end of sidewalk
 Solution: Provide barricade with cane detectable warning at end of sidewalk
 Bar. Severity: 1 Necessary Cost Estimate: \$1,350.00 Status:
 Implementation Priority: 4 Facility Function:
 Implementation Phase: Implementation Date:
 Official Responsible:

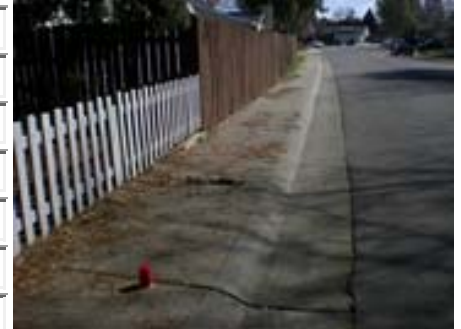
Field Date: 3/11/2011 Report Date: 3/14/2011 Barrier #: 5972
 Location: Daffodil Wy - North
 X Coordinate: -121.25671
 Y Coordinate: 38.70871
 Barrier Area: Sidewalks
 Barrier Type: Cross Slope - Existing (2.1% to 3.0%)
 Code Ref: CBC 1133B.7.1.3 and ADA/ABA 403.3

As Built Meas: 70 Quantity: LF
 Description: Cross slope exceeds 2.0% (2.1% to 3.0%)
 As Built Desc: 3.0% cross slope
 Solution: Low severity barrier - no remediation recommended
 Bar. Severity: 4 Low Severity Cost Estimate: \$0.00 Status:
 Implementation Priority: 4 Facility Function:
 Implementation Phase: Implementation Date:
 Official Responsible:

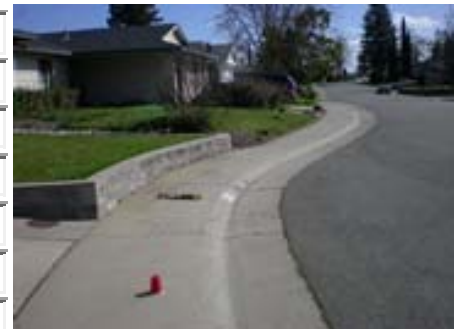
Field Date: 3/11/2011 Report Date: 3/14/2011 Barrier #: 5973
 Location: Claypool Wy - North
 X Coordinate: -121.25593
 Y Coordinate: 38.70979
 Barrier Area: Sidewalks
 Barrier Type: Cross Slope - Existing (3.1% to 4.0%)
 Code Ref: CBC 1133B.7.1.3 and ADA/ABA 403.3

As Built Meas: 440 Quantity: LF
 Description: Cross slope exceeds 2.0% (3.1% to 4.0%)
 As Built Desc: 3.8% cross slope
 Solution: Demolish existing and construct new route
 Bar. Severity: 3 Hinderance Cost Estimate: \$55,000.00 Status:
 Implementation Priority: 3 Facility Function:
 Implementation Phase: Implementation Date:
 Official Responsible:

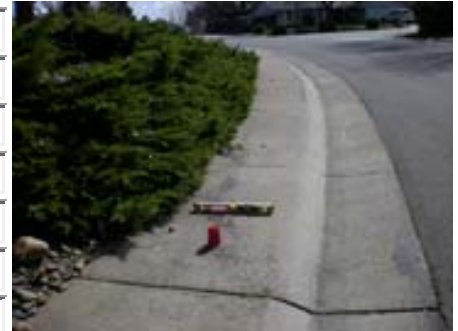
Barrier Type: Clear Width - Existing ($\leq 31''$ or less)

Code Ref: CBC 1133B.7.1

As Built Meas: 1 Quantity: LF

Description: Pedestrian route is not min. 48" wide ($\leq 31''$ or less)

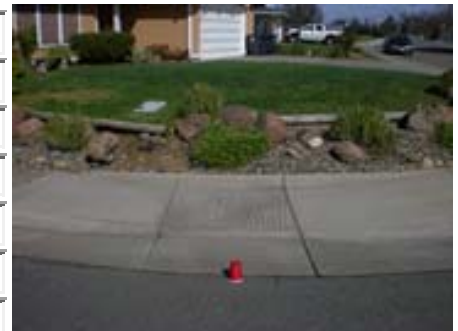
Barrier Type: 12" Grooves - Existing (4.1% to 4.9%)

Code Ref: CBC 1127B.5.6

As Built Meas: 1 Quantity: EACH

Description: 12" grooves at top of curb ramp are not level (4.1% to 4.9%)

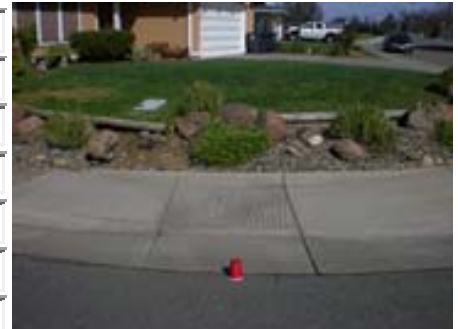
Field Date: 3/11/2011 Report Date: 3/14/2011 Barrier #: 5975C
 Location: Claypool Wy and Wintergreen Dr - Corner A A-A
 X Coordinate: -121.2538
 Y Coordinate: 38.7096
 Barrier Area: Curb Ramps
 Barrier Type: Gutter Slope - Existing (6.6% to 8.2%)
 Code Ref: CBC 1127B.5.3 and ADA/ABA 406.2

As Built Meas: 6 Quantity: SF
 Description: Gutter slope exceeds 5.0% (6.6% to 8.2%)
 As Built Desc: 6.9% gutter slope
 Solution: Demolish existing and construct new gutter
 Bar. Severity: 2 Recommended Cost Estimate: \$750.00 Status:
 Implementation Priority: 3 Facility Function:
 Implementation Phase: Implementation Date:
 Official Responsible:

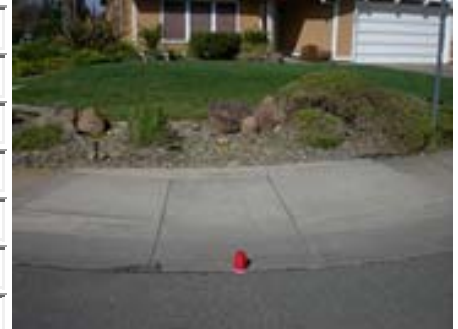
Field Date: 3/11/2011 Report Date: 3/14/2011 Barrier #: 5976A
 Location: Claypool Wy and Wintergreen Dr - Corner A A-B
 X Coordinate: -121.25373
 Y Coordinate: 38.70964
 Barrier Area: Curb Ramps
 Barrier Type: 12" Grooves - Existing (>5.0%)
 Code Ref: CBC 1127B.5.6

As Built Meas: 1 Quantity: EACH
 Description: 12" grooves at top of curb ramp are not level (>5.0%)
 As Built Desc: 6.5% at 12" grooves
 Solution: Demolish existing and construct new curb ramp
 Bar. Severity: 1 Necessary Cost Estimate: \$2,500.00 Status:
 Implementation Priority: 3 Facility Function:
 Implementation Phase: Implementation Date:
 Official Responsible:

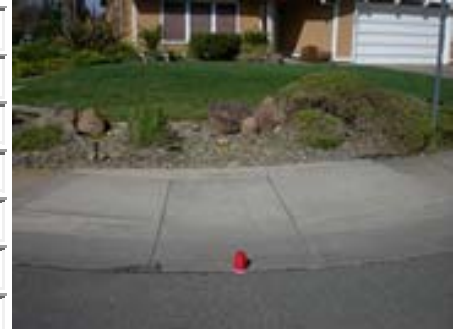
Field Date: 3/11/2011 Report Date: 3/14/2011 Barrier #: 5976B
 Location: Claypool Wy and Wintergreen Dr - Corner A A-B
 X Coordinate: -121.25373
 Y Coordinate: 38.70964
 Barrier Area: Curb Ramps
 Barrier Type: Detectable Warnings - Truncated Domes
 Code Ref: CBC 1127B.5.7 and ADA/ABA 705.1.3

As Built Meas: 1 Quantity: EACH
 Description: No truncated domes provided at curb ramp
 As Built Desc: No detectable warnings at curb ramp
 Solution: Provide compliant truncated domes
 Bar. Severity: 2 Recommended Cost Estimate: \$1,400.00 Status:
 Implementation Priority: 3 Facility Function:
 Implementation Phase: Implementation Date:
 Official Responsible:

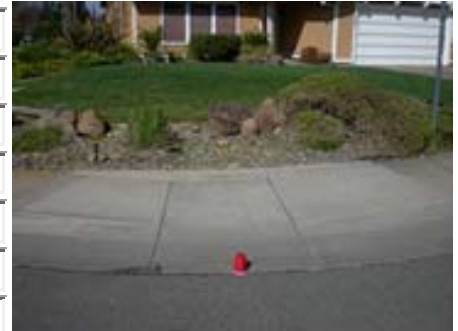
Field Date: 3/11/2011 Report Date: 3/14/2011 Barrier #: 5976C
 Location: Claypool Wy and Wintergreen Dr - Corner A A-B
 X Coordinate: -121.25373
 Y Coordinate: 38.70964
 Barrier Area: Curb Ramps
 Barrier Type: Gutter Slope - Existing (6.6% to 8.2%)
 Code Ref: CBC 1127B.5.3 and ADA/ABA 406.2

As Built Meas: 6 Quantity: SF
 Description: Gutter slope exceeds 5.0% (6.6% to 8.2%)
 As Built Desc: 7.9% gutter slope
 Solution: Demolish existing and construct new gutter
 Bar. Severity: 2 Recommended Cost Estimate: \$750.00 Status:
 Implementation Priority: 3 Facility Function:
 Implementation Phase: Implementation Date:
 Official Responsible:

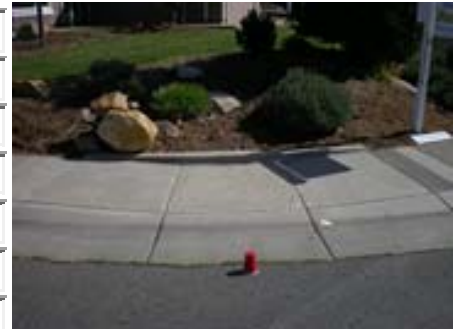
Field Date: 3/11/2011 Report Date: 3/14/2011 Barrier #: 5977
 Location: Claypool Wy and Wintergreen Dr - Corner B A-A
 X Coordinate: -121.25356
 Y Coordinate: 38.70965
 Barrier Area: Curb Ramps
 Barrier Type: Detectable Warnings - Truncated Domes
 Code Ref: CBC 1127B.5.7 and ADA/ABA 705.1.3

As Built Meas: 1 Quantity: EACH
 Description: No truncated domes provided at curb ramp
 As Built Desc: No detectable warnings at curb ramp
 Solution: Provide compliant truncated domes
 Bar. Severity: 2 Recommended Cost Estimate: \$1,400.00 Status:
 Implementation Priority: 3 Facility Function:
 Implementation Phase: Implementation Date:
 Official Responsible:

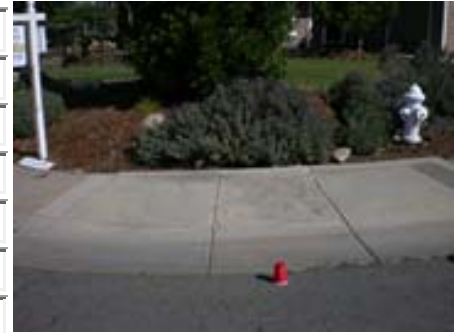
Barrier Type: 12" Grooves - Existing (>5.0%)

Code Ref: CBC 1127B.5.6

As Built Meas: 1 Quantity: EACH

Description: 12" grooves at top of curb ramp are not level (>5.0%)

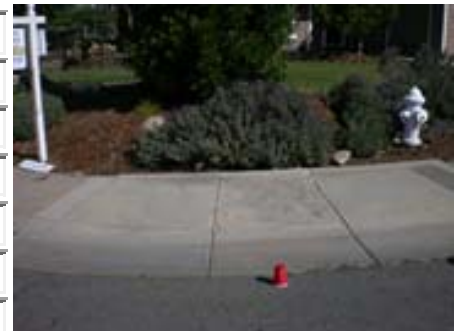
Barrier Type: Perpendicular Ramp Landing (4.1% to 4.9%)

Code Ref: CBC 1127B.5.4 and ADA/ABA 406.4

As Built Meas: 1 Quantity: EACH

Description: Curb ramp top landing not level (4.1% to 4.9%)

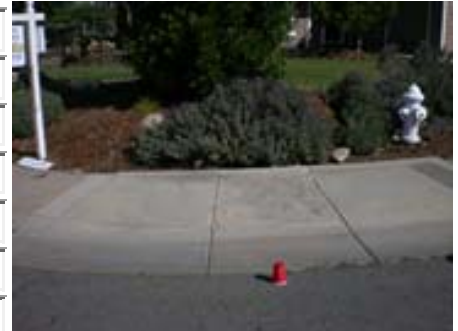
Field Date: 3/11/2011 Report Date: 3/14/2011 Barrier #: 5978C
 Location: Claypool Wy and Wintergreen Dr - Corner B A-B
 X Coordinate: -121.25349
 Y Coordinate: 38.70961
 Barrier Area: Curb Ramps
 Barrier Type: Detectable Warnings - Truncated Domes
 Code Ref: CBC 1127B.5.7 and ADA/ABA 705.1.3

As Built Meas: 1 Quantity: EACH
 Description: No truncated domes provided at curb ramp
 As Built Desc: No detectable warnings at curb ramp
 Solution: Provide compliant truncated domes
 Bar. Severity: 2 Recommended Cost Estimate: \$1,400.00 Status:
 Implementation Priority: 3 Facility Function:
 Implementation Phase: Implementation Date:
 Official Responsible:

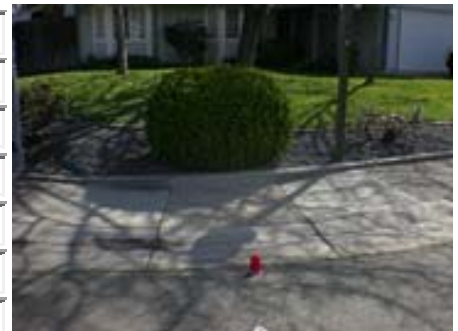
Field Date: 3/11/2011 Report Date: 3/14/2011 Barrier #: 5979A
 Location: Claypool Wy and Wintergreen Dr - Corner C A-A
 X Coordinate: -121.25357
 Y Coordinate: 38.7095
 Barrier Area: Curb Ramps
 Barrier Type: Running Slope - Existing (9.5% or more)
 Code Ref: CBC 1127B.5.3 and ADA/ABA 406.1

As Built Meas: 1 Quantity: EACH
 Description: Ramp run cross slope exceeds 2.0% (9.5% or more)
 As Built Desc: 10.2% running slope
 Solution: Demolish existing and construct new curb ramp
 Bar. Severity: 1 Necessary Cost Estimate: \$2,500.00 Status:
 Implementation Priority: 3 Facility Function:
 Implementation Phase: Implementation Date:
 Official Responsible:

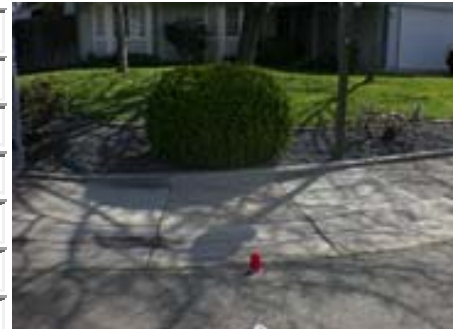
Field Date: 3/11/2011 Report Date: 3/14/2011 Barrier #: 5979C
 Location: Claypool Wy and Wintergreen Dr - Corner C A-A
 X Coordinate: -121.25357
 Y Coordinate: 38.7095
 Barrier Area: Curb Ramps
 Barrier Type: Gutter Slope - Existing (6.6% to 8.2%)
 Code Ref: CBC 1127B.5.3 and ADA/ABA 406.2

As Built Meas: 6 Quantity: SF
 Description: Gutter slope exceeds 5.0% (6.6% to 8.2%)
 As Built Desc: 6.6% gutter slope
 Solution: Demolish existing and construct new gutter
 Bar. Severity: 2 Recommended Cost Estimate: \$750.00 Status:
 Implementation Priority: 3 Facility Function:
 Implementation Phase: Implementation Date:
 Official Responsible:

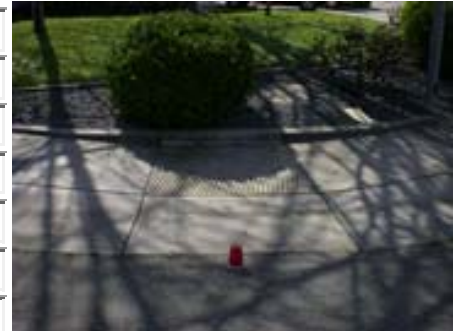
Field Date: 3/11/2011 Report Date: 3/14/2011 Barrier #: 5980A
 Location: Claypool Wy and Wintergreen Dr - Corner C A-B
 X Coordinate: -121.25351
 Y Coordinate: 38.70955
 Barrier Area: Curb Ramps
 Barrier Type: 12" Grooves - Existing (4.1% to 4.9%)
 Code Ref: CBC 1127B.5.6

As Built Meas: 1 Quantity: EACH
 Description: 12" grooves at top of curb ramp are not level (4.1% to 4.9%)
 As Built Desc: 4.2% at 12" grooves
 Solution: Demolish existing and construct new curb ramp
 Bar. Severity: 2 Recommended Cost Estimate: \$2,500.00 Status:
 Implementation Priority: 3 Facility Function:
 Implementation Phase: Implementation Date:
 Official Responsible:

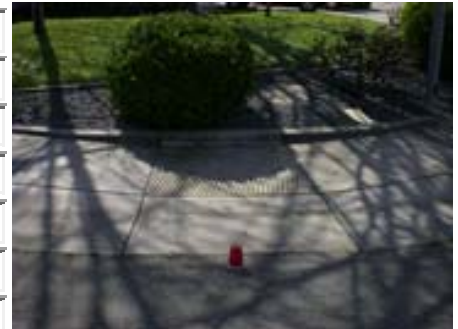
Field Date: 3/11/2011 Report Date: 3/14/2011 Barrier #: 5980B
 Location: Claypool Wy and Wintergreen Dr - Corner C A-B
 X Coordinate: -121.25351
 Y Coordinate: 38.70955
 Barrier Area: Curb Ramps
 Barrier Type: Parallel Ramp Landing - Existing (3.1% to 4.0%)
 Code Ref: CBC 1127B.5.4 and ADA/ABA 406.4

As Built Meas: 1 Quantity: EACH
 Description: Curb ramp landing or pan not level (3.1% to 4.0%)
 As Built Desc: 3.4% landing slope
 Solution: Demolish existing and construct new transition
 Bar. Severity: 3 Hindrance Cost Estimate: \$250.00 Status:
 Implementation Priority: 3 Facility Function:
 Implementation Phase: Implementation Date:
 Official Responsible:

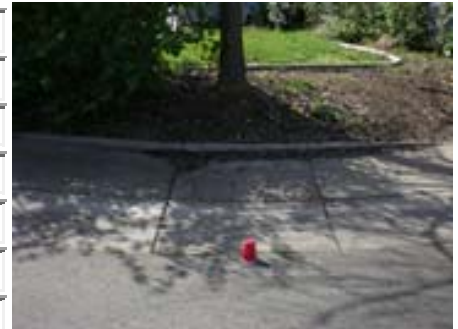
Field Date: 3/11/2011 Report Date: 3/14/2011 Barrier #: 5981A
 Location: Claypool Wy and Wintergreen Dr - Corner D A-A
 X Coordinate: -121.25378
 Y Coordinate: 38.70953
 Barrier Area: Curb Ramps
 Barrier Type: 12" Grooves - Existing (>5.0%)
 Code Ref: CBC 1127B.5.6

As Built Meas: 1 Quantity: EACH
 Description: 12" grooves at top of curb ramp are not level (>5.0%)
 As Built Desc: 5.1% at 12" grooves
 Solution: Demolish existing and construct new curb ramp
 Bar. Severity: 1 Necessary Cost Estimate: \$2,500.00 Status:
 Implementation Priority: 3 Facility Function:
 Implementation Phase: Implementation Date:
 Official Responsible:

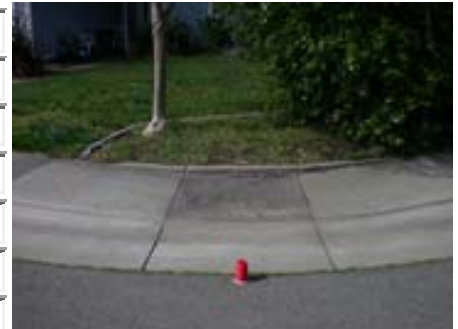
Field Date: 3/11/2011 Report Date: 3/14/2011 Barrier #: 5982C
 Location: Claypool Wy and Wintergreen Dr - Corner D A-B
 X Coordinate: -121.25372
 Y Coordinate: 38.70949
 Barrier Area: Curb Ramps
 Barrier Type: Gutter Slope - Existing (8.3% or more)
 Code Ref: CBC 1127B.5.3 and ADA/ABA 406.2

As Built Meas: 6 Quantity: SF
 Description: Gutter slope exceeds 5.0% (8.3% or more)
 As Built Desc: 7.4% gutter slope
 Solution: Demolish existing and construct new gutter
 Bar. Severity: 1 Necessary Cost Estimate: \$750.00 Status:
 Implementation Priority: 3 Facility Function:
 Implementation Phase: Implementation Date:
 Official Responsible:
