**DRAFT ADA TRANSITION PLAN UPDATE
NEIGHBORHOOD AREA 8 CHASE
SEPTEMBER 20, 2011**

CITY OF CITRUS HEIGHTS

Conditions - CHASE Area 8

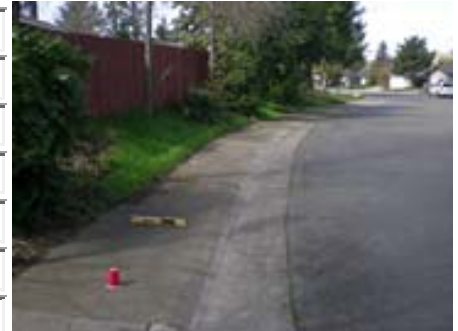
Barrier Type: Cross Slope - Existing (3.1% to 4.0%)

Code Ref: CBC 1133B.7.1.3 and ADA/ABA 403.3

As Built Meas: 446 Quantity: LF

Description: Cross slope exceeds 2.0% (3.1% to 4.0%)

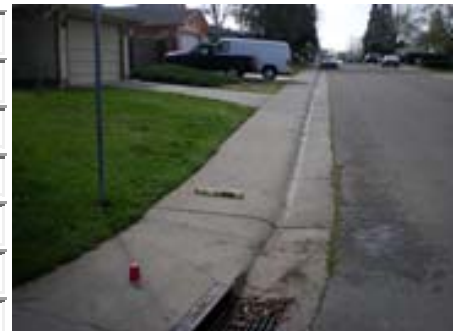
Barrier Type: Cross Slope - Existing (3.1% to 4.0%)

Code Ref: CBC 1133B.7.1.3 and ADA/ABA 403.3

As Built Meas: 635 Quantity: LF

Description: Cross slope exceeds 2.0% (3.1% to 4.0%)

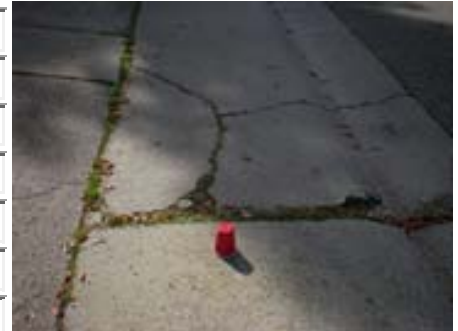
Field Date: 3/11/2011 Report Date: 3/14/2011 Barrier #: 5984B
 Location: Sun Terrace Wy - East
 X Coordinate: -121.25442
 Y Coordinate: 38.70861
 Barrier Area: Sidewalks
 Barrier Type: Surface Condition - Damaged
 Code Ref: CBC 1133B.7.1 and ADA/ABA 302.1

As Built Meas: 4 Quantity: LF
 Description: Surface is not firm and stable (cracked, broken or loose soil, etc.)
 As Built Desc: Cracked concrete
 Solution: Repair surface to make firm and stable
 Bar. Severity: 1 Necessary Cost Estimate: \$500.00 Status:
 Implementation Priority: 4 Facility Function:
 Implementation Phase: Implementation Date:
 Official Responsible:

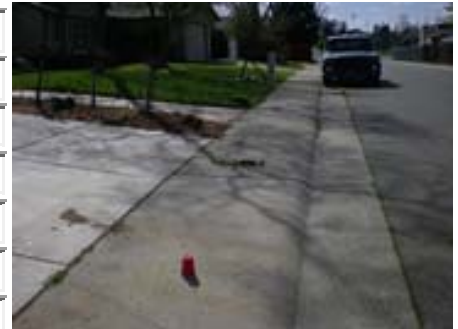
Field Date: 3/11/2011 Report Date: 3/14/2011 Barrier #: 5985
 Location: Sun Terrace Wy - East
 X Coordinate: -121.25444
 Y Coordinate: 38.70667
 Barrier Area: Sidewalks
 Barrier Type: Cross Slope - Existing (3.1% to 4.0%)
 Code Ref: CBC 1133B.7.1.3 and ADA/ABA 403.3

As Built Meas: 446 Quantity: LF
 Description: Cross slope exceeds 2.0% (3.1% to 4.0%)
 As Built Desc: 3.7% cross slope
 Solution: Demolish existing and construct new route
 Bar. Severity: 3 Hinderance Cost Estimate: \$55,750.00 Status:
 Implementation Priority: 4 Facility Function:
 Implementation Phase: Implementation Date:
 Official Responsible:

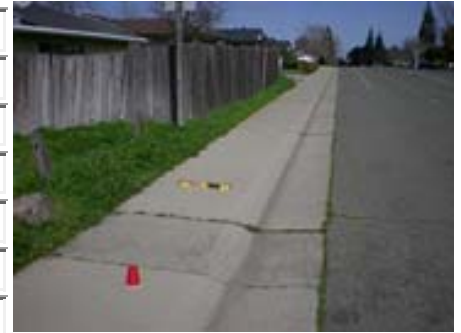
Field Date: 3/11/2011 Report Date: 3/14/2011 Barrier #: 5986
 Location: Wintergreen Dr - West
 X Coordinate: -121.25371
 Y Coordinate: 38.70598
 Barrier Area: Sidewalks
 Barrier Type: Cross Slope - Existing (3.1% to 4.0%)
 Code Ref: CBC 1133B.7.1.3 and ADA/ABA 403.3

As Built Meas: 635 Quantity: LF
 Description: Cross slope exceeds 2.0% (3.1% to 4.0%)
 As Built Desc: 3.6% cross slope
 Solution: Demolish existing and construct new route
 Bar. Severity: 3 Hinderance Cost Estimate: \$79,375.00 Status:
 Implementation Priority: 3 Facility Function:
 Implementation Phase: Implementation Date:
 Official Responsible:

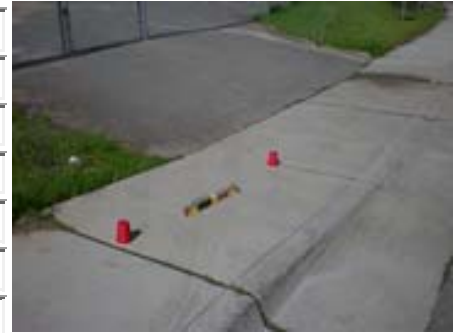
Field Date: 3/11/2011 Report Date: 3/14/2011 Barrier #: 5988
 Location: Wintergreen Dr - West
 X Coordinate: -121.25385
 Y Coordinate: 38.71089
 Barrier Area: Sidewalks
 Barrier Type: Driveway - Running Slope in New Construction
 Code Ref: CBC 1133B.7.1.3 and ADA/ABA 403.3

As Built Meas: 7 Quantity: LF
 Description: Transition ramp into driveway not compliant (slope exceeds 8.3%)
 As Built Desc: 8.8% running slope
 Solution: Demolish existing and construct new transition ramp
 Bar. Severity: 1 Necessary Cost Estimate: \$875.00 Status:
 Implementation Priority: 3 Facility Function:
 Implementation Phase: Implementation Date:
 Official Responsible:

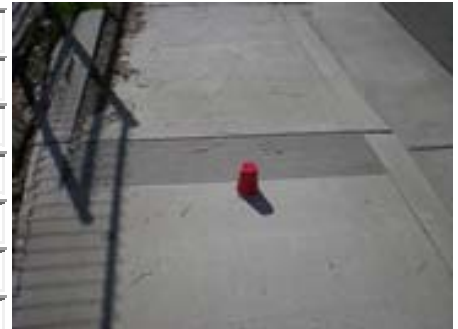
Field Date: 3/11/2011 Report Date: 3/14/2011 Barrier #: 5989
 Location: Wintergreen Dr - East
 X Coordinate: -121.25359
 Y Coordinate: 38.71044
 Barrier Area: Sidewalks
 Barrier Type: Driveway -12" Grooves Incorrect Application
 Code Ref: CBC 1127B.5.6

As Built Meas: 1 Quantity: JOB
 Description: 12" grooves required only at curb ramps identified at transition into driveway
 As Built Desc: 12" grooves incorrectly provided where no curb ramp exists
 Solution: No remediation recommended, until new construction is performed in area
 Bar. Severity: 4 Low Severity Cost Estimate: \$0.00 Status:
 Implementation Priority: 3 Facility Function:
 Implementation Phase: Implementation Date:
 Official Responsible:

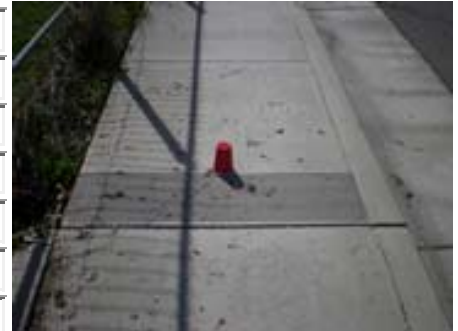
Field Date: 3/11/2011 Report Date: 3/14/2011 Barrier #: 5990
 Location: Wintergreen Dr - East
 X Coordinate: -121.2536
 Y Coordinate: 38.7103
 Barrier Area: Sidewalks
 Barrier Type: Driveway -12" Grooves Incorrect Application
 Code Ref: CBC 1127B.5.6

As Built Meas: 1 Quantity: JOB
 Description: 12" grooves required only at curb ramps identified at transition into driveway
 As Built Desc: 12" grooves incorrectly provided where no curb ramp exists
 Solution: No remediation recommended, until new construction is performed in area
 Bar. Severity: 4 Low Severity Cost Estimate: \$0.00 Status:
 Implementation Priority: 3 Facility Function:
 Implementation Phase: Implementation Date:
 Official Responsible:

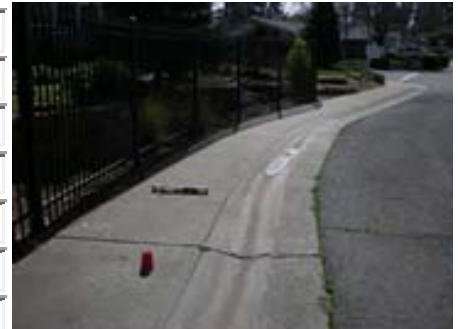
Field Date: 3/11/2011 Report Date: 3/14/2011 Barrier #: 5991
 Location: Wintergreen Dr - East
 X Coordinate: -121.25359
 Y Coordinate: 38.70989
 Barrier Area: Sidewalks
 Barrier Type: Cross Slope - Existing (3.1% to 4.0%)
 Code Ref: CBC 1133B.7.1.3 and ADA/ABA 403.3

As Built Meas: 85 Quantity: LF
 Description: Cross slope exceeds 2.0% (3.1% to 4.0%)
 As Built Desc: 3.6% cross slope
 Solution: Demolish existing and construct new route
 Bar. Severity: 3 Hinderance Cost Estimate: \$10,625.00 Status:
 Implementation Priority: 3 Facility Function:
 Implementation Phase: Implementation Date:
 Official Responsible:

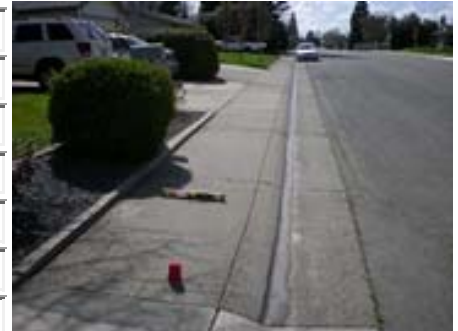
Field Date: 3/11/2011 Report Date: 3/14/2011 Barrier #: 5992
 Location: Wintergreen Dr - East
 X Coordinate: -121.25356
 Y Coordinate: 38.70945
 Barrier Area: Sidewalks
 Barrier Type: Cross Slope - Existing (5.0% or more)
 Code Ref: CBC 1133B.7.1.3 and ADA/ABA 403.3

As Built Meas: 420 Quantity: LF
 Description: Cross slope exceeds 2.0% (5.0% or more)
 As Built Desc: 5.1% cross slope
 Solution: Demolish existing and construct new route
 Bar. Severity: 1 Necessary Cost Estimate: \$52,500.00 Status:
 Implementation Priority: 3 Facility Function:
 Implementation Phase: Implementation Date:
 Official Responsible:

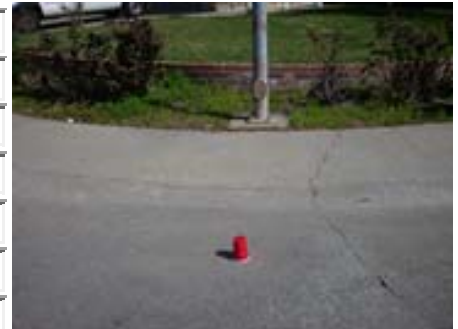
Field Date: 3/11/2011 Report Date: 3/14/2011 Barrier #: 5993
 Location: Wintergreen Dr and Berman Wy - Corner B
 X Coordinate: -121.25353
 Y Coordinate: 38.70824
 Barrier Area: Curb Ramps
 Barrier Type: No Curb Ramp - Depressed Existing Curb
 Code Ref: CBC 1127B.5.1 and ADA/ABA 402.2

As Built Meas: 1 Quantity: EACH
 Description: No compliant curb cut at corner (intersection)
 As Built Desc: 11.5% running slope at depressed area
 Solution: Demolish existing and construct curb cut
 Bar. Severity: 1 Necessary Cost Estimate: \$2,500.00 Status:
 Implementation Priority: 3 Facility Function:
 Implementation Phase: Implementation Date:
 Official Responsible:

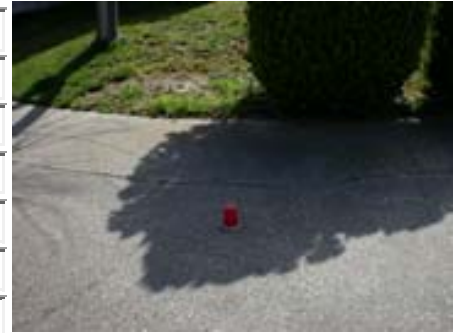
Field Date: 3/11/2011 Report Date: 3/14/2011 Barrier #: 5994
 Location: Wintergreen Dr and Berman Wy - Corner C
 X Coordinate: -121.25354
 Y Coordinate: 38.70812
 Barrier Area: Curb Ramps
 Barrier Type: No Curb Ramp - Depressed Existing Curb
 Code Ref: CBC 1127B.5.1 and ADA/ABA 402.2

As Built Meas: 1 Quantity: EACH
 Description: No compliant curb cut at corner (intersection)
 As Built Desc: 10.4% running slope at depressed area
 Solution: Demolish existing and construct curb cut
 Bar. Severity: 1 Necessary Cost Estimate: \$2,500.00 Status:
 Implementation Priority: 3 Facility Function:
 Implementation Phase: Implementation Date:
 Official Responsible:

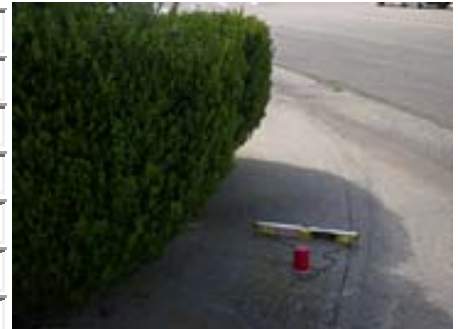
Field Date: 3/11/2011 Report Date: 3/14/2011 Barrier #: 5995
 Location: Wintergreen Dr - East
 X Coordinate: -121.25353
 Y Coordinate: 38.70812
 Barrier Area: Sidewalks
 Barrier Type: Clear Width - Existing ($\leq 31''$ or less)
 Code Ref: CBC 1133B.7.1

As Built Meas: 16 Quantity: LF
 Description: Pedestrian route is not min. 48" wide ($\leq 31''$ or less)
 As Built Desc: 24" clear width
 Solution: Demolish existing and construct new route
 Bar. Severity: 1 Necessary Cost Estimate: \$2,000.00 Status:
 Implementation Priority: 3 Facility Function:
 Implementation Phase: Implementation Date:
 Official Responsible:

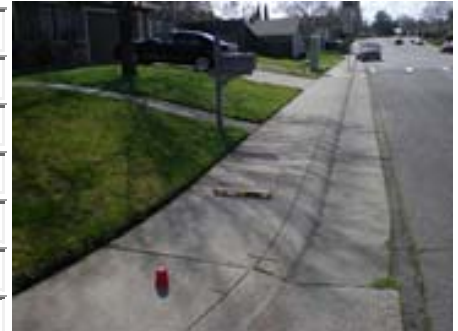
Field Date: 3/11/2011 Report Date: 3/14/2011 Barrier #: 5996A
 Location: Wintergreen Dr - East
 X Coordinate: -121.25355
 Y Coordinate: 38.70808
 Barrier Area: Sidewalks
 Barrier Type: Cross Slope - Existing (4.1% to 4.9%)
 Code Ref: CBC 1133B.7.1.3 and ADA/ABA 403.3

As Built Meas: 220 Quantity: LF
 Description: Cross slope exceeds 2.0% (4.1% to 4.9%)
 As Built Desc: 4.9% cross slope
 Solution: Demolish existing and construct new route
 Bar. Severity: 2 Recommended Cost Estimate: \$27,500.00 Status:
 Implementation Priority: 3 Facility Function:
 Implementation Phase: Implementation Date:
 Official Responsible:

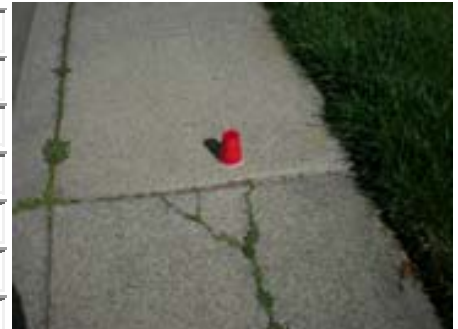
Field Date: 3/11/2011 Report Date: 3/14/2011 Barrier #: 5996B
 Location: Wintergreen Dr - East
 X Coordinate: -121.25356
 Y Coordinate: 38.70767
 Barrier Area: Sidewalks
 Barrier Type: Abrupt Change in Level - > 1/2"
 Code Ref: CBC 1133B.7.1 and ADA/ABA 303.3

As Built Meas: 4 Quantity: LF
 Description: Change in level greater than 1/2"
 As Built Desc: 1/2" lip in sidewalk surface
 Solution: Grind or repair sidewalk to remove trip hazard
 Bar. Severity: 1 Necessary Cost Estimate: \$1,000.00 Status:
 Implementation Priority: 3 Facility Function:
 Implementation Phase: Implementation Date:
 Official Responsible:

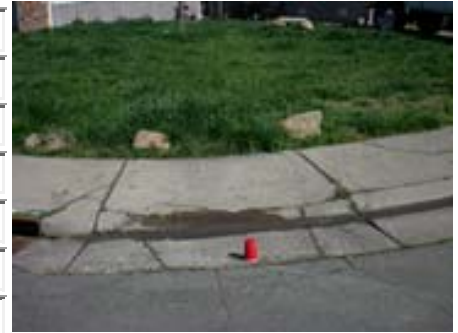
Field Date: 3/11/2011 Report Date: 3/14/2011 Barrier #: 5997
 Location: Wintergreen Dr and Keyesport Wy - Corner B
 X Coordinate: -121.25352
 Y Coordinate: 38.70747
 Barrier Area: Curb Ramps
 Barrier Type: No Curb Ramp - Depressed Existing Curb
 Code Ref: CBC 1127B.5.1 and ADA/ABA 402.2

As Built Meas: 1 Quantity: EACH
 Description: No compliant curb cut at corner (intersection)
 As Built Desc: 10.6% running slope at depressed area
 Solution: Demolish existing and construct curb cut
 Bar. Severity: 1 Necessary Cost Estimate: \$2,500.00 Status:
 Implementation Priority: 3 Facility Function:
 Implementation Phase: Implementation Date:
 Official Responsible:

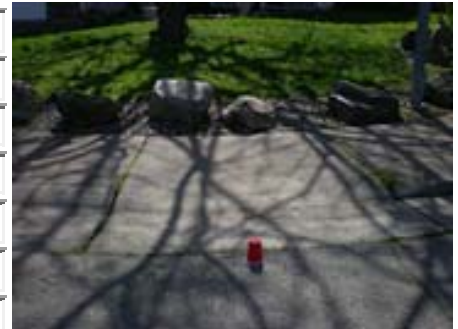
Field Date: 3/11/2011 Report Date: 3/14/2011 Barrier #: 5998
 Location: Wintergreen Dr and Keyesport Wy - Corner C
 X Coordinate: -121.25352
 Y Coordinate: 38.70739
 Barrier Area: Curb Ramps
 Barrier Type: No Curb Ramp - Depressed Existing Curb
 Code Ref: CBC 1127B.5.1 and ADA/ABA 402.2

As Built Meas: 1 Quantity: EACH
 Description: No compliant curb cut at corner (intersection)
 As Built Desc: 6.2% running slope at depressed area
 Solution: Demolish existing and construct curb cut
 Bar. Severity: 1 Necessary Cost Estimate: \$2,500.00 Status:
 Implementation Priority: 3 Facility Function:
 Implementation Phase: Implementation Date:
 Official Responsible:

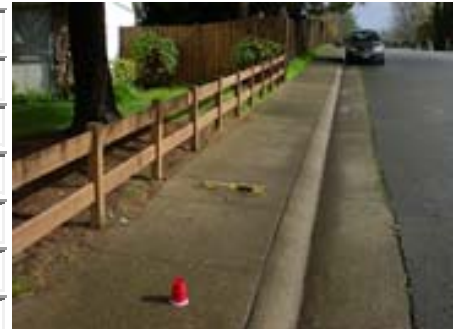
Field Date: 3/14/2011 Report Date: 3/16/2011 Barrier #: 6000
 Location: Claypool Wy - West
 X Coordinate: -121.25254
 Y Coordinate: 38.70577
 Barrier Area: Sidewalks
 Barrier Type: Cross Slope - Existing (3.1% to 4.0%)
 Code Ref: CBC 1133B.7.1.3 and ADA/ABA 403.3

As Built Meas: 108 Quantity: LF
 Description: Cross slope exceeds 2.0% (3.1% to 4.0%)
 As Built Desc: 3.3% cross slope
 Solution: Demolish existing and construct new route
 Bar. Severity: 3 Hinderance Cost Estimate: \$13,500.00 Status:
 Implementation Priority: 3 Facility Function:
 Implementation Phase: Implementation Date:
 Official Responsible:

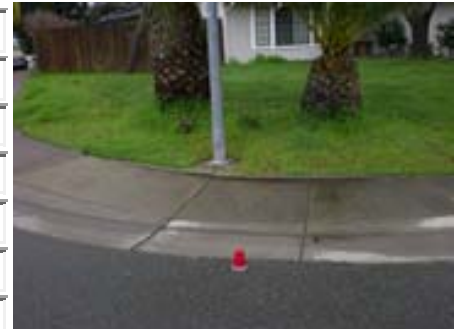
Field Date: 3/14/2011 Report Date: 3/16/2011 Barrier #: 6002A
 Location: Claypool Wy and Elgin Ct - Corner D
 X Coordinate: -121.25208
 Y Coordinate: 38.70621
 Barrier Area: Curb Ramps
 Barrier Type: Cross Slope - Existing (3.1% to 4.0%)
 Code Ref: CBC 1127B.5.3 and ADA/ABA 406.2

As Built Meas: 1 Quantity: EACH
 Description: Ramp run cross slope exceeds 2.0% (3.1% to 4.0%)
 As Built Desc: 3.4% cross slope
 Solution: Demolish existing and construct new curb ramp
 Bar. Severity: 3 Hindrance Cost Estimate: \$2,500.00 Status:
 Implementation Priority: 3 Facility Function:
 Implementation Phase: Implementation Date:
 Official Responsible:

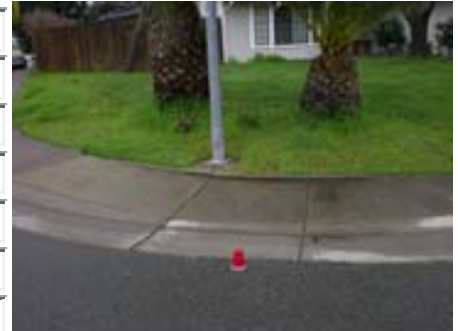
Field Date: 3/14/2011 Report Date: 3/16/2011 Barrier #: 6002B
 Location: Claypool Wy and Elgin Ct - Corner D
 X Coordinate: -121.25208
 Y Coordinate: 38.70621
 Barrier Area: Curb Ramps
 Barrier Type: Detectable Warnings - Truncated Domes
 Code Ref: CBC 1127B.5.7 and ADA/ABA 705.1.3

As Built Meas: 1 Quantity: EACH
 Description: No truncated domes provided at curb ramp
 As Built Desc: No detectable warnings at curb ramp
 Solution: Provide compliant truncated domes
 Bar. Severity: 2 Recommended Cost Estimate: \$1,400.00 Status:
 Implementation Priority: 3 Facility Function:
 Implementation Phase: Implementation Date:
 Official Responsible:

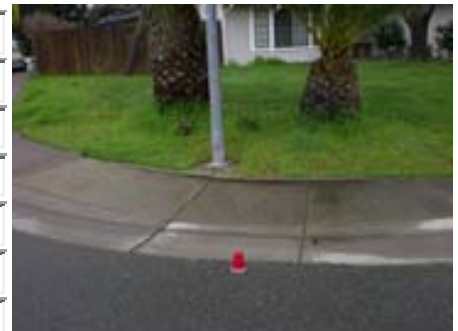
Field Date: 3/14/2011 Report Date: 3/16/2011 Barrier #: 6002C
 Location: Claypool Wy and Elgin Ct - Corner D
 X Coordinate: -121.25208
 Y Coordinate: 38.70621
 Barrier Area: Curb Ramps
 Barrier Type: Cross Slope - Existing (3.1% to 4.0%)
 Code Ref: CBC 1127B.5.3 and ADA/ABA 406.2

As Built Meas: 1 Quantity: EACH
 Description: Ramp run cross slope exceeds 2.0% (3.1% to 4.0%)
 As Built Desc: 3.6% cross slope
 Solution: Demolish existing and construct new curb ramp
 Bar. Severity: 3 Hindrance Cost Estimate: \$2,500.00 Status:
 Implementation Priority: 3 Facility Function:
 Implementation Phase: Implementation Date:
 Official Responsible:

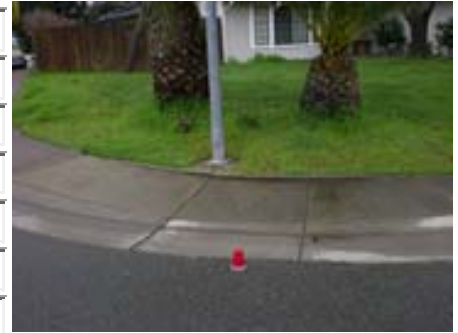
Field Date: 3/14/2011 Report Date: 3/16/2011 Barrier #: 6002D
 Location: Claypool Wy and Elgin Ct - Corner D
 X Coordinate: -121.25208
 Y Coordinate: 38.70621
 Barrier Area: Curb Ramps
 Barrier Type: 12" Grooves - Existing (>5.0%)
 Code Ref: CBC 1127B.5.6

As Built Meas: 1 Quantity: EACH
 Description: 12" grooves at top of curb ramp are not level (>5.0%)
 As Built Desc: 5.4% at 12" grooves
 Solution: Demolish existing and construct new curb ramp
 Bar. Severity: 1 Necessary Cost Estimate: \$2,500.00 Status:
 Implementation Priority: 3 Facility Function:
 Implementation Phase: Implementation Date:
 Official Responsible:

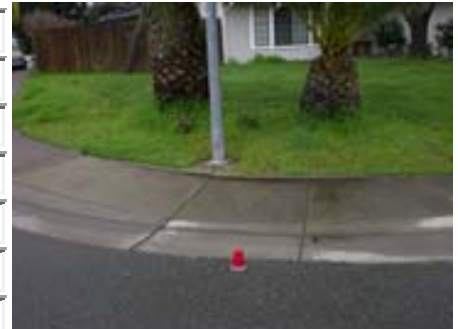
Field Date: 3/14/2011 Report Date: 3/16/2011 Barrier #: 6002E
 Location: Claypool Wy and Elgin Ct - Corner D
 X Coordinate: -121.25208
 Y Coordinate: 38.70621
 Barrier Area: Curb Ramps
 Barrier Type: Gutter Slope - Existing (5.9% - 6.5%)
 Code Ref: CBC 1127B.5.3 and ADA/ABA 406.2

As Built Meas: 6 Quantity: SF
 Description: Gutter slope exceeds 5.0% (5.9% - 6.5%)
 As Built Desc: 6.4% gutter slope
 Solution: Demolish existing and construct new gutter
 Bar. Severity: 3 Hindrance Cost Estimate: \$750.00 Status:
 Implementation Priority: 3 Facility Function:
 Implementation Phase: Implementation Date:
 Official Responsible:

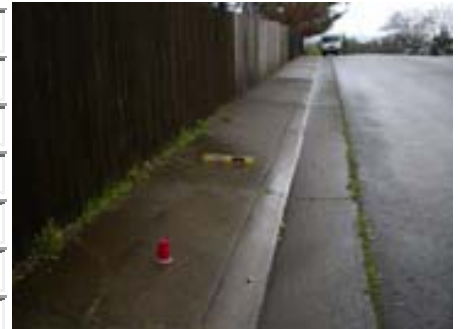
Field Date: 3/14/2011 Report Date: 3/16/2011 Barrier #: 6004
 Location: Claypool Wy - West
 X Coordinate: -121.25185
 Y Coordinate: 38.70638
 Barrier Area: Sidewalks
 Barrier Type: Cross Slope - Existing (3.1% to 4.0%)
 Code Ref: CBC 1133B.7.1.3 and ADA/ABA 403.3

As Built Meas: 190 Quantity: LF
 Description: Cross slope exceeds 2.0% (3.1% to 4.0%)
 As Built Desc: 3.8% cross slope
 Solution: Demolish existing and construct new route
 Bar. Severity: 3 Hinderance Cost Estimate: \$23,750.00 Status:
 Implementation Priority: 3 Facility Function:
 Implementation Phase: Implementation Date:
 Official Responsible:

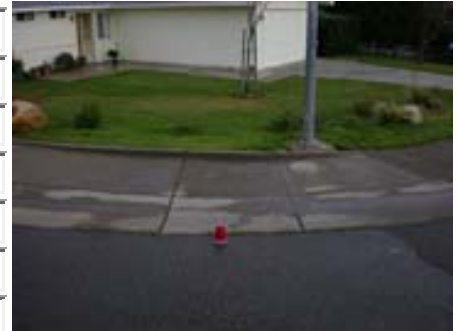
Field Date: 3/14/2011 Report Date: 3/16/2011 Barrier #: 6005A
 Location: Claypool Wy and Keyesport Wy - Corner A
 X Coordinate: -121.25134
 Y Coordinate: 38.70687
 Barrier Area: Curb Ramps
 Barrier Type: 12" Grooves - Existing (3.1% to 4.0%)
 Code Ref: CBC 1127B.5.6

As Built Meas: 1 Quantity: EACH
 Description: 12" grooves at top of curb ramp are not level (3.1% to 4.0%)
 As Built Desc: 3.5% at 12" grooves
 Solution: Demolish existing and construct new curb ramp
 Bar. Severity: 3 Hindrance Cost Estimate: \$2,500.00 Status:
 Implementation Priority: 3 Facility Function:
 Implementation Phase: Implementation Date:
 Official Responsible:

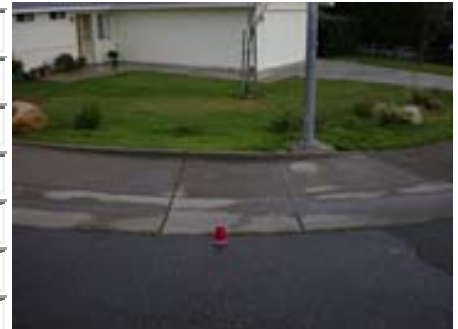
Field Date: 3/14/2011 Report Date: 3/16/2011 Barrier #: 6005B
 Location: Claypool Wy and Keyesport Wy - Corner A
 X Coordinate: -121.25134
 Y Coordinate: 38.70687
 Barrier Area: Curb Ramps
 Barrier Type: Perpendicular Ramp Landing (>5.0% or more)
 Code Ref: CBC 1127B.5.4 and ADA/ABA 406.4

As Built Meas: 1 Quantity: EACH
 Description: Curb ramp top landing not level (>5.0% or more)
 As Built Desc: 5.0% landing slope
 Solution: Demolish existing and construct new transition
 Bar. Severity: 1 Necessary Cost Estimate: \$250.00 Status:
 Implementation Priority: 3 Facility Function:
 Implementation Phase: Implementation Date:
 Official Responsible:

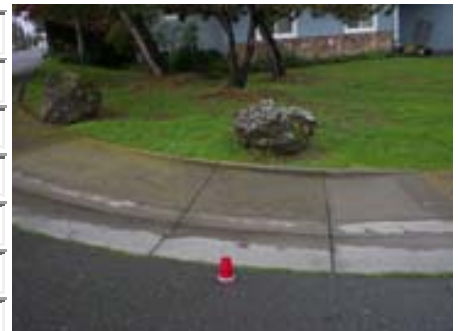
Field Date: 3/14/2011 Report Date: 3/16/2011 Barrier #: 6006A
 Location: Claypool Wy and Keyesport Wy - Corner D
 X Coordinate: -121.25142
 Y Coordinate: 38.7068
 Barrier Area: Curb Ramps
 Barrier Type: 12" Grooves - Existing (>5.0%)
 Code Ref: CBC 1127B.5.6

As Built Meas: 1 Quantity: EACH
 Description: 12" grooves at top of curb ramp are not level (>5.0%)
 As Built Desc: 7.7% at 12" grooves
 Solution: Demolish existing and construct new curb ramp
 Bar. Severity: 1 Necessary Cost Estimate: \$2,500.00 Status:
 Implementation Priority: 3 Facility Function:
 Implementation Phase: Implementation Date:
 Official Responsible:

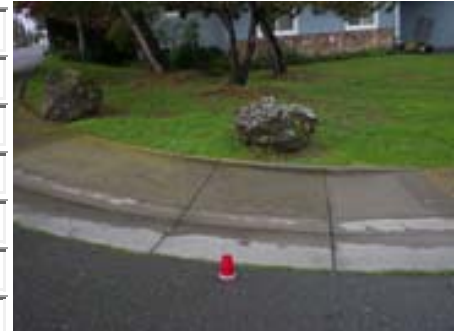
Field Date: 3/14/2011 Report Date: 3/16/2011 Barrier #: 6006B
 Location: Claypool Wy and Keyesport Wy - Corner D
 X Coordinate: -121.25142
 Y Coordinate: 38.7068
 Barrier Area: Curb Ramps
 Barrier Type: Running Slope - Existing (9.5% or more)
 Code Ref: CBC 1127B.5.3 and ADA/ABA 406.1

As Built Meas: 1 Quantity: EACH
 Description: Ramp run cross slope exceeds 2.0% (9.5% or more)
 As Built Desc: 9.8% running slope
 Solution: Demolish existing and construct new curb ramp
 Bar. Severity: 1 Necessary Cost Estimate: \$2,500.00 Status:
 Implementation Priority: 3 Facility Function:
 Implementation Phase: Implementation Date:
 Official Responsible:

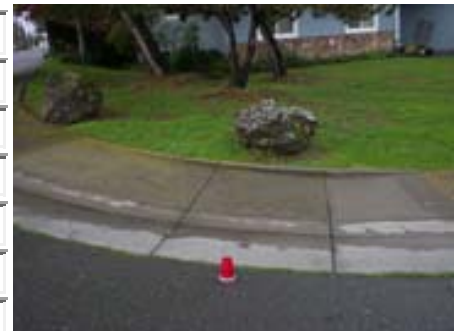
Field Date: 3/14/2011 Report Date: 3/16/2011 Barrier #: 6006C
 Location: Claypool Wy and Keyesport Wy - Corner D
 X Coordinate: -121.25142
 Y Coordinate: 38.7068
 Barrier Area: Curb Ramps
 Barrier Type: Perpendicular Ramp Landing (>5.0% or more)
 Code Ref: CBC 1127B.5.4 and ADA/ABA 406.4

As Built Meas: 1 Quantity: EACH
 Description: Curb ramp top landing not level (>5.0% or more)
 As Built Desc: 7.3% landing slope
 Solution: Demolish existing and construct new transition
 Bar. Severity: 1 Necessary Cost Estimate: \$250.00 Status:
 Implementation Priority: 3 Facility Function:
 Implementation Phase: Implementation Date:
 Official Responsible:

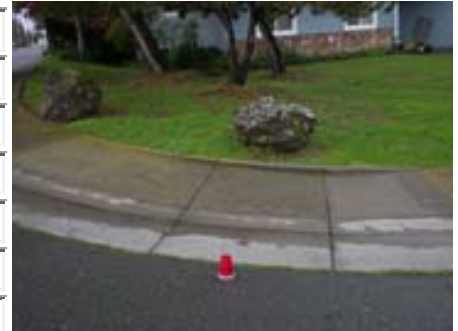
Field Date: 3/14/2011 Report Date: 3/16/2011 Barrier #: 6006D
 Location: Claypool Wy and Keyesport Wy - Corner D
 X Coordinate: -121.25142
 Y Coordinate: 38.7068
 Barrier Area: Curb Ramps
 Barrier Type: Detectable Warnings - Truncated Domes
 Code Ref: CBC 1127B.5.7 and ADA/ABA 705.1.3

As Built Meas: 1 Quantity: EACH
 Description: No truncated domes provided at curb ramp
 As Built Desc: No detectable warnings at curb ramp
 Solution: Provide compliant truncated domes
 Bar. Severity: 2 Recommended Cost Estimate: \$1,400.00 Status:
 Implementation Priority: 3 Facility Function:
 Implementation Phase: Implementation Date:
 Official Responsible:

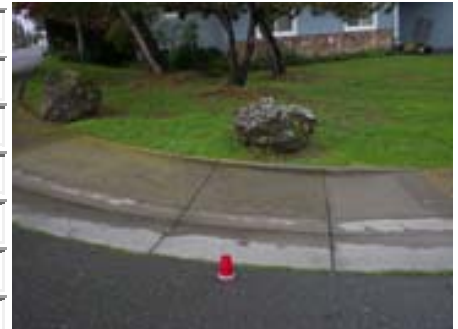
Field Date: 3/14/2011 Report Date: 3/16/2011 Barrier #: 6006E
 Location: Claypool Wy and Keyesport Wy - Corner D
 X Coordinate: -121.25142
 Y Coordinate: 38.7068
 Barrier Area: Curb Ramps
 Barrier Type: Gutter Slope - Existing (6.6% to 8.2%)
 Code Ref: CBC 1127B.5.3 and ADA/ABA 406.2

As Built Meas: 6 Quantity: SF
 Description: Gutter slope exceeds 5.0% (6.6% to 8.2%)
 As Built Desc: 7.2% gutter slope
 Solution: Demolish existing and construct new gutter
 Bar. Severity: 2 Recommended Cost Estimate: \$750.00 Status:
 Implementation Priority: 3 Facility Function:
 Implementation Phase: Implementation Date:
 Official Responsible:

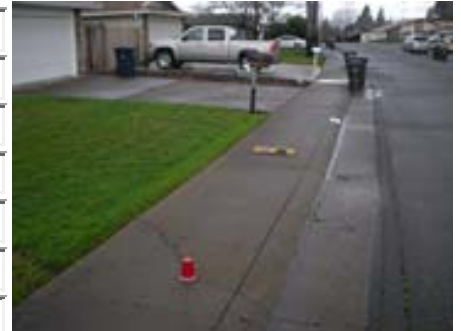
Barrier Type: Cross Slope - Existing (3.1% to 4.0%)

As Built Meas: 542 Quantity: LF

Description: Cross slope exceeds 2.0% (3.1% to 4.0%)

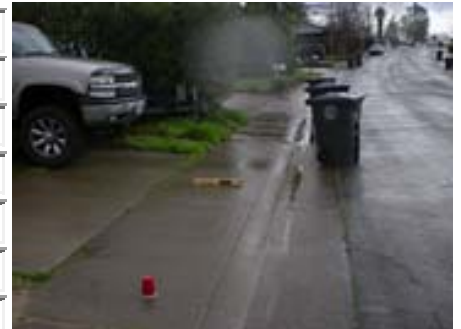
Barrier Type: Cross Slope - Existing (3.1% to 4.0%)

As Built Meas: 320 Quantity: LF

Description: Cross slope exceeds 2.0% (3.1% to 4.0%)

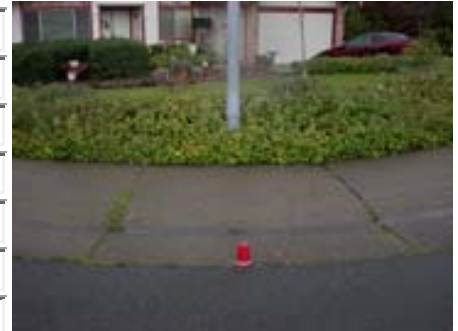
Field Date: 3/14/2011 Report Date: 3/16/2011 Barrier #: 6009
 Location: Keyesport Wy and Keyesport Wy Ct - Corner A
 X Coordinate: -121.25223
 Y Coordinate: 38.70732
 Barrier Area: Curb Ramps
 Barrier Type: No Curb Ramp - Depressed Existing Curb
 Code Ref: CBC 1127B.5.1 and ADA/ABA 402.2

As Built Meas: 6 Quantity: EACH
 Description: No compliant curb cut at corner (intersection)
 As Built Desc: 12.2% running slope at depressed area
 Solution: Demolish existing and construct curb cut
 Bar. Severity: 1 Necessary Cost Estimate: \$15,000.00 Status:
 Implementation Priority: 4 Facility Function:
 Implementation Phase: Implementation Date:
 Official Responsible:

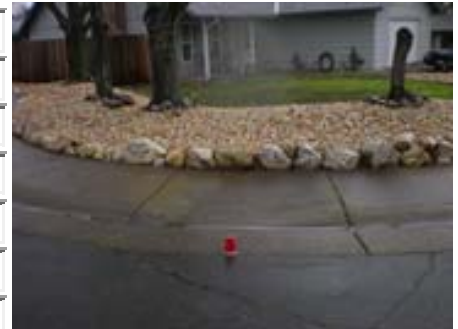
Field Date: 3/14/2011 Report Date: 3/16/2011 Barrier #: 6010
 Location: Keyesport Wy and Keyesport Wy Ct - Corner B
 X Coordinate: -121.25204
 Y Coordinate: 38.70725
 Barrier Area: Curb Ramps
 Barrier Type: No Curb Ramp - Depressed Existing Curb
 Code Ref: CBC 1127B.5.1 and ADA/ABA 402.2

As Built Meas: 6 Quantity: EACH
 Description: No compliant curb cut at corner (intersection)
 As Built Desc: 10.0% running slope at depressed area
 Solution: Demolish existing and construct curb cut
 Bar. Severity: 1 Necessary Cost Estimate: \$15,000.00 Status:
 Implementation Priority: 4 Facility Function:
 Implementation Phase: Implementation Date:
 Official Responsible:

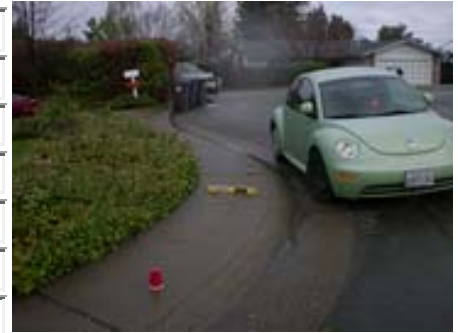
Field Date: 3/14/2011 Report Date: 3/16/2011 Barrier #: 6011A
 Location: Keyesport Wy Ct - West
 X Coordinate: -121.2522
 Y Coordinate: 38.70732
 Barrier Area: Sidewalks
 Barrier Type: Cross Slope - Existing (5.0% or more)
 Code Ref: CBC 1133B.7.1.3 and ADA/ABA 403.3

As Built Meas: 115 Quantity: LF
 Description: Cross slope exceeds 2.0% (5.0% or more)
 As Built Desc: 5.5% cross slope
 Solution: Demolish existing and construct new route
 Bar. Severity: 1 Necessary Cost Estimate: \$14,375.00 Status:
 Implementation Priority: 4 Facility Function:
 Implementation Phase: Implementation Date:
 Official Responsible:

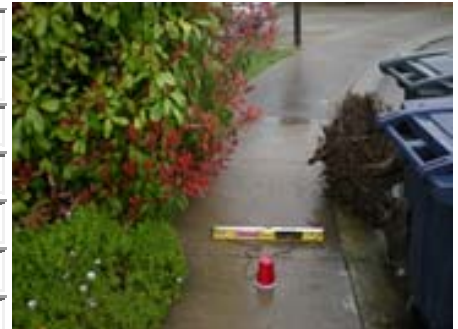
Field Date: 3/14/2011 Report Date: 3/16/2011 Barrier #: 6011B
 Location: Keyesport Wy Ct - West
 X Coordinate: -121.25218
 Y Coordinate: 38.70743
 Barrier Area: Sidewalks
 Barrier Type: Clear Width - Existing ($\leq 31''$ or less)
 Code Ref: CBC 1133B.7.1

As Built Meas: 1 Quantity: LF
 Description: Pedestrian route is not min. 48" wide ($\leq 31''$ or less)
 As Built Desc: 24" clear width due to foliage
 Solution: Trim foliage to provide min. 48" clear width
 Bar. Severity: 1 Necessary Cost Estimate: \$125.00 Status:
 Implementation Priority: 4 Facility Function:
 Implementation Phase: Implementation Date:
 Official Responsible:

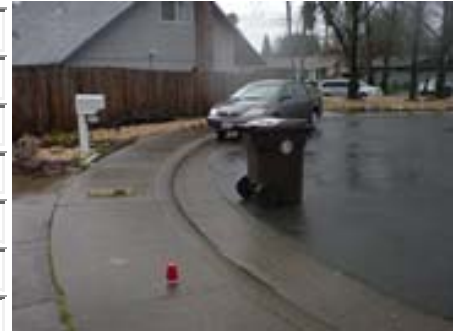
Barrier Type: Cross Slope - Existing (3.1% to 4.0%)

As Built Meas: 100 Quantity: LF

Description: Cross slope exceeds 2.0% (3.1% to 4.0%)

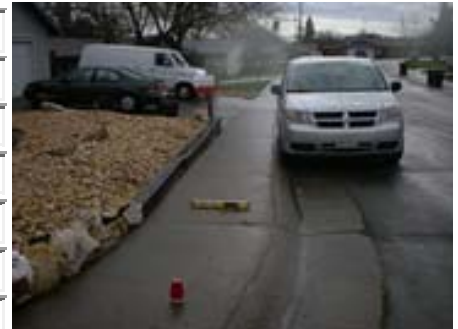
Barrier Type: Cross Slope - Existing (3.1% to 4.0%)

As Built Meas: 212 Quantity: LF

Description: Cross slope exceeds 2.0% (3.1% to 4.0%)

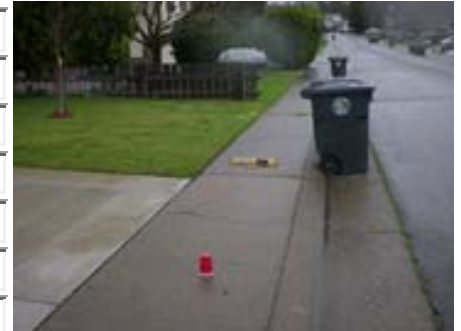
Field Date: 3/14/2011 Report Date: 3/16/2011 Barrier #: 6014A
 Location: Claypool Wy - West
 X Coordinate: -121.25116
 Y Coordinate: 38.70696
 Barrier Area: Sidewalks
 Barrier Type: Cross Slope - Existing (3.1% to 4.0%)
 Code Ref: CBC 1133B.7.1.3 and ADA/ABA 403.3

As Built Meas: 105 Quantity: LF
 Description: Cross slope exceeds 2.0% (3.1% to 4.0%)
 As Built Desc: 3.1% cross slope
 Solution: Demolish existing and construct new route
 Bar. Severity: 3 Hinderance Cost Estimate: \$13,125.00 Status:
 Implementation Priority: 3 Facility Function:
 Implementation Phase: Implementation Date:
 Official Responsible:

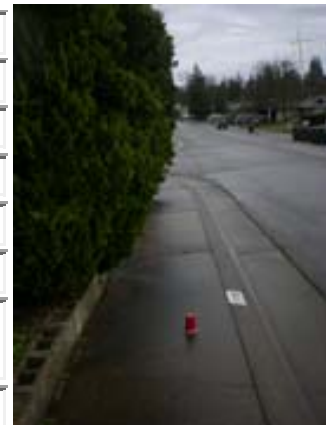
Field Date: 3/14/2011 Report Date: 3/16/2011 Barrier #: 6014B
 Location: Claypool Wy - West
 X Coordinate: -121.25097
 Y Coordinate: 38.70713
 Barrier Area: Sidewalks
 Barrier Type: Clear Width - Existing (44" to 48")
 Code Ref: CBC 1133B.7.1

As Built Meas: 1 Quantity: LF
 Description: Pedestrian route is not min. 48" wide (44" to 48")
 As Built Desc: 48" clear width due to foliage
 Solution: Trim foliage to provide min. 48" clear width
 Bar. Severity: 1 Necessary Cost Estimate: \$125.00 Status:
 Implementation Priority: 3 Facility Function:
 Implementation Phase: Implementation Date:
 Official Responsible:

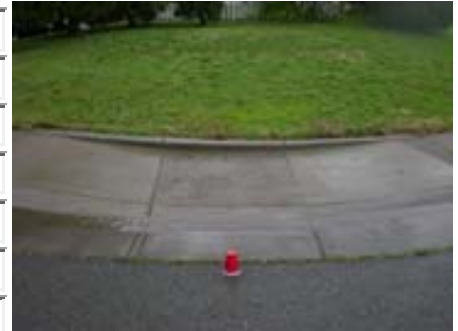
Field Date: 3/14/2011 Report Date: 3/16/2011 Barrier #: 6015A
 Location: Claypool Wy and Claypool Wy Ct - Corner A
 X Coordinate: -121.25076
 Y Coordinate: 38.70736
 Barrier Area: Curb Ramps
 Barrier Type: Detectable Warnings - Truncated Domes
 Code Ref: CBC 1127B.5.7 and ADA/ABA 705.1.3

As Built Meas: 1 Quantity: EACH
 Description: No truncated domes provided at curb ramp
 As Built Desc: No detectable warnings at curb ramp
 Solution: Provide compliant truncated domes
 Bar. Severity: 2 Recommended Cost Estimate: \$1,400.00 Status:
 Implementation Priority: 3 Facility Function:
 Implementation Phase: Implementation Date:
 Official Responsible:

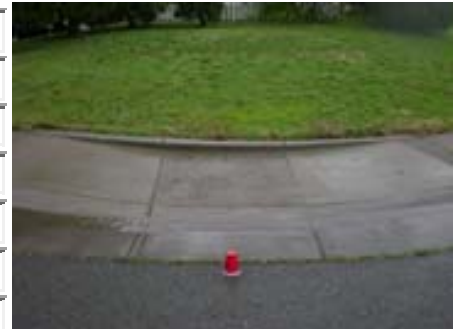
Field Date: 3/14/2011 Report Date: 3/16/2011 Barrier #: 6015B
 Location: Claypool Wy and Claypool Wy Ct - Corner A
 X Coordinate: -121.25076
 Y Coordinate: 38.70736
 Barrier Area: Curb Ramps
 Barrier Type: Gutter Slope - Existing (5.9% - 6.5%)
 Code Ref: CBC 1127B.5.3 and ADA/ABA 406.2

As Built Meas: 6 Quantity: SF
 Description: Gutter slope exceeds 5.0% (5.9% - 6.5%)
 As Built Desc: 6.2% gutter slope
 Solution: Demolish existing and construct new gutter
 Bar. Severity: 3 Hindrance Cost Estimate: \$750.00 Status:
 Implementation Priority: 3 Facility Function:
 Implementation Phase: Implementation Date:
 Official Responsible:

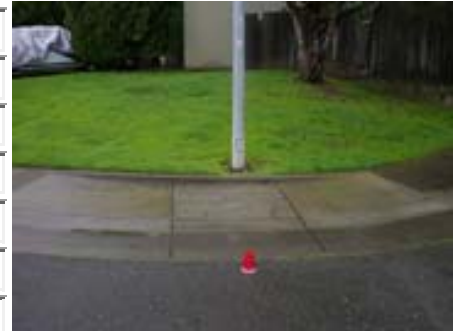
Field Date: 3/14/2011 Report Date: 3/16/2011 Barrier #: 6016A
 Location: Claypool Wy and Claypool Wy Ct - Corner D
 X Coordinate: -121.25083
 Y Coordinate: 38.70725
 Barrier Area: Curb Ramps
 Barrier Type: 12" Grooves - Existing (>5.0%)
 Code Ref: CBC 1127B.5.6

As Built Meas: 1 Quantity: EACH
 Description: 12" grooves at top of curb ramp are not level (>5.0%)
 As Built Desc: 5.7% at 12" grooves
 Solution: Demolish existing and construct new curb ramp
 Bar. Severity: 1 Necessary Cost Estimate: \$2,500.00 Status:
 Implementation Priority: 3 Facility Function:
 Implementation Phase: Implementation Date:
 Official Responsible:

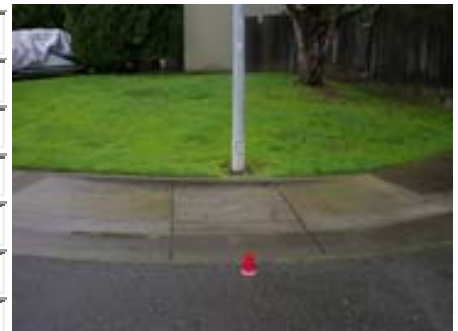
Field Date: 3/14/2011 Report Date: 3/16/2011 Barrier #: 6016B
 Location: Claypool Wy and Claypool Wy Ct - Corner D
 X Coordinate: -121.25083
 Y Coordinate: 38.70725
 Barrier Area: Curb Ramps
 Barrier Type: Detectable Warnings - Truncated Domes
 Code Ref: CBC 1127B.5.7 and ADA/ABA 705.1.3

As Built Meas: 1 Quantity: EACH
 Description: No truncated domes provided at curb ramp
 As Built Desc: No detectable warnings at curb ramp
 Solution: Provide compliant truncated domes
 Bar. Severity: 2 Recommended Cost Estimate: \$1,400.00 Status:
 Implementation Priority: 3 Facility Function:
 Implementation Phase: Implementation Date:
 Official Responsible:

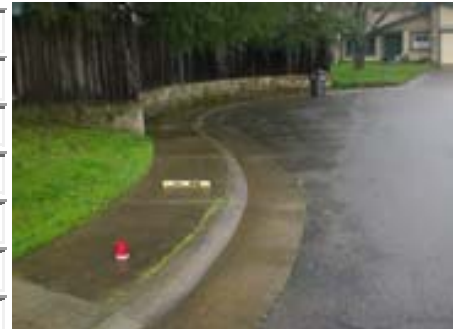
Field Date: 3/14/2011 Report Date: 3/16/2011 Barrier #: 6017
 Location: Claypool Wy Ct - South
 X Coordinate: -121.25085
 Y Coordinate: 38.70728
 Barrier Area: Sidewalks
 Barrier Type: Cross Slope - Existing (3.1% to 4.0%)
 Code Ref: CBC 1133B.7.1.3 and ADA/ABA 403.3

As Built Meas: 83 Quantity: LF
 Description: Cross slope exceeds 2.0% (3.1% to 4.0%)
 As Built Desc: 3.8% cross slope
 Solution: Demolish existing and construct new route
 Bar. Severity: 3 Hinderance Cost Estimate: \$10,375.00 Status:
 Implementation Priority: 3 Facility Function:
 Implementation Phase: Implementation Date:
 Official Responsible:

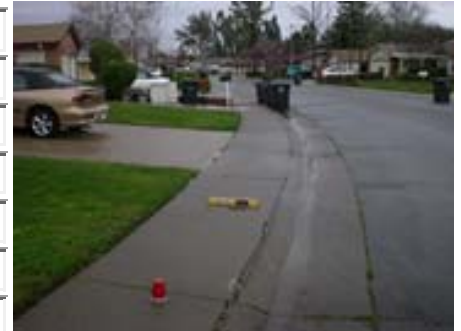
Field Date: 3/14/2011 Report Date: 3/16/2011 Barrier #: 6020A
 Location: Claypool Wy - South
 X Coordinate: -121.24985
 Y Coordinate: 38.70825
 Barrier Area: Sidewalks
 Barrier Type: Cross Slope - Existing (5.0% or more)
 Code Ref: CBC 1133B.7.1.3 and ADA/ABA 403.3

As Built Meas: 820 Quantity: LF
 Description: Cross slope exceeds 2.0% (5.0% or more)
 As Built Desc: 5.1% cross slope
 Solution: Demolish existing and construct new route
 Bar. Severity: 1 Necessary Cost Estimate: \$102,500.00 Status:
 Implementation Priority: 3 Facility Function:
 Implementation Phase: Implementation Date:
 Official Responsible:

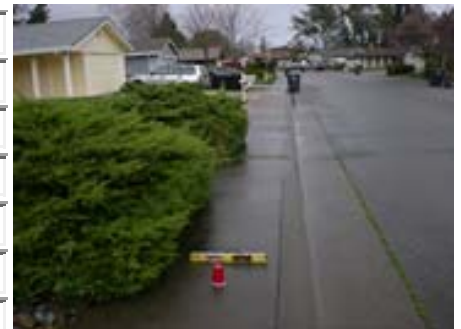
Field Date: 3/14/2011 Report Date: 3/16/2011 Barrier #: 6020B
 Location: Claypool Wy - South
 X Coordinate: -121.24992
 Y Coordinate: 38.70855
 Barrier Area: Sidewalks
 Barrier Type: Clear Width - Existing ($\leq 31''$ or less)
 Code Ref: CBC 1133B.7.1

As Built Meas: 1 Quantity: LF
 Description: Pedestrian route is not min. 48" wide ($\leq 31''$ or less)
 As Built Desc: 24" clear width due to foliage
 Solution: Trim foliage to provide min. 48" clear width
 Bar. Severity: 1 Necessary Cost Estimate: \$125.00 Status:
 Implementation Priority: 3 Facility Function:
 Implementation Phase: Implementation Date:
 Official Responsible:

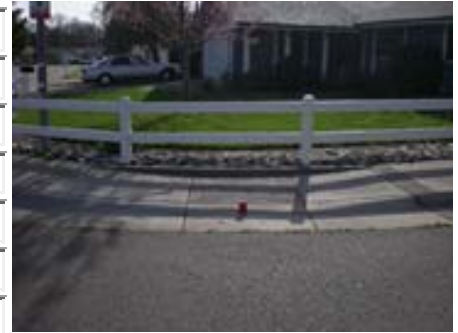
Field Date: 3/17/2011 Report Date: 3/17/2011 Barrier #: 6021A
 Location: Claypool Wy and Collegiality Wy - Corner C
 X Coordinate: -121.25161
 Y Coordinate: 38.70945
 Barrier Area: Curb Ramps
 Barrier Type: 12" Grooves - Existing (2.1% to 3.0%)
 Code Ref: CBC 1127B.5.6

As Built Meas: 1 Quantity: EACH
 Description: 12" grooves at top of curb ramp are not level (2.1% to 3.0%)
 As Built Desc: 2.4% at 12" grooves
 Solution: Demolish existing and construct new curb ramp
 Bar. Severity: 4 Low Severity Cost Estimate: \$2,500.00 Status:
 Implementation Priority: 3 Facility Function:
 Implementation Phase: Implementation Date:
 Official Responsible:

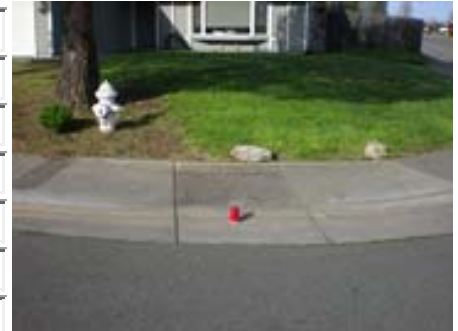
Field Date: 3/17/2011 Report Date: 3/17/2011 Barrier #: 6022B
 Location: Claypool Wy and Collegiality Wy - Corner D
 X Coordinate: -121.25175
 Y Coordinate: 38.70946
 Barrier Area: Curb Ramps
 Barrier Type: Detectable Warnings - Truncated Domes
 Code Ref: CBC 1127B.5.7 and ADA/ABA 705.1.3

As Built Meas: 1 Quantity: EACH
 Description: No truncated domes provided at curb ramp
 As Built Desc: No detectable warnings at curb ramp
 Solution: Provide compliant truncated domes
 Bar. Severity: 2 Recommended Cost Estimate: \$1,400.00 Status:
 Implementation Priority: 3 Facility Function:
 Implementation Phase: Implementation Date:
 Official Responsible:

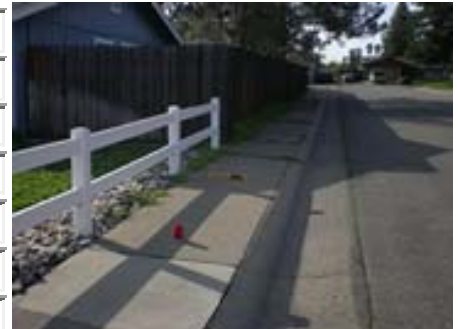
Field Date: 3/17/2011 Report Date: 3/17/2011 Barrier #: 6023
 Location: Collegiality Wy - East
 X Coordinate: -121.25164
 Y Coordinate: 38.70934
 Barrier Area: Sidewalks
 Barrier Type: Cross Slope - Existing (5.0% or more)
 Code Ref: CBC 1133B.7.1.3 and ADA/ABA 403.3

As Built Meas: 188 Quantity: LF
 Description: Cross slope exceeds 2.0% (5.0% or more)
 As Built Desc: 6.6% cross slope
 Solution: Demolish existing and construct new route
 Bar. Severity: 1 Necessary Cost Estimate: \$23,500.00 Status:
 Implementation Priority: 4 Facility Function:
 Implementation Phase: Implementation Date:
 Official Responsible:

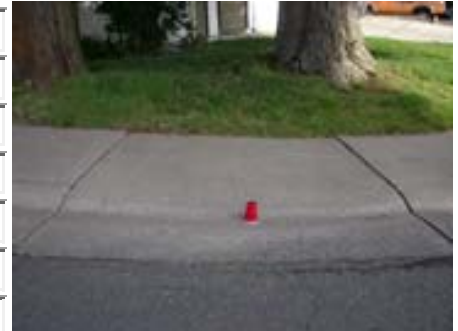
Field Date: 3/17/2011 Report Date: 3/17/2011 Barrier #: 6024
 Location: Collegiality Wy and Berman Walk Wy - Corner A
 X Coordinate: -121.25173
 Y Coordinate: 38.70887
 Barrier Area: Curb Ramps
 Barrier Type: No Curb Ramp - Depressed Existing Curb
 Code Ref: CBC 1127B.5.1 and ADA/ABA 402.2

As Built Meas: 1 Quantity: EACH
 Description: No compliant curb cut at corner (intersection)
 As Built Desc: 9.9% running slope at depressed area
 Solution: Demolish existing and construct curb cut
 Bar. Severity: 1 Necessary Cost Estimate: \$2,500.00 Status:
 Implementation Priority: 4 Facility Function:
 Implementation Phase: Implementation Date:
 Official Responsible:

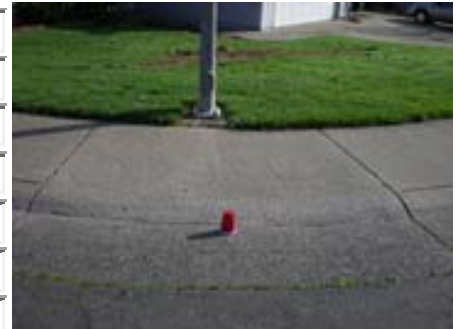
Field Date: 3/17/2011 Report Date: 3/17/2011 Barrier #: 6025
 Location: Collegiality Wy and Berman Walk Wy - Corner B
 X Coordinate: -121.25163
 Y Coordinate: 38.70887
 Barrier Area: Curb Ramps
 Barrier Type: No Curb Ramp - Depressed Existing Curb
 Code Ref: CBC 1127B.5.1 and ADA/ABA 402.2

As Built Meas: 1 Quantity: EACH
 Description: No compliant curb cut at corner (intersection)
 As Built Desc: 8.5% running slope at depressed area
 Solution: Demolish existing and construct curb cut
 Bar. Severity: 1 Necessary Cost Estimate: \$2,500.00 Status:
 Implementation Priority: 4 Facility Function:
 Implementation Phase: Implementation Date:
 Official Responsible:

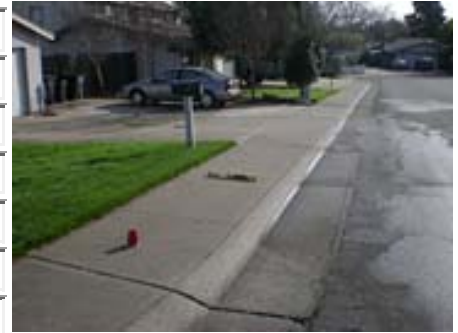
Field Date: 3/17/2011 Report Date: 3/17/2011 Barrier #: 6026
 Location: Berman Walk Wy - North
 X Coordinate: -121.2515
 Y Coordinate: 38.70888
 Barrier Area: Sidewalks
 Barrier Type: Cross Slope - Existing (3.1% to 4.0%)
 Code Ref: CBC 1133B.7.1.3 and ADA/ABA 403.3

As Built Meas: 207 Quantity: LF
 Description: Cross slope exceeds 2.0% (3.1% to 4.0%)
 As Built Desc: 4.0% cross slope
 Solution: Demolish existing and construct new route
 Bar. Severity: 3 Hinderance Cost Estimate: \$25,875.00 Status:
 Implementation Priority: 4 Facility Function:
 Implementation Phase: Implementation Date:
 Official Responsible:

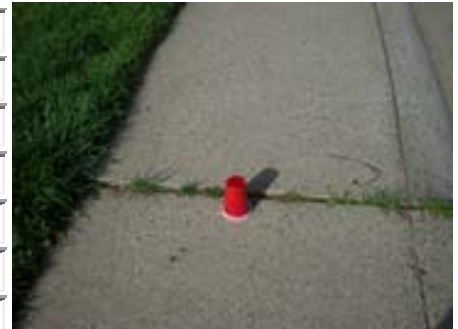
Field Date: 3/17/2011 Report Date: 3/17/2011 Barrier #: 6028B
 Location: Berman Walk Wy - South
 X Coordinate: -121.25182
 Y Coordinate: 38.70812
 Barrier Area: Sidewalks
 Barrier Type: Abrupt Change in Level - > 1/2"
 Code Ref: CBC 1133B.7.1 and ADA/ABA 303.3

As Built Meas: 4 Quantity: LF
 Description: Change in level greater than 1/2"
 As Built Desc: 1/2" lip in sidewalk surface
 Solution: Grind or repair sidewalk to remove trip hazard
 Bar. Severity: 1 Necessary Cost Estimate: \$1,000.00 Status:
 Implementation Priority: 4 Facility Function:
 Implementation Phase: Implementation Date:
 Official Responsible:

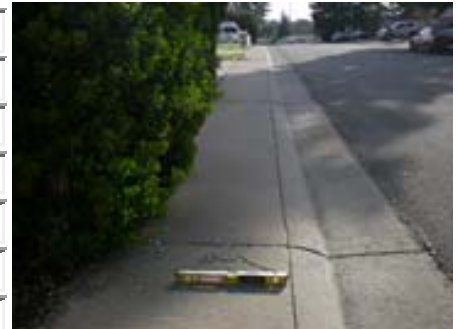
Field Date: 3/17/2011 Report Date: 3/17/2011 Barrier #: 6029B
 Location: Berman Walk Wy - North
 X Coordinate: -121.25294
 Y Coordinate: 38.70827
 Barrier Area: Sidewalks
 Barrier Type: Clear Width - Existing ($\leq 31''$ or less)
 Code Ref: CBC 1133B.7.1

As Built Meas: 1 Quantity: LF
 Description: Pedestrian route is not min. 48" wide ($\leq 31''$ or less)
 As Built Desc: 24" clear width due to foliage
 Solution: Trim foliage to provide min. 48" clear width
 Bar. Severity: 1 Necessary Cost Estimate: \$125.00 Status:
 Implementation Priority: 4 Facility Function:
 Implementation Phase: Implementation Date:
 Official Responsible:

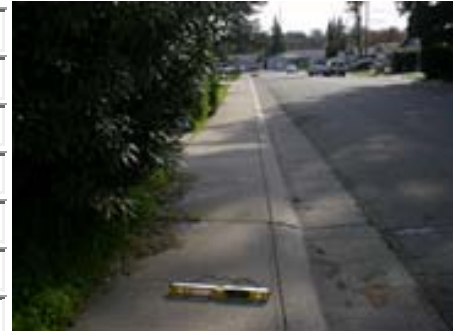
Field Date: 3/17/2011 Report Date: 3/17/2011 Barrier #: 6029C
 Location: Berman Walk Wy - North
 X Coordinate: -121.25225
 Y Coordinate: 38.70828
 Barrier Area: Sidewalks
 Barrier Type: Protruding Hazard
 Code Ref: CBC 1133B.8.6.1 and ADA/ABA 307.2

As Built Meas: 1 Quantity: JOB
 Description: Protruding object in route of travel between 27" and 80" high
 As Built Desc: 48" at tree branch
 Solution: Remove object or provide detectable warning
 Bar. Severity: 1 Necessary Cost Estimate: \$1,400.00 Status:
 Implementation Priority: 4 Facility Function:
 Implementation Phase: Implementation Date:
 Official Responsible:

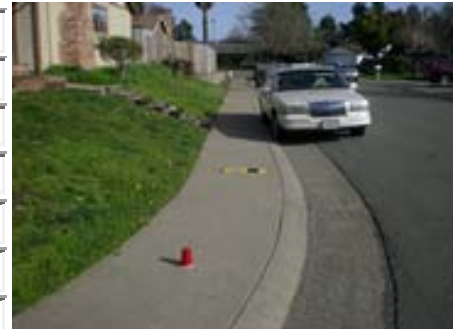
Field Date: 3/17/2011 Report Date: 3/17/2011 Barrier #: 6030
 Location: Berman Walk Wy - West
 X Coordinate: -121.25097
 Y Coordinate: 38.70827
 Barrier Area: Sidewalks
 Barrier Type: Cross Slope - Existing (4.1% to 4.9%)
 Code Ref: CBC 1133B.7.1.3 and ADA/ABA 403.3

As Built Meas: 195 Quantity: LF
 Description: Cross slope exceeds 2.0% (4.1% to 4.9%)
 As Built Desc: 4.1% cross slope
 Solution: Demolish existing and construct new route
 Bar. Severity: 2 Recommended Cost Estimate: \$24,375.00 Status:
 Implementation Priority: 4 Facility Function:
 Implementation Phase: Implementation Date:
 Official Responsible:

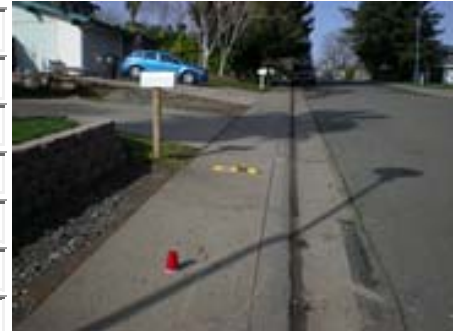
Field Date: 3/17/2011 Report Date: 3/17/2011 Barrier #: 6031A
 Location: Berman Walk Wy - South
 X Coordinate: -121.25109
 Y Coordinate: 38.70877
 Barrier Area: Sidewalks
 Barrier Type: Cross Slope - Existing (4.1% to 4.9%)
 Code Ref: CBC 1133B.7.1.3 and ADA/ABA 403.3

As Built Meas: 216 Quantity: LF
 Description: Cross slope exceeds 2.0% (4.1% to 4.9%)
 As Built Desc: 4.8% cross slope
 Solution: Demolish existing and construct new route
 Bar. Severity: 2 Recommended Cost Estimate: \$27,000.00 Status:
 Implementation Priority: 4 Facility Function:
 Implementation Phase: Implementation Date:
 Official Responsible:

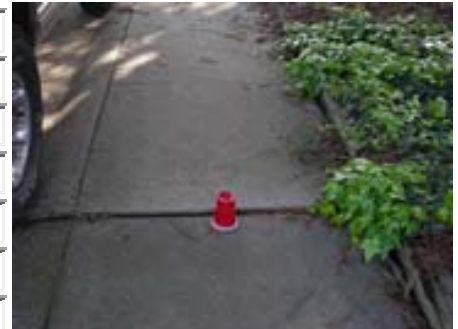
Field Date: 3/17/2011 Report Date: 3/17/2011 Barrier #: 6031B
 Location: Berman Walk Wy - South
 X Coordinate: -121.25152
 Y Coordinate: 38.70878
 Barrier Area: Sidewalks
 Barrier Type: Abrupt Change in Level - > 1/2"
 Code Ref: CBC 1133B.7.1 and ADA/ABA 303.3

As Built Meas: 4 Quantity: LF
 Description: Change in level greater than 1/2"
 As Built Desc: 1/2" lip in sidewalk surface
 Solution: Grind or repair sidewalk to remove trip hazard
 Bar. Severity: 1 Necessary Cost Estimate: \$1,000.00 Status:
 Implementation Priority: 4 Facility Function:
 Implementation Phase: Implementation Date:
 Official Responsible:

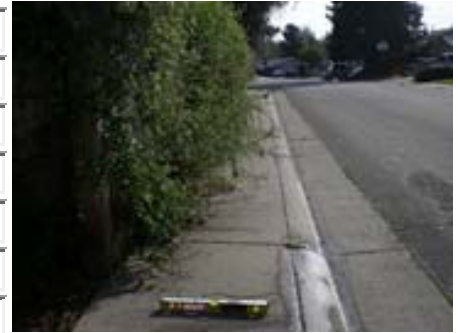
Field Date: 3/17/2011 Report Date: 3/17/2011 Barrier #: 6033B
 Location: Berman Walk Wy Ct - North
 X Coordinate: -121.25217
 Y Coordinate: 38.70887
 Barrier Area: Sidewalks
 Barrier Type: Clear Width - Existing ($\leq 31''$ or less)
 Code Ref: CBC 1133B.7.1

As Built Meas: 1 Quantity: LF
 Description: Pedestrian route is not min. 48" wide ($\leq 31''$ or less)
 As Built Desc: 5" clear width due to foliage
 Solution: Trim foliage to provide min. 48" clear width
 Bar. Severity: 1 Necessary Cost Estimate: \$125.00 Status:
 Implementation Priority: 4 Facility Function:
 Implementation Phase: Implementation Date:
 Official Responsible:

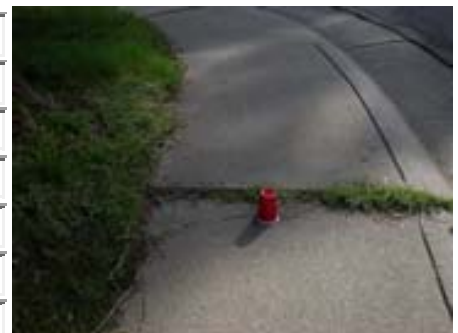
Field Date: 3/17/2011 Report Date: 3/17/2011 Barrier #: 6033C
 Location: Berman Walk Wy Ct - North
 X Coordinate: -121.25188
 Y Coordinate: 38.70887
 Barrier Area: Sidewalks
 Barrier Type: Abrupt Change in Level - $> 1/2''$
 Code Ref: CBC 1133B.7.1 and ADA/ABA 303.3

As Built Meas: 4 Quantity: LF
 Description: Change in level greater than 1/2"
 As Built Desc: 1" lip in sidewalk surface
 Solution: Grind or repair sidewalk to remove trip hazard
 Bar. Severity: 1 Necessary Cost Estimate: \$1,000.00 Status:
 Implementation Priority: 4 Facility Function:
 Implementation Phase: Implementation Date:
 Official Responsible:

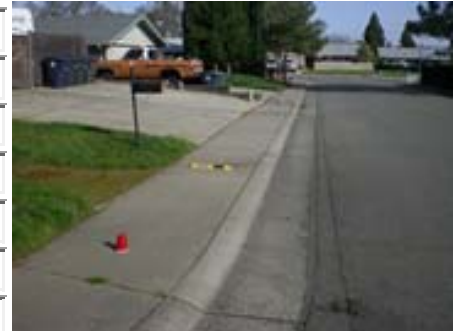
Field Date: 3/17/2011 Report Date: 3/17/2011 Barrier #: 6034
 Location: Collegiality Wy - West
 X Coordinate: -121.25178
 Y Coordinate: 38.70898
 Barrier Area: Sidewalks
 Barrier Type: Cross Slope - Existing (5.0% or more)
 Code Ref: CBC 1133B.7.1.3 and ADA/ABA 403.3

As Built Meas: 192 Quantity: LF
 Description: Cross slope exceeds 2.0% (5.0% or more)
 As Built Desc: 5.1% cross slope
 Solution: Demolish existing and construct new route
 Bar. Severity: 1 Necessary Cost Estimate: \$24,000.00 Status:
 Implementation Priority: 4 Facility Function:
 Implementation Phase: Implementation Date:
 Official Responsible:

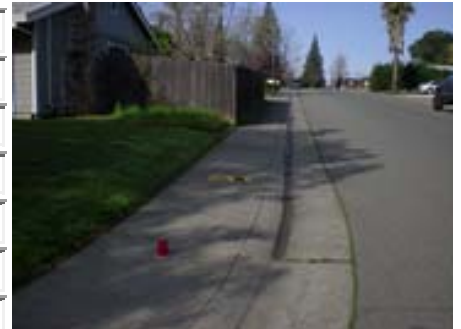
Field Date: 3/17/2011 Report Date: 3/17/2011 Barrier #: 6035
 Location: Claypool Wy - South
 X Coordinate: -121.25189
 Y Coordinate: 38.70949
 Barrier Area: Sidewalks
 Barrier Type: Cross Slope - Existing (5.0% or more)
 Code Ref: CBC 1133B.7.1.3 and ADA/ABA 403.3

As Built Meas: 458 Quantity: LF
 Description: Cross slope exceeds 2.0% (5.0% or more)
 As Built Desc: 6.9% cross slope
 Solution: Demolish existing and construct new route
 Bar. Severity: 1 Necessary Cost Estimate: \$57,250.00 Status:
 Implementation Priority: 3 Facility Function:
 Implementation Phase: Implementation Date:
 Official Responsible:

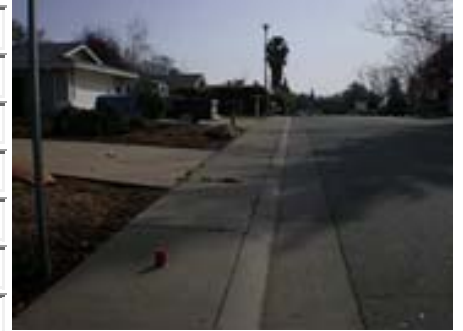
Field Date: 3/17/2011 Report Date: 3/17/2011 Barrier #: 6036A
 Location: Claypool Wy - North
 X Coordinate: -121.25338
 Y Coordinate: 38.70961
 Barrier Area: Sidewalks
 Barrier Type: Cross Slope - Existing (4.1% to 4.9%)
 Code Ref: CBC 1133B.7.1.3 and ADA/ABA 403.3

As Built Meas: 942 Quantity: LF
 Description: Cross slope exceeds 2.0% (4.1% to 4.9%)
 As Built Desc: 4.8% cross slope
 Solution: Demolish existing and construct new route
 Bar. Severity: 2 Recommended Cost Estimate: \$117,750.00 Status:
 Implementation Priority: 3 Facility Function:
 Implementation Phase: Implementation Date:
 Official Responsible:

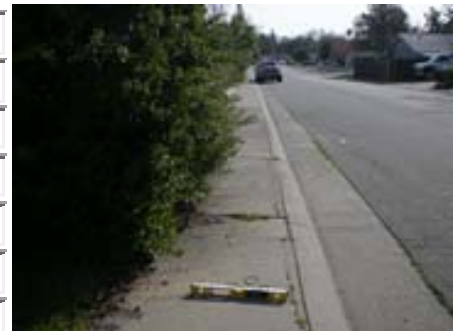
Field Date: 3/17/2011 Report Date: 3/17/2011 Barrier #: 6036B
 Location: Claypool Wy - North
 X Coordinate: -121.25259
 Y Coordinate: 38.70959
 Barrier Area: Sidewalks
 Barrier Type: Clear Width - Existing ($\leq 31''$ or less)
 Code Ref: CBC 1133B.7.1

As Built Meas: 1 Quantity: LF
 Description: Pedestrian route is not min. 48" wide ($\leq 31''$ or less)
 As Built Desc: 24" clear width due to foliage
 Solution: Trim foliage to provide min. 48" clear width
 Bar. Severity: 1 Necessary Cost Estimate: \$125.00 Status:
 Implementation Priority: 3 Facility Function:
 Implementation Phase: Implementation Date:
 Official Responsible:

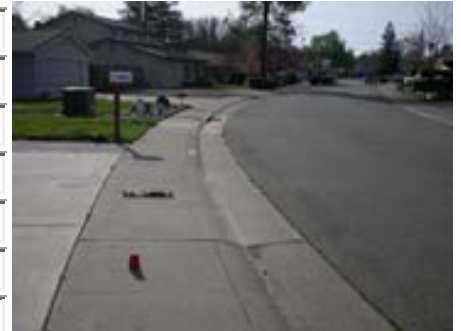
Field Date: 3/17/2011 Report Date: 3/17/2011 Barrier #: 6037
 Location: Claypool Wy - East
 X Coordinate: -121.25021
 Y Coordinate: 38.70938
 Barrier Area: Sidewalks
 Barrier Type: Cross Slope - Existing (5.0% or more)
 Code Ref: CBC 1133B.7.1.3 and ADA/ABA 403.3

As Built Meas: 815 Quantity: LF
 Description: Cross slope exceeds 2.0% (5.0% or more)
 As Built Desc: 5.1% cross slope
 Solution: Demolish existing and construct new route
 Bar. Severity: 1 Necessary Cost Estimate: \$101,875.00 Status:
 Implementation Priority: 3 Facility Function:
 Implementation Phase: Implementation Date:
 Official Responsible:

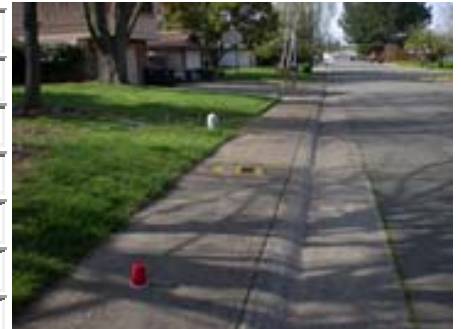
Field Date: 3/17/2011 Report Date: 3/17/2011 Barrier #: 6038
 Location: Claypool Wy - East
 X Coordinate: -121.25144
 Y Coordinate: 38.70658
 Barrier Area: Sidewalks
 Barrier Type: Cross Slope - Existing (2.1% to 3.0%)
 Code Ref: CBC 1133B.7.1.3 and ADA/ABA 403.3

As Built Meas: 459 Quantity: LF
 Description: Cross slope exceeds 2.0% (2.1% to 3.0%)
 As Built Desc: 3.0% cross slope
 Solution: Low severity barrier - no remediation recommended
 Bar. Severity: 4 Low Severity Cost Estimate: \$0.00 Status:
 Implementation Priority: 3 Facility Function:
 Implementation Phase: Implementation Date:
 Official Responsible:

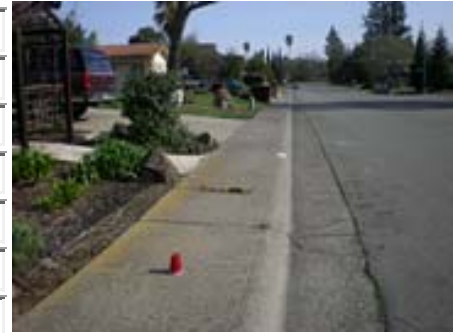
Field Date: 3/17/2011 Report Date: 3/17/2011 Barrier #: 6039
 Location: Olivine Ave - West
 X Coordinate: -121.25125
 Y Coordinate: 38.70485
 Barrier Area: Sidewalks
 Barrier Type: Cross Slope - Existing (4.1% to 4.9%)
 Code Ref: CBC 1133B.7.1.3 and ADA/ABA 403.3

As Built Meas: 752 Quantity: LF
 Description: Cross slope exceeds 2.0% (4.1% to 4.9%)
 As Built Desc: 4.7% cross slope
 Solution: Demolish existing and construct new route
 Bar. Severity: 2 Recommended Cost Estimate: \$94,000.00 Status:
 Implementation Priority: 2 Facility Function:
 Implementation Phase: Implementation Date:
 Official Responsible:
