**DRAFT ADA TRANSITION PLAN UPDATE
NEIGHBORHOOD AREA 8 CHASE
SEPTEMBER 20, 2011**

CITY OF CITRUS HEIGHTS

Conditions - CHASE Area 8

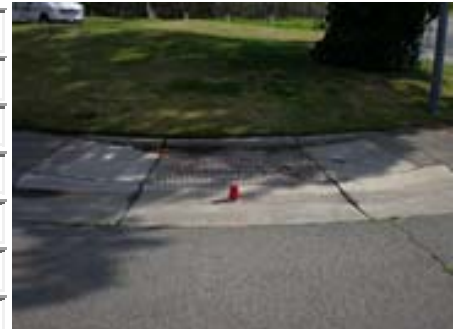
Field Date: 3/17/2011 Report Date: 3/17/2011 Barrier #: 6040A
 Location: Olivine Ave and Olivine Ave Ct - Corner A
 X Coordinate: -121.24942
 Y Coordinate: 38.70647
 Barrier Area: Curb Ramps
 Barrier Type: 12" Grooves - Existing (>5.0%)
 Code Ref: CBC 1127B.5.6

As Built Meas: 1 Quantity: EACH
 Description: 12" grooves at top of curb ramp are not level (>5.0%)
 As Built Desc: 6.3% at 12" grooves
 Solution: Demolish existing and construct new curb ramp
 Bar. Severity: 1 Necessary Cost Estimate: \$2,500.00 Status:
 Implementation Priority: 2 Facility Function:
 Implementation Phase: Implementation Date:
 Official Responsible:

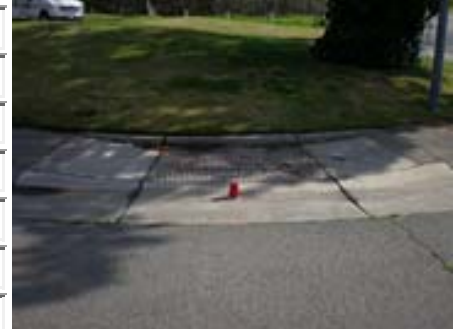
Field Date: 3/17/2011 Report Date: 3/17/2011 Barrier #: 6040B
 Location: Olivine Ave and Olivine Ave Ct - Corner A
 X Coordinate: -121.24942
 Y Coordinate: 38.70647
 Barrier Area: Curb Ramps
 Barrier Type: Detectable Warnings - Truncated Domes
 Code Ref: CBC 1127B.5.7 and ADA/ABA 705.1.3

As Built Meas: 1 Quantity: EACH
 Description: No truncated domes provided at curb ramp
 As Built Desc: No detectable warnings at curb ramp
 Solution: Provide compliant truncated domes
 Bar. Severity: 2 Recommended Cost Estimate: \$1,400.00 Status:
 Implementation Priority: 2 Facility Function:
 Implementation Phase: Implementation Date:
 Official Responsible:

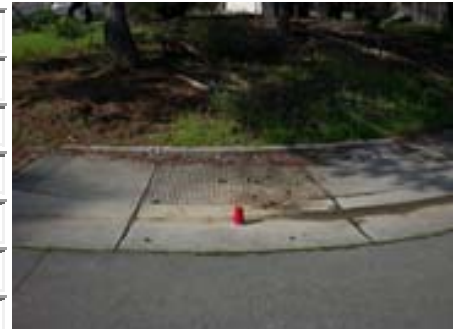
Field Date: 3/17/2011 Report Date: 3/17/2011 Barrier #: 6041A
 Location: Olivine Ave and Olivine Ave Ct - Corner D
 X Coordinate: -121.24951
 Y Coordinate: 38.70641
 Barrier Area: Curb Ramps
 Barrier Type: 12" Grooves - Existing (>5.0%)
 Code Ref: CBC 1127B.5.6

As Built Meas: 1 Quantity: EACH
 Description: 12" grooves at top of curb ramp are not level (>5.0%)
 As Built Desc: 5.3% at 12" grooves
 Solution: Demolish existing and construct new curb ramp
 Bar. Severity: 1 Necessary Cost Estimate: \$2,500.00 Status:
 Implementation Priority: 2 Facility Function:
 Implementation Phase: Implementation Date:
 Official Responsible:

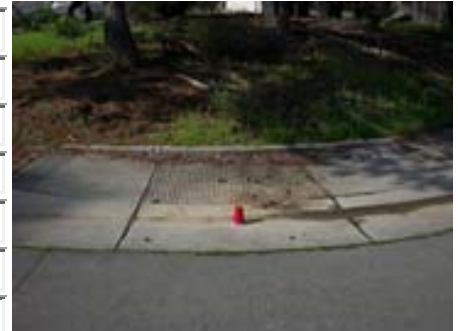
Field Date: 3/17/2011 Report Date: 3/17/2011 Barrier #: 6041B
 Location: Olivine Ave and Olivine Ave Ct - Corner D
 X Coordinate: -121.24951
 Y Coordinate: 38.70641
 Barrier Area: Curb Ramps
 Barrier Type: Parallel Ramp Landing - Existing (2.1% to 3.0%)
 Code Ref: CBC 1127B.5.4 and ADA/ABA 406.4

As Built Meas: 1 Quantity: EACH
 Description: Curb ramp landing or pan not level (2.1% to 3.0%)
 As Built Desc: 2.6% landing slope
 Solution: Demolish existing and construct new transition
 Bar. Severity: 4 Low Severity Cost Estimate: \$250.00 Status:
 Implementation Priority: 2 Facility Function:
 Implementation Phase: Implementation Date:
 Official Responsible:

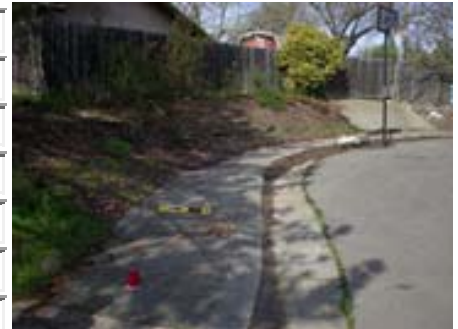
Field Date: 3/17/2011 Report Date: 3/17/2011 Barrier #: 6042A
 Location: Olivine Ave Ct - South
 X Coordinate: -121.24956
 Y Coordinate: 38.70642
 Barrier Area: Sidewalks
 Barrier Type: Cross Slope - Existing (4.1% to 4.9%)
 Code Ref: CBC 1133B.7.1.3 and ADA/ABA 403.3

As Built Meas: 98 Quantity: LF
 Description: Cross slope exceeds 2.0% (4.1% to 4.9%)
 As Built Desc: 4.4% cross slope
 Solution: Demolish existing and construct new route
 Bar. Severity: 2 Recommended Cost Estimate: \$12,250.00 Status:
 Implementation Priority: 2 Facility Function:
 Implementation Phase: Implementation Date:
 Official Responsible:

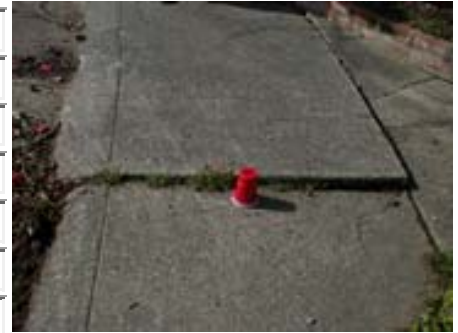
Field Date: 3/17/2011 Report Date: 3/17/2011 Barrier #: 6042B
 Location: Olivine Ave Ct - South
 X Coordinate: -121.24968
 Y Coordinate: 38.70657
 Barrier Area: Sidewalks
 Barrier Type: Abrupt Change in Level - Tree Heaves
 Code Ref: CBC 1133B.7.1 and ADA/ABA 303.3

As Built Meas: 4 Quantity: LF
 Description: Change in level greater than 1/2"
 As Built Desc: 1/2" lip due to tree heaves
 Solution: Grind or repair sidewalk to remove trip hazard
 Bar. Severity: 1 Necessary Cost Estimate: \$1,000.00 Status:
 Implementation Priority: 2 Facility Function:
 Implementation Phase: Implementation Date:
 Official Responsible:

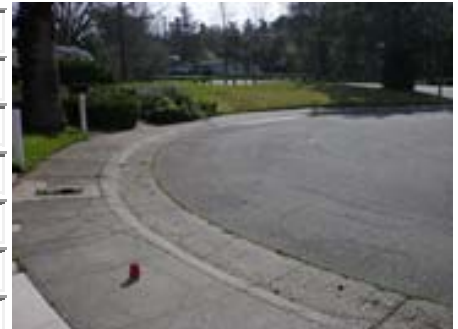
Field Date: 3/17/2011 Report Date: 3/17/2011 Barrier #: 6043A
 Location: Olivine Ave Ct - North
 X Coordinate: -121.24957
 Y Coordinate: 38.70661
 Barrier Area: Sidewalks
 Barrier Type: Cross Slope - Existing (4.1% to 4.9%)
 Code Ref: CBC 1133B.7.1.3 and ADA/ABA 403.3

As Built Meas: 99 Quantity: LF
 Description: Cross slope exceeds 2.0% (4.1% to 4.9%)
 As Built Desc: 4.4% cross slope
 Solution: Demolish existing and construct new route
 Bar. Severity: 2 Recommended Cost Estimate: \$12,375.00 Status:
 Implementation Priority: 2 Facility Function:
 Implementation Phase: Implementation Date:
 Official Responsible:

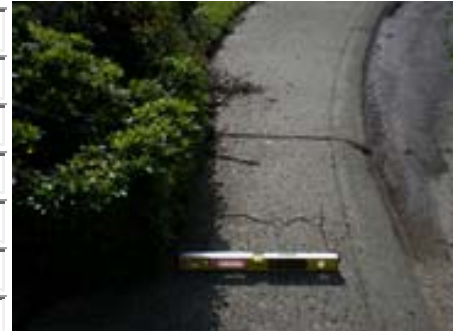
Field Date: 3/17/2011 Report Date: 3/17/2011 Barrier #: 6043B
 Location: Olivine Ave Ct - North
 X Coordinate: -121.24946
 Y Coordinate: 38.70659
 Barrier Area: Sidewalks
 Barrier Type: Clear Width - Existing ($\leq 31''$ or less)
 Code Ref: CBC 1133B.7.1

As Built Meas: 1 Quantity: LF
 Description: Pedestrian route is not min. 48" wide ($\leq 31''$ or less)
 As Built Desc: 24" clear width due to foliage
 Solution: Trim foliage to provide min. 48" clear width
 Bar. Severity: 1 Necessary Cost Estimate: \$125.00 Status:
 Implementation Priority: 2 Facility Function:
 Implementation Phase: Implementation Date:
 Official Responsible:

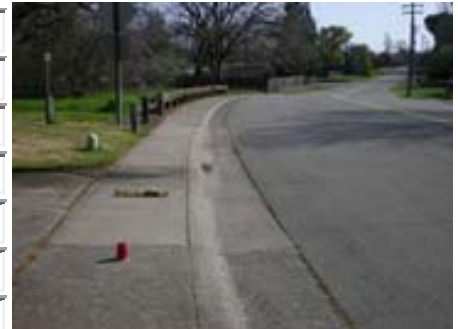
Field Date: 3/17/2011 Report Date: 3/17/2011 Barrier #: 6044A
 Location: Olivine Ave - North
 X Coordinate: -121.24927
 Y Coordinate: 38.70643
 Barrier Area: Sidewalks
 Barrier Type: Cross Slope - Existing (4.1% to 4.9%)
 Code Ref: CBC 1133B.7.1.3 and ADA/ABA 403.3

As Built Meas: 210 Quantity: LF
 Description: Cross slope exceeds 2.0% (4.1% to 4.9%)
 As Built Desc: 4.5% cross slope
 Solution: Demolish existing and construct new route
 Bar. Severity: 2 Recommended Cost Estimate: \$26,250.00 Status:
 Implementation Priority: 2 Facility Function:
 Implementation Phase: Implementation Date:
 Official Responsible:

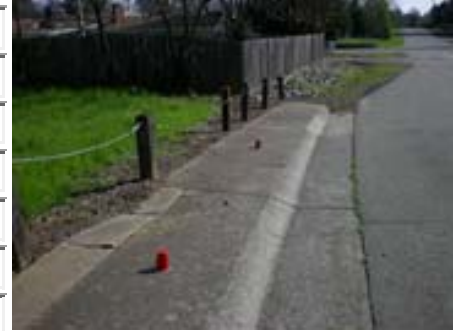
Field Date: 3/17/2011 Report Date: 3/17/2011 Barrier #: 6044B
 Location: Olivine Ave - North
 X Coordinate: -121.24869
 Y Coordinate: 38.7066
 Barrier Area: Sidewalks
 Barrier Type: Surface Condition - Damaged
 Code Ref: CBC 1133B.7.1 and ADA/ABA 302.1

As Built Meas: 16 Quantity: LF
 Description: Surface is not firm and stable (cracked, broken or loose soil, etc.)
 As Built Desc: Cracked concrete
 Solution: Repair surface to make firm and stable
 Bar. Severity: 1 Necessary Cost Estimate: \$2,000.00 Status:
 Implementation Priority: 2 Facility Function:
 Implementation Phase: Implementation Date:
 Official Responsible:

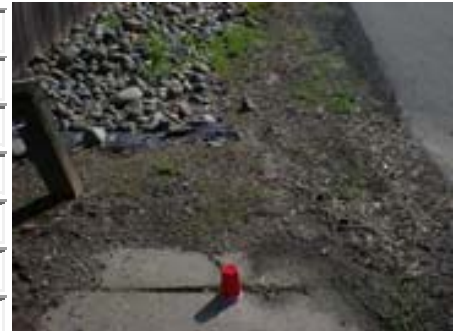
Field Date: 3/17/2011 Report Date: 3/17/2011 Barrier #: 6045
 Location: Olivine Ave - North
 X Coordinate: -121.2486
 Y Coordinate: 38.70661
 Barrier Area: Sidewalks
 Barrier Type: No Sidewalk - No Barricade
 Code Ref: MUTCD Section 6D.01

As Built Meas: 1 Quantity: JOB
 Description: No barricade provided where sidewalk ends in hazardous location
 As Built Desc: No barricade or other warning provided for the visually impaired at end of sidewalk
 Solution: Provide barricade with cane detectable warning at end of sidewalk
 Bar. Severity: 1 Necessary Cost Estimate: \$1,350.00 Status:
 Implementation Priority: 2 Facility Function:
 Implementation Phase: Implementation Date:
 Official Responsible:

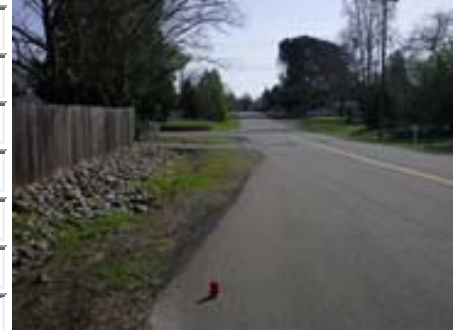
Field Date: 3/17/2011 Report Date: 3/17/2011 Barrier #: 6046
 Location: Olivine Ave - North
 X Coordinate: -121.24858
 Y Coordinate: 38.70659
 Barrier Area: Sidewalks
 Barrier Type: No sidewalk
 Code Ref: CBC 1127B.1 and ADA/ABA 206.2.1

As Built Meas: 127 Quantity: LF
 Description: No pedestrian route provided
 As Built Desc: No sidewalk provided
 Solution: Construct new firm and stable pedestrian route
 Bar. Severity: 1 Necessary Cost Estimate: \$12,700.00 Status:
 Implementation Priority: 2 Facility Function:
 Implementation Phase: Implementation Date:
 Official Responsible:

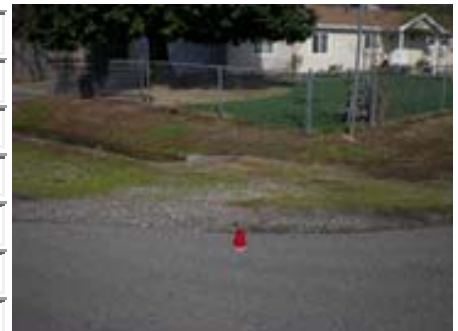
Field Date: 3/17/2011 Report Date: 3/17/2011 Barrier #: 6047
 Location: Olivine Ave and Feldspar Ct - Corner A
 X Coordinate: -121.24811
 Y Coordinate: 38.70658
 Barrier Area: Blended Transitions
 Barrier Type: Detectable Warnings - Truncated Domes
 Code Ref: CBC 1127B.5.3

As Built Meas: 1 Quantity: EACH
 Description: No truncated domes provided at transition into roadway
 As Built Desc: No detectable warning provided
 Solution: Provide compliant truncated domes
 Bar. Severity: 2 Recommended Cost Estimate: \$1,400.00 Status:
 Implementation Priority: 2 Facility Function:
 Implementation Phase: Implementation Date:
 Official Responsible:

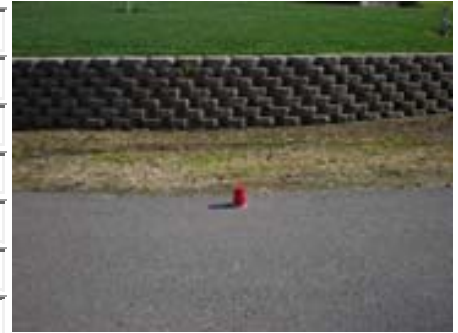
Field Date: 3/17/2011 Report Date: 3/17/2011 Barrier #: 6048
 Location: Olivine Ave and Feldspar Ct - Corner B
 X Coordinate: -121.24798
 Y Coordinate: 38.70659
 Barrier Area: Blended Transitions
 Barrier Type: Detectable Warnings - Truncated Domes
 Code Ref: CBC 1127B.5.3

As Built Meas: 1 Quantity: EACH
 Description: No truncated domes provided at transition into roadway
 As Built Desc: No detectable warning
 Solution: Provide compliant truncated domes
 Bar. Severity: 2 Recommended Cost Estimate: \$1,400.00 Status:
 Implementation Priority: 2 Facility Function:
 Implementation Phase: Implementation Date:
 Official Responsible:

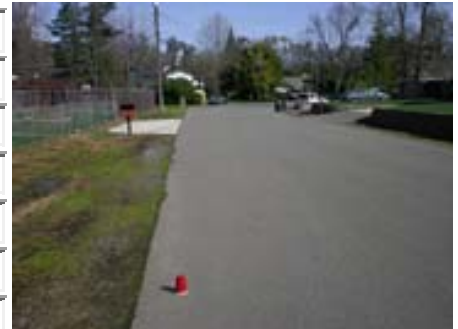
Field Date: 3/17/2011 Report Date: 3/17/2011 Barrier #: 6049
 Location: Feldspar Ct - West
 X Coordinate: -121.24814
 Y Coordinate: 38.70665
 Barrier Area: Sidewalks
 Barrier Type: No sidewalk
 Code Ref: CBC 1127B.1 and ADA/ABA 206.2.1

As Built Meas: 269 Quantity: LF
 Description: No pedestrian route provided
 As Built Desc: No sidewalk provided
 Solution: Construct new firm and stable pedestrian route
 Bar. Severity: 1 Necessary Cost Estimate: \$26,900.00 Status:
 Implementation Priority: 4 Facility Function:
 Implementation Phase: Implementation Date:
 Official Responsible:

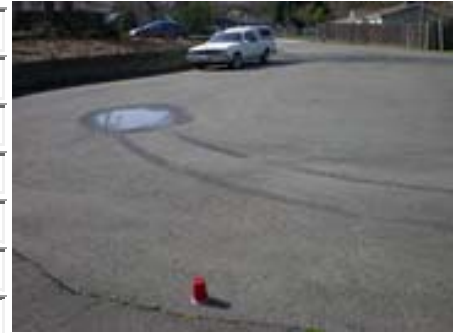
Field Date: 3/17/2011 Report Date: 3/17/2011 Barrier #: 6050
 Location: Feldspar Ct - East
 X Coordinate: -121.24792
 Y Coordinate: 38.70715
 Barrier Area: Sidewalks
 Barrier Type: No sidewalk (shoulder)
 Code Ref: CBC 1127B.1 and ADA/ABA 206.2.1

As Built Meas: 307 Quantity: LF
 Description: Sidewalk route ends where an opposite sidewalk exists
 As Built Desc: Directional sign not provided to lead pedestrians to opposite sidewalk
 Solution: Provide directional sign at junction in route leading pedestrians to opposite side of roadway
 Bar. Severity: 1 Necessary Cost Estimate: \$30,700.00 Status:
 Implementation Priority: 4 Facility Function:
 Implementation Phase: Implementation Date:
 Official Responsible:

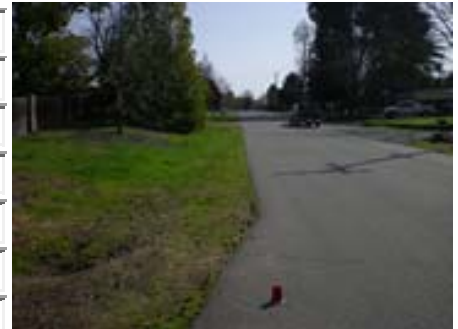
Field Date: 3/17/2011 Report Date: 3/17/2011 Barrier #: 6051
 Location: Olivine Ave - North
 X Coordinate: -121.24787
 Y Coordinate: 38.70658
 Barrier Area: Sidewalks
 Barrier Type: No sidewalk
 Code Ref: CBC 1127B.1 and ADA/ABA 206.2.1

As Built Meas: 745 Quantity: LF
 Description: No pedestrian route provided
 As Built Desc: No sidewalk provided
 Solution: Construct new firm and stable pedestrian route
 Bar. Severity: 1 Necessary Cost Estimate: \$74,500.00 Status:
 Implementation Priority: 2 Facility Function:
 Implementation Phase: Implementation Date:
 Official Responsible:

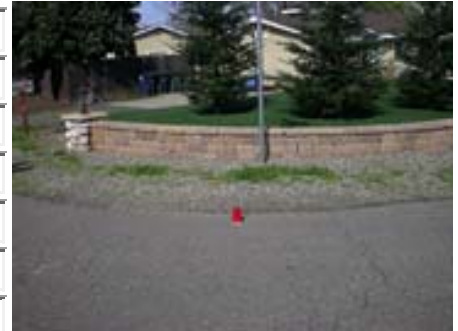
Field Date: 3/17/2011 Report Date: 3/17/2011 Barrier #: 6052
 Location: Olivine Ave and Galena Wy - Corner A
 X Coordinate: -121.24646
 Y Coordinate: 38.70657
 Barrier Area: Blended Transitions
 Barrier Type: Detectable Warnings - Truncated Domes
 Code Ref: CBC 1127B.5.3

As Built Meas: 1 Quantity: EACH
 Description: No truncated domes provided at transition into roadway
 As Built Desc: No detectable warning provided
 Solution: Provide compliant truncated domes
 Bar. Severity: 2 Recommended Cost Estimate: \$1,400.00 Status:
 Implementation Priority: 2 Facility Function:
 Implementation Phase: Implementation Date:
 Official Responsible:

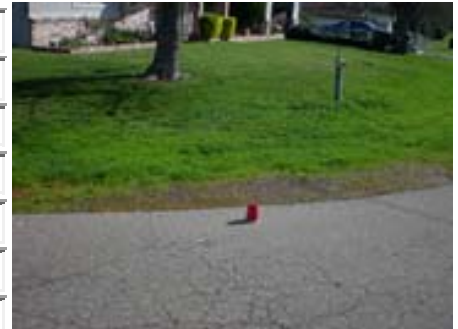
Field Date: 3/17/2011 Report Date: 3/17/2011 Barrier #: 6053
 Location: Olivine Ave and Galena Wy - Corner B
 X Coordinate: -121.24632
 Y Coordinate: 38.70656
 Barrier Area: Blended Transitions
 Barrier Type: Detectable Warnings - Truncated Domes
 Code Ref: CBC 1127B.5.3

As Built Meas: 1 Quantity: EACH
 Description: No truncated domes provided at transition into roadway
 As Built Desc: No detectable warning provided
 Solution: Provide compliant truncated domes
 Bar. Severity: 2 Recommended Cost Estimate: \$1,400.00 Status:
 Implementation Priority: 2 Facility Function:
 Implementation Phase: Implementation Date:
 Official Responsible:

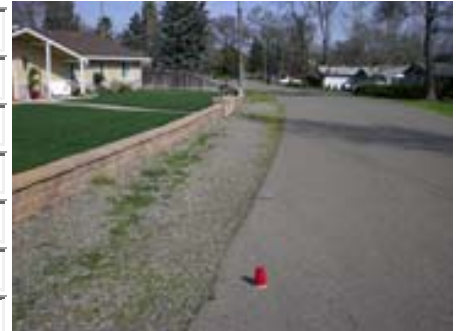
Field Date: 3/17/2011 Report Date: 3/17/2011 Barrier #: 6054
 Location: Galena Wy - West
 X Coordinate: -121.24647
 Y Coordinate: 38.70671
 Barrier Area: Sidewalks
 Barrier Type: No sidewalk
 Code Ref: CBC 1127B.1 and ADA/ABA 206.2.1

As Built Meas: 435 Quantity: LF
 Description: No pedestrian route provided
 As Built Desc: No sidewalk provided
 Solution: Construct new firm and stable pedestrian route
 Bar. Severity: 1 Necessary Cost Estimate: \$43,500.00 Status:
 Implementation Priority: 4 Facility Function:
 Implementation Phase: Implementation Date:
 Official Responsible:

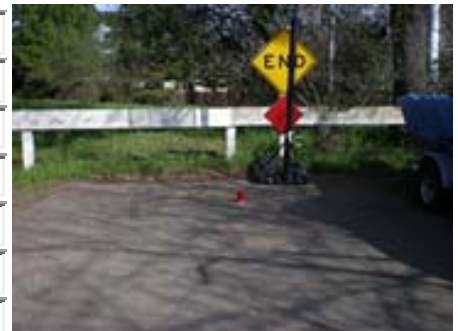
Field Date: 3/17/2011 Report Date: 3/17/2011 Barrier #: 6055
 Location: Galena Wy - West
 X Coordinate: -121.24647
 Y Coordinate: 38.70678
 Barrier Area: Sidewalks
 Barrier Type: No Sidewalk - Cane Detectable Barricade
 Code Ref: CBC 1133B.8.6 and MUTCD Section 6D.02

As Built Meas: 60 Quantity: LF
 Description: No cane detectable warning on existing barricade
 As Built Desc: Existing barricade lacks warning for the visually impaired
 Solution: Provide cane detectable warning on barricade (max. 6" above ground)
 Bar. Severity: 1 Necessary Cost Estimate: \$6,000.00 Status:
 Implementation Priority: 4 Facility Function:
 Implementation Phase: Implementation Date:
 Official Responsible:

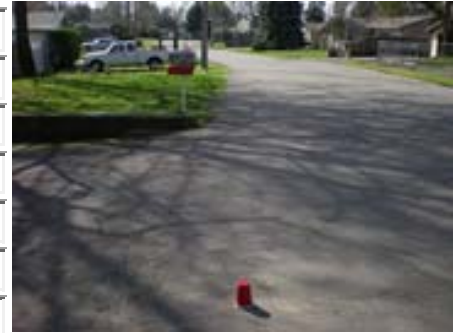
Field Date: 3/17/2011 Report Date: 3/17/2011 Barrier #: 6056
 Location: Galena Wy - East
 X Coordinate: -121.2466
 Y Coordinate: 38.70754
 Barrier Area: Sidewalks
 Barrier Type: No sidewalk
 Code Ref: CBC 1127B.1 and ADA/ABA 206.2.1

As Built Meas: 435 Quantity: LF
 Description: No pedestrian route provided
 As Built Desc: No sidewalk provided
 Solution: Construct new firm and stable pedestrian route
 Bar. Severity: 1 Necessary Cost Estimate: \$43,500.00 Status:
 Implementation Priority: 4 Facility Function:
 Implementation Phase: Implementation Date:
 Official Responsible:

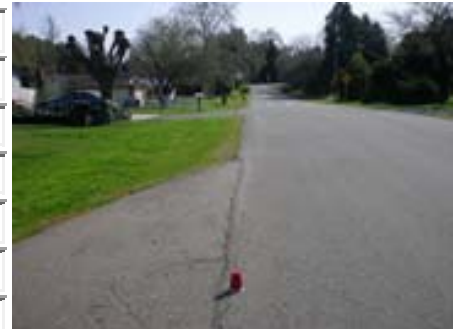
Field Date: 3/17/2011 Report Date: 3/17/2011 Barrier #: 6057
 Location: Olivine Ave - North
 X Coordinate: -121.24619
 Y Coordinate: 38.70655
 Barrier Area: Sidewalks
 Barrier Type: No sidewalk
 Code Ref: CBC 1127B.1 and ADA/ABA 206.2.1

As Built Meas: 539 Quantity: LF
 Description: No pedestrian route provided
 As Built Desc: No sidewalk provided
 Solution: Construct new firm and stable pedestrian route
 Bar. Severity: 1 Necessary Cost Estimate: \$53,900.00 Status:
 Implementation Priority: 2 Facility Function:
 Implementation Phase: Implementation Date:
 Official Responsible:

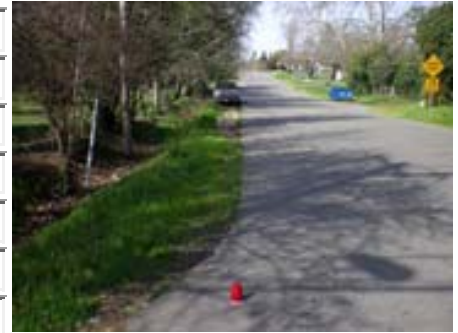
Field Date: 3/17/2011 Report Date: 3/17/2011 Barrier #: 6058
 Location: Olivine Ave - South
 X Coordinate: -121.24446
 Y Coordinate: 38.70644
 Barrier Area: Sidewalks
 Barrier Type: No sidewalk
 Code Ref: CBC 1127B.1 and ADA/ABA 206.2.1

As Built Meas: 866 Quantity: LF
 Description: No pedestrian route provided
 As Built Desc: No sidewalk provided
 Solution: Construct new firm and stable pedestrian route
 Bar. Severity: 1 Necessary Cost Estimate: \$86,600.00 Status:
 Implementation Priority: 2 Facility Function:
 Implementation Phase: Implementation Date:
 Official Responsible:

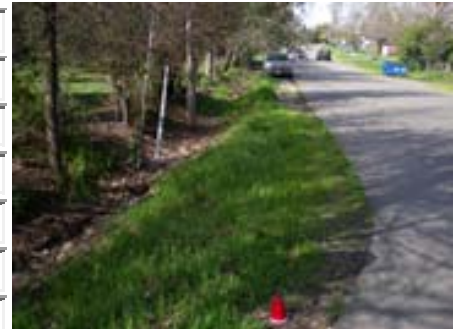
Field Date: 3/17/2011 Report Date: 3/17/2011 Barrier #: 6059
 Location: Olivine Ave - South
 X Coordinate: -121.24451
 Y Coordinate: 38.70644
 Barrier Area: Sidewalks
 Barrier Type: Drop-off Along Ped Route (> 4")
 Code Ref: CBC 1133B.8.1

As Built Meas: 115 Quantity: LF
 Description: Drop of more than 4" along pedestrian route lacks warning curb
 As Built Desc: 36" drop off creates hazardous condition for the visually impaired
 Solution: Provide curb projecting at least 6" above the walk or sidewalk surface to warn the blind of a potent
 Bar. Severity: 1 Necessary Cost Estimate: \$20,125.00 Status:
 Implementation Priority: 2 Facility Function:
 Implementation Phase: Implementation Date:
 Official Responsible:

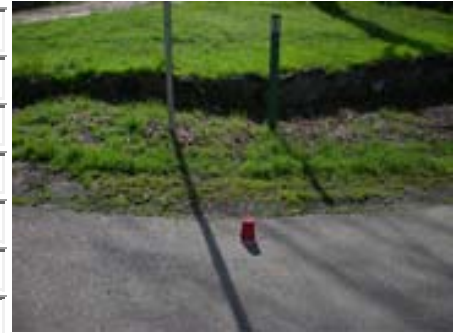
Field Date: 3/17/2011 Report Date: 3/17/2011 Barrier #: 6060
 Location: Olivine Ave and Mica Wy - Corner C
 X Coordinate: -121.24748
 Y Coordinate: 38.70643
 Barrier Area: Blended Transitions
 Barrier Type: Detectable Warnings - Truncated Domes
 Code Ref: CBC 1127B.5.3

As Built Meas: 1 Quantity: EACH
 Description: No truncated domes provided at transition into roadway
 As Built Desc: No detectable warning
 Solution: Provide compliant truncated domes
 Bar. Severity: 2 Recommended Cost Estimate: \$1,400.00 Status:
 Implementation Priority: 2 Facility Function:
 Implementation Phase: Implementation Date:
 Official Responsible:

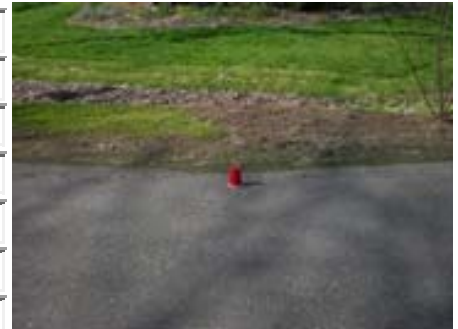
Field Date: 3/17/2011 Report Date: 3/17/2011 Barrier #: 6061
 Location: Olivine Ave and Mica Wy - Corner D
 X Coordinate: -121.24763
 Y Coordinate: 38.70642
 Barrier Area: Blended Transitions
 Barrier Type: Detectable Warnings - Truncated Domes
 Code Ref: CBC 1127B.5.3

As Built Meas: 1 Quantity: EACH
 Description: No truncated domes provided at transition into roadway
 As Built Desc: Provide compliant truncated domes
 Solution: Provide compliant truncated domes
 Bar. Severity: 2 Recommended Cost Estimate: \$1,400.00 Status:
 Implementation Priority: 2 Facility Function:
 Implementation Phase: Implementation Date:
 Official Responsible:

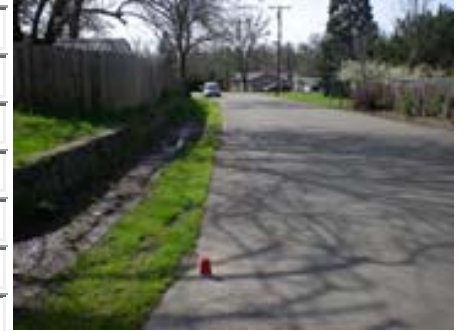
Field Date: 3/17/2011 Report Date: 3/17/2011 Barrier #: 6062
 Location: Mica Wy - East
 X Coordinate: -121.2475
 Y Coordinate: 38.70627
 Barrier Area: Sidewalks
 Barrier Type: No sidewalk
 Code Ref: CBC 1127B.1 and ADA/ABA 206.2.1

As Built Meas: 367 Quantity: LF
 Description: No pedestrian route provided
 As Built Desc: No sidewalk provided
 Solution: Construct new firm and stable pedestrian route
 Bar. Severity: 1 Necessary Cost Estimate: \$36,700.00 Status:
 Implementation Priority: 4 Facility Function:
 Implementation Phase: Implementation Date:
 Official Responsible:

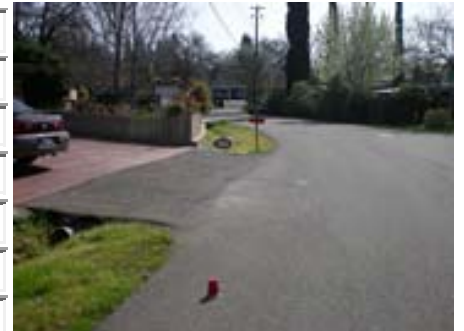
Field Date: 3/17/2011 Report Date: 3/17/2011 Barrier #: 6063
 Location: Mica Wy - North
 X Coordinate: -121.2471
 Y Coordinate: 38.70549
 Barrier Area: Sidewalks
 Barrier Type: No sidewalk
 Code Ref: CBC 1127B.1 and ADA/ABA 206.2.1

As Built Meas: 289 Quantity: LF
 Description: No pedestrian route provided
 As Built Desc: No sidewalk provided
 Solution: Construct new firm and stable pedestrian route
 Bar. Severity: 1 Necessary Cost Estimate: \$28,900.00 Status:
 Implementation Priority: 4 Facility Function:
 Implementation Phase: Implementation Date:
 Official Responsible:

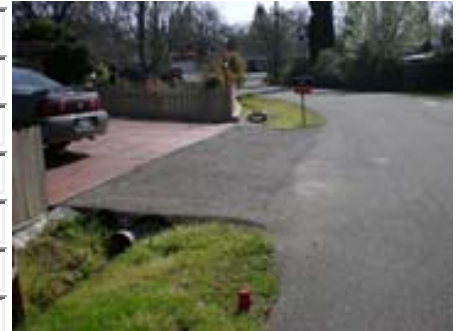
Field Date: 3/17/2011 Report Date: 3/17/2011 Barrier #: 6064
 Location: Mica Wy - North
 X Coordinate: -121.24709
 Y Coordinate: 38.70545
 Barrier Area: Sidewalks
 Barrier Type: Drop-off Along Ped Route (> 4")
 Code Ref: CBC 1133B.8.1

As Built Meas: 90 Quantity: LF
 Description: Drop of more than 4" along pedestrian route lacks warning curb
 As Built Desc: 36" drop off creates hazardous condition for the visually impaired
 Solution: Provide curb projecting at least 6" above the walk or sidewalk surface to warn the blind of a potent
 Bar. Severity: 1 Necessary Cost Estimate: \$15,750.00 Status:
 Implementation Priority: 4 Facility Function:
 Implementation Phase: Implementation Date:
 Official Responsible:

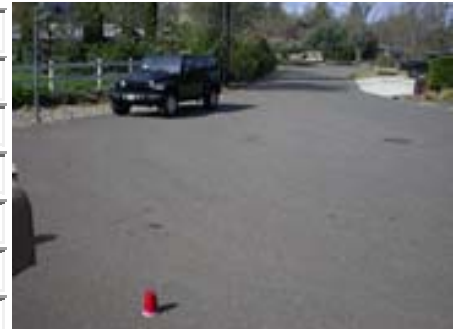
Field Date: 3/17/2011 Report Date: 3/17/2011 Barrier #: 6065
 Location: Mica Wy - South
 X Coordinate: -121.2464
 Y Coordinate: 38.70533
 Barrier Area: Sidewalks
 Barrier Type: No sidewalk
 Code Ref: CBC 1127B.1 and ADA/ABA 206.2.1

As Built Meas: 207 Quantity: LF
 Description: No pedestrian route provided
 As Built Desc: No sidewalk provided
 Solution: Construct new firm and stable pedestrian route
 Bar. Severity: 1 Necessary Cost Estimate: \$20,700.00 Status:
 Implementation Priority: 4 Facility Function:
 Implementation Phase: Implementation Date:
 Official Responsible:

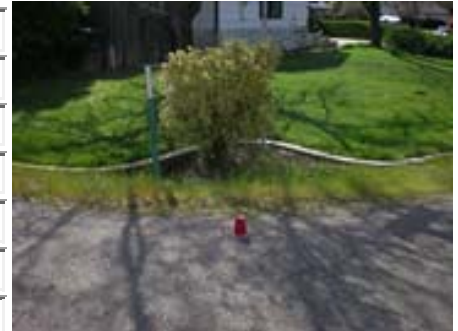
Field Date: 3/17/2011 Report Date: 3/17/2011 Barrier #: 6066
 Location: Mica Wy and Aplite Ct - Corner C
 X Coordinate: -121.24701
 Y Coordinate: 38.70533
 Barrier Area: Blended Transitions
 Barrier Type: Detectable Warnings - Truncated Domes
 Code Ref: CBC 1127B.5.3

As Built Meas: 1 Quantity: EACH
 Description: No truncated domes provided at transition into roadway
 As Built Desc: No detectable warning provided
 Solution: Provide compliant truncated domes
 Bar. Severity: 2 Recommended Cost Estimate: \$1,400.00 Status:
 Implementation Priority: 4 Facility Function:
 Implementation Phase: Implementation Date:
 Official Responsible:

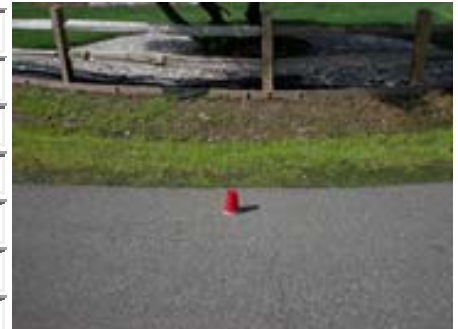
Field Date: 3/17/2011 Report Date: 3/17/2011 Barrier #: 6067
 Location: Mica Wy and Aplite Ct - Corner D
 X Coordinate: -121.24715
 Y Coordinate: 38.70536
 Barrier Area: Blended Transitions
 Barrier Type: Detectable Warnings - Truncated Domes
 Code Ref: CBC 1127B.5.3

As Built Meas: 1 Quantity: EACH
 Description: No truncated domes provided at transition into roadway
 As Built Desc: No detectable warning provided
 Solution: Provide compliant truncated domes
 Bar. Severity: 2 Recommended Cost Estimate: \$1,400.00 Status:
 Implementation Priority: 4 Facility Function:
 Implementation Phase: Implementation Date:
 Official Responsible:

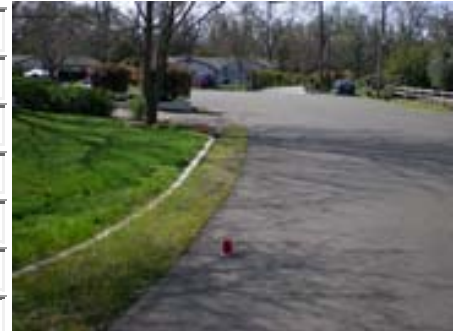
Field Date: 3/17/2011 Report Date: 3/17/2011 Barrier #: 6068
 Location: Aplite Ct - East
 X Coordinate: -121.24703
 Y Coordinate: 38.70523
 Barrier Area: Sidewalks
 Barrier Type: No sidewalk
 Code Ref: CBC 1127B.1 and ADA/ABA 206.2.1

As Built Meas: 189 Quantity: LF
 Description: No pedestrian route provided
 As Built Desc: No sidewalk provided
 Solution: Construct new firm and stable pedestrian route
 Bar. Severity: 1 Necessary Cost Estimate: \$18,900.00 Status:
 Implementation Priority: 4 Facility Function:
 Implementation Phase: Implementation Date:
 Official Responsible:

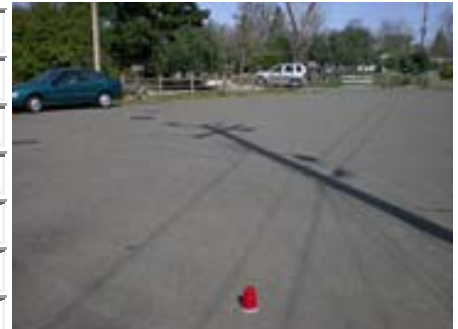
Field Date: 3/17/2011 Report Date: 3/17/2011 Barrier #: 6069
 Location: Aplite Ct - West
 X Coordinate: -121.24724
 Y Coordinate: 38.705
 Barrier Area: Sidewalks
 Barrier Type: No sidewalk
 Code Ref: CBC 1127B.1 and ADA/ABA 206.2.1

As Built Meas: 213 Quantity: LF
 Description: No pedestrian route provided
 As Built Desc: No sidewalk provided
 Solution: Construct new firm and stable pedestrian route
 Bar. Severity: 1 Necessary Cost Estimate: \$21,300.00 Status:
 Implementation Priority: 4 Facility Function:
 Implementation Phase: Implementation Date:
 Official Responsible:

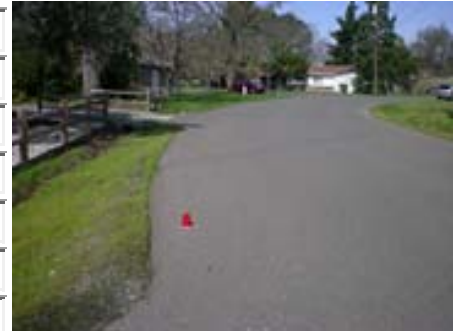
Field Date: 3/17/2011 Report Date: 3/17/2011 Barrier #: 6070
 Location: Mica Wy - South
 X Coordinate: -121.24719
 Y Coordinate: 38.70541
 Barrier Area: Sidewalks
 Barrier Type: No sidewalk
 Code Ref: CBC 1127B.1 and ADA/ABA 206.2.1

As Built Meas: 58 Quantity: LF
 Description: No pedestrian route provided
 As Built Desc: No sidewalk provided
 Solution: Construct new firm and stable pedestrian route
 Bar. Severity: 1 Necessary Cost Estimate: \$5,800.00 Status:
 Implementation Priority: 4 Facility Function:
 Implementation Phase: Implementation Date:
 Official Responsible:

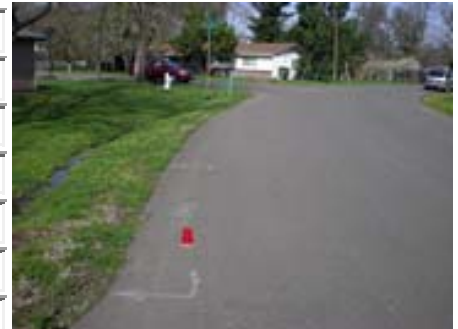
Field Date: 3/17/2011 Report Date: 3/17/2011 Barrier #: 6071
 Location: Mica Wy - West
 X Coordinate: -121.24739
 Y Coordinate: 38.70549
 Barrier Area: Sidewalks
 Barrier Type: No sidewalk
 Code Ref: CBC 1127B.1 and ADA/ABA 206.2.1

As Built Meas: 137 Quantity: LF
 Description: No pedestrian route provided
 As Built Desc: No sidewalk provided
 Solution: Construct new firm and stable pedestrian route
 Bar. Severity: 1 Necessary Cost Estimate: \$13,700.00 Status:
 Implementation Priority: 4 Facility Function:
 Implementation Phase: Implementation Date:
 Official Responsible:

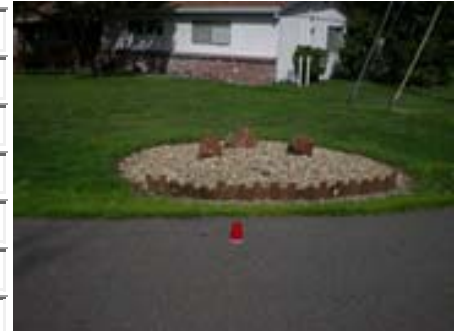
Field Date: 3/17/2011 Report Date: 3/17/2011 Barrier #: 6072
 Location: Mica Wy and Basalt Ct - Corner A
 X Coordinate: -121.24759
 Y Coordinate: 38.70579
 Barrier Area: Blended Transitions
 Barrier Type: Detectable Warnings - Truncated Domes
 Code Ref: CBC 1127B.5.3

As Built Meas: 1 Quantity: EACH
 Description: No truncated domes provided at transition into roadway
 As Built Desc: No detectable warning provided
 Solution: Provide compliant truncated domes
 Bar. Severity: 2 Recommended Cost Estimate: \$1,400.00 Status:
 Implementation Priority: 4 Facility Function:
 Implementation Phase: Implementation Date:
 Official Responsible:

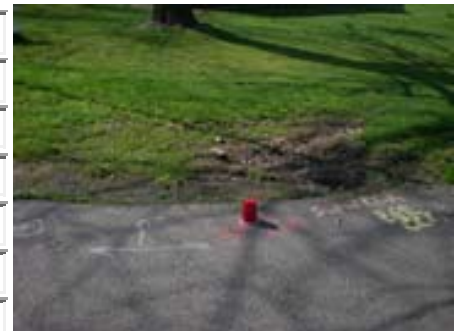
Field Date: 3/17/2011 Report Date: 3/17/2011 Barrier #: 6073
 Location: Mica Wy and Basalt Ct - Corner D
 X Coordinate: -121.24756
 Y Coordinate: 38.7057
 Barrier Area: Blended Transitions
 Barrier Type: Detectable Warnings - Truncated Domes
 Code Ref: CBC 1127B.5.3

As Built Meas: 1 Quantity: EACH
 Description: No truncated domes provided at transition into roadway
 As Built Desc: No detectable warning provided
 Solution: Provide compliant truncated domes
 Bar. Severity: 2 Recommended Cost Estimate: \$1,400.00 Status:
 Implementation Priority: 4 Facility Function:
 Implementation Phase: Implementation Date:
 Official Responsible:

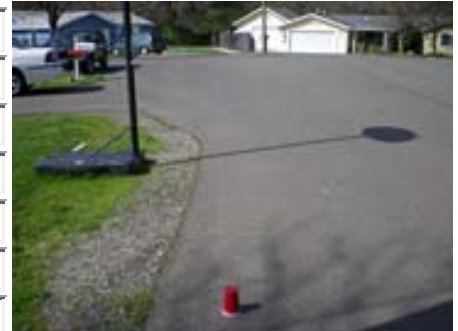
Barrier Type: No sidewalk

Code Ref: CBC 1127B.1 and ADA/ABA 206.2.1

As Built Meas: 278 Quantity: LF

Description: No pedestrian route provided

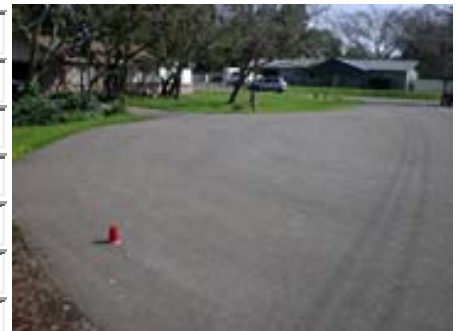
Barrier Type: No sidewalk

Code Ref: CBC 1127B.1 and ADA/ABA 206.2.1

As Built Meas: 170 Quantity: LF

Description: No pedestrian route provided

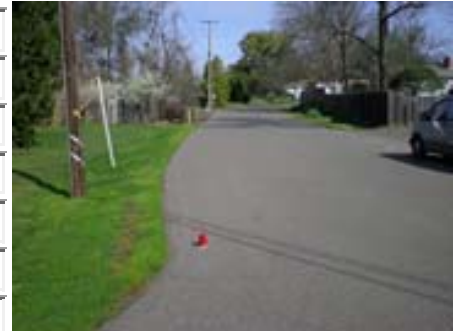
Field Date: 3/17/2011 Report Date: 3/17/2011 Barrier #: 6076
 Location: Mica Wy - West
 X Coordinate: -121.24758
 Y Coordinate: 38.70582
 Barrier Area: Sidewalks
 Barrier Type: No sidewalk
 Code Ref: CBC 1127B.1 and ADA/ABA 206.2.1

As Built Meas: 229 Quantity: LF
 Description: No pedestrian route provided
 As Built Desc: No sidewalk provided
 Solution: Construct new firm and stable pedestrian route
 Bar. Severity: 1 Necessary Cost Estimate: \$22,900.00 Status:
 Implementation Priority: 4 Facility Function:
 Implementation Phase: Implementation Date:
 Official Responsible:

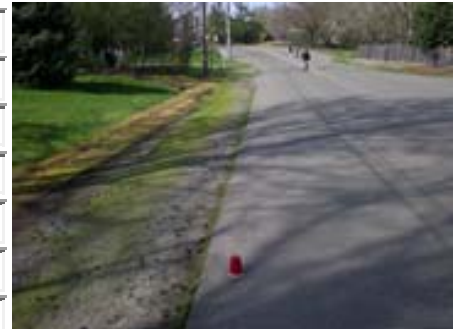
Field Date: 3/17/2011 Report Date: 3/17/2011 Barrier #: 6077
 Location: Olivine Ave - South
 X Coordinate: -121.24784
 Y Coordinate: 38.70652
 Barrier Area: Sidewalks
 Barrier Type: No sidewalk
 Code Ref: CBC 1127B.1 and ADA/ABA 206.2.1

As Built Meas: 251 Quantity: LF
 Description: No pedestrian route provided
 As Built Desc: No sidewalk provided
 Solution: Construct new firm and stable pedestrian route
 Bar. Severity: 1 Necessary Cost Estimate: \$25,100.00 Status:
 Implementation Priority: 2 Facility Function:
 Implementation Phase: Implementation Date:
 Official Responsible:

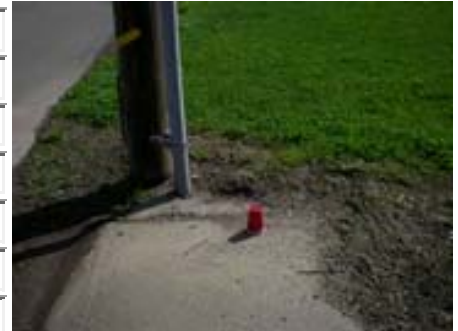
Field Date: 3/17/2011 Report Date: 3/17/2011 Barrier #: 6078
 Location: Olivine Ave - South
 X Coordinate: -121.24865
 Y Coordinate: 38.70646
 Barrier Area: Sidewalks
 Barrier Type: No Sidewalk - No Barricade
 Code Ref: MUTCD Section 6D.01

As Built Meas: 1 Quantity: JOB
 Description: No barricade provided where sidewalk ends in hazardous location
 As Built Desc: No barricade or other warning provided for the visually impaired at end of sidewalk
 Solution: Provide barricade with cane detectable warning at end of sidewalk
 Bar. Severity: 1 Necessary Cost Estimate: \$1,350.00 Status:
 Implementation Priority: 2 Facility Function:
 Implementation Phase: Implementation Date:
 Official Responsible:

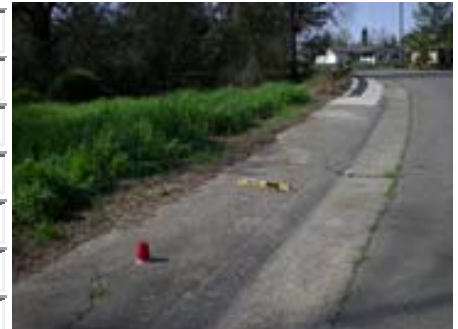
Field Date: 3/17/2011 Report Date: 3/17/2011 Barrier #: 6079A
 Location: Olivine Ave - South
 X Coordinate: -121.2487
 Y Coordinate: 38.70646
 Barrier Area: Sidewalks
 Barrier Type: Cross Slope - Existing (3.1% to 4.0%)
 Code Ref: CBC 1133B.7.1.3 and ADA/ABA 403.3

As Built Meas: 173 Quantity: LF
 Description: Cross slope exceeds 2.0% (3.1% to 4.0%)
 As Built Desc: 3.3% cross slope
 Solution: Demolish existing and construct new route
 Bar. Severity: 3 Hinderance Cost Estimate: \$21,625.00 Status:
 Implementation Priority: 2 Facility Function:
 Implementation Phase: Implementation Date:
 Official Responsible:

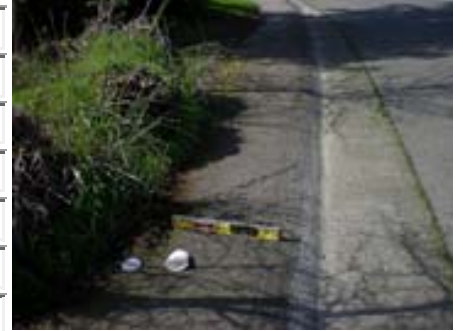
Field Date: 3/17/2011 Report Date: 3/17/2011 Barrier #: 6079B
 Location: Olivine Ave - South
 X Coordinate: -121.24919
 Y Coordinate: 38.70631
 Barrier Area: Sidewalks
 Barrier Type: Clear Width - Existing ($\leq 31''$ or less)
 Code Ref: CBC 1133B.7.1

As Built Meas: 1 Quantity: LF
 Description: Pedestrian route is not min. 48" wide ($\leq 31''$ or less)
 As Built Desc: 24" clear width due to foliage
 Solution: Trim foliage to provide min. 48" clear width
 Bar. Severity: 1 Necessary Cost Estimate: \$125.00 Status:
 Implementation Priority: 2 Facility Function:
 Implementation Phase: Implementation Date:
 Official Responsible:

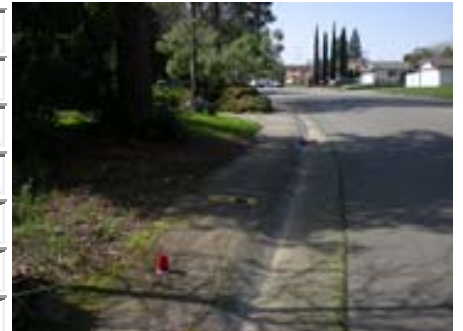
Field Date: 3/17/2011 Report Date: 3/17/2011 Barrier #: 6080A
 Location: Olivine Ave - East
 X Coordinate: -121.24927
 Y Coordinate: 38.70629
 Barrier Area: Sidewalks
 Barrier Type: Cross Slope - Existing (5.0% or more)
 Code Ref: CBC 1133B.7.1.3 and ADA/ABA 403.3

As Built Meas: 583 Quantity: LF
 Description: Cross slope exceeds 2.0% (5.0% or more)
 As Built Desc: 5.0% cross slope
 Solution: Demolish existing and construct new route
 Bar. Severity: 1 Necessary Cost Estimate: \$72,875.00 Status:
 Implementation Priority: 2 Facility Function:
 Implementation Phase: Implementation Date:
 Official Responsible:

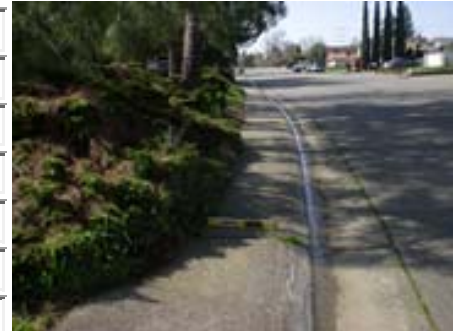
Field Date: 3/17/2011 Report Date: 3/17/2011 Barrier #: 6080B
 Location: Olivine Ave - East
 X Coordinate: -121.24943
 Y Coordinate: 38.70621
 Barrier Area: Sidewalks
 Barrier Type: Clear Width - Existing ($\leq 31''$ or less)
 Code Ref: CBC 1133B.7.1

As Built Meas: 1 Quantity: LF
 Description: Pedestrian route is not min. 48" wide ($\leq 31''$ or less)
 As Built Desc: 24" clear width due to foliage
 Solution: Trim foliage to provide min. 48" clear width
 Bar. Severity: 1 Necessary Cost Estimate: \$125.00 Status:
 Implementation Priority: 2 Facility Function:
 Implementation Phase: Implementation Date:
 Official Responsible:

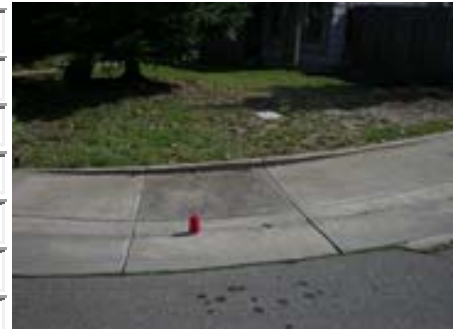
Field Date: 3/17/2011 Report Date: 3/17/2011 Barrier #: 6081A
 Location: Olivine Ave and Zancanaro Ct - Corner B
 X Coordinate: -121.2507
 Y Coordinate: 38.70512
 Barrier Area: Curb Ramps
 Barrier Type: 12" Grooves - Existing (2.1% to 3.0%)
 Code Ref: CBC 1127B.5.6

As Built Meas: 1 Quantity: EACH
 Description: 12" grooves at top of curb ramp are not level (2.1% to 3.0%)
 As Built Desc: 2.7% at 12" grooves
 Solution: Demolish existing and construct new curb ramp
 Bar. Severity: 4 Low Severity Cost Estimate: \$2,500.00 Status:
 Implementation Priority: 2 Facility Function:
 Implementation Phase: Implementation Date:
 Official Responsible:

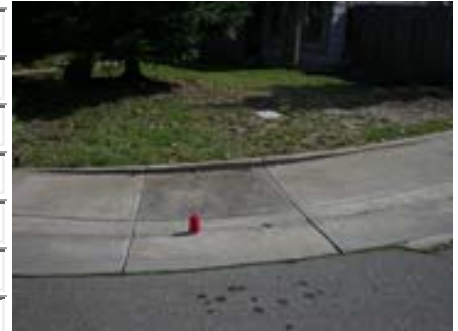
Field Date: 3/17/2011 Report Date: 3/17/2011 Barrier #: 6081B
 Location: Olivine Ave and Zancanaro Ct - Corner B
 X Coordinate: -121.2507
 Y Coordinate: 38.70512
 Barrier Area: Curb Ramps
 Barrier Type: Parallel Ramp Landing - Existing (>5.0% or more)
 Code Ref: CBC 1127B.5.4 and ADA/ABA 406.4

As Built Meas: 1 Quantity: EACH
 Description: Curb ramp landing or pan not level (>5.0% or more)
 As Built Desc: 7.0% landing slope
 Solution: Demolish existing and construct new transition
 Bar. Severity: 1 Necessary Cost Estimate: \$250.00 Status:
 Implementation Priority: 2 Facility Function:
 Implementation Phase: Implementation Date:
 Official Responsible:

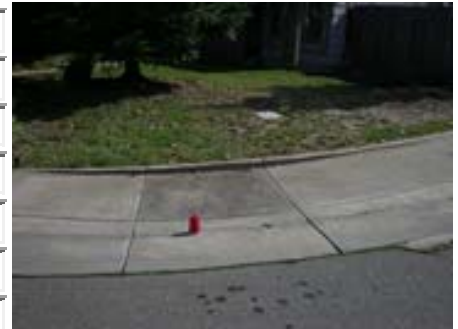
Field Date: 3/17/2011 Report Date: 3/17/2011 Barrier #: 6081C
 Location: Olivine Ave and Zancanaro Ct - Corner B
 X Coordinate: -121.2507
 Y Coordinate: 38.70512
 Barrier Area: Curb Ramps
 Barrier Type: Detectable Warnings - Truncated Domes
 Code Ref: CBC 1127B.5.7 and ADA/ABA 705.1.3

As Built Meas: 1 Quantity: EACH
 Description: No truncated domes provided at curb ramp
 As Built Desc: No detectable warnings at curb ramp
 Solution: Provide compliant truncated domes
 Bar. Severity: 2 Recommended Cost Estimate: \$1,400.00 Status:
 Implementation Priority: 2 Facility Function:
 Implementation Phase: Implementation Date:
 Official Responsible:

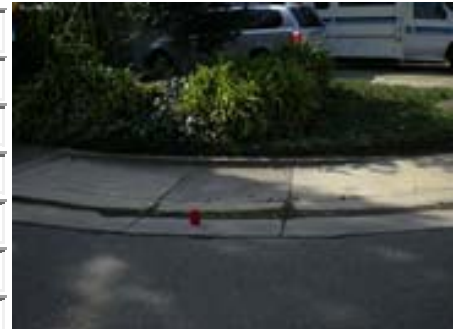
Field Date: 3/17/2011 Report Date: 3/17/2011 Barrier #: 6082A
 Location: Olivine Ave and Zancanaro Ct - Corner C
 X Coordinate: -121.25074
 Y Coordinate: 38.70507
 Barrier Area: Curb Ramps
 Barrier Type: Parallel Ramp Landing - Existing (3.1% to 4.0%)
 Code Ref: CBC 1127B.5.4 and ADA/ABA 406.4

As Built Meas: 1 Quantity: EACH
 Description: Curb ramp landing or pan not level (3.1% to 4.0%)
 As Built Desc: 3.4% landing slope
 Solution: Demolish existing and construct new transition
 Bar. Severity: 3 Hindrance Cost Estimate: \$250.00 Status:
 Implementation Priority: 2 Facility Function:
 Implementation Phase: Implementation Date:
 Official Responsible:

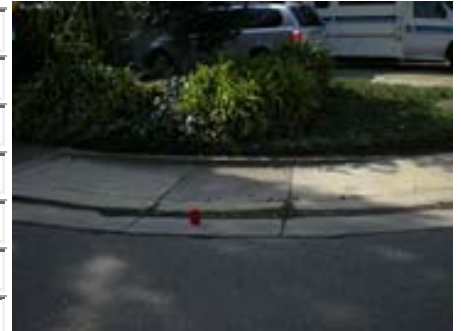
Field Date: 3/17/2011 Report Date: 3/17/2011 Barrier #: 6082B
 Location: Olivine Ave and Zancanaro Ct - Corner C
 X Coordinate: -121.25074
 Y Coordinate: 38.70507
 Barrier Area: Curb Ramps
 Barrier Type: Detectable Warnings - Truncated Domes
 Code Ref: CBC 1127B.5.7 and ADA/ABA 705.1.3

As Built Meas: 1 Quantity: EACH
 Description: No truncated domes provided at curb ramp
 As Built Desc: No detectable warnings at curb ramp
 Solution: Provide compliant truncated domes
 Bar. Severity: 2 Recommended Cost Estimate: \$1,400.00 Status:
 Implementation Priority: 2 Facility Function:
 Implementation Phase: Implementation Date:
 Official Responsible:

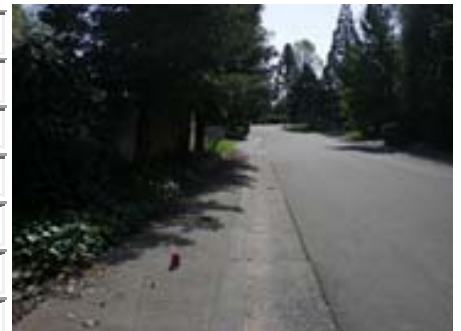
Field Date: 3/17/2011 Report Date: 3/17/2011 Barrier #: 6083A
 Location: Zancanaro Ct - North
 X Coordinate: -121.25058
 Y Coordinate: 38.7051
 Barrier Area: Sidewalks
 Barrier Type: Cross Slope - Existing (4.1% to 4.9%)
 Code Ref: CBC 1133B.7.1.3 and ADA/ABA 403.3

As Built Meas: 492 Quantity: LF
 Description: Cross slope exceeds 2.0% (4.1% to 4.9%)
 As Built Desc: 4.8% cross slope
 Solution: Demolish existing and construct new route
 Bar. Severity: 2 Recommended Cost Estimate: \$61,500.00 Status:
 Implementation Priority: 4 Facility Function:
 Implementation Phase: Implementation Date:
 Official Responsible:

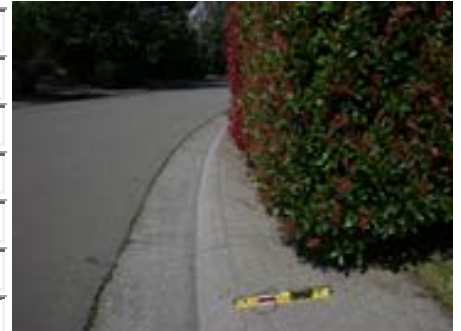
Field Date: 3/17/2011 Report Date: 3/17/2011 Barrier #: 6083B
 Location: Zancanaro Ct - North
 X Coordinate: -121.2502
 Y Coordinate: 38.70488
 Barrier Area: Sidewalks
 Barrier Type: Clear Width - Existing ($\leq 31''$ or less)
 Code Ref: CBC 1133B.7.1

As Built Meas: 1 Quantity: LF
 Description: Pedestrian route is not min. 48" wide ($\leq 31''$ or less)
 As Built Desc: 24" clear width due to foliage
 Solution: Trim foliage to provide min. 48" clear width
 Bar. Severity: 1 Necessary Cost Estimate: \$125.00 Status:
 Implementation Priority: 4 Facility Function:
 Implementation Phase: Implementation Date:
 Official Responsible:

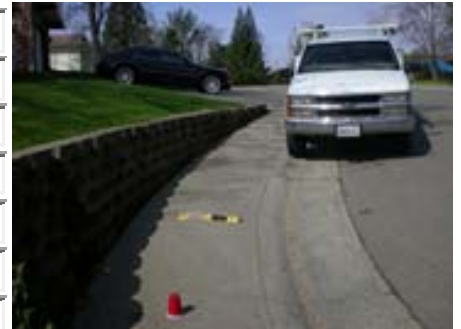
Field Date: 3/17/2011 Report Date: 3/17/2011 Barrier #: 6084
 Location: Zancanaro Ct - South
 X Coordinate: -121.2493
 Y Coordinate: 38.70455
 Barrier Area: Sidewalks
 Barrier Type: Cross Slope - Existing (4.1% to 4.9%)
 Code Ref: CBC 1133B.7.1.3 and ADA/ABA 403.3

As Built Meas: 539 Quantity: LF
 Description: Cross slope exceeds 2.0% (4.1% to 4.9%)
 As Built Desc: 4.3% cross slope
 Solution: Demolish existing and construct new route
 Bar. Severity: 2 Recommended Cost Estimate: \$67,375.00 Status:
 Implementation Priority: 4 Facility Function:
 Implementation Phase: Implementation Date:
 Official Responsible:

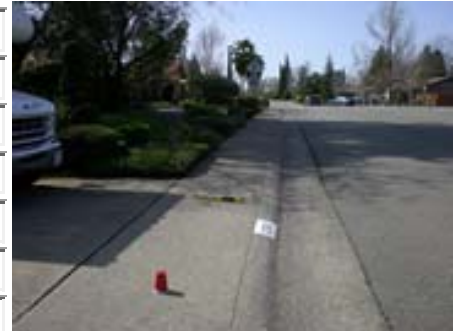
Field Date: 3/17/2011 Report Date: 3/17/2011 Barrier #: 6085A
 Location: Olivine Ave - East
 X Coordinate: -121.25081
 Y Coordinate: 38.70497
 Barrier Area: Sidewalks
 Barrier Type: Cross Slope - Existing (4.1% to 4.9%)
 Code Ref: CBC 1133B.7.1.3 and ADA/ABA 403.3

As Built Meas: 436 Quantity: LF
 Description: Cross slope exceeds 2.0% (4.1% to 4.9%)
 As Built Desc: 4.4% cross slope
 Solution: Demolish existing and construct new route
 Bar. Severity: 2 Recommended Cost Estimate: \$54,500.00 Status:
 Implementation Priority: 2 Facility Function:
 Implementation Phase: Implementation Date:
 Official Responsible:

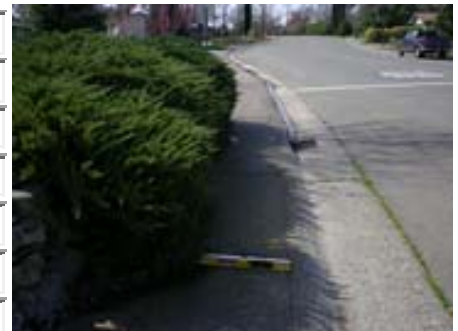
Field Date: 3/17/2011 Report Date: 3/17/2011 Barrier #: 6085B
 Location: Olivine Ave - East
 X Coordinate: -121.25128
 Y Coordinate: 38.70466
 Barrier Area: Sidewalks
 Barrier Type: Clear Width - Existing ($\leq 31''$ or less)
 Code Ref: CBC 1133B.7.1

As Built Meas: 1 Quantity: LF
 Description: Pedestrian route is not min. 48" wide ($\leq 31''$ or less)
 As Built Desc: 24" clear width due to foliage
 Solution: Trim foliage to provide min. 48" clear width
 Bar. Severity: 1 Necessary Cost Estimate: \$125.00 Status:
 Implementation Priority: 2 Facility Function:
 Implementation Phase: Implementation Date:
 Official Responsible:

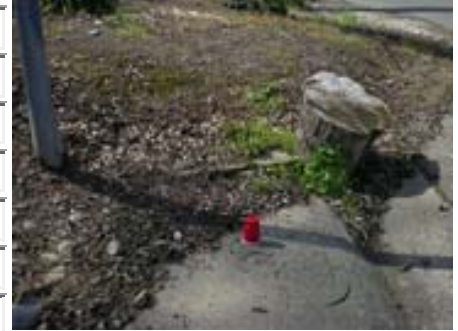
Field Date: 3/17/2011 Report Date: 3/17/2011 Barrier #: 6085C
 Location: Olivine Ave - East
 X Coordinate: -121.25173
 Y Coordinate: 38.70408
 Barrier Area: Sidewalks
 Barrier Type: No Sidewalk - No Barricade
 Code Ref: MUTCD Section 6D.01

As Built Meas: 1 Quantity: JOB
 Description: No barricade provided where sidewalk ends in hazardous location
 As Built Desc: No barricade or other warning provided for the visually impaired at end of sidewalk
 Solution: Provide barricade with cane detectable warning at end of sidewalk
 Bar. Severity: 1 Necessary Cost Estimate: \$1,350.00 Status:
 Implementation Priority: 2 Facility Function:
 Implementation Phase: Implementation Date:
 Official Responsible:

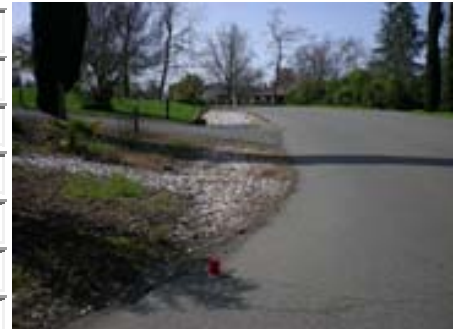
Field Date: 3/17/2011 Report Date: 3/17/2011 Barrier #: 6086
 Location: Olivine Ave - East
 X Coordinate: -121.2518
 Y Coordinate: 38.70407
 Barrier Area: Sidewalks
 Barrier Type: No sidewalk
 Code Ref: CBC 1127B.1 and ADA/ABA 206.2.1

As Built Meas: 1333 Quantity: LF
 Description: No pedestrian route provided
 As Built Desc: No sidewalk provided
 Solution: Construct new firm and stable pedestrian route
 Bar. Severity: 1 Necessary Cost Estimate: \$133,300.00 Status:
 Implementation Priority: 2 Facility Function:
 Implementation Phase: Implementation Date:
 Official Responsible:

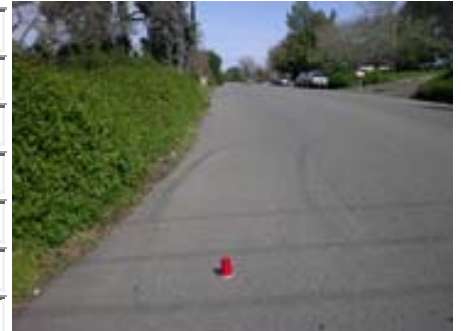
Field Date: 3/17/2011 Report Date: 3/17/2011 Barrier #: 6087
 Location: Olivine Ave - West
 X Coordinate: -121.25222
 Y Coordinate: 38.70063
 Barrier Area: Sidewalks
 Barrier Type: No sidewalk
 Code Ref: CBC 1127B.1 and ADA/ABA 206.2.1

As Built Meas: 1270 Quantity: LF
 Description: No pedestrian route provided
 As Built Desc: No sidewalk provided
 Solution: Construct new firm and stable pedestrian route
 Bar. Severity: 1 Necessary Cost Estimate: \$127,000.00 Status:
 Implementation Priority: 2 Facility Function:
 Implementation Phase: Implementation Date:
 Official Responsible:

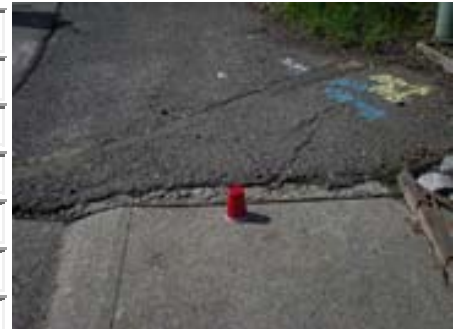
Field Date: 3/17/2011 Report Date: 3/17/2011 Barrier #: 6088
 Location: Olivine Ave - West
 X Coordinate: -121.25201
 Y Coordinate: 38.70408
 Barrier Area: Sidewalks
 Barrier Type: No Sidewalk - No Barricade
 Code Ref: MUTCD Section 6D.01

As Built Meas: 1 Quantity: JOB
 Description: No barricade provided where sidewalk ends in hazardous location
 As Built Desc: No barricade or other warning provided for the visually impaired at end of sidewalk
 Solution: Provide barricade with cane detectable warning at end of sidewalk
 Bar. Severity: 1 Necessary Cost Estimate: \$1,350.00 Status:
 Implementation Priority: 2 Facility Function:
 Implementation Phase: Implementation Date:
 Official Responsible:

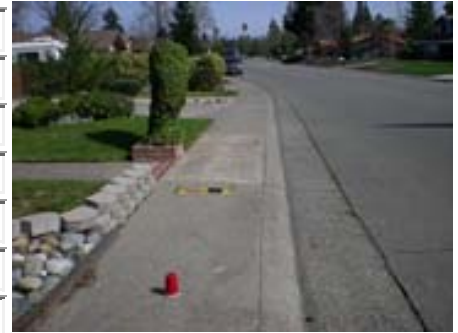
Field Date: 3/17/2011 Report Date: 3/17/2011 Barrier #: 6089A
 Location: Olivine Ave - West
 X Coordinate: -121.25198
 Y Coordinate: 38.7041
 Barrier Area: Sidewalks
 Barrier Type: Cross Slope - Existing (3.1% to 4.0%)
 Code Ref: CBC 1133B.7.1.3 and ADA/ABA 403.3

As Built Meas: 365 Quantity: LF
 Description: Cross slope exceeds 2.0% (3.1% to 4.0%)
 As Built Desc: 3.8% cross slope
 Solution: Demolish existing and construct new route
 Bar. Severity: 3 Hinderance Cost Estimate: \$45,625.00 Status:
 Implementation Priority: 2 Facility Function:
 Implementation Phase: Implementation Date:
 Official Responsible:

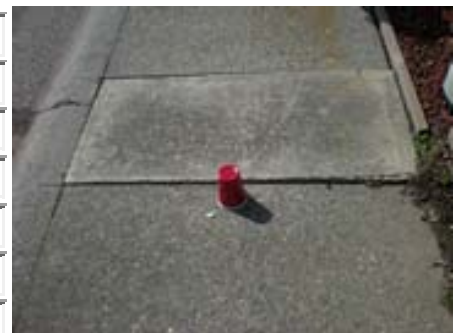
Field Date: 3/17/2011 Report Date: 3/17/2011 Barrier #: 6089B
 Location: Olivine Ave - West
 X Coordinate: -121.2516
 Y Coordinate: 38.70442
 Barrier Area: Sidewalks
 Barrier Type: Abrupt Change in Level - > 1/2"
 Code Ref: CBC 1133B.7.1 and ADA/ABA 303.3

As Built Meas: 4 Quantity: LF
 Description: Change in level greater than 1/2"
 As Built Desc: 1/2" lip in sidewalk surface
 Solution: Grind or repair sidewalk to remove trip hazard
 Bar. Severity: 1 Necessary Cost Estimate: \$1,000.00 Status:
 Implementation Priority: 2 Facility Function:
 Implementation Phase: Implementation Date:
 Official Responsible:

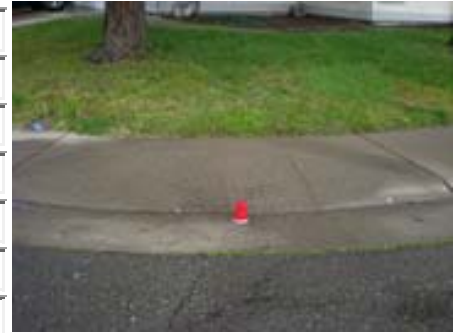
Field Date: 3/22/2011 Report Date: 3/22/2011 Barrier #: 6090A
 Location: Bearded Iris Dr and Aster Ct - Corner A
 X Coordinate: -121.24857
 Y Coordinate: 38.70095
 Barrier Area: Curb Ramps
 Barrier Type: Parallel Ramp Landing - Existing (>5.0% or more)
 Code Ref: CBC 1127B.5.4 and ADA/ABA 406.4

As Built Meas: 1 Quantity: EACH
 Description: Curb ramp landing or pan not level (>5.0% or more)
 As Built Desc: 7.7% landing slope
 Solution: Demolish existing and construct new transition
 Bar. Severity: 1 Necessary Cost Estimate: \$250.00 Status:
 Implementation Priority: 4 Facility Function:
 Implementation Phase: Implementation Date:
 Official Responsible:

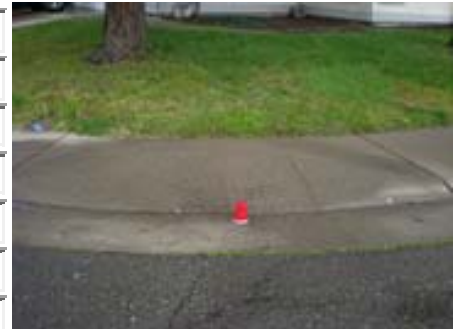
Field Date: 3/22/2011 Report Date: 3/22/2011 Barrier #: 6090B
 Location: Bearded Iris Dr and Aster Ct - Corner A
 X Coordinate: -121.24857
 Y Coordinate: 38.70095
 Barrier Area: Curb Ramps
 Barrier Type: Detectable Warnings - Truncated Domes
 Code Ref: CBC 1127B.5.7 and ADA/ABA 705.1.3

As Built Meas: 1 Quantity: EACH
 Description: No truncated domes provided at curb ramp
 As Built Desc: No detectable warnings at curb ramp
 Solution: Provide compliant truncated domes
 Bar. Severity: 2 Recommended Cost Estimate: \$1,400.00 Status:
 Implementation Priority: 4 Facility Function:
 Implementation Phase: Implementation Date:
 Official Responsible:

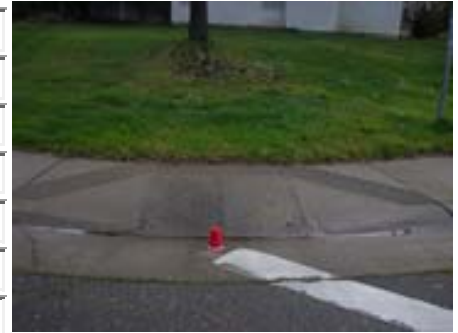
Field Date: 3/22/2011 Report Date: 3/22/2011 Barrier #: 6091A
 Location: Bearded Iris Dr and Aster Ct - Corner B
 X Coordinate: -121.24844
 Y Coordinate: 38.7009
 Barrier Area: Curb Ramps
 Barrier Type: 12" Grooves - Existing (3.1% to 4.0%)
 Code Ref: CBC 1127B.5.6

As Built Meas: 1 Quantity: EACH
 Description: 12" grooves at top of curb ramp are not level (3.1% to 4.0%)
 As Built Desc: 3.8% at 12" grooves
 Solution: Demolish existing and construct new curb ramp
 Bar. Severity: 3 Hindrance Cost Estimate: \$2,500.00 Status:
 Implementation Priority: 4 Facility Function:
 Implementation Phase: Implementation Date:
 Official Responsible:
