**DRAFT ADA TRANSITION PLAN UPDATE
NEIGHBORHOOD AREA 8 CHASE
SEPTEMBER 20, 2011**

CITY OF CITRUS HEIGHTS

Conditions - CHASE Area 8

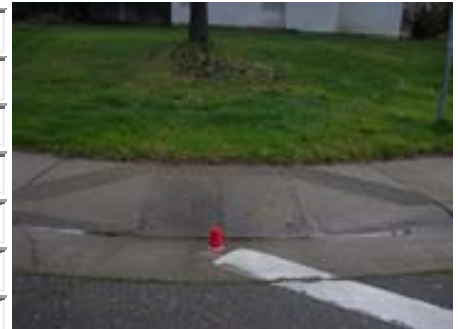
Field Date: 3/22/2011 Report Date: 3/22/2011 Barrier #: 6091B
 Location: Bearded Iris Dr and Aster Ct - Corner B
 X Coordinate: -121.24844
 Y Coordinate: 38.7009
 Barrier Area: Curb Ramps
 Barrier Type: Perpendicular Ramp Landing (>5.0% or more)
 Code Ref: CBC 1127B.5.4 and ADA/ABA 406.4

As Built Meas: 1 Quantity: EACH
 Description: Curb ramp top landing not level (>5.0% or more)
 As Built Desc: 5.8% landing slope
 Solution: Demolish existing and construct new transition
 Bar. Severity: 1 Necessary Cost Estimate: \$250.00 Status:
 Implementation Priority: 4 Facility Function:
 Implementation Phase: Implementation Date:
 Official Responsible:

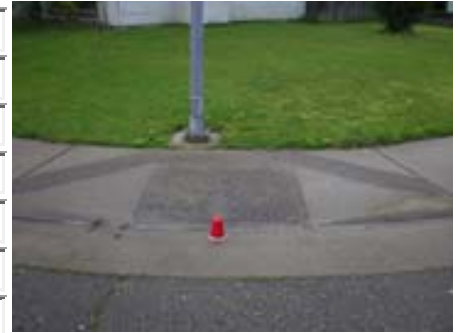
Field Date: 3/22/2011 Report Date: 3/22/2011 Barrier #: 6092A
 Location: Bearded Iris Dr and Aster Ct - Corner C
 X Coordinate: -121.24848
 Y Coordinate: 38.7008
 Barrier Area: Curb Ramps
 Barrier Type: Perpendicular Ramp Landing (>5.0% or more)
 Code Ref: CBC 1127B.5.4 and ADA/ABA 406.4

As Built Meas: 1 Quantity: EACH
 Description: Curb ramp top landing not level (>5.0% or more)
 As Built Desc: 6.3% landing slope
 Solution: Demolish existing and construct new transition
 Bar. Severity: 1 Necessary Cost Estimate: \$250.00 Status:
 Implementation Priority: 4 Facility Function:
 Implementation Phase: Implementation Date:
 Official Responsible:

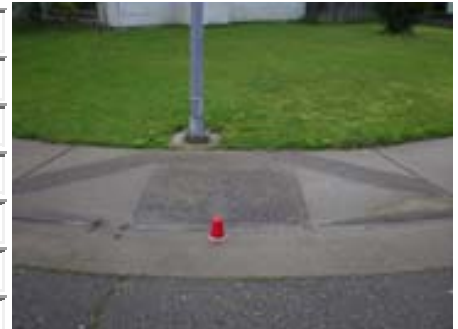
Field Date: 3/22/2011 Report Date: 3/22/2011 Barrier #: 6092B
 Location: Bearded Iris Dr and Aster Ct - Corner C
 X Coordinate: -121.24848
 Y Coordinate: 38.7008
 Barrier Area: Curb Ramps
 Barrier Type: Detectable Warnings - Truncated Domes
 Code Ref: CBC 1127B.5.7 and ADA/ABA 705.1.3

As Built Meas: 1 Quantity: EACH
 Description: No truncated domes provided at curb ramp
 As Built Desc: No detectable warnings at curb ramp
 Solution: Provide compliant truncated domes
 Bar. Severity: 2 Recommended Cost Estimate: \$1,400.00 Status:
 Implementation Priority: 4 Facility Function:
 Implementation Phase: Implementation Date:
 Official Responsible:

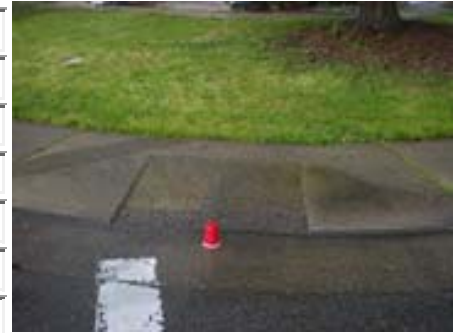
Field Date: 3/22/2011 Report Date: 3/22/2011 Barrier #: 6093A
 Location: Bearded Iris Dr and Aster Ct - Corner D
 X Coordinate: -121.24865
 Y Coordinate: 38.70082
 Barrier Area: Curb Ramps
 Barrier Type: 12" Grooves - Existing (>5.0%)
 Code Ref: CBC 1127B.5.6

As Built Meas: 1 Quantity: EACH
 Description: 12" grooves at top of curb ramp are not level (>5.0%)
 As Built Desc: 5.2% at 12" grooves
 Solution: Demolish existing and construct new curb ramp
 Bar. Severity: 1 Necessary Cost Estimate: \$2,500.00 Status:
 Implementation Priority: 4 Facility Function:
 Implementation Phase: Implementation Date:
 Official Responsible:

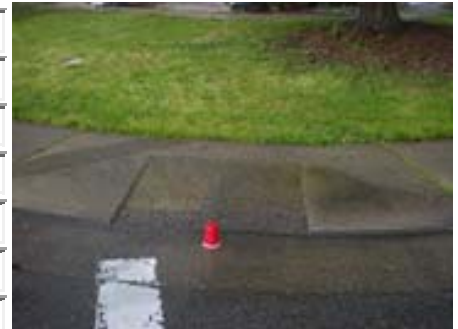
Field Date: 3/22/2011 Report Date: 3/22/2011 Barrier #: 6093B
 Location: Bearded Iris Dr and Aster Ct - Corner D
 X Coordinate: -121.24865
 Y Coordinate: 38.70082
 Barrier Area: Curb Ramps
 Barrier Type: Perpendicular Ramp Landing (>5.0% or more)
 Code Ref: CBC 1127B.5.4 and ADA/ABA 406.4

As Built Meas: 1 Quantity: EACH
 Description: Curb ramp top landing not level (>5.0% or more)
 As Built Desc: 6.5% landing slope
 Solution: Demolish existing and construct new transition
 Bar. Severity: 1 Necessary Cost Estimate: \$250.00 Status:
 Implementation Priority: 4 Facility Function:
 Implementation Phase: Implementation Date:
 Official Responsible:

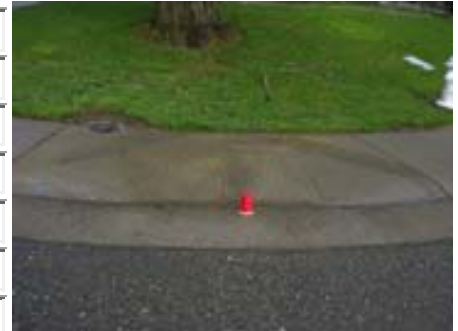
Field Date: 3/22/2011 Report Date: 3/22/2011 Barrier #: 6094A
 Location: Fireweed Cir and Blue Rose Ct - Corner A
 X Coordinate: -121.24834
 Y Coordinate: 38.70156
 Barrier Area: Curb Ramps
 Barrier Type: Parallel Ramp Landing - Existing (>5.0% or more)
 Code Ref: CBC 1127B.5.4 and ADA/ABA 406.4

As Built Meas: 1 Quantity: EACH
 Description: Curb ramp landing or pan not level (>5.0% or more)
 As Built Desc: 6.6% landing slope
 Solution: Demolish existing and construct new transition
 Bar. Severity: 1 Necessary Cost Estimate: \$250.00 Status:
 Implementation Priority: 4 Facility Function:
 Implementation Phase: Implementation Date:
 Official Responsible:

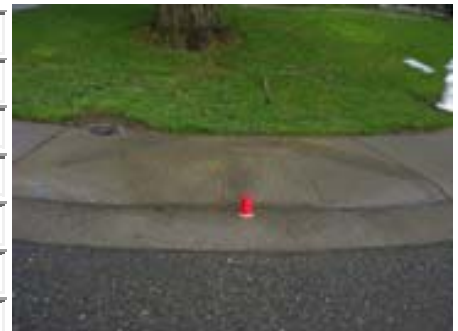
Field Date: 3/22/2011 Report Date: 3/22/2011 Barrier #: 6094B
 Location: Fireweed Cir and Blue Rose Ct - Corner A
 X Coordinate: -121.24834
 Y Coordinate: 38.70156
 Barrier Area: Curb Ramps
 Barrier Type: Detectable Warnings - Truncated Domes
 Code Ref: CBC 1127B.5.7 and ADA/ABA 705.1.3

As Built Meas: 1 Quantity: EACH
 Description: No truncated domes provided at curb ramp
 As Built Desc: No detectable warnings at curb ramp
 Solution: Provide compliant truncated domes
 Bar. Severity: 2 Recommended Cost Estimate: \$1,400.00 Status:
 Implementation Priority: 4 Facility Function:
 Implementation Phase: Implementation Date:
 Official Responsible:

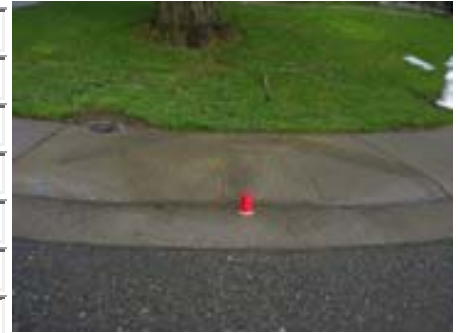
Field Date: 3/22/2011 Report Date: 3/22/2011 Barrier #: 6094C
 Location: Fireweed Cir and Blue Rose Ct - Corner A
 X Coordinate: -121.24834
 Y Coordinate: 38.70156
 Barrier Area: Curb Ramps
 Barrier Type: Gutter Slope - Existing (5.9% - 6.5%)
 Code Ref: CBC 1127B.5.3 and ADA/ABA 406.2

As Built Meas: 6 Quantity: SF
 Description: Gutter slope exceeds 5.0% (5.9% - 6.5%)
 As Built Desc: 6.2% gutter slope
 Solution: Demolish existing and construct new gutter
 Bar. Severity: 3 Hindrance Cost Estimate: \$750.00 Status:
 Implementation Priority: 4 Facility Function:
 Implementation Phase: Implementation Date:
 Official Responsible:

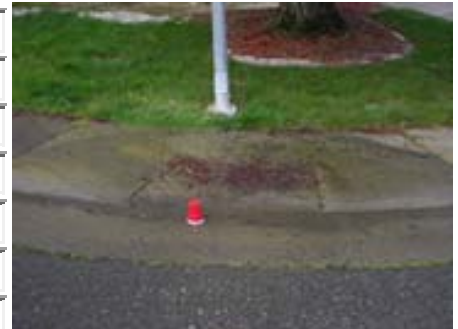
Field Date: 3/22/2011 Report Date: 3/22/2011 Barrier #: 6095A
 Location: Fireweed Cir and Blue Rose Ct - Corner D
 X Coordinate: -121.24839
 Y Coordinate: 38.70143
 Barrier Area: Curb Ramps
 Barrier Type: 12" Grooves - Existing (>5.0%)
 Code Ref: CBC 1127B.5.6

As Built Meas: 1 Quantity: EACH
 Description: 12" grooves at top of curb ramp are not level (>5.0%)
 As Built Desc: 6.3% at 12" grooves
 Solution: Demolish existing and construct new curb ramp
 Bar. Severity: 1 Necessary Cost Estimate: \$2,500.00 Status:
 Implementation Priority: 4 Facility Function:
 Implementation Phase: Implementation Date:
 Official Responsible:

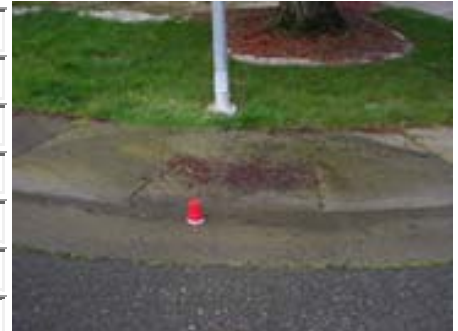
Field Date: 3/22/2011 Report Date: 3/22/2011 Barrier #: 6095B
 Location: Fireweed Cir and Blue Rose Ct - Corner D
 X Coordinate: -121.24839
 Y Coordinate: 38.70143
 Barrier Area: Curb Ramps
 Barrier Type: Perpendicular Ramp Landing (>5.0% or more)
 Code Ref: CBC 1127B.5.4 and ADA/ABA 406.4

As Built Meas: 1 Quantity: EACH
 Description: Curb ramp top landing not level (>5.0% or more)
 As Built Desc: 7.2% landing slope
 Solution: Demolish existing and construct new transition
 Bar. Severity: 1 Necessary Cost Estimate: \$250.00 Status:
 Implementation Priority: 4 Facility Function:
 Implementation Phase: Implementation Date:
 Official Responsible:

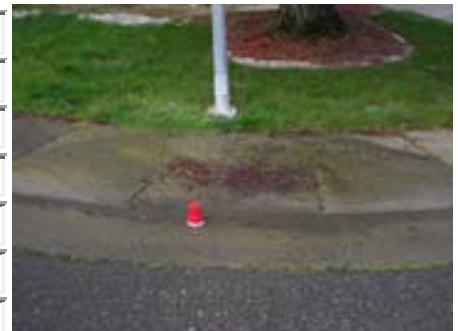
Field Date: 3/22/2011 Report Date: 3/22/2011 Barrier #: 6095C
 Location: Fireweed Cir and Blue Rose Ct - Corner D
 X Coordinate: -121.24839
 Y Coordinate: 38.70143
 Barrier Area: Curb Ramps
 Barrier Type: Detectable Warnings - Truncated Domes
 Code Ref: CBC 1127B.5.7 and ADA/ABA 705.1.3

As Built Meas: 1 Quantity: EACH
 Description: No truncated domes provided at curb ramp
 As Built Desc: No detectable warnings at curb ramp
 Solution: Provide compliant truncated domes
 Bar. Severity: 2 Recommended Cost Estimate: \$1,400.00 Status:
 Implementation Priority: 4 Facility Function:
 Implementation Phase: Implementation Date:
 Official Responsible:

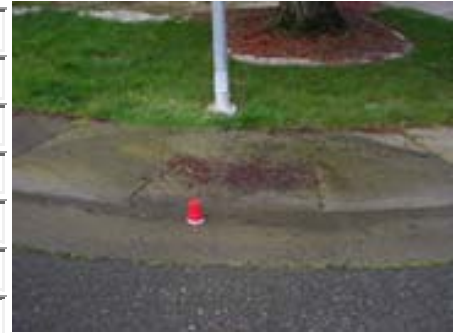
Field Date: 3/22/2011 Report Date: 3/22/2011 Barrier #: 6095D
 Location: Fireweed Cir and Blue Rose Ct - Corner D
 X Coordinate: -121.24839
 Y Coordinate: 38.70143
 Barrier Area: Curb Ramps
 Barrier Type: Gutter Slope - Existing (5.9% - 6.5%)
 Code Ref: CBC 1127B.5.3 and ADA/ABA 406.2

As Built Meas: 6 Quantity: SF
 Description: Gutter slope exceeds 5.0% (5.9% - 6.5%)
 As Built Desc: 6.1% gutter slope
 Solution: Demolish existing and construct new gutter
 Bar. Severity: 3 Hindrance Cost Estimate: \$750.00 Status:
 Implementation Priority: 4 Facility Function:
 Implementation Phase: Implementation Date:
 Official Responsible:

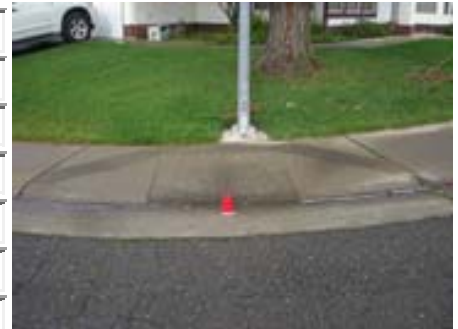
Field Date: 3/22/2011 Report Date: 3/22/2011 Barrier #: 6096A
 Location: Fireweed Cir and Trellium Ct - Corner A
 X Coordinate: -121.24839
 Y Coordinate: 38.70143
 Barrier Area: Curb Ramps
 Barrier Type: 12" Grooves - Existing (2.1% to 3.0%)
 Code Ref: CBC 1127B.5.6

As Built Meas: 1 Quantity: EACH
 Description: 12" grooves at top of curb ramp are not level (2.1% to 3.0%)
 As Built Desc: 2.5% at 12" grooves
 Solution: Demolish existing and construct new curb ramp
 Bar. Severity: 4 Low Severity Cost Estimate: \$2,500.00 Status:
 Implementation Priority: 4 Facility Function:
 Implementation Phase: Implementation Date:
 Official Responsible:

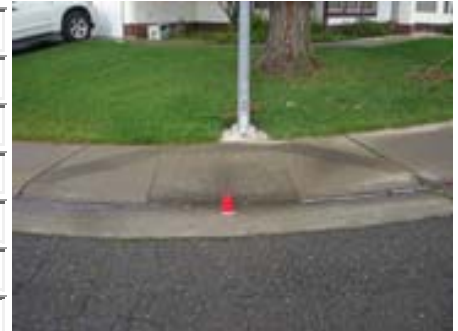
Field Date: 3/22/2011 Report Date: 3/22/2011 Barrier #: 6096B
 Location: Fireweed Cir and Trellium Ct - Corner A
 X Coordinate: -121.24839
 Y Coordinate: 38.70143
 Barrier Area: Curb Ramps
 Barrier Type: Parallel Ramp Landing - Existing (>5.0% or more)
 Code Ref: CBC 1127B.5.4 and ADA/ABA 406.4

As Built Meas: 1 Quantity: EACH
 Description: Curb ramp landing or pan not level (>5.0% or more)
 As Built Desc: 6.9% landing slope
 Solution: Demolish existing and construct new transition
 Bar. Severity: 1 Necessary Cost Estimate: \$250.00 Status:
 Implementation Priority: 4 Facility Function:
 Implementation Phase: Implementation Date:
 Official Responsible:

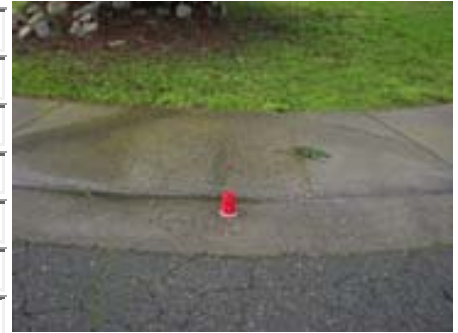
Field Date: 3/22/2011 Report Date: 3/22/2011 Barrier #: 6097B
 Location: Fireweed Cir and Trellium Ct - Corner D
 X Coordinate: -121.24849
 Y Coordinate: 38.70251
 Barrier Area: Curb Ramps
 Barrier Type: Parallel Ramp Landing - Existing (>5.0% or more)
 Code Ref: CBC 1127B.5.4 and ADA/ABA 406.4

As Built Meas: 1 Quantity: EACH
 Description: Curb ramp landing or pan not level (>5.0% or more)
 As Built Desc: 7.6% landing slope
 Solution: Demolish existing and construct new transition
 Bar. Severity: 1 Necessary Cost Estimate: \$250.00 Status:
 Implementation Priority: 4 Facility Function:
 Implementation Phase: Implementation Date:
 Official Responsible:

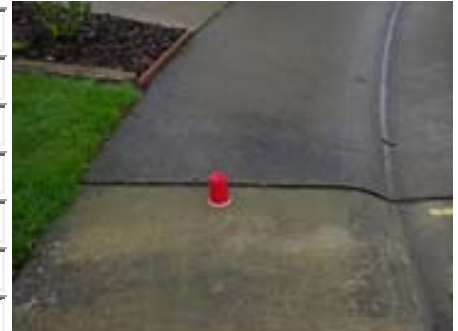
Field Date: 3/22/2011 Report Date: 3/22/2011 Barrier #: 6098
 Location: Trellium Ct - North
 X Coordinate: -121.24886
 Y Coordinate: 38.70228
 Barrier Area: Sidewalks
 Barrier Type: Abrupt Change in Level - > 1/2"
 Code Ref: CBC 1133B.7.1 and ADA/ABA 303.3

As Built Meas: 4 Quantity: LF
 Description: Change in level greater than 1/2"
 As Built Desc: 1/2" lip in sidewalk surface
 Solution: Grind or repair sidewalk to remove trip hazard
 Bar. Severity: 1 Necessary Cost Estimate: \$1,000.00 Status:
 Implementation Priority: 4 Facility Function:
 Implementation Phase: Implementation Date:
 Official Responsible:

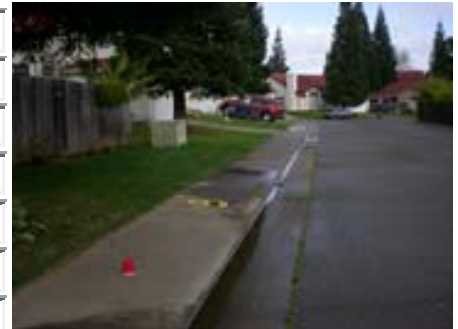
Field Date: 3/22/2011 Report Date: 3/22/2011 Barrier #: 6099
 Location: Fireweed Cir - West
 X Coordinate: -121.24871
 Y Coordinate: 38.70273
 Barrier Area: Sidewalks
 Barrier Type: Cross Slope - Existing (4.1% to 4.9%)
 Code Ref: CBC 1133B.7.1.3 and ADA/ABA 403.3

As Built Meas: 47 Quantity: LF
 Description: Cross slope exceeds 2.0% (4.1% to 4.9%)
 As Built Desc: 4.3% cross slope
 Solution: Demolish existing and construct new route
 Bar. Severity: 2 Recommended Cost Estimate: \$5,875.00 Status:
 Implementation Priority: 4 Facility Function:
 Implementation Phase: Implementation Date:
 Official Responsible:

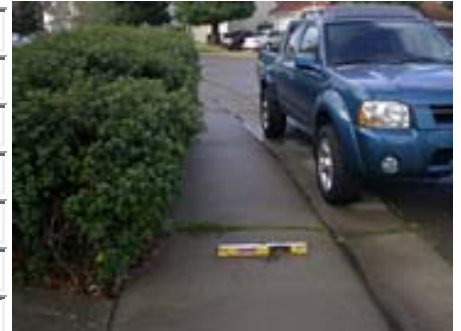
Barrier Type: Clear Width - Existing ($\leq 31''$ or less)

Description: Pedestrian route is not min. 48" wide ($\leq 31''$ or less)

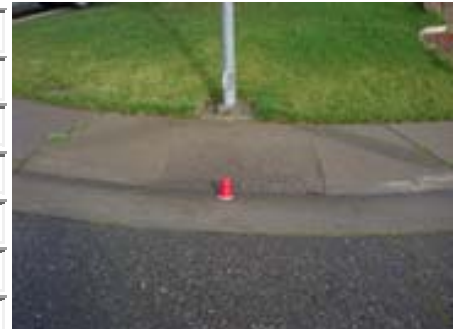
Barrier Type: 12" Grooves - Existing ($> 5.0\%$)

Description: 12" grooves at top of curb ramp are not level ($> 5.0\%$)

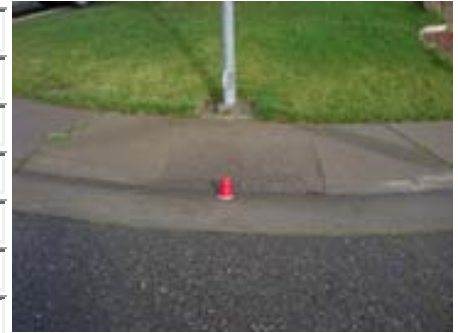
Field Date: 3/22/2011 Report Date: 3/22/2011 Barrier #: 6101B
 Location: Fireweed Cir and Bluebell Ct - Corner A
 X Coordinate: -121.24968
 Y Coordinate: 38.70094
 Barrier Area: Curb Ramps
 Barrier Type: Flares - Existing (10.4% to 10.7%)
 Code Ref: CBC 1127B.5.3 and ADA/ABA 406.3

As Built Meas: 1 Quantity: EACH
 Description: Ramp flare slope exceeds 10.0% (10.4% to 10.7%)
 As Built Desc: 10.6% flare slope
 Solution: Demolish existing and construct new curb ramp
 Bar. Severity: 3 Hindrance Cost Estimate: \$2,500.00 Status:
 Implementation Priority: 4 Facility Function:
 Implementation Phase: Implementation Date:
 Official Responsible:

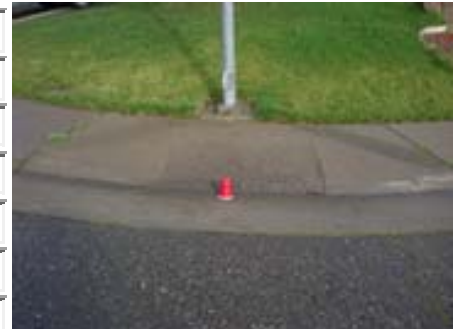
Field Date: 3/22/2011 Report Date: 3/22/2011 Barrier #: 6101C
 Location: Fireweed Cir and Bluebell Ct - Corner A
 X Coordinate: -121.24968
 Y Coordinate: 38.70094
 Barrier Area: Curb Ramps
 Barrier Type: Parallel Ramp Landing - Existing (>5.0% or more)
 Code Ref: CBC 1127B.5.4 and ADA/ABA 406.4

As Built Meas: 1 Quantity: EACH
 Description: Curb ramp landing or pan not level (>5.0% or more)
 As Built Desc: 7.6% landing slope
 Solution: Demolish existing and construct new transition
 Bar. Severity: 1 Necessary Cost Estimate: \$250.00 Status:
 Implementation Priority: 4 Facility Function:
 Implementation Phase: Implementation Date:
 Official Responsible:

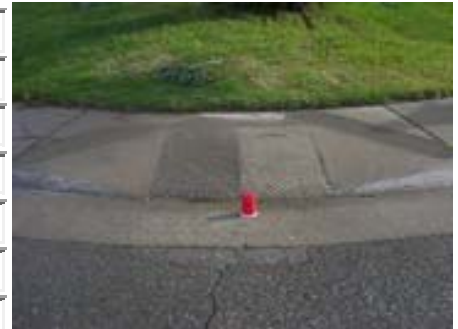
Field Date: 3/22/2011 Report Date: 3/22/2011 Barrier #: 6102A
 Location: Fireweed Cir and Bluebell Ct - Corner B
 X Coordinate: -121.24957
 Y Coordinate: 38.70095
 Barrier Area: Curb Ramps
 Barrier Type: Parallel Ramp Landing - Existing (>5.0% or more)
 Code Ref: CBC 1127B.5.4 and ADA/ABA 406.4

As Built Meas: 1 Quantity: EACH
 Description: Curb ramp landing or pan not level (>5.0% or more)
 As Built Desc: 8.1% landing slope
 Solution: Demolish existing and construct new transition
 Bar. Severity: 1 Necessary Cost Estimate: \$250.00 Status:
 Implementation Priority: 4 Facility Function:
 Implementation Phase: Implementation Date:
 Official Responsible:

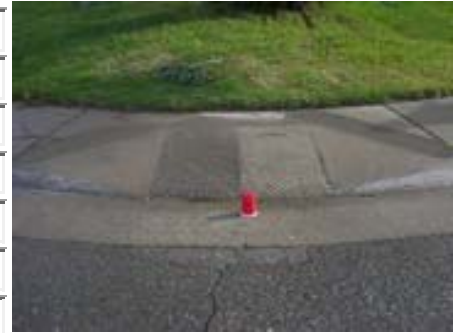
Field Date: 3/22/2011 Report Date: 3/22/2011 Barrier #: 6102B
 Location: Fireweed Cir and Bluebell Ct - Corner B
 X Coordinate: -121.24957
 Y Coordinate: 38.70095
 Barrier Area: Curb Ramps
 Barrier Type: Detectable Warnings - Truncated Domes
 Code Ref: CBC 1127B.5.7 and ADA/ABA 705.1.3

As Built Meas: 1 Quantity: EACH
 Description: No truncated domes provided at curb ramp
 As Built Desc: No detectable warnings at curb ramp
 Solution: Provide compliant truncated domes
 Bar. Severity: 2 Recommended Cost Estimate: \$1,400.00 Status:
 Implementation Priority: 4 Facility Function:
 Implementation Phase: Implementation Date:
 Official Responsible:

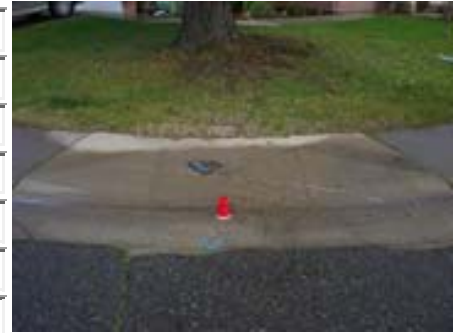
Field Date: 3/22/2011 Report Date: 3/22/2011 Barrier #: 6103A
 Location: Fireweed Cir and Foxglove Ct - Corner A
 X Coordinate: -121.24955
 Y Coordinate: 38.70168
 Barrier Area: Curb Ramps
 Barrier Type: 12" Grooves - Existing (3.1% to 4.0%)
 Code Ref: CBC 1127B.5.6

As Built Meas: 1 Quantity: EACH
 Description: 12" grooves at top of curb ramp are not level (3.1% to 4.0%)
 As Built Desc: 3.8% at 12" grooves
 Solution: Demolish existing and construct new curb ramp
 Bar. Severity: 3 Hindrance Cost Estimate: \$2,500.00 Status:
 Implementation Priority: 4 Facility Function:
 Implementation Phase: Implementation Date:
 Official Responsible:

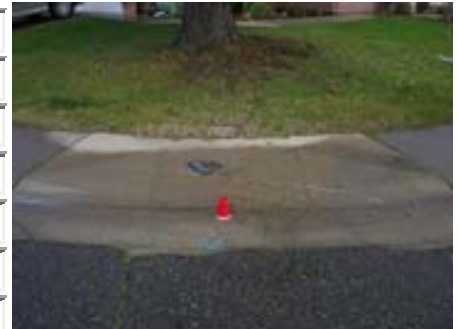
Field Date: 3/22/2011 Report Date: 3/22/2011 Barrier #: 6103B
 Location: Fireweed Cir and Foxglove Ct - Corner A
 X Coordinate: -121.24955
 Y Coordinate: 38.70168
 Barrier Area: Curb Ramps
 Barrier Type: Parallel Ramp Landing - Existing (>5.0% or more)
 Code Ref: CBC 1127B.5.4 and ADA/ABA 406.4

As Built Meas: 1 Quantity: EACH
 Description: Curb ramp landing or pan not level (>5.0% or more)
 As Built Desc: 5.3% landing slope
 Solution: Demolish existing and construct new transition
 Bar. Severity: 1 Necessary Cost Estimate: \$250.00 Status:
 Implementation Priority: 4 Facility Function:
 Implementation Phase: Implementation Date:
 Official Responsible:

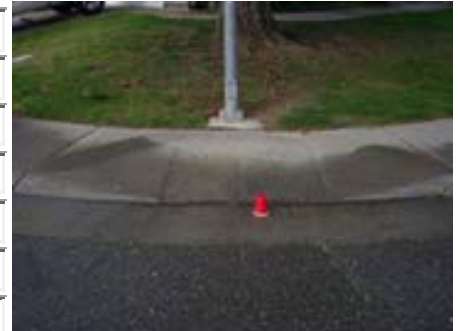
Field Date: 3/22/2011 Report Date: 3/22/2011 Barrier #: 6104A
 Location: Fireweed Cir and Foxglove Ct - Corner D
 X Coordinate: -121.24961
 Y Coordinate: 38.70156
 Barrier Area: Curb Ramps
 Barrier Type: 12" Grooves - Existing (2.1% to 3.0%)
 Code Ref: CBC 1127B.5.6

As Built Meas: 1 Quantity: EACH
 Description: 12" grooves at top of curb ramp are not level (2.1% to 3.0%)
 As Built Desc: 3.0% at 12" grooves
 Solution: Demolish existing and construct new curb ramp
 Bar. Severity: 4 Low Severity Cost Estimate: \$2,500.00 Status:
 Implementation Priority: 4 Facility Function:
 Implementation Phase: Implementation Date:
 Official Responsible:

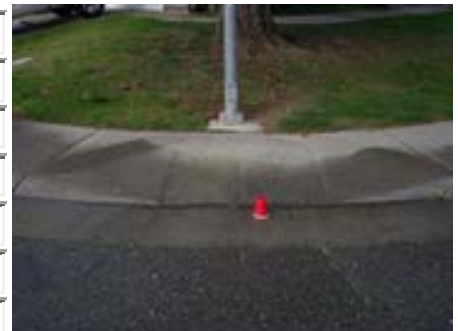
Field Date: 3/22/2011 Report Date: 3/22/2011 Barrier #: 6104B
 Location: Fireweed Cir and Foxglove Ct - Corner D
 X Coordinate: -121.24961
 Y Coordinate: 38.70156
 Barrier Area: Curb Ramps
 Barrier Type: Parallel Ramp Landing - Existing (>5.0% or more)
 Code Ref: CBC 1127B.5.4 and ADA/ABA 406.4

As Built Meas: 1 Quantity: EACH
 Description: Curb ramp landing or pan not level (>5.0% or more)
 As Built Desc: 7.4% landing slope
 Solution: Demolish existing and construct new transition
 Bar. Severity: 1 Necessary Cost Estimate: \$250.00 Status:
 Implementation Priority: 4 Facility Function:
 Implementation Phase: Implementation Date:
 Official Responsible:

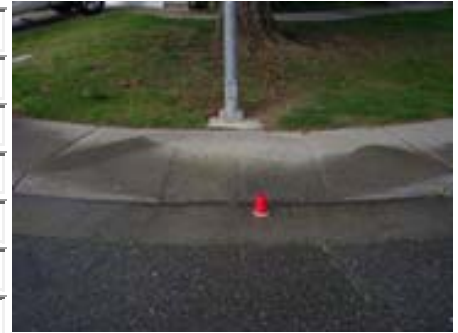
Field Date: 3/22/2011 Report Date: 3/22/2011 Barrier #: 6104C
 Location: Fireweed Cir and Foxglove Ct - Corner D
 X Coordinate: -121.24961
 Y Coordinate: 38.70156
 Barrier Area: Curb Ramps
 Barrier Type: Detectable Warnings - Truncated Domes
 Code Ref: CBC 1127B.5.7 and ADA/ABA 705.1.3

As Built Meas: 1 Quantity: EACH
 Description: No truncated domes provided at curb ramp
 As Built Desc: No detectable warnings at curb ramp
 Solution: Provide compliant truncated domes
 Bar. Severity: 2 Recommended Cost Estimate: \$1,400.00 Status:
 Implementation Priority: 4 Facility Function:
 Implementation Phase: Implementation Date:
 Official Responsible:

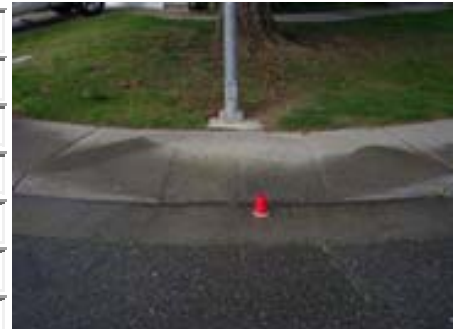
Field Date: 3/22/2011 Report Date: 3/22/2011 Barrier #: 6104D
 Location: Fireweed Cir and Foxglove Ct - Corner D
 X Coordinate: -121.24961
 Y Coordinate: 38.70156
 Barrier Area: Curb Ramps
 Barrier Type: Gutter Slope - Existing (6.6% to 8.2%)
 Code Ref: CBC 1127B.5.3 and ADA/ABA 406.2

As Built Meas: 6 Quantity: SF
 Description: Gutter slope exceeds 5.0% (6.6% to 8.2%)
 As Built Desc: 7.0% gutter slope
 Solution: Demolish existing and construct new gutter
 Bar. Severity: 2 Recommended Cost Estimate: \$750.00 Status:
 Implementation Priority: 4 Facility Function:
 Implementation Phase: Implementation Date:
 Official Responsible:

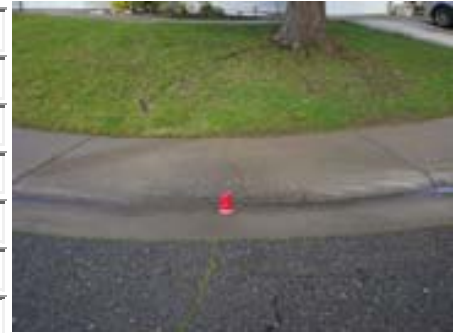
Field Date: 3/22/2011 Report Date: 3/22/2011 Barrier #: 6105A
 Location: Fireweed Cir and Shasta Daisy Ct - Corner A
 X Coordinate: -121.24978
 Y Coordinate: 38.70264
 Barrier Area: Curb Ramps
 Barrier Type: 12" Grooves - Existing (2.1% to 3.0%)
 Code Ref: CBC 1127B.5.6

As Built Meas: 1 Quantity: EACH
 Description: 12" grooves at top of curb ramp are not level (2.1% to 3.0%)
 As Built Desc: 3.0% at 12" grooves
 Solution: Demolish existing and construct new curb ramp
 Bar. Severity: 4 Low Severity Cost Estimate: \$2,500.00 Status:
 Implementation Priority: 4 Facility Function:
 Implementation Phase: Implementation Date:
 Official Responsible:

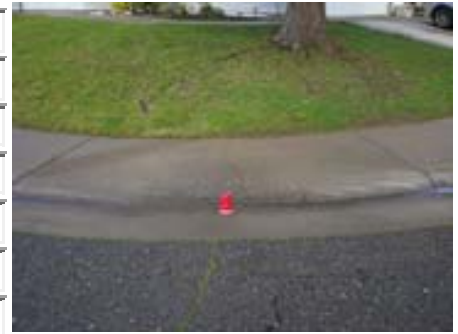
Field Date: 3/22/2011 Report Date: 3/22/2011 Barrier #: 6105B
 Location: Fireweed Cir and Shasta Daisy Ct - Corner A
 X Coordinate: -121.24978
 Y Coordinate: 38.70264
 Barrier Area: Curb Ramps
 Barrier Type: Parallel Ramp Landing - Existing (>5.0% or more)
 Code Ref: CBC 1127B.5.4 and ADA/ABA 406.4

As Built Meas: 1 Quantity: EACH
 Description: Curb ramp landing or pan not level (>5.0% or more)
 As Built Desc: 7.9% landing slope
 Solution: Demolish existing and construct new transition
 Bar. Severity: 1 Necessary Cost Estimate: \$250.00 Status:
 Implementation Priority: 4 Facility Function:
 Implementation Phase: Implementation Date:
 Official Responsible:

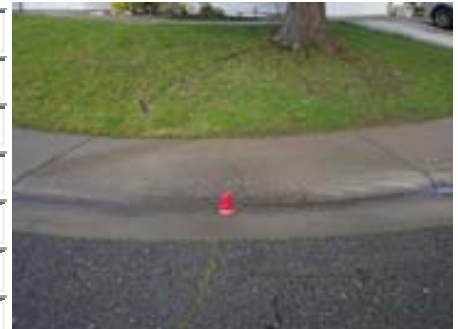
Field Date: 3/22/2011 Report Date: 3/22/2011 Barrier #: 6105D
 Location: Fireweed Cir and Shasta Daisy Ct - Corner A
 X Coordinate: -121.24978
 Y Coordinate: 38.70264
 Barrier Area: Curb Ramps
 Barrier Type: Gutter Slope - Existing (6.6% to 8.2%)
 Code Ref: CBC 1127B.5.3 and ADA/ABA 406.2

As Built Meas: 6 Quantity: SF
 Description: Gutter slope exceeds 5.0% (6.6% to 8.2%)
 As Built Desc: 6.6% gutter slope
 Solution: Demolish existing and construct new gutter
 Bar. Severity: 2 Recommended Cost Estimate: \$750.00 Status:
 Implementation Priority: 4 Facility Function:
 Implementation Phase: Implementation Date:
 Official Responsible:

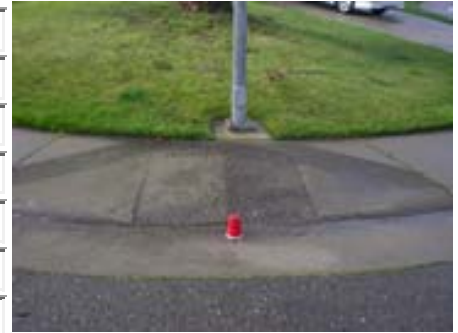
Field Date: 3/22/2011 Report Date: 3/22/2011 Barrier #: 6106A
 Location: Fireweed Cir and Shasta Daisy Ct - Corner D
 X Coordinate: -121.24972
 Y Coordinate: 38.70254
 Barrier Area: Curb Ramps
 Barrier Type: 12" Grooves - Existing (>5.0%)
 Code Ref: CBC 1127B.5.6

As Built Meas: 1 Quantity: EACH
 Description: 12" grooves at top of curb ramp are not level (>5.0%)
 As Built Desc: 6.5% at 12" grooves
 Solution: Demolish existing and construct new curb ramp
 Bar. Severity: 1 Necessary Cost Estimate: \$2,500.00 Status:
 Implementation Priority: 4 Facility Function:
 Implementation Phase: Implementation Date:
 Official Responsible:

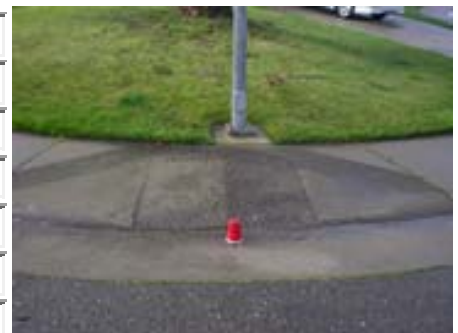
Field Date: 3/22/2011 Report Date: 3/22/2011 Barrier #: 6106B
 Location: Fireweed Cir and Shasta Daisy Ct - Corner D
 X Coordinate: -121.24972
 Y Coordinate: 38.70254
 Barrier Area: Curb Ramps
 Barrier Type: Parallel Ramp Landing - Existing (>5.0% or more)
 Code Ref: CBC 1127B.5.4 and ADA/ABA 406.4

As Built Meas: 1 Quantity: EACH
 Description: Curb ramp landing or pan not level (>5.0% or more)
 As Built Desc: 7.7% landing slope
 Solution: Demolish existing and construct new transition
 Bar. Severity: 1 Necessary Cost Estimate: \$250.00 Status:
 Implementation Priority: 4 Facility Function:
 Implementation Phase: Implementation Date:
 Official Responsible:

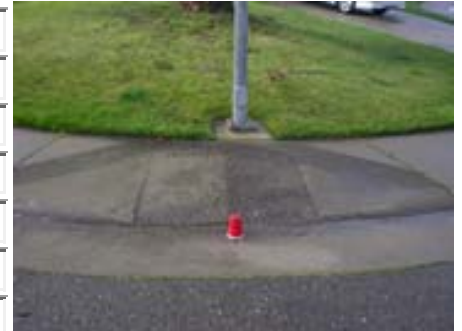
Field Date: 3/22/2011 Report Date: 3/22/2011 Barrier #: 6106C
 Location: Fireweed Cir and Shasta Daisy Ct - Corner D
 X Coordinate: -121.24972
 Y Coordinate: 38.70254
 Barrier Area: Curb Ramps
 Barrier Type: Detectable Warnings - Truncated Domes
 Code Ref: CBC 1127B.5.7 and ADA/ABA 705.1.3

As Built Meas: 1 Quantity: EACH
 Description: No truncated domes provided at curb ramp
 As Built Desc: No detectable warnings at curb ramp
 Solution: Provide compliant truncated domes
 Bar. Severity: 2 Recommended Cost Estimate: \$1,400.00 Status:
 Implementation Priority: 4 Facility Function:
 Implementation Phase: Implementation Date:
 Official Responsible:

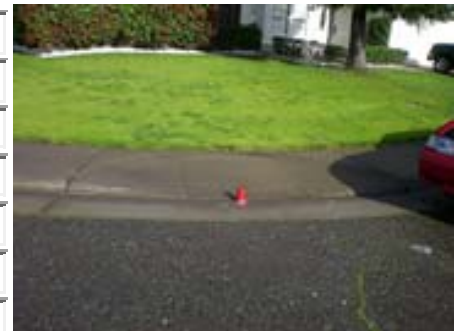
Field Date: 3/22/2011 Report Date: 3/22/2011 Barrier #: 6107A
 Location: Fireweed Cir and Merry Mum Ct - Corner A
 X Coordinate: -121.24996
 Y Coordinate: 38.7033
 Barrier Area: Curb Ramps
 Barrier Type: 12" Grooves - Existing (4.1% to 4.9%)
 Code Ref: CBC 1127B.5.6

As Built Meas: 1 Quantity: EACH
 Description: 12" grooves at top of curb ramp are not level (4.1% to 4.9%)
 As Built Desc: 4.8% at 12" grooves
 Solution: Demolish existing and construct new curb ramp
 Bar. Severity: 2 Recommended Cost Estimate: \$2,500.00 Status:
 Implementation Priority: 4 Facility Function:
 Implementation Phase: Implementation Date:
 Official Responsible:

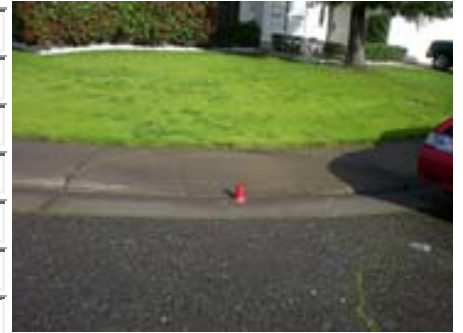
Field Date: 3/22/2011 Report Date: 3/22/2011 Barrier #: 6107B
 Location: Fireweed Cir and Merry Mum Ct - Corner A
 X Coordinate: -121.24996
 Y Coordinate: 38.7033
 Barrier Area: Curb Ramps
 Barrier Type: Parallel Ramp Landing - Existing (>5.0% or more)
 Code Ref: CBC 1127B.5.4 and ADA/ABA 406.4

As Built Meas: 1 Quantity: EACH
 Description: Curb ramp landing or pan not level (>5.0% or more)
 As Built Desc: 7.6% landing slope
 Solution: Demolish existing and construct new transition
 Bar. Severity: 1 Necessary Cost Estimate: \$250.00 Status:
 Implementation Priority: 4 Facility Function:
 Implementation Phase: Implementation Date:
 Official Responsible:

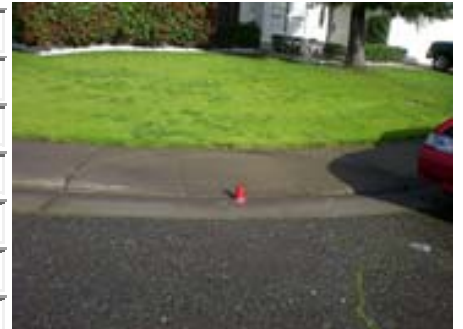
Field Date: 3/22/2011 Report Date: 3/22/2011 Barrier #: 6107C
 Location: Fireweed Cir and Merry Mum Ct - Corner A
 X Coordinate: -121.24996
 Y Coordinate: 38.7033
 Barrier Area: Curb Ramps
 Barrier Type: Detectable Warnings - Truncated Domes
 Code Ref: CBC 1127B.5.7 and ADA/ABA 705.1.3

As Built Meas: 1 Quantity: EACH
 Description: No truncated domes provided at curb ramp
 As Built Desc: No detectable warnings at curb ramp
 Solution: Provide compliant truncated domes
 Bar. Severity: 2 Recommended Cost Estimate: \$1,400.00 Status:
 Implementation Priority: 4 Facility Function:
 Implementation Phase: Implementation Date:
 Official Responsible:

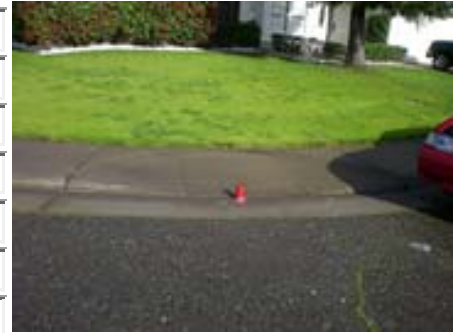
Field Date: 3/22/2011 Report Date: 3/22/2011 Barrier #: 6107D
 Location: Fireweed Cir and Merry Mum Ct - Corner A
 X Coordinate: -121.24996
 Y Coordinate: 38.7033
 Barrier Area: Curb Ramps
 Barrier Type: Gutter Slope - Existing (6.6% to 8.2%)
 Code Ref: CBC 1127B.5.3 and ADA/ABA 406.2

As Built Meas: 6 Quantity: SF
 Description: Gutter slope exceeds 5.0% (6.6% to 8.2%)
 As Built Desc: 8.0% gutter slope
 Solution: Demolish existing and construct new gutter
 Bar. Severity: 2 Recommended Cost Estimate: \$750.00 Status:
 Implementation Priority: 4 Facility Function:
 Implementation Phase: Implementation Date:
 Official Responsible:

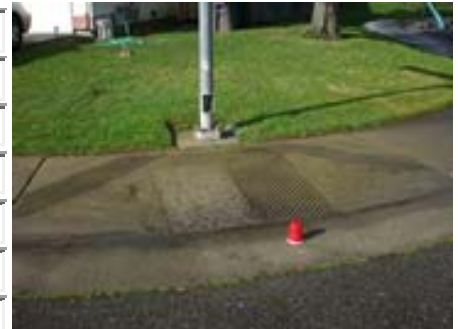
Field Date: 3/22/2011 Report Date: 3/22/2011 Barrier #: 6108A
 Location: Fireweed Cir and Merry Mum Ct - Corner D
 X Coordinate: -121.24998
 Y Coordinate: 38.70317
 Barrier Area: Curb Ramps
 Barrier Type: 12" Grooves - Existing (>5.0%)
 Code Ref: CBC 1127B.5.6

As Built Meas: 1 Quantity: EACH
 Description: 12" grooves at top of curb ramp are not level (>5.0%)
 As Built Desc: 5.1% at 12" grooves
 Solution: Demolish existing and construct new curb ramp
 Bar. Severity: 1 Necessary Cost Estimate: \$2,500.00 Status:
 Implementation Priority: 4 Facility Function:
 Implementation Phase: Implementation Date:
 Official Responsible:

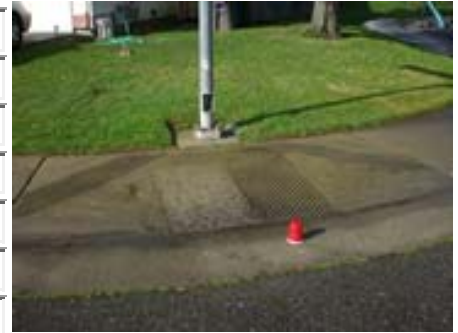
Field Date: 3/22/2011 Report Date: 3/22/2011 Barrier #: 6108B
 Location: Fireweed Cir and Merry Mum Ct - Corner D
 X Coordinate: -121.24998
 Y Coordinate: 38.70317
 Barrier Area: Curb Ramps
 Barrier Type: Perpendicular Ramp Landing (>5.0% or more)
 Code Ref: CBC 1127B.5.4 and ADA/ABA 406.4

As Built Meas: 1 Quantity: EACH
 Description: Curb ramp top landing not level (>5.0% or more)
 As Built Desc: 7.9% landing slope
 Solution: Demolish existing and construct new transition
 Bar. Severity: 1 Necessary Cost Estimate: \$250.00 Status:
 Implementation Priority: 4 Facility Function:
 Implementation Phase: Implementation Date:
 Official Responsible:

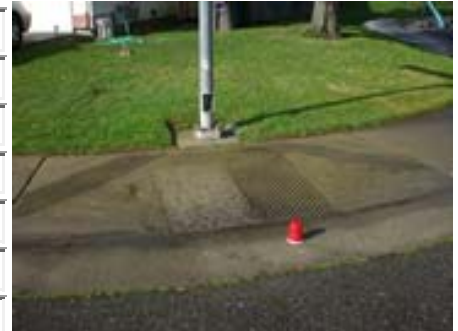
Field Date: 3/22/2011 Report Date: 3/22/2011 Barrier #: 6108D
 Location: Fireweed Cir and Merry Mum Ct - Corner D
 X Coordinate: -121.24998
 Y Coordinate: 38.70317
 Barrier Area: Curb Ramps
 Barrier Type: Gutter Slope - Existing (6.6% to 8.2%)
 Code Ref: CBC 1127B.5.3 and ADA/ABA 406.2

As Built Meas: 6 Quantity: SF
 Description: Gutter slope exceeds 5.0% (6.6% to 8.2%)
 As Built Desc: 7.2% gutter slope
 Solution: Demolish existing and construct new gutter
 Bar. Severity: 2 Recommended Cost Estimate: \$750.00 Status:
 Implementation Priority: 4 Facility Function:
 Implementation Phase: Implementation Date:
 Official Responsible:

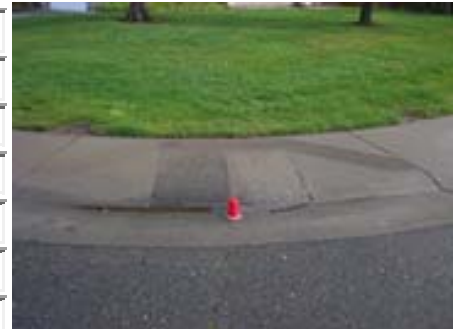
Field Date: 3/22/2011 Report Date: 3/22/2011 Barrier #: 6109A
 Location: Fireweed Cir and Bunchberry Ct - Corner A
 X Coordinate: -121.24973
 Y Coordinate: 38.70365
 Barrier Area: Curb Ramps
 Barrier Type: 12" Grooves - Existing (4.1% to 4.9%)
 Code Ref: CBC 1127B.5.6

As Built Meas: 1 Quantity: EACH
 Description: 12" grooves at top of curb ramp are not level (4.1% to 4.9%)
 As Built Desc: 4.6% at 12" grooves
 Solution: Demolish existing and construct new curb ramp
 Bar. Severity: 2 Recommended Cost Estimate: \$2,500.00 Status:
 Implementation Priority: 4 Facility Function:
 Implementation Phase: Implementation Date:
 Official Responsible:

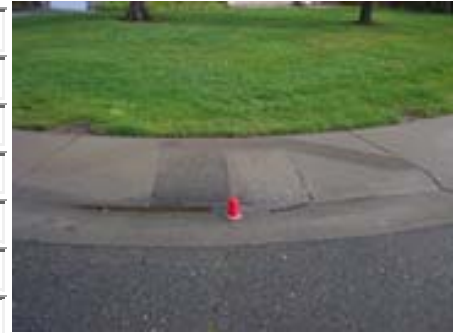
Field Date: 3/22/2011 Report Date: 3/22/2011 Barrier #: 6109B
 Location: Fireweed Cir and Bunchberry Ct - Corner A
 X Coordinate: -121.24973
 Y Coordinate: 38.70365
 Barrier Area: Curb Ramps
 Barrier Type: Perpendicular Ramp Landing (4.1% to 4.9%)
 Code Ref: CBC 1127B.5.4 and ADA/ABA 406.4

As Built Meas: 1 Quantity: EACH
 Description: Curb ramp top landing not level (4.1% to 4.9%)
 As Built Desc: 4.6% landing slope
 Solution: Demolish existing and construct new transition
 Bar. Severity: 2 Recommended Cost Estimate: \$250.00 Status:
 Implementation Priority: 4 Facility Function:
 Implementation Phase: Implementation Date:
 Official Responsible:

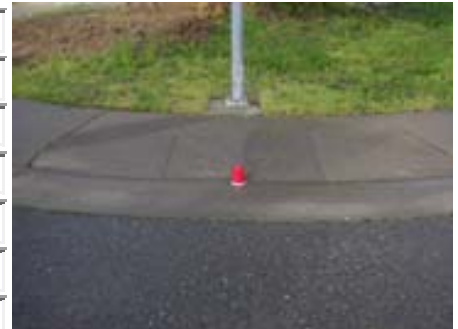
Field Date: 3/22/2011 Report Date: 3/22/2011 Barrier #: 6110A
 Location: Fireweed Cir and Bunchberry Ct - Corner D
 X Coordinate: -121.24984
 Y Coordinate: 38.7036
 Barrier Area: Curb Ramps
 Barrier Type: 12" Grooves - Existing (3.1% to 4.0%)
 Code Ref: CBC 1127B.5.6

As Built Meas: 1 Quantity: EACH
 Description: 12" grooves at top of curb ramp are not level (3.1% to 4.0%)
 As Built Desc: 3.9% at 12" grooves
 Solution: Demolish existing and construct new curb ramp
 Bar. Severity: 3 Hindrance Cost Estimate: \$2,500.00 Status:
 Implementation Priority: 4 Facility Function:
 Implementation Phase: Implementation Date:
 Official Responsible:

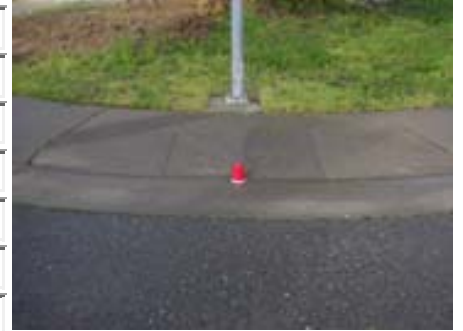
Field Date: 3/22/2011 Report Date: 3/22/2011 Barrier #: 6110B
 Location: Fireweed Cir and Bunchberry Ct - Corner D
 X Coordinate: -121.24984
 Y Coordinate: 38.7036
 Barrier Area: Curb Ramps
 Barrier Type: Parallel Ramp Landing - Existing (>5.0% or more)
 Code Ref: CBC 1127B.5.4 and ADA/ABA 406.4

As Built Meas: 1 Quantity: EACH
 Description: Curb ramp landing or pan not level (>5.0% or more)
 As Built Desc: 6.7% landing slope
 Solution: Demolish existing and construct new transition
 Bar. Severity: 1 Necessary Cost Estimate: \$250.00 Status:
 Implementation Priority: 4 Facility Function:
 Implementation Phase: Implementation Date:
 Official Responsible:

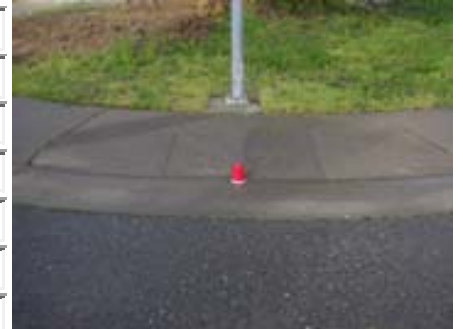
Field Date: 3/22/2011 Report Date: 3/22/2011 Barrier #: 6110C
 Location: Fireweed Cir and Bunchberry Ct - Corner D
 X Coordinate: -121.24984
 Y Coordinate: 38.7036
 Barrier Area: Curb Ramps
 Barrier Type: Detectable Warnings - Truncated Domes
 Code Ref: CBC 1127B.5.7 and ADA/ABA 705.1.3

As Built Meas: 1 Quantity: EACH
 Description: No truncated domes provided at curb ramp
 As Built Desc: No detectable warnings at curb ramp
 Solution: Provide compliant truncated domes
 Bar. Severity: 2 Recommended Cost Estimate: \$1,400.00 Status:
 Implementation Priority: 4 Facility Function:
 Implementation Phase: Implementation Date:
 Official Responsible:

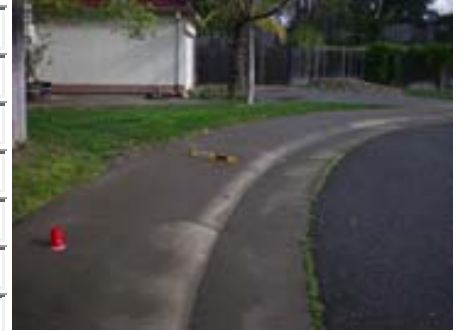
Field Date: 3/22/2011 Report Date: 3/22/2011 Barrier #: 6111
 Location: Bunchberry Ct - South
 X Coordinate: -121.25010
 Y Coordinate: 38.70379
 Barrier Area: Sidewalks
 Barrier Type: Cross Slope - Existing (4.1% to 4.9%)
 Code Ref: CBC 1133B.7.1.3 and ADA/ABA 403.3

As Built Meas: 26 Quantity: LF
 Description: Cross slope exceeds 2.0% (4.1% to 4.9%)
 As Built Desc: 4.4% cross slope
 Solution: Demolish existing and construct new route
 Bar. Severity: 2 Recommended Cost Estimate: \$3,250.00 Status:
 Implementation Priority: 4 Facility Function:
 Implementation Phase: Implementation Date:
 Official Responsible:

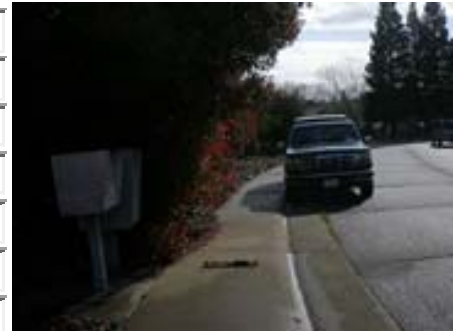
Field Date: 3/22/2011 Report Date: 3/22/2011 Barrier #: 6112
 Location: Fireweed Cir - North
 X Coordinate: -121.24924
 Y Coordinate: 38.70383
 Barrier Area: Sidewalks
 Barrier Type: Protruding Hazard
 Code Ref: CBC 1133B.8.6.1 and ADA/ABA 307.2

As Built Meas: 1 Quantity: JOB
 Description: Protruding object in route of travel between 27" and 80" high
 As Built Desc: 32" at tree branch
 Solution: Remove object or provide detectable warning
 Bar. Severity: 1 Necessary Cost Estimate: \$1,400.00 Status:
 Implementation Priority: 4 Facility Function:
 Implementation Phase: Implementation Date:
 Official Responsible:

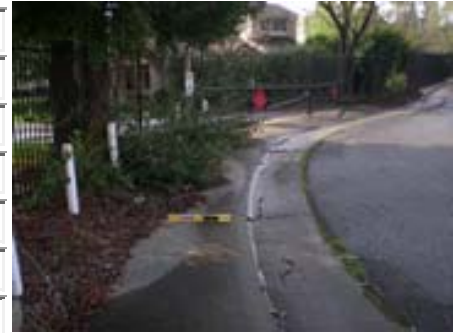
Barrier Type: Clear Width - New Construction

Description: Pedestrian route is not min. 48" wide

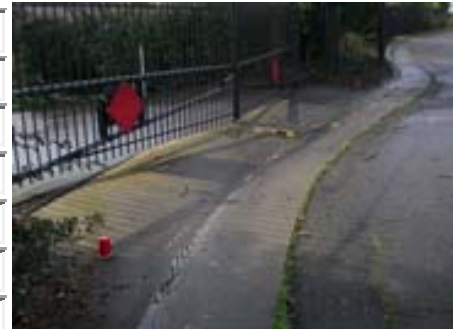
Barrier Type: Driveway - Existing (4.1% to 4.9%)

Description: Driveway cross slope exceeds 2.0% (4.1% to 4.9%)

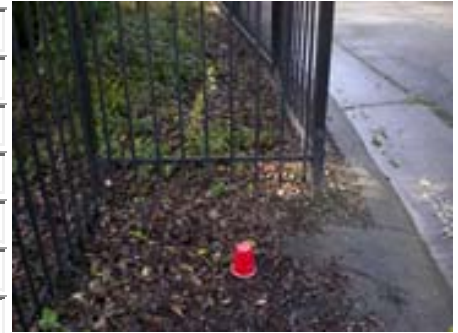
Field Date: 3/22/2011 Report Date: 3/22/2011 Barrier #: 6115
 Location: Fireweed Cir - East
 X Coordinate: -121.24865
 Y Coordinate: 38.70356
 Barrier Area: Sidewalks
 Barrier Type: No Sidewalk - No Barricade
 Code Ref: MUTCD Section 6D.01

As Built Meas: 1 Quantity: JOB
 Description: No barricade provided where sidewalk ends in hazardous location
 As Built Desc: No barricade or other warning provided for the visually impaired at end of sidewalk
 Solution: Provide barricade with cane detectable warning at end of sidewalk
 Bar. Severity: 1 Necessary Cost Estimate: \$1,350.00 Status:
 Implementation Priority: 4 Facility Function:
 Implementation Phase: Implementation Date:
 Official Responsible:

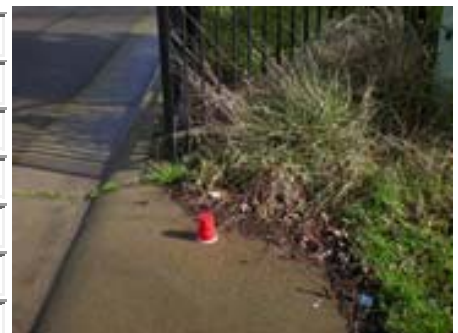
Field Date: 3/22/2011 Report Date: 3/22/2011 Barrier #: 6116
 Location: Fireweed Cir - East
 X Coordinate: -121.24839
 Y Coordinate: 38.70098
 Barrier Area: Sidewalks
 Barrier Type: No Sidewalk - No Barricade
 Code Ref: MUTCD Section 6D.01

As Built Meas: 1 Quantity: JOB
 Description: No barricade provided where sidewalk ends in hazardous location
 As Built Desc: No barricade or other warning provided for the visually impaired at end of sidewalk
 Solution: Provide barricade with cane detectable warning at end of sidewalk
 Bar. Severity: 1 Necessary Cost Estimate: \$1,350.00 Status:
 Implementation Priority: 4 Facility Function:
 Implementation Phase: Implementation Date:
 Official Responsible:

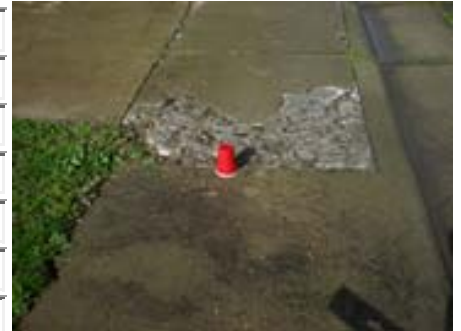
Barrier Type: Surface Condition - Damaged

Description: Surface is not firm and stable (cracked, broken or loose soil, etc.)

As Built Desc: Cracked concrete

Solution: Repair surface to make firm and stable

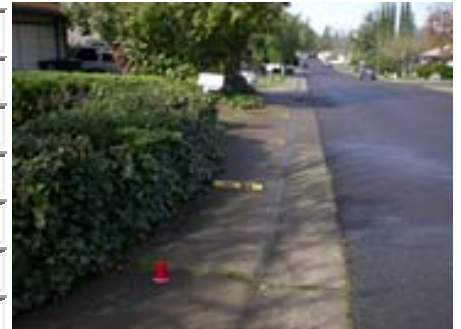
Barrier Type: Cross Slope - Existing (5.0% or more)

Description: Cross slope exceeds 2.0% (5.0% or more)

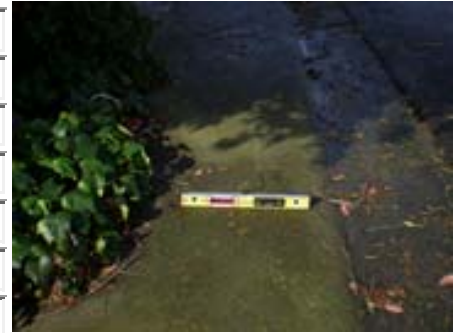
Field Date: 3/22/2011 Report Date: 3/22/2011 Barrier #: 6118B
 Location: Pitalo Wy - South
 X Coordinate: -121.24492
 Y Coordinate: 38.70858
 Barrier Area: Sidewalks
 Barrier Type: Abrupt Change in Level - > 1/2"
 Code Ref: CBC 1133B.7.1 and ADA/ABA 303.3

As Built Meas: 8 Quantity: LF
 Description: Change in level greater than 1/2"
 As Built Desc: 1/2" lip in sidewalk surface
 Solution: Grind or repair sidewalk to remove trip hazard
 Bar. Severity: 1 Necessary Cost Estimate: \$2,000.00 Status:
 Implementation Priority: 4 Facility Function:
 Implementation Phase: Implementation Date:
 Official Responsible:

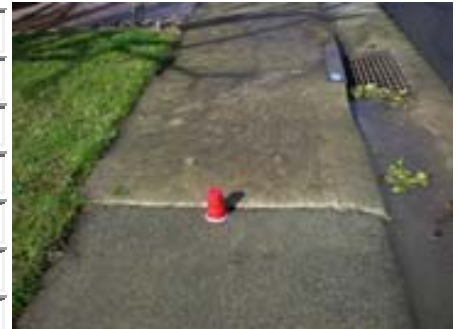
Field Date: 3/22/2011 Report Date: 3/22/2011 Barrier #: 6119
 Location: Pitalo Wy - South
 X Coordinate: -121.24623
 Y Coordinate: 38.70859
 Barrier Area: Sidewalks
 Barrier Type: Clear Width - Existing (≤31" or less)
 Code Ref: CBC 1133B.7.1

As Built Meas: 1 Quantity: LF
 Description: Pedestrian route is not min. 48" wide (≤31" or less)
 As Built Desc: 24" clear width due to foliage
 Solution: Trim foliage to provide min. 48" clear width
 Bar. Severity: 1 Necessary Cost Estimate: \$125.00 Status:
 Implementation Priority: 4 Facility Function:
 Implementation Phase: Implementation Date:
 Official Responsible:

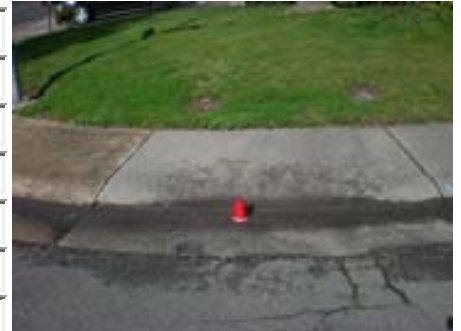
Field Date: 3/22/2011 Report Date: 3/22/2011 Barrier #: 6122
 Location: Avalos Wy and Zeigler Ct - Corner A
 X Coordinate: -121.24720
 Y Coordinate: 38.70942
 Barrier Area: Curb Ramps
 Barrier Type: No Curb Ramp - Depressed Existing Curb
 Code Ref: CBC 1127B.5.1 and ADA/ABA 402.2

As Built Meas: 1 Quantity: EACH
 Description: No compliant curb cut at corner (intersection)
 As Built Desc: 10.7% running slope at depressed area
 Solution: Demolish existing and construct curb cut
 Bar. Severity: 1 Necessary Cost Estimate: \$2,500.00 Status:
 Implementation Priority: 4 Facility Function:
 Implementation Phase: Implementation Date:
 Official Responsible:

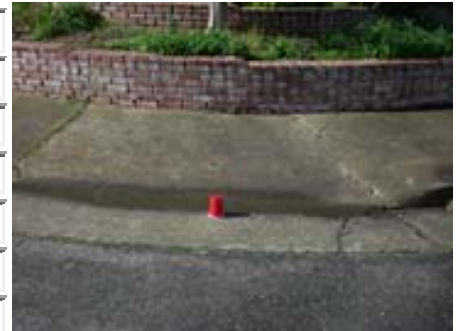
Field Date: 3/22/2011 Report Date: 3/22/2011 Barrier #: 6123
 Location: Avalos Wy and Zeigler Ct - Corner D
 X Coordinate: -121.24720
 Y Coordinate: 38.70932
 Barrier Area: Curb Ramps
 Barrier Type: No Curb Ramp - Depressed Existing Curb
 Code Ref: CBC 1127B.5.1 and ADA/ABA 402.2

As Built Meas: 1 Quantity: EACH
 Description: No compliant curb cut at corner (intersection)
 As Built Desc: 8.2% running slope at depressed area
 Solution: Demolish existing and construct curb cut
 Bar. Severity: 1 Necessary Cost Estimate: \$2,500.00 Status:
 Implementation Priority: 4 Facility Function:
 Implementation Phase: Implementation Date:
 Official Responsible:

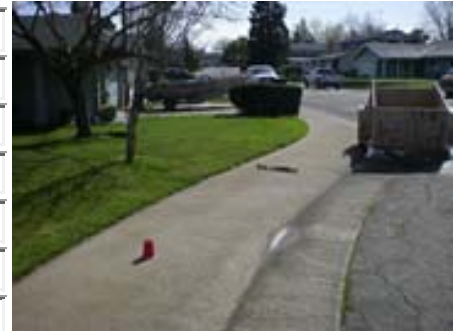
Barrier Type: Cross Slope - Existing (2.1% to 3.0%)

Description: Cross slope exceeds 2.0% (2.1% to 3.0%)

Solution: Low severity barrier - no remediation recommended

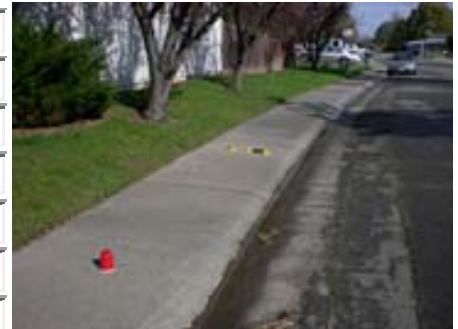
Barrier Type: Cross Slope - Existing (3.1% to 4.0%)

Description: Cross slope exceeds 2.0% (3.1% to 4.0%)

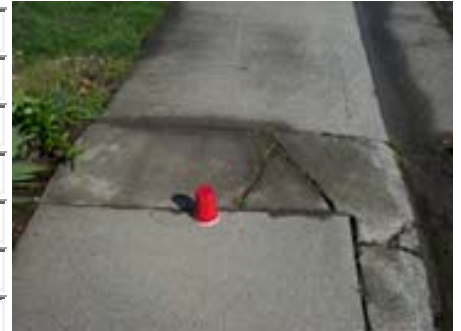
Field Date: 3/22/2011 Report Date: 3/22/2011 Barrier #: 6125B
 Location: Avalos Wy - West
 X Coordinate: -121.24715
 Y Coordinate: 38.71002
 Barrier Area: Sidewalks
 Barrier Type: Surface Condition - Damaged
 Code Ref: CBC 1133B.7.1 and ADA/ABA 302.1

As Built Meas: 4 Quantity: LF
 Description: Surface is not firm and stable (cracked, broken or loose soil, etc.)
 As Built Desc: Cracked concrete
 Solution: Repair surface to make firm and stable
 Bar. Severity: 1 Necessary Cost Estimate: \$500.00 Status:
 Implementation Priority: 4 Facility Function:
 Implementation Phase: Implementation Date:
 Official Responsible:

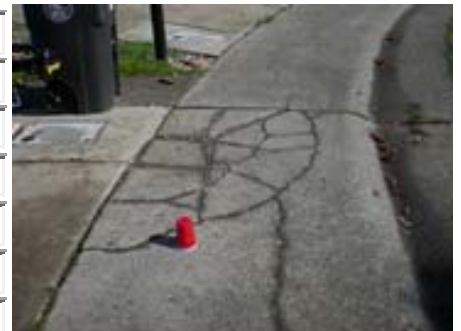
Field Date: 3/22/2011 Report Date: 3/22/2011 Barrier #: 6125C
 Location: Avalos Wy - West
 X Coordinate: -121.24717
 Y Coordinate: 38.71147
 Barrier Area: Sidewalks
 Barrier Type: Surface Condition - Damaged
 Code Ref: CBC 1133B.7.1 and ADA/ABA 302.1

As Built Meas: 4 Quantity: LF
 Description: Surface is not firm and stable (cracked, broken or loose soil, etc.)
 As Built Desc: Cracked concrete
 Solution: Repair surface to make firm and stable
 Bar. Severity: 1 Necessary Cost Estimate: \$500.00 Status:
 Implementation Priority: 4 Facility Function:
 Implementation Phase: Implementation Date:
 Official Responsible:

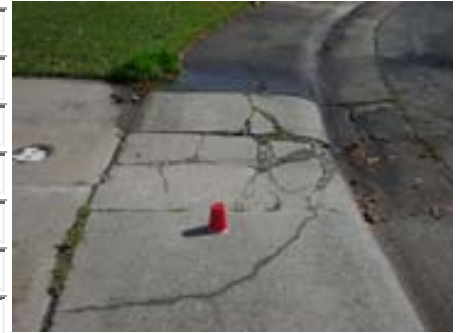
Field Date: 3/22/2011 Report Date: 3/22/2011 Barrier #: 6125D
 Location: Avalos Wy - West
 X Coordinate: -121.24711
 Y Coordinate: 38.71153
 Barrier Area: Sidewalks
 Barrier Type: Surface Condition - Damaged
 Code Ref: CBC 1133B.7.1 and ADA/ABA 302.1

As Built Meas: 4 Quantity: LF
 Description: Surface is not firm and stable (cracked, broken or loose soil, etc.)
 As Built Desc: Cracked concrete
 Solution: Repair surface to make firm and stable
 Bar. Severity: 1 Necessary Cost Estimate: \$500.00 Status:
 Implementation Priority: 4 Facility Function:
 Implementation Phase: Implementation Date:
 Official Responsible:

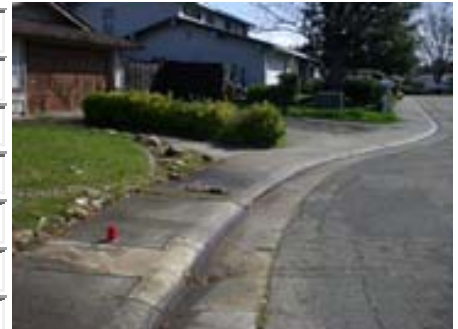
Field Date: 3/22/2011 Report Date: 3/22/2011 Barrier #: 6126
 Location: Avalos Wy - North
 X Coordinate: -121.24702
 Y Coordinate: 38.71156
 Barrier Area: Sidewalks
 Barrier Type: Cross Slope - Existing (3.1% to 4.0%)
 Code Ref: CBC 1133B.7.1.3 and ADA/ABA 403.3

As Built Meas: 276 Quantity: LF
 Description: Cross slope exceeds 2.0% (3.1% to 4.0%)
 As Built Desc: 3.7% cross slope
 Solution: Demolish existing and construct new route
 Bar. Severity: 3 Hinderance Cost Estimate: \$34,500.00 Status:
 Implementation Priority: 4 Facility Function:
 Implementation Phase: Implementation Date:
 Official Responsible:

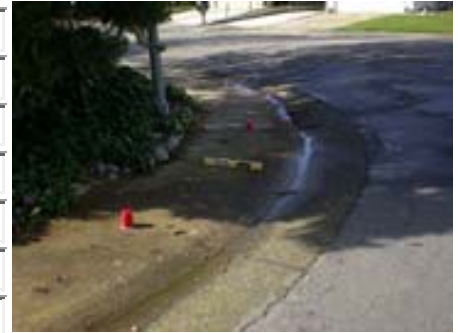
Barrier Type: Elbow in Sidewalk - Cross Slope (5.0% or more)

Description: Cross slope at elbow exceeds 2.0% (5.0% or more)

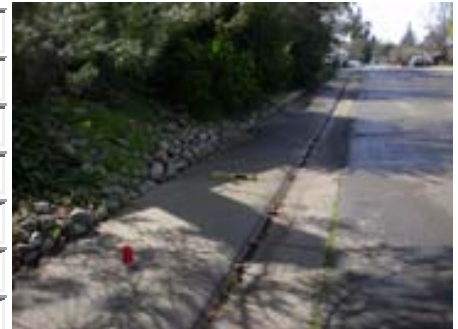
Barrier Type: Cross Slope - Existing (2.1% to 3.0%)

Description: Cross slope exceeds 2.0% (2.1% to 3.0%)

Solution: Low severity barrier - no remediation recommended

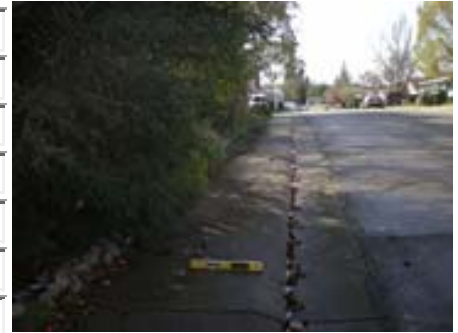
Field Date: 3/22/2011 Report Date: 3/22/2011 Barrier #: 6128B
 Location: Avalos Wy - East
 X Coordinate: -121.24699
 Y Coordinate: 38.71123
 Barrier Area: Sidewalks
 Barrier Type: Clear Width - Existing ($\leq 31''$ or less)
 Code Ref: CBC 1133B.7.1

As Built Meas: 1 Quantity: LF
 Description: Pedestrian route is not min. 48" wide ($\leq 31''$ or less)
 As Built Desc: 24" clear width due to foliage
 Solution: Trim foliage to provide min. 48" clear width
 Bar. Severity: 1 Necessary Cost Estimate: \$125.00 Status:
 Implementation Priority: 4 Facility Function:
 Implementation Phase: Implementation Date:
 Official Responsible:

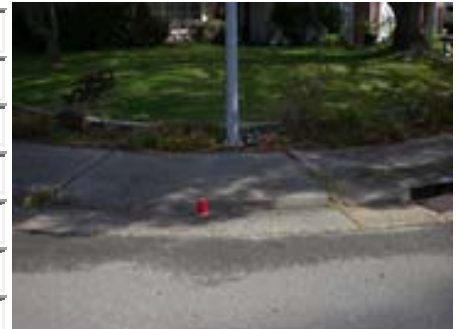
Field Date: 3/22/2011 Report Date: 3/22/2011 Barrier #: 6129
 Location: Avalos Wy and Ahrentzen Ct - Corner B
 X Coordinate: -121.24699
 Y Coordinate: 38.71088
 Barrier Area: Curb Ramps
 Barrier Type: No Curb Ramp - Depressed Existing Curb
 Code Ref: CBC 1127B.5.1 and ADA/ABA 402.2

As Built Meas: 1 Quantity: EACH
 Description: No compliant curb cut at corner (intersection)
 As Built Desc: 10.2% running slope at depressed area
 Solution: Demolish existing and construct curb cut
 Bar. Severity: 1 Necessary Cost Estimate: \$2,500.00 Status:
 Implementation Priority: 4 Facility Function:
 Implementation Phase: Implementation Date:
 Official Responsible:

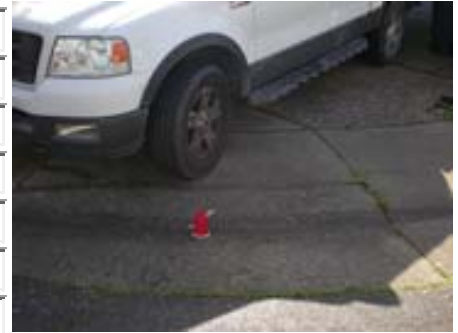
Field Date: 3/22/2011 Report Date: 3/22/2011 Barrier #: 6130
 Location: Avalos Wy and Ahrentzen Ct - Corner C
 X Coordinate: -121.24699
 Y Coordinate: 38.71076
 Barrier Area: Curb Ramps
 Barrier Type: No Curb Ramp - Depressed Existing Curb
 Code Ref: CBC 1127B.5.1 and ADA/ABA 402.2

As Built Meas: 1 Quantity: EACH
 Description: No compliant curb cut at corner (intersection)
 As Built Desc: 10.2% running slope at depressed area
 Solution: Demolish existing and construct curb cut
 Bar. Severity: 1 Necessary Cost Estimate: \$2,500.00 Status:
 Implementation Priority: 4 Facility Function:
 Implementation Phase: Implementation Date:
 Official Responsible:
