**DRAFT ADA TRANSITION PLAN UPDATE
NEIGHBORHOOD AREA 8 CHASE
SEPTEMBER 20, 2011**

CITY OF CITRUS HEIGHTS

Conditions - CHASE Area 8

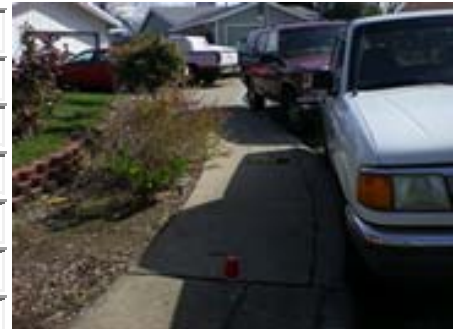
Field Date: 3/22/2011 Report Date: 3/22/2011 Barrier #: 6131
 Location: Ahrentzen Ct - North
 X Coordinate: -121.24649
 Y Coordinate: 38.71087
 Barrier Area: Sidewalks
 Barrier Type: Cross Slope - Existing (4.1% to 4.9%)
 Code Ref: CBC 1133B.7.1.3 and ADA/ABA 403.3

As Built Meas: 71 Quantity: LF
 Description: Cross slope exceeds 2.0% (4.1% to 4.9%)
 As Built Desc: 4.4% cross slope
 Solution: Demolish existing and construct new route
 Bar. Severity: 2 Recommended Cost Estimate: \$8,875.00 Status:
 Implementation Priority: 4 Facility Function:
 Implementation Phase: Implementation Date:
 Official Responsible:

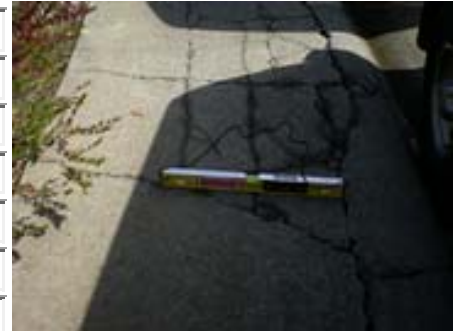
Barrier Type: Clear Width - Existing ($\leq 31''$ or less)

Description: Pedestrian route is not min. 48" wide ($\leq 31''$ or less)

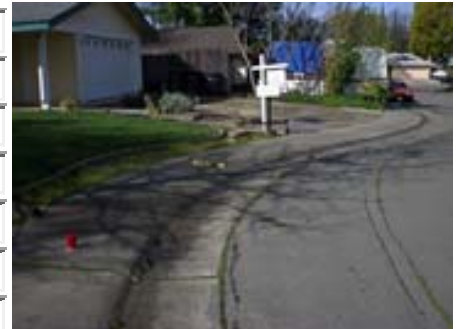
Barrier Type: Cross Slope - Existing (3.1% to 4.0%)

Description: Cross slope exceeds 2.0% (3.1% to 4.0%)

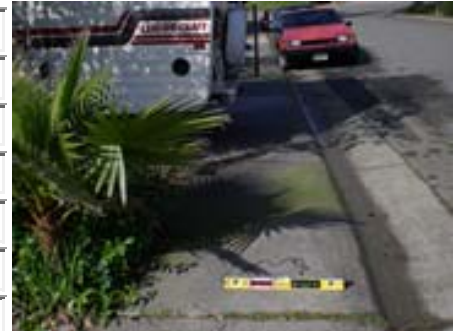
Field Date: 3/22/2011 Report Date: 3/22/2011 Barrier #: 6133B
 Location: Ahrentzen Ct - South
 X Coordinate: -121.24654
 Y Coordinate: 38.71074
 Barrier Area: Sidewalks
 Barrier Type: Protruding Hazard
 Code Ref: CBC 1133B.8.6.1 and ADA/ABA 307.2

As Built Meas: 1 Quantity: JOB
 Description: Protruding object in route of travel between 27" and 80" high
 As Built Desc: 24" at tree branch
 Solution: Remove object or provide detectable warning
 Bar. Severity: 1 Necessary Cost Estimate: \$1,400.00 Status:
 Implementation Priority: 4 Facility Function:
 Implementation Phase: Implementation Date:
 Official Responsible:

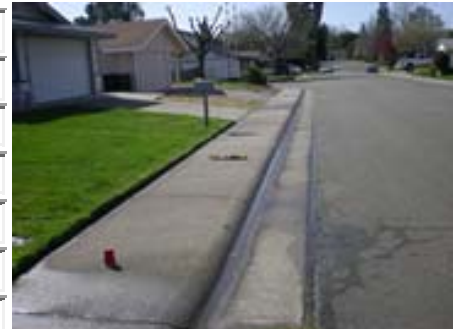
Field Date: 3/22/2011 Report Date: 3/22/2011 Barrier #: 6134
 Location: Avalos Wy - East
 X Coordinate: -121.24700
 Y Coordinate: 38.71041
 Barrier Area: Sidewalks
 Barrier Type: Cross Slope - Existing (2.1% to 3.0%)
 Code Ref: CBC 1133B.7.1.3 and ADA/ABA 403.3

As Built Meas: 130 Quantity: LF
 Description: Cross slope exceeds 2.0% (2.1% to 3.0%)
 As Built Desc: 3.0% cross slope
 Solution: Low severity barrier - no remediation recommended
 Bar. Severity: 4 Low Severity Cost Estimate: \$0.00 Status:
 Implementation Priority: 4 Facility Function:
 Implementation Phase: Implementation Date:
 Official Responsible:

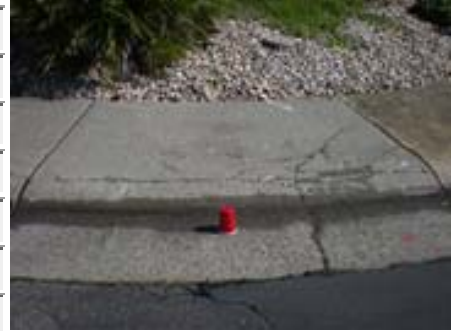
Field Date: 3/22/2011 Report Date: 3/22/2011 Barrier #: 6135
 Location: Avalos Wy and La Bounty Ct - Corner B
 X Coordinate: -121.24699
 Y Coordinate: 38.71013
 Barrier Area: Curb Ramps
 Barrier Type: No Curb Ramp - Depressed Existing Curb
 Code Ref: CBC 1127B.5.1 and ADA/ABA 402.2

As Built Meas: 1 Quantity: EACH
 Description: No compliant curb cut at corner (intersection)
 As Built Desc: 10.7% running slope at depressed area
 Solution: Demolish existing and construct curb cut
 Bar. Severity: 1 Necessary Cost Estimate: \$2,500.00 Status:
 Implementation Priority: 4 Facility Function:
 Implementation Phase: Implementation Date:
 Official Responsible:

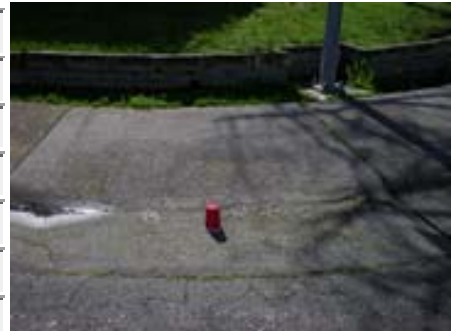
Field Date: 3/22/2011 Report Date: 3/22/2011 Barrier #: 6136
 Location: Avalos Wy and La Bounty Ct - Corner C
 X Coordinate: -121.24700
 Y Coordinate: 38.71002
 Barrier Area: Curb Ramps
 Barrier Type: No Curb Ramp - Depressed Existing Curb
 Code Ref: CBC 1127B.5.1 and ADA/ABA 402.2

As Built Meas: 1 Quantity: EACH
 Description: No compliant curb cut at corner (intersection)
 As Built Desc: 12.3% running slope at depressed area
 Solution: Demolish existing and construct curb cut
 Bar. Severity: 1 Necessary Cost Estimate: \$2,500.00 Status:
 Implementation Priority: 4 Facility Function:
 Implementation Phase: Implementation Date:
 Official Responsible:

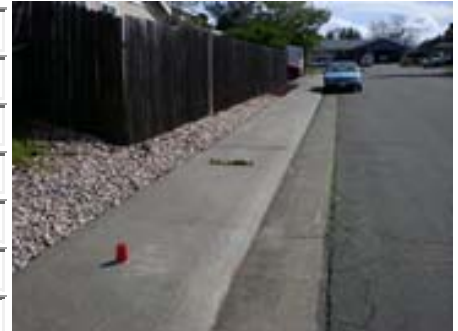
Field Date: 3/22/2011 Report Date: 3/22/2011 Barrier #: 6137
 Location: La Bounty Ct - North
 X Coordinate: -121.24686
 Y Coordinate: 38.71015
 Barrier Area: Sidewalks
 Barrier Type: Cross Slope - Existing (5.0% or more)
 Code Ref: CBC 1133B.7.1.3 and ADA/ABA 403.3

As Built Meas: 270 Quantity: LF
 Description: Cross slope exceeds 2.0% (5.0% or more)
 As Built Desc: 5.0% cross slope
 Solution: Demolish existing and construct new route
 Bar. Severity: 1 Necessary Cost Estimate: \$33,750.00 Status:
 Implementation Priority: 4 Facility Function:
 Implementation Phase: Implementation Date:
 Official Responsible:

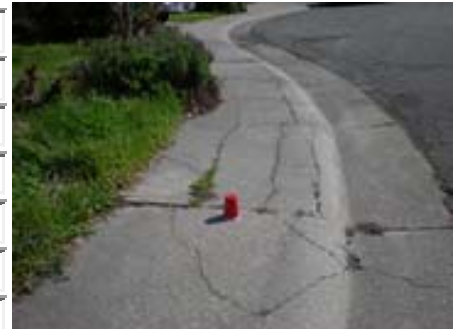
Field Date: 3/22/2011 Report Date: 3/22/2011 Barrier #: 6138
 Location: La Bounty Ct - North
 X Coordinate: -121.24642
 Y Coordinate: 38.71016
 Barrier Area: Sidewalks
 Barrier Type: Surface Condition - Damaged
 Code Ref: CBC 1133B.7.1 and ADA/ABA 302.1

As Built Meas: 4 Quantity: LF
 Description: Surface is not firm and stable (cracked, broken or loose soil, etc.)
 As Built Desc: Cracked concrete
 Solution: Repair surface to make firm and stable
 Bar. Severity: 1 Necessary Cost Estimate: \$500.00 Status:
 Implementation Priority: 4 Facility Function:
 Implementation Phase: Implementation Date:
 Official Responsible:

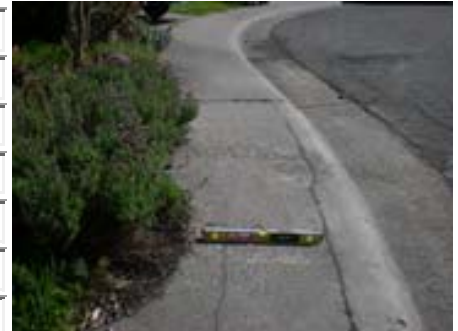
Field Date: 3/22/2011 Report Date: 3/22/2011 Barrier #: 6139
 Location: La Bounty Ct - North
 X Coordinate: -121.24658
 Y Coordinate: 38.71002
 Barrier Area: Sidewalks
 Barrier Type: Clear Width - Existing ($\leq 31''$ or less)
 Code Ref: CBC 1133B.7.1

As Built Meas: 1 Quantity: LF
 Description: Pedestrian route is not min. 48" wide ($\leq 31''$ or less)
 As Built Desc: 24" clear width due to foliage
 Solution: Trim foliage to provide min. 48" clear width
 Bar. Severity: 1 Necessary Cost Estimate: \$125.00 Status:
 Implementation Priority: 4 Facility Function:
 Implementation Phase: Implementation Date:
 Official Responsible:

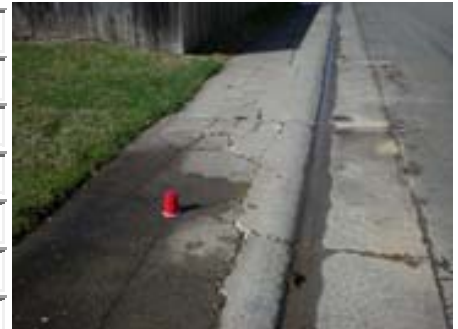
Field Date: 3/22/2011 Report Date: 3/22/2011 Barrier #: 6140
 Location: La Bounty Ct - South
 X Coordinate: -121.24700
 Y Coordinate: 38.70994
 Barrier Area: Sidewalks
 Barrier Type: Surface Condition - Damaged
 Code Ref: CBC 1133B.7.1 and ADA/ABA 302.1

As Built Meas: 8 Quantity: LF
 Description: Surface is not firm and stable (cracked, broken or loose soil, etc.)
 As Built Desc: Cracked concrete
 Solution: Repair surface to make firm and stable
 Bar. Severity: 1 Necessary Cost Estimate: \$1,000.00 Status:
 Implementation Priority: 4 Facility Function:
 Implementation Phase: Implementation Date:
 Official Responsible:

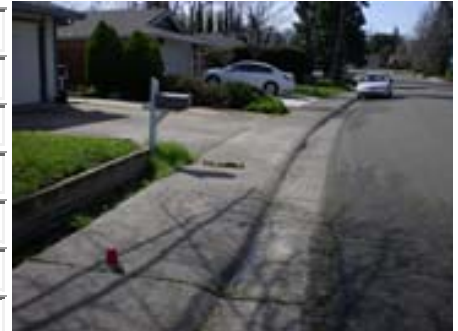
Barrier Type: Cross Slope - Existing (2.1% to 3.0%)

Description: Cross slope exceeds 2.0% (2.1% to 3.0%)

Solution: Low severity barrier - no remediation recommended

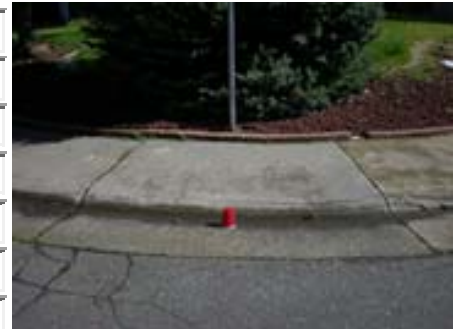
Barrier Type: No Curb Ramp - Depressed Existing Curb

Description: No compliant curb cut at corner (intersection)

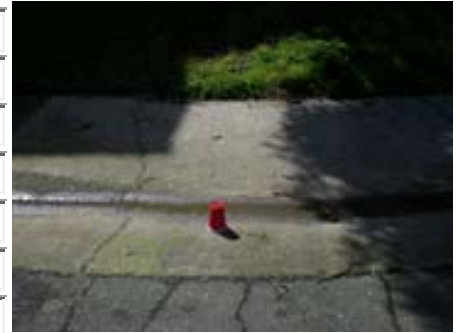
Field Date: 3/22/2011 Report Date: 3/22/2011 Barrier #: 6143
 Location: Avalos Wy and McCrone Ct - Corner C
 X Coordinate: -121.24689
 Y Coordinate: 38.70942
 Barrier Area: Curb Ramps
 Barrier Type: No Curb Ramp - Depressed Existing Curb
 Code Ref: CBC 1127B.5.1 and ADA/ABA 402.2

As Built Meas: 1 Quantity: EACH
 Description: No compliant curb cut at corner (intersection)
 As Built Desc: 9.1% running slope at depressed area
 Solution: Demolish existing and construct curb cut
 Bar. Severity: 1 Necessary Cost Estimate: \$2,500.00 Status:
 Implementation Priority: 4 Facility Function:
 Implementation Phase: Implementation Date:
 Official Responsible:

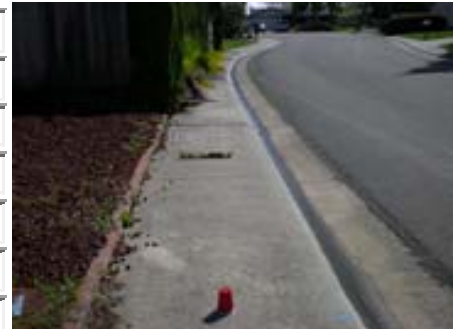
Field Date: 3/22/2011 Report Date: 3/22/2011 Barrier #: 6144A
 Location: McCrone Ct - North
 X Coordinate: -121.24675
 Y Coordinate: 38.70941
 Barrier Area: Sidewalks
 Barrier Type: Cross Slope - Existing (4.1% to 4.9%)
 Code Ref: CBC 1133B.7.1.3 and ADA/ABA 403.3

As Built Meas: 281 Quantity: LF
 Description: Cross slope exceeds 2.0% (4.1% to 4.9%)
 As Built Desc: 4.6% cross slope
 Solution: Demolish existing and construct new route
 Bar. Severity: 2 Recommended Cost Estimate: \$35,125.00 Status:
 Implementation Priority: 4 Facility Function:
 Implementation Phase: Implementation Date:
 Official Responsible:

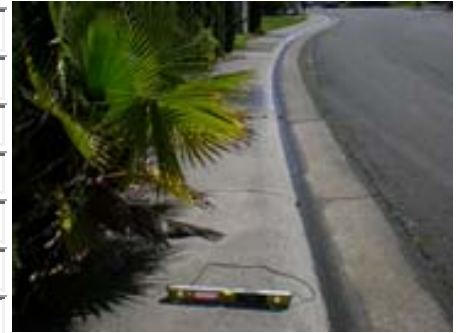
Field Date: 3/22/2011 Report Date: 3/22/2011 Barrier #: 6144B
 Location: McCrone Ct - North
 X Coordinate: -121.24635
 Y Coordinate: 38.70942
 Barrier Area: Sidewalks
 Barrier Type: Clear Width - Existing ($\leq 31''$ or less)
 Code Ref: CBC 1133B.7.1

As Built Meas: 1 Quantity: LF
 Description: Pedestrian route is not min. 48" wide ($\leq 31''$ or less)
 As Built Desc: 20" clear width due to foliage
 Solution: Trim foliage to provide min. 48" clear width
 Bar. Severity: 1 Necessary Cost Estimate: \$125.00 Status:
 Implementation Priority: 4 Facility Function:
 Implementation Phase: Implementation Date:
 Official Responsible:

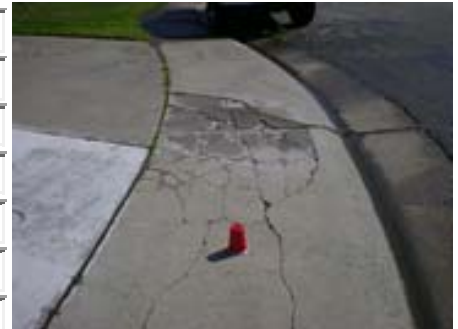
Field Date: 3/22/2011 Report Date: 3/22/2011 Barrier #: 6144C
 Location: McCrone Ct - North
 X Coordinate: -121.24608
 Y Coordinate: 38.7094
 Barrier Area: Sidewalks
 Barrier Type: Surface Condition - Damaged
 Code Ref: CBC 1133B.7.1 and ADA/ABA 302.1

As Built Meas: 8 Quantity: LF
 Description: Surface is not firm and stable (cracked, broken or loose soil, etc.)
 As Built Desc: Cracked concrete
 Solution: Repair surface to make firm and stable
 Bar. Severity: 1 Necessary Cost Estimate: \$1,000.00 Status:
 Implementation Priority: 4 Facility Function:
 Implementation Phase: Implementation Date:
 Official Responsible:

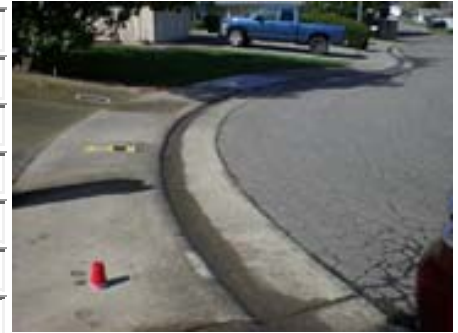
Field Date: 3/22/2011 Report Date: 3/22/2011 Barrier #: 6145A
 Location: McCrone Ct - South
 X Coordinate: -121.24621
 Y Coordinate: 38.70928
 Barrier Area: Sidewalks
 Barrier Type: Cross Slope - Existing (3.1% to 4.0%)
 Code Ref: CBC 1133B.7.1.3 and ADA/ABA 403.3

As Built Meas: 280 Quantity: LF
 Description: Cross slope exceeds 2.0% (3.1% to 4.0%)
 As Built Desc: 3.1% cross slope
 Solution: Demolish existing and construct new route
 Bar. Severity: 3 Hinderance Cost Estimate: \$35,000.00 Status:
 Implementation Priority: 4 Facility Function:
 Implementation Phase: Implementation Date:
 Official Responsible:

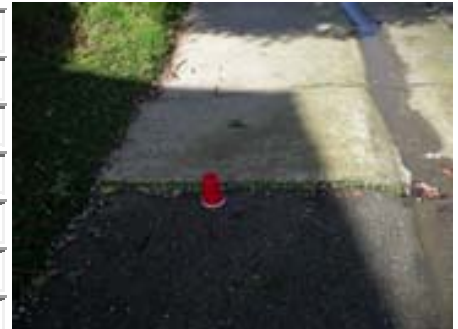
Field Date: 3/22/2011 Report Date: 3/22/2011 Barrier #: 6145B
 Location: McCrone Ct - South
 X Coordinate: -121.24655
 Y Coordinate: 38.70934
 Barrier Area: Sidewalks
 Barrier Type: Abrupt Change in Level - > 1/2"
 Code Ref: CBC 1133B.7.1 and ADA/ABA 303.3

As Built Meas: 4 Quantity: LF
 Description: Change in level greater than 1/2"
 As Built Desc: 1/2" lip in sidewalk surface
 Solution: Grind or repair sidewalk to remove trip hazard
 Bar. Severity: 1 Necessary Cost Estimate: \$1,000.00 Status:
 Implementation Priority: 4 Facility Function:
 Implementation Phase: Implementation Date:
 Official Responsible:

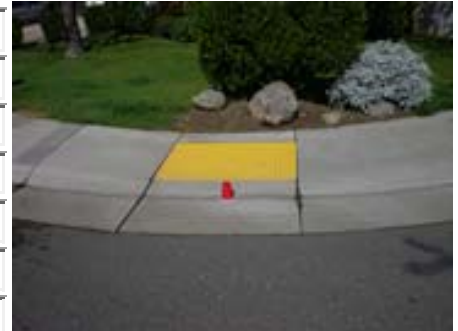
Field Date: 3/22/2011 Report Date: 3/22/2011 Barrier #: 6146A
 Location: Crutchfield Ct and Talbot Wy - Corner A
 X Coordinate: -121.24534
 Y Coordinate: 38.70873
 Barrier Area: Curb Ramps
 Barrier Type: 12" Grooves - Existing (3.1% to 4.0%)
 Code Ref: CBC 1127B.5.6

As Built Meas: 1 Quantity: EACH
 Description: 12" grooves at top of curb ramp are not level (3.1% to 4.0%)
 As Built Desc: 4.0% at 12" grooves
 Solution: Demolish existing and construct new curb ramp
 Bar. Severity: 3 Hindrance Cost Estimate: \$2,500.00 Status:
 Implementation Priority: 4 Facility Function:
 Implementation Phase: Implementation Date:
 Official Responsible:

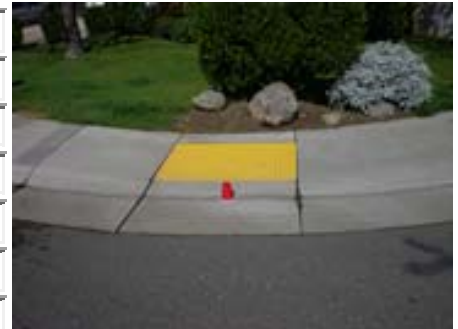
Field Date: 3/22/2011 Report Date: 3/22/2011 Barrier #: 6146B
 Location: Crutchfield Ct and Talbot Wy - Corner A
 X Coordinate: -121.24534
 Y Coordinate: 38.70873
 Barrier Area: Curb Ramps
 Barrier Type: Parallel Ramp Landing - Existing (3.1% to 4.0%)
 Code Ref: CBC 1127B.5.4 and ADA/ABA 406.4

As Built Meas: 1 Quantity: EACH
 Description: Curb ramp landing or pan not level (3.1% to 4.0%)
 As Built Desc: 3.7% landing slope
 Solution: Demolish existing and construct new transition
 Bar. Severity: 3 Hindrance Cost Estimate: \$250.00 Status:
 Implementation Priority: 4 Facility Function:
 Implementation Phase: Implementation Date:
 Official Responsible:

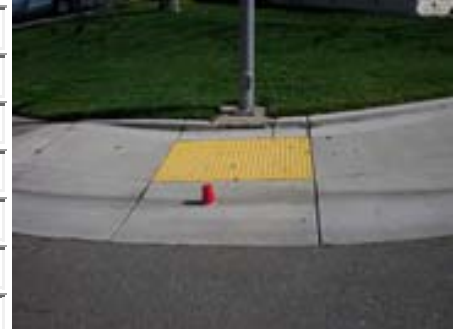
Field Date: 3/22/2011 Report Date: 3/22/2011 Barrier #: 6147A
 Location: Crutchfield Ct and Talbot Wy - Corner B
 X Coordinate: -121.24518
 Y Coordinate: 38.70872
 Barrier Area: Curb Ramps
 Barrier Type: 12" Grooves - Existing (>5.0%)
 Code Ref: CBC 1127B.5.6

As Built Meas: 1 Quantity: EACH
 Description: 12" grooves at top of curb ramp are not level (>5.0%)
 As Built Desc: 9.4% at 12" grooves
 Solution: Demolish existing and construct new curb ramp
 Bar. Severity: 1 Necessary Cost Estimate: \$2,500.00 Status:
 Implementation Priority: 4 Facility Function:
 Implementation Phase: Implementation Date:
 Official Responsible:

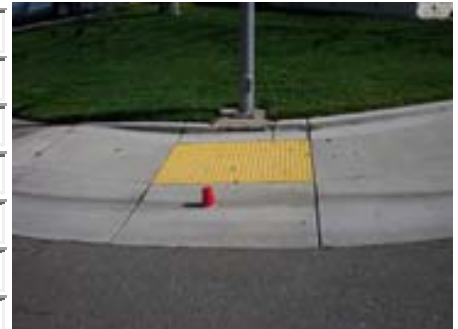
Field Date: 3/22/2011 Report Date: 3/22/2011 Barrier #: 6147B
 Location: Crutchfield Ct and Talbot Wy - Corner B
 X Coordinate: -121.24518
 Y Coordinate: 38.70872
 Barrier Area: Curb Ramps
 Barrier Type: Parallel Ramp Landing - Existing (>5.0% or more)
 Code Ref: CBC 1127B.5.4 and ADA/ABA 406.4

As Built Meas: 1 Quantity: EACH
 Description: Curb ramp landing or pan not level (>5.0% or more)
 As Built Desc: 6.2% landing slope
 Solution: Demolish existing and construct new transition
 Bar. Severity: 1 Necessary Cost Estimate: \$250.00 Status:
 Implementation Priority: 4 Facility Function:
 Implementation Phase: Implementation Date:
 Official Responsible:

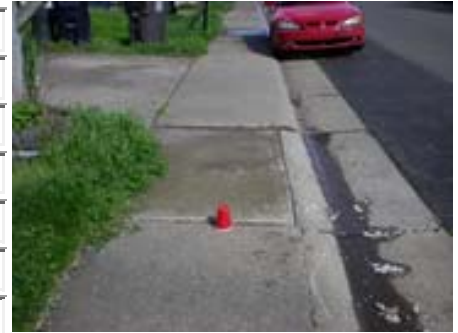
Field Date: 3/22/2011 Report Date: 3/22/2011 Barrier #: 6148
 Location: Talbot Wy - West
 X Coordinate: -121.24532
 Y Coordinate: 38.70937
 Barrier Area: Sidewalks
 Barrier Type: Abrupt Change in Level - > 1/2"
 Code Ref: CBC 1133B.7.1 and ADA/ABA 303.3

As Built Meas: 6 Quantity: LF
 Description: Change in level greater than 1/2"
 As Built Desc: 1/2" lip in sidewalk surface
 Solution: Grind or repair sidewalk to remove trip hazard
 Bar. Severity: 1 Necessary Cost Estimate: \$1,500.00 Status:
 Implementation Priority: 4 Facility Function:
 Implementation Phase: Implementation Date:
 Official Responsible:

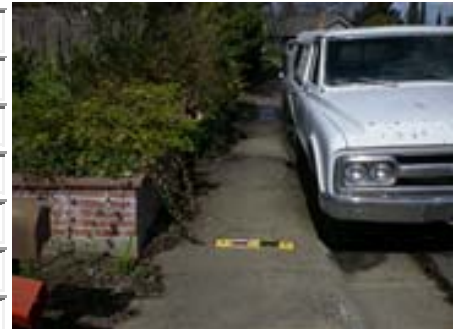
Field Date: 3/22/2011 Report Date: 3/22/2011 Barrier #: 6149
 Location: Talbot Wy - West
 X Coordinate: -121.24579
 Y Coordinate: 38.71135
 Barrier Area: Sidewalks
 Barrier Type: Clear Width - Existing ($\leq 31"$ or less)
 Code Ref: CBC 1133B.7.1

As Built Meas: 1 Quantity: LF
 Description: Pedestrian route is not min. 48" wide ($\leq 31"$ or less)
 As Built Desc: 24" clear width due to foliage
 Solution: Trim foliage to provide min. 48" clear width
 Bar. Severity: 1 Necessary Cost Estimate: \$125.00 Status:
 Implementation Priority: 4 Facility Function:
 Implementation Phase: Implementation Date:
 Official Responsible:

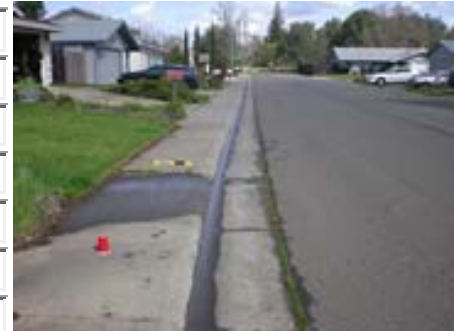
Field Date: 3/22/2011 Report Date: 3/22/2011 Barrier #: 6150
 Location: Talbot Wy - West
 X Coordinate: -121.24612
 Y Coordinate: 38.71187
 Barrier Area: Sidewalks
 Barrier Type: Cross Slope - Existing (3.1% to 4.0%)
 Code Ref: CBC 1133B.7.1.3 and ADA/ABA 403.3

As Built Meas: 294 Quantity: LF
 Description: Cross slope exceeds 2.0% (3.1% to 4.0%)
 As Built Desc: 3.8% cross slope
 Solution: Demolish existing and construct new route
 Bar. Severity: 3 Hinderance Cost Estimate: \$36,750.00 Status:
 Implementation Priority: 4 Facility Function:
 Implementation Phase: Implementation Date:
 Official Responsible:

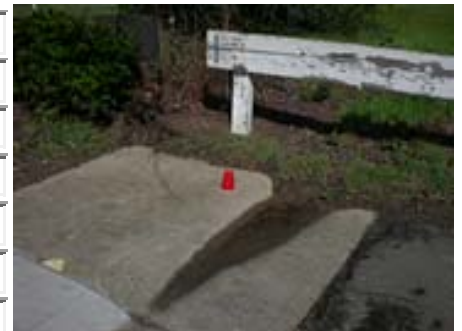
Field Date: 3/22/2011 Report Date: 3/22/2011 Barrier #: 6151
 Location: Talbot Wy - West
 X Coordinate: -121.24611
 Y Coordinate: 38.71274
 Barrier Area: Sidewalks
 Barrier Type: No Sidewalk - Transition to Shoulder
 Code Ref: CBC 1121B.2 and ADA/ABA 206.2.1

As Built Meas: 1 Quantity: JOB
 Description: Sidewalk ends and no ramp to pedestrian shoulder is provided
 As Built Desc: No ramp to shoulder to enable pedestrian travel onto existing shoulder
 Solution: Provide transition ramp to paved shoulder where no opposite sidewalk exists
 Bar. Severity: 1 Necessary Cost Estimate: \$2,500.00 Status:
 Implementation Priority: 4 Facility Function:
 Implementation Phase: Implementation Date:
 Official Responsible:

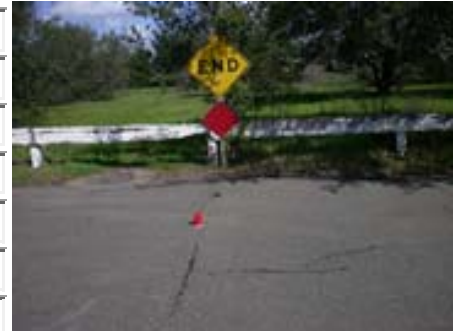
Field Date: 3/22/2011 Report Date: 3/22/2011 Barrier #: 6152
 Location: Talbot Wy - West
 X Coordinate: -121.24601
 Y Coordinate: 38.71279
 Barrier Area: Sidewalks
 Barrier Type: No Sidewalk - Cane Detectable Barricade
 Code Ref: CBC 1133B.8.6 and MUTCD Section 6D.02

As Built Meas: 60 Quantity: LF
 Description: No cane detectable warning on existing barricade
 As Built Desc: Existing barricade lacks warning for the visually impaired
 Solution: Provide cane detectable warning on barricade (max. 6" above ground)
 Bar. Severity: 1 Necessary Cost Estimate: \$6,000.00 Status:
 Implementation Priority: 4 Facility Function:
 Implementation Phase: Implementation Date:
 Official Responsible:

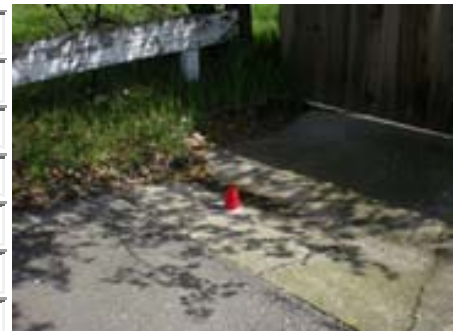
Field Date: 3/22/2011 Report Date: 3/22/2011 Barrier #: 6153
 Location: Talbot Wy - West
 X Coordinate: -121.24595
 Y Coordinate: 38.71274
 Barrier Area: Sidewalks
 Barrier Type: No Sidewalk - Transition to Shoulder
 Code Ref: CBC 1121B.2 and ADA/ABA 206.2.1

As Built Meas: 1 Quantity: JOB
 Description: Sidewalk ends and no ramp to pedestrian shoulder is provided
 As Built Desc: No ramp to shoulder to enable pedestrian travel onto existing shoulder
 Solution: Provide transition ramp to paved shoulder where no opposite sidewalk exists
 Bar. Severity: 1 Necessary Cost Estimate: \$2,500.00 Status:
 Implementation Priority: 4 Facility Function:
 Implementation Phase: Implementation Date:
 Official Responsible:

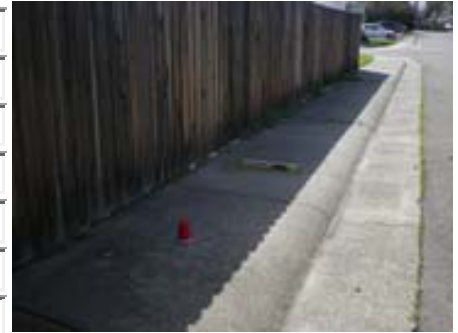
Field Date: 3/22/2011 Report Date: 3/22/2011 Barrier #: 6154
 Location: Talbot Wy - East
 X Coordinate: -121.24598
 Y Coordinate: 38.71263
 Barrier Area: Sidewalks
 Barrier Type: Cross Slope - Existing (2.1% to 3.0%)
 Code Ref: CBC 1133B.7.1.3 and ADA/ABA 403.3

As Built Meas: 90 Quantity: LF
 Description: Cross slope exceeds 2.0% (2.1% to 3.0%)
 As Built Desc: 3.0% cross slope
 Solution: Low severity barrier - no remediation recommended
 Bar. Severity: 4 Low Severity Cost Estimate: \$0.00 Status:
 Implementation Priority: 4 Facility Function:
 Implementation Phase: Implementation Date:
 Official Responsible:

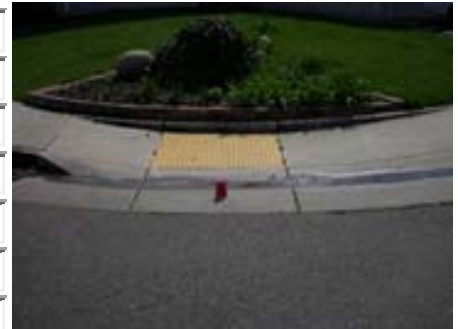
Field Date: 3/22/2011 Report Date: 3/22/2011 Barrier #: 6155A
 Location: Talbot Wy and Poticelli Wy - Corner C
 X Coordinate: -121.24596
 Y Coordinate: 38.7124
 Barrier Area: Curb Ramps
 Barrier Type: 12" Grooves - Existing (4.1% to 4.9%)
 Code Ref: CBC 1127B.5.6

As Built Meas: 1 Quantity: EACH
 Description: 12" grooves at top of curb ramp are not level (4.1% to 4.9%)
 As Built Desc: 4.5% at 12" grooves
 Solution: Demolish existing and construct new curb ramp
 Bar. Severity: 2 Recommended Cost Estimate: \$2,500.00 Status:
 Implementation Priority: 4 Facility Function:
 Implementation Phase: Implementation Date:
 Official Responsible:

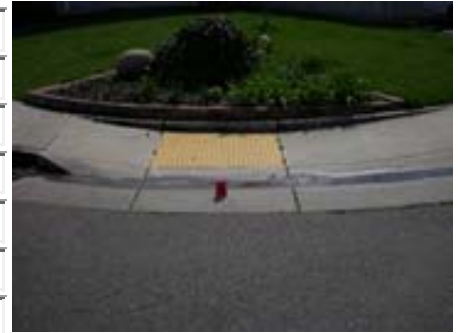
Field Date: 3/22/2011 Report Date: 3/22/2011 Barrier #: 6155B
 Location: Talbot Wy and Poticelli Wy - Corner C
 X Coordinate: -121.24596
 Y Coordinate: 38.7124
 Barrier Area: Curb Ramps
 Barrier Type: Parallel Ramp Landing - Existing (2.1% to 3.0%)
 Code Ref: CBC 1127B.5.4 and ADA/ABA 406.4

As Built Meas: 1 Quantity: EACH
 Description: Curb ramp landing or pan not level (2.1% to 3.0%)
 As Built Desc: 2.5% landing slope
 Solution: Demolish existing and construct new transition
 Bar. Severity: 4 Low Severity Cost Estimate: \$250.00 Status:
 Implementation Priority: 4 Facility Function:
 Implementation Phase: Implementation Date:
 Official Responsible:

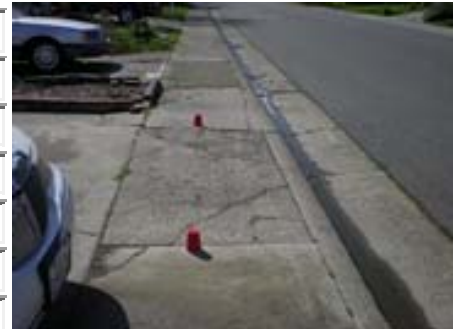
Field Date: 3/22/2011 Report Date: 3/22/2011 Barrier #: 6156
 Location: Talbot Wy - East
 X Coordinate: -121.24593
 Y Coordinate: 38.71223
 Barrier Area: Sidewalks
 Barrier Type: Surface Condition - Damaged
 Code Ref: CBC 1133B.7.1 and ADA/ABA 302.1

As Built Meas: 8 Quantity: LF
 Description: Surface is not firm and stable (cracked, broken or loose soil, etc.)
 As Built Desc: Cracked concrete
 Solution: Repair surface to make firm and stable
 Bar. Severity: 1 Necessary Cost Estimate: \$1,000.00 Status:
 Implementation Priority: 4 Facility Function:
 Implementation Phase: Implementation Date:
 Official Responsible:

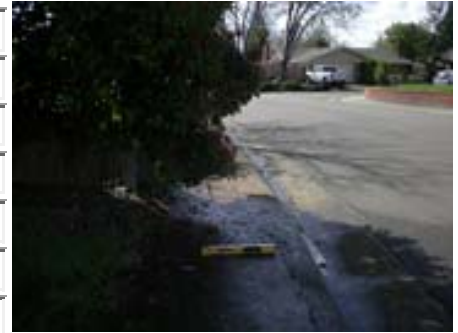
Field Date: 3/22/2011 Report Date: 3/22/2011 Barrier #: 6157
 Location: Talbot Wy - East
 X Coordinate: -121.24597
 Y Coordinate: 38.71193
 Barrier Area: Sidewalks
 Barrier Type: Protruding Hazard
 Code Ref: CBC 1133B.8.6.1 and ADA/ABA 307.2

As Built Meas: 1 Quantity: JOB
 Description: Protruding object in route of travel between 27" and 80" high
 As Built Desc: 32" at tree branch
 Solution: Remove object or provide detectable warning
 Bar. Severity: 1 Necessary Cost Estimate: \$1,400.00 Status:
 Implementation Priority: 4 Facility Function:
 Implementation Phase: Implementation Date:
 Official Responsible:

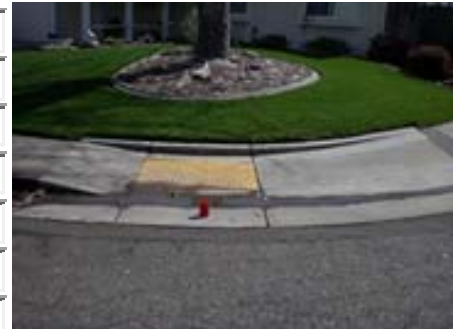
Field Date: 3/22/2011 Report Date: 3/22/2011 Barrier #: 6158
 Location: Talbot Wy and Bannock Ct - Corner C
 X Coordinate: -121.24557
 Y Coordinate: 38.71136
 Barrier Area: Curb Ramps
 Barrier Type: 12" Grooves - Existing (4.1% to 4.9%)
 Code Ref: CBC 1127B.5.6

As Built Meas: 1 Quantity: EACH
 Description: 12" grooves at top of curb ramp are not level (4.1% to 4.9%)
 As Built Desc: 4.1% at 12" grooves
 Solution: Demolish existing and construct new curb ramp
 Bar. Severity: 2 Recommended Cost Estimate: \$2,500.00 Status:
 Implementation Priority: 4 Facility Function:
 Implementation Phase: Implementation Date:
 Official Responsible:

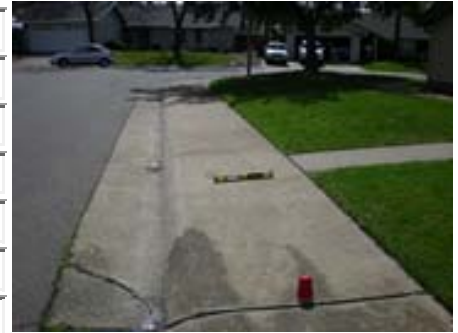
Field Date: 3/22/2011 Report Date: 3/22/2011 Barrier #: 6159
 Location: Argo Dr - West
 X Coordinate: -121.24705
 Y Coordinate: 38.715
 Barrier Area: Sidewalks
 Barrier Type: Cross Slope - Existing (3.1% to 4.0%)
 Code Ref: CBC 1133B.7.1.3 and ADA/ABA 403.3

As Built Meas: 58 Quantity: LF
 Description: Cross slope exceeds 2.0% (3.1% to 4.0%)
 As Built Desc: 3.8% cross slope
 Solution: Demolish existing and construct new route
 Bar. Severity: 3 Hinderance Cost Estimate: \$7,250.00 Status:
 Implementation Priority: 4 Facility Function:
 Implementation Phase: Implementation Date:
 Official Responsible:

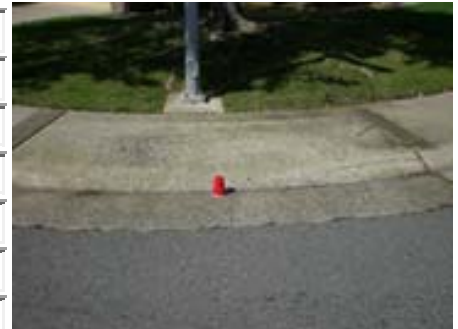
Field Date: 3/22/2011 Report Date: 3/22/2011 Barrier #: 6160
 Location: Argo Dr and Talbot Wy - Corner A
 X Coordinate: -121.24695
 Y Coordinate: 38.71485
 Barrier Area: Curb Ramps
 Barrier Type: No Curb Ramp - Depressed Existing Curb
 Code Ref: CBC 1127B.5.1 and ADA/ABA 402.2

As Built Meas: 1 Quantity: EACH
 Description: No compliant curb cut at corner (intersection)
 As Built Desc: 12.2% running slope at depressed area
 Solution: Demolish existing and construct curb cut
 Bar. Severity: 1 Necessary Cost Estimate: \$2,500.00 Status:
 Implementation Priority: 4 Facility Function:
 Implementation Phase: Implementation Date:
 Official Responsible:

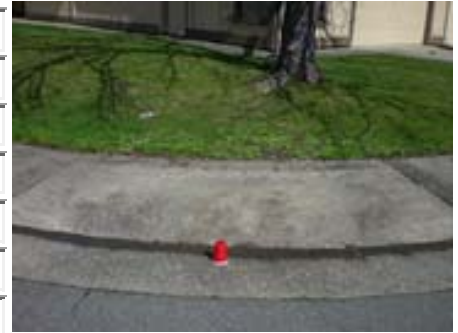
Field Date: 3/22/2011 Report Date: 3/22/2011 Barrier #: 6161
 Location: Argo Dr and Talbot Wy - Corner B
 X Coordinate: -121.24678
 Y Coordinate: 38.71495
 Barrier Area: Curb Ramps
 Barrier Type: No Curb Ramp - Depressed Existing Curb
 Code Ref: CBC 1127B.5.1 and ADA/ABA 402.2

As Built Meas: 1 Quantity: EACH
 Description: No compliant curb cut at corner (intersection)
 As Built Desc: 13.8% running slope at depressed area
 Solution: Demolish existing and construct curb cut
 Bar. Severity: 1 Necessary Cost Estimate: \$2,500.00 Status:
 Implementation Priority: 4 Facility Function:
 Implementation Phase: Implementation Date:
 Official Responsible:

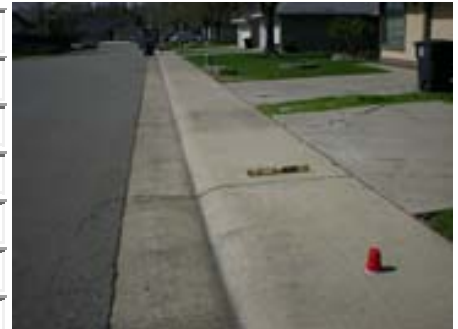
Field Date: 3/22/2011 Report Date: 3/22/2011 Barrier #: 6162
 Location: Talbot Wy - North
 X Coordinate: -121.24702
 Y Coordinate: 38.71479
 Barrier Area: Sidewalks
 Barrier Type: Cross Slope - Existing (4.1% to 4.9%)
 Code Ref: CBC 1133B.7.1.3 and ADA/ABA 403.3

As Built Meas: 124 Quantity: LF
 Description: Cross slope exceeds 2.0% (4.1% to 4.9%)
 As Built Desc: 4.3% cross slope
 Solution: Demolish existing and construct new route
 Bar. Severity: 2 Recommended Cost Estimate: \$15,500.00 Status:
 Implementation Priority: 4 Facility Function:
 Implementation Phase: Implementation Date:
 Official Responsible:

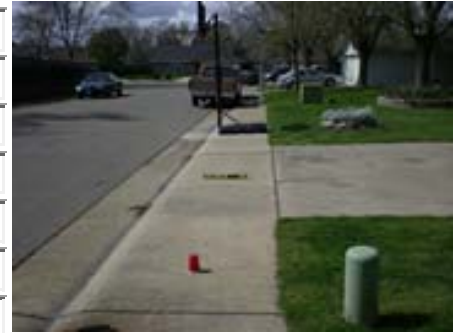
Field Date: 3/22/2011 Report Date: 3/22/2011 Barrier #: 6163
 Location: Weddell Ct - North
 X Coordinate: -121.24739
 Y Coordinate: 38.71459
 Barrier Area: Sidewalks
 Barrier Type: Cross Slope - Existing (4.1% to 4.9%)
 Code Ref: CBC 1133B.7.1.3 and ADA/ABA 403.3

As Built Meas: 243 Quantity: LF
 Description: Cross slope exceeds 2.0% (4.1% to 4.9%)
 As Built Desc: 4.3% cross slope
 Solution: Demolish existing and construct new route
 Bar. Severity: 2 Recommended Cost Estimate: \$30,375.00 Status:
 Implementation Priority: 4 Facility Function:
 Implementation Phase: Implementation Date:
 Official Responsible:

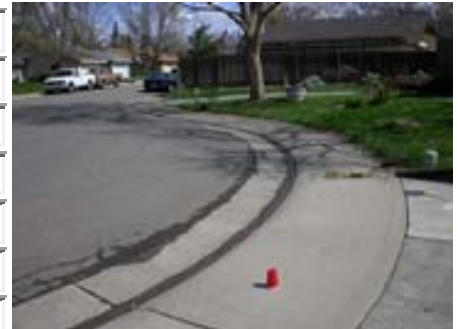
Field Date: 3/22/2011 Report Date: 3/22/2011 Barrier #: 6164
 Location: Weddell Ct - South
 X Coordinate: -121.24774
 Y Coordinate: 38.71415
 Barrier Area: Sidewalks
 Barrier Type: Cross Slope - Existing (5.0% or more)
 Code Ref: CBC 1133B.7.1.3 and ADA/ABA 403.3

As Built Meas: 195 Quantity: LF
 Description: Cross slope exceeds 2.0% (5.0% or more)
 As Built Desc: 5.0% cross slope
 Solution: Demolish existing and construct new route
 Bar. Severity: 1 Necessary Cost Estimate: \$24,375.00 Status:
 Implementation Priority: 4 Facility Function:
 Implementation Phase: Implementation Date:
 Official Responsible:

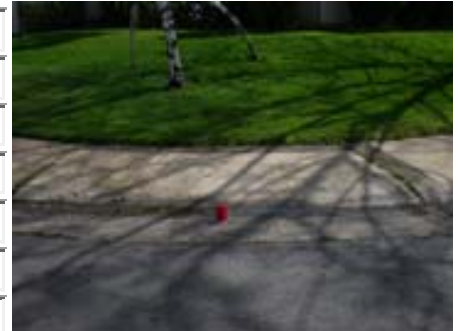
Field Date: 3/22/2011 Report Date: 3/22/2011 Barrier #: 6165
 Location: Talbot Wy and Phoebe Wy - Corner C
 X Coordinate: -121.24709
 Y Coordinate: 38.7146
 Barrier Area: Curb Ramps
 Barrier Type: No Curb Ramp - Depressed Existing Curb
 Code Ref: CBC 1127B.5.1 and ADA/ABA 402.2

As Built Meas: 1 Quantity: EACH
 Description: No compliant curb cut at corner (intersection)
 As Built Desc: 12.0% running slope at depressed area
 Solution: Demolish existing and construct curb cut
 Bar. Severity: 1 Necessary Cost Estimate: \$2,500.00 Status:
 Implementation Priority: 4 Facility Function:
 Implementation Phase: Implementation Date:
 Official Responsible:

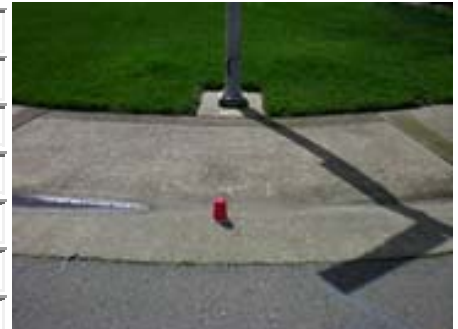
Field Date: 3/22/2011 Report Date: 3/22/2011 Barrier #: 6166
 Location: Talbot Wy and Phoebe Wy - Corner D
 X Coordinate: -121.24720
 Y Coordinate: 38.71454
 Barrier Area: Curb Ramps
 Barrier Type: No Curb Ramp - Depressed Existing Curb
 Code Ref: CBC 1127B.5.1 and ADA/ABA 402.2

As Built Meas: 1 Quantity: EACH
 Description: No compliant curb cut at corner (intersection)
 As Built Desc: 13.0% running slope at depressed area
 Solution: Demolish existing and construct curb cut
 Bar. Severity: 1 Necessary Cost Estimate: \$2,500.00 Status:
 Implementation Priority: 4 Facility Function:
 Implementation Phase: Implementation Date:
 Official Responsible:

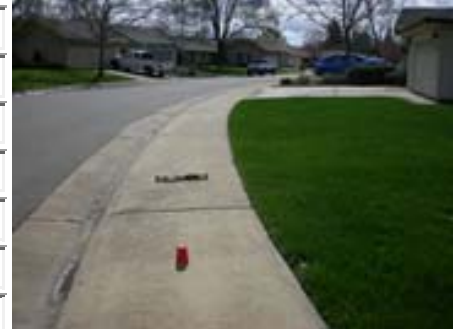
Field Date: 3/22/2011 Report Date: 3/22/2011 Barrier #: 6167
 Location: Phoebe Wy - West
 X Coordinate: -121.24704
 Y Coordinate: 38.71376
 Barrier Area: Sidewalks
 Barrier Type: Cross Slope - Existing (3.1% to 4.0%)
 Code Ref: CBC 1133B.7.1.3 and ADA/ABA 403.3

As Built Meas: 290 Quantity: LF
 Description: Cross slope exceeds 2.0% (3.1% to 4.0%)
 As Built Desc: 3.8% cross slope
 Solution: Demolish existing and construct new route
 Bar. Severity: 3 Hinderance Cost Estimate: \$36,250.00 Status:
 Implementation Priority: 4 Facility Function:
 Implementation Phase: Implementation Date:
 Official Responsible:

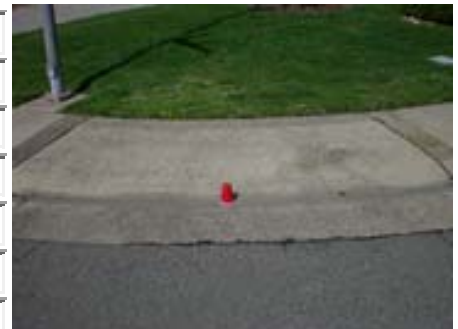
Field Date: 3/22/2011 Report Date: 3/22/2011 Barrier #: 6168
 Location: Phoebe Wy and Thethys Wy - Corner A
 X Coordinate: -121.24705
 Y Coordinate: 38.71364
 Barrier Area: Curb Ramps
 Barrier Type: No Curb Ramp - Depressed Existing Curb
 Code Ref: CBC 1127B.5.1 and ADA/ABA 402.2

As Built Meas: 1 Quantity: EACH
 Description: No compliant curb cut at corner (intersection)
 As Built Desc: 11.3% running slope at depressed area
 Solution: Demolish existing and construct curb cut
 Bar. Severity: 1 Necessary Cost Estimate: \$2,500.00 Status:
 Implementation Priority: 4 Facility Function:
 Implementation Phase: Implementation Date:
 Official Responsible:

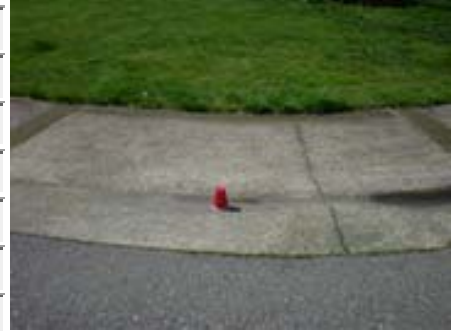
Field Date: 3/22/2011 Report Date: 3/22/2011 Barrier #: 6169
 Location: Phoebe Wy and Thethys Wy - Corner D
 X Coordinate: -121.24705
 Y Coordinate: 38.71356
 Barrier Area: Curb Ramps
 Barrier Type: No Curb Ramp - Depressed Existing Curb
 Code Ref: CBC 1127B.5.1 and ADA/ABA 402.2

As Built Meas: 1 Quantity: EACH
 Description: No compliant curb cut at corner (intersection)
 As Built Desc: 10.7% running slope at depressed area
 Solution: Demolish existing and construct curb cut
 Bar. Severity: 1 Necessary Cost Estimate: \$2,500.00 Status:
 Implementation Priority: 4 Facility Function:
 Implementation Phase: Implementation Date:
 Official Responsible:

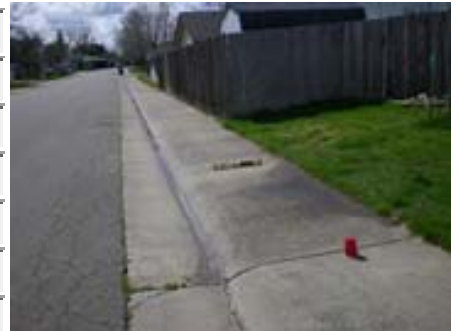
Field Date: 3/22/2011 Report Date: 3/22/2011 Barrier #: 6170
 Location: Phoebe Wy - West
 X Coordinate: -121.24707
 Y Coordinate: 38.71345
 Barrier Area: Sidewalks
 Barrier Type: Cross Slope - Existing (3.1% to 4.0%)
 Code Ref: CBC 1133B.7.1.3 and ADA/ABA 403.3

As Built Meas: 219 Quantity: LF
 Description: Cross slope exceeds 2.0% (3.1% to 4.0%)
 As Built Desc: 3.4% cross slope
 Solution: Demolish existing and construct new route
 Bar. Severity: 3 Hinderance Cost Estimate: \$27,375.00 Status:
 Implementation Priority: 4 Facility Function:
 Implementation Phase: Implementation Date:
 Official Responsible:

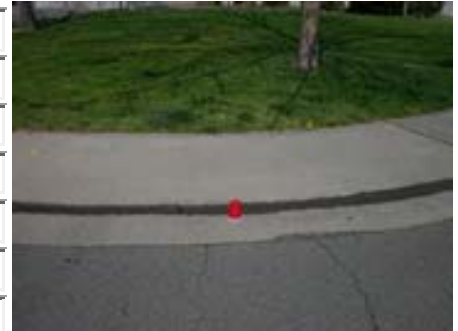
Field Date: 3/22/2011 Report Date: 3/22/2011 Barrier #: 6171
 Location: Phoebe Wy and Phoebe Wy Ct - Corner A
 X Coordinate: -121.24708
 Y Coordinate: 38.71288
 Barrier Area: Curb Ramps
 Barrier Type: No Curb Ramp - Depressed Existing Curb
 Code Ref: CBC 1127B.5.1 and ADA/ABA 402.2

As Built Meas: 1 Quantity: EACH
 Description: No compliant curb cut at corner (intersection)
 As Built Desc: 8.8% running slope at depressed area
 Solution: Demolish existing and construct curb cut
 Bar. Severity: 1 Necessary Cost Estimate: \$2,500.00 Status:
 Implementation Priority: 4 Facility Function:
 Implementation Phase: Implementation Date:
 Official Responsible:

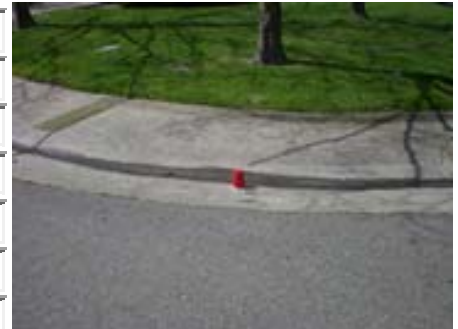
Field Date: 3/22/2011 Report Date: 3/22/2011 Barrier #: 6172
 Location: Phoebe Wy and Phoebe Wy Ct - Corner D
 X Coordinate: -121.24709
 Y Coordinate: 38.71275
 Barrier Area: Curb Ramps
 Barrier Type: No Curb Ramp - Depressed Existing Curb
 Code Ref: CBC 1127B.5.1 and ADA/ABA 402.2

As Built Meas: 1 Quantity: EACH
 Description: No compliant curb cut at corner (intersection)
 As Built Desc: 7.4% running slope at depressed area
 Solution: Demolish existing and construct curb cut
 Bar. Severity: 1 Necessary Cost Estimate: \$2,500.00 Status:
 Implementation Priority: 4 Facility Function:
 Implementation Phase: Implementation Date:
 Official Responsible:

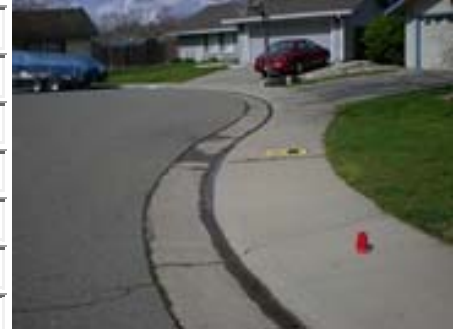
Field Date: 3/22/2011 Report Date: 3/22/2011 Barrier #: 6173
 Location: Phoebe Wy Ct - North
 X Coordinate: -121.24717
 Y Coordinate: 38.71286
 Barrier Area: Sidewalks
 Barrier Type: Cross Slope - Existing (3.1% to 4.0%)
 Code Ref: CBC 1133B.7.1.3 and ADA/ABA 403.3

As Built Meas: 125 Quantity: LF
 Description: Cross slope exceeds 2.0% (3.1% to 4.0%)
 As Built Desc: 3.5% cross slope
 Solution: Demolish existing and construct new route
 Bar. Severity: 3 Hinderance Cost Estimate: \$15,625.00 Status:
 Implementation Priority: 4 Facility Function:
 Implementation Phase: Implementation Date:
 Official Responsible:

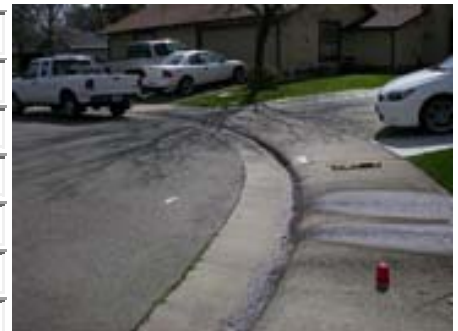
Field Date: 3/22/2011 Report Date: 3/22/2011 Barrier #: 6174
 Location: Phoebe Wy Ct - South
 X Coordinate: -121.24743
 Y Coordinate: 38.71278
 Barrier Area: Sidewalks
 Barrier Type: Cross Slope - Existing (3.1% to 4.0%)
 Code Ref: CBC 1133B.7.1.3 and ADA/ABA 403.3

As Built Meas: 78 Quantity: LF
 Description: Cross slope exceeds 2.0% (3.1% to 4.0%)
 As Built Desc: 3.4% cross slope
 Solution: Demolish existing and construct new route
 Bar. Severity: 3 Hinderance Cost Estimate: \$9,750.00 Status:
 Implementation Priority: 4 Facility Function:
 Implementation Phase: Implementation Date:
 Official Responsible:

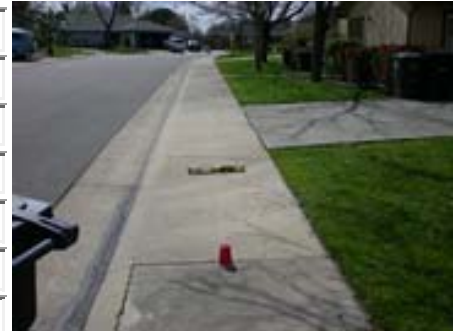
Field Date: 3/22/2011 Report Date: 3/22/2011 Barrier #: 6175
 Location: Phoebe Wy - West
 X Coordinate: -121.24707
 Y Coordinate: 38.71266
 Barrier Area: Sidewalks
 Barrier Type: Cross Slope - Existing (3.1% to 4.0%)
 Code Ref: CBC 1133B.7.1.3 and ADA/ABA 403.3

As Built Meas: 168 Quantity: LF
 Description: Cross slope exceeds 2.0% (3.1% to 4.0%)
 As Built Desc: 3.9% cross slope
 Solution: Demolish existing and construct new route
 Bar. Severity: 3 Hinderance Cost Estimate: \$21,000.00 Status:
 Implementation Priority: 4 Facility Function:
 Implementation Phase: Implementation Date:
 Official Responsible:

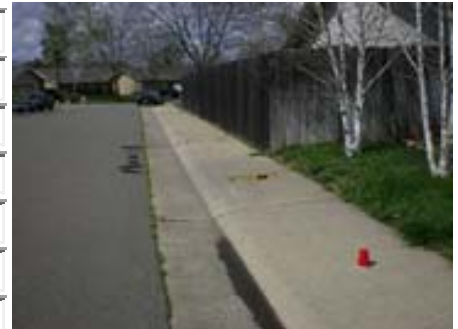
Field Date: 3/22/2011 Report Date: 3/22/2011 Barrier #: 6176
 Location: Phoebe Wy - North
 X Coordinate: -121.24723
 Y Coordinate: 38.71226
 Barrier Area: Sidewalks
 Barrier Type: Cross Slope - Existing (3.1% to 4.0%)
 Code Ref: CBC 1133B.7.1.3 and ADA/ABA 403.3

As Built Meas: 198 Quantity: LF
 Description: Cross slope exceeds 2.0% (3.1% to 4.0%)
 As Built Desc: 3.4% cross slope
 Solution: Demolish existing and construct new route
 Bar. Severity: 3 Hinderance Cost Estimate: \$24,750.00 Status:
 Implementation Priority: 4 Facility Function:
 Implementation Phase: Implementation Date:
 Official Responsible:

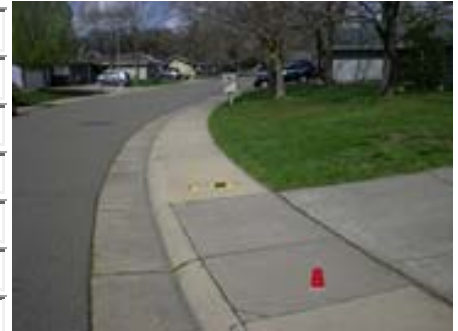
Field Date: 3/22/2011 Report Date: 3/22/2011 Barrier #: 6177
 Location: Phoebe Wy - East
 X Coordinate: -121.24791
 Y Coordinate: 38.71239
 Barrier Area: Sidewalks
 Barrier Type: Cross Slope - Existing (3.1% to 4.0%)
 Code Ref: CBC 1133B.7.1.3 and ADA/ABA 403.3

As Built Meas: 298 Quantity: LF
 Description: Cross slope exceeds 2.0% (3.1% to 4.0%)
 As Built Desc: 3.2% cross slope
 Solution: Demolish existing and construct new route
 Bar. Severity: 3 Hinderance Cost Estimate: \$37,250.00 Status:
 Implementation Priority: 4 Facility Function:
 Implementation Phase: Implementation Date:
 Official Responsible:

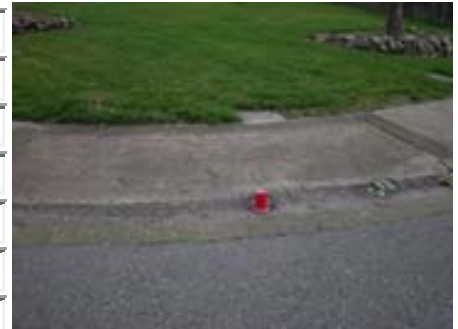
Field Date: 3/22/2011 Report Date: 3/22/2011 Barrier #: 6178
 Location: Phoebe Wy and Thethys Wy - Corner B
 X Coordinate: -121.24852
 Y Coordinate: 38.71309
 Barrier Area: Curb Ramps
 Barrier Type: No Curb Ramp - Depressed Existing Curb
 Code Ref: CBC 1127B.5.1 and ADA/ABA 402.2

As Built Meas: 1 Quantity: EACH
 Description: No compliant curb cut at corner (intersection)
 As Built Desc: 14.2% running slope at depressed area
 Solution: Demolish existing and construct curb cut
 Bar. Severity: 1 Necessary Cost Estimate: \$2,500.00 Status:
 Implementation Priority: 4 Facility Function:
 Implementation Phase: Implementation Date:
 Official Responsible:

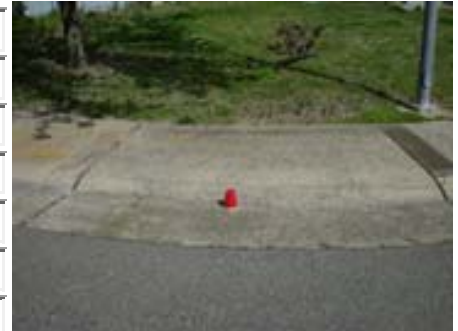
Field Date: 3/22/2011 Report Date: 3/22/2011 Barrier #: 6179
 Location: Phoebe Wy and Thethys Wy - Corner C
 X Coordinate: -121.24846
 Y Coordinate: 38.71301
 Barrier Area: Curb Ramps
 Barrier Type: No Curb Ramp - Depressed Existing Curb
 Code Ref: CBC 1127B.5.1 and ADA/ABA 402.2

As Built Meas: 1 Quantity: EACH
 Description: No compliant curb cut at corner (intersection)
 As Built Desc: 8.2% running slope at depressed area
 Solution: Demolish existing and construct curb cut
 Bar. Severity: 1 Necessary Cost Estimate: \$2,500.00 Status:
 Implementation Priority: 4 Facility Function:
 Implementation Phase: Implementation Date:
 Official Responsible:

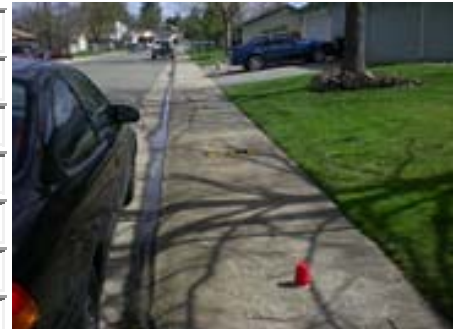
Field Date: 3/22/2011 Report Date: 3/22/2011 Barrier #: 6180
 Location: Thethys Wy - South
 X Coordinate: -121.24839
 Y Coordinate: 38.71307
 Barrier Area: Sidewalks
 Barrier Type: Cross Slope - Existing (3.1% to 4.0%)
 Code Ref: CBC 1133B.7.1.3 and ADA/ABA 403.3

As Built Meas: 429 Quantity: LF
 Description: Cross slope exceeds 2.0% (3.1% to 4.0%)
 As Built Desc: 3.4% cross slope
 Solution: Demolish existing and construct new route
 Bar. Severity: 3 Hinderance Cost Estimate: \$53,625.00 Status:
 Implementation Priority: 4 Facility Function:
 Implementation Phase: Implementation Date:
 Official Responsible:

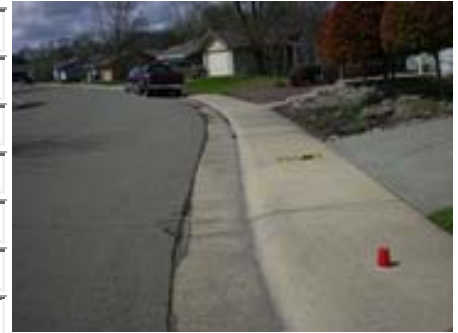
Barrier Type: Cross Slope - Existing (3.1% to 4.0%)

As Built Meas: 444 Quantity: LF

Description: Cross slope exceeds 2.0% (3.1% to 4.0%)

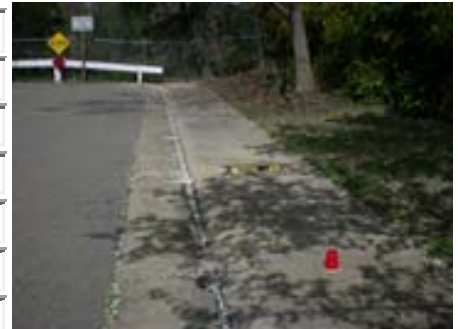
Barrier Type: Cross Slope - Existing (2.1% to 3.0%)

As Built Meas: 20 Quantity: LF

Description: Cross slope exceeds 2.0% (2.1% to 3.0%)

Solution: Low severity barrier - no remediation recommended

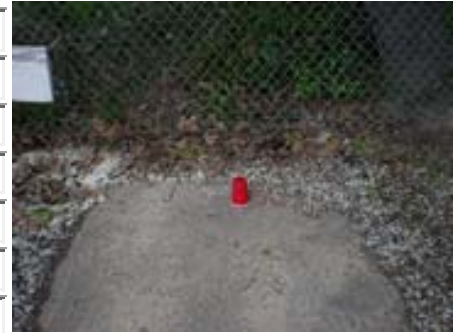
Field Date: 3/22/2011 Report Date: 3/22/2011 Barrier #: 6182B
 Location: Phoebe Wy - East
 X Coordinate: -121.24872
 Y Coordinate: 38.71335
 Barrier Area: Sidewalks
 Barrier Type: No Sidewalk - No Barricade
 Code Ref: MUTCD Section 6D.01

As Built Meas: 1 Quantity: JOB
 Description: No barricade provided where sidewalk ends in hazardous location
 As Built Desc: No barricade or other warning provided for the visually impaired at end of sidewalk
 Solution: Provide barricade with cane detectable warning at end of sidewalk
 Bar. Severity: 1 Necessary Cost Estimate: \$1,350.00 Status:
 Implementation Priority: 4 Facility Function:
 Implementation Phase: Implementation Date:
 Official Responsible:

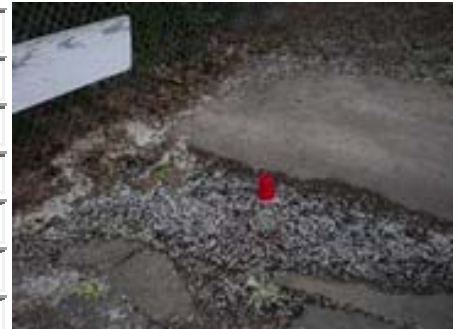
Field Date: 3/22/2011 Report Date: 3/22/2011 Barrier #: 6183
 Location: Phoebe Wy - East
 X Coordinate: -121.24874
 Y Coordinate: 38.71331
 Barrier Area: Sidewalks
 Barrier Type: No Sidewalk - Transition to Shoulder
 Code Ref: CBC 1121B.2 and ADA/ABA 206.2.1

As Built Meas: 1 Quantity: JOB
 Description: Sidewalk ends and no ramp to pedestrian shoulder is provided
 As Built Desc: No ramp to shoulder to enable pedestrian travel onto existing shoulder
 Solution: Provide transition ramp to paved shoulder where no opposite sidewalk exists
 Bar. Severity: 1 Necessary Cost Estimate: \$2,500.00 Status:
 Implementation Priority: 4 Facility Function:
 Implementation Phase: Implementation Date:
 Official Responsible:

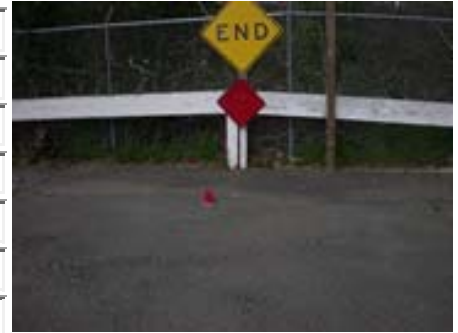
Field Date: 3/22/2011 Report Date: 3/22/2011 Barrier #: 6184
 Location: Phoebe Wy - East
 X Coordinate: -121.24880
 Y Coordinate: 38.71334
 Barrier Area: Sidewalks
 Barrier Type: No Sidewalk - Cane Detectable Barricade
 Code Ref: CBC 1133B.8.6 and MUTCD Section 6D.02

As Built Meas: 50 Quantity: LF
 Description: No cane detectable warning on existing barricade
 As Built Desc: Existing barricade lacks warning for the visually impaired
 Solution: Provide cane detectable warning on barricade (max. 6" above ground)
 Bar. Severity: 1 Necessary Cost Estimate: \$5,000.00 Status:
 Implementation Priority: 4 Facility Function:
 Implementation Phase: Implementation Date:
 Official Responsible:

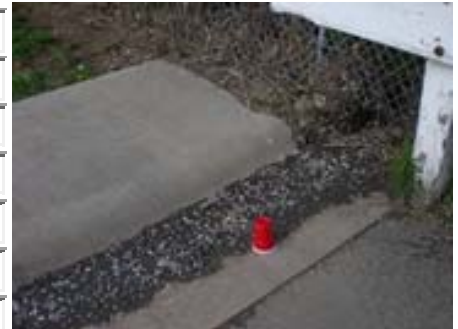
Field Date: 3/22/2011 Report Date: 3/22/2011 Barrier #: 6185
 Location: Phoebe Wy - West
 X Coordinate: -121.24882
 Y Coordinate: 38.71327
 Barrier Area: Sidewalks
 Barrier Type: No Sidewalk - Transition to Shoulder
 Code Ref: CBC 1121B.2 and ADA/ABA 206.2.1

As Built Meas: 1 Quantity: JOB
 Description: Sidewalk ends and no ramp to pedestrian shoulder is provided
 As Built Desc: No ramp to shoulder to enable pedestrian travel onto existing shoulder
 Solution: Provide transition ramp to paved shoulder where no opposite sidewalk exists
 Bar. Severity: 1 Necessary Cost Estimate: \$2,500.00 Status:
 Implementation Priority: 4 Facility Function:
 Implementation Phase: Implementation Date:
 Official Responsible:

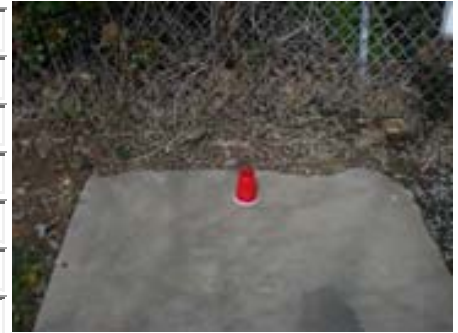
Field Date: 3/22/2011 Report Date: 3/22/2011 Barrier #: 6186
 Location: Phoebe Wy - West
 X Coordinate: -121.24886
 Y Coordinate: 38.7133
 Barrier Area: Sidewalks
 Barrier Type: No Sidewalk - No Barricade
 Code Ref: MUTCD Section 6D.01

As Built Meas: 1 Quantity: JOB
 Description: No barricade provided where sidewalk ends in hazardous location
 As Built Desc: No barricade or other warning provided for the visually impaired at end of sidewalk
 Solution: Provide barricade with cane detectable warning at end of sidewalk
 Bar. Severity: 1 Necessary Cost Estimate: \$1,350.00 Status:
 Implementation Priority: 4 Facility Function:
 Implementation Phase: Implementation Date:
 Official Responsible:

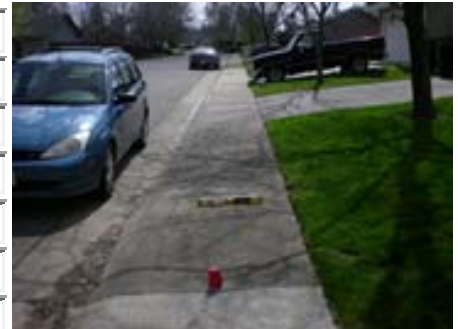
Field Date: 3/22/2011 Report Date: 3/22/2011 Barrier #: 6187
 Location: Phoebe Wy - West
 X Coordinate: -121.24873
 Y Coordinate: 38.71314
 Barrier Area: Sidewalks
 Barrier Type: Cross Slope - Existing (5.0% or more)
 Code Ref: CBC 1133B.7.1.3 and ADA/ABA 403.3

As Built Meas: 484 Quantity: LF
 Description: Cross slope exceeds 2.0% (5.0% or more)
 As Built Desc: 5.9% cross slope
 Solution: Demolish existing and construct new route
 Bar. Severity: 1 Necessary Cost Estimate: \$60,500.00 Status:
 Implementation Priority: 4 Facility Function:
 Implementation Phase: Implementation Date:
 Official Responsible:

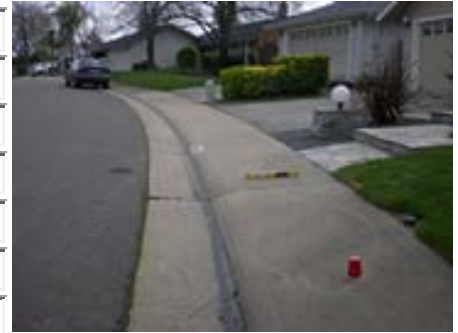
Field Date: 3/22/2011 Report Date: 3/22/2011 Barrier #: 6188
 Location: Phoebe Wy - South
 X Coordinate: -121.24785
 Y Coordinate: 38.71223
 Barrier Area: Sidewalks
 Barrier Type: Cross Slope - Existing (5.0% or more)
 Code Ref: CBC 1133B.7.1.3 and ADA/ABA 403.3

As Built Meas: 267 Quantity: LF
 Description: Cross slope exceeds 2.0% (5.0% or more)
 As Built Desc: 5.6% cross slope
 Solution: Demolish existing and construct new route
 Bar. Severity: 1 Necessary Cost Estimate: \$33,375.00 Status:
 Implementation Priority: 4 Facility Function:
 Implementation Phase: Implementation Date:
 Official Responsible:

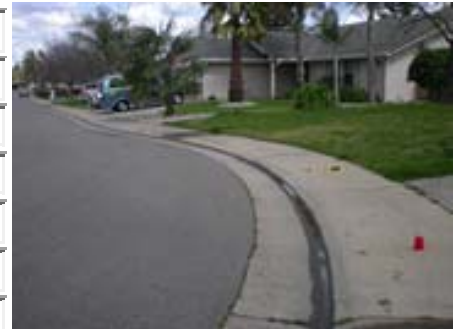
Field Date: 3/22/2011 Report Date: 3/22/2011 Barrier #: 6189A
 Location: Phoebe Wy - East
 X Coordinate: -121.24696
 Y Coordinate: 38.7122
 Barrier Area: Sidewalks
 Barrier Type: Cross Slope - Existing (4.1% to 4.9%)
 Code Ref: CBC 1133B.7.1.3 and ADA/ABA 403.3

As Built Meas: 886 Quantity: LF
 Description: Cross slope exceeds 2.0% (4.1% to 4.9%)
 As Built Desc: 4.8% cross slope
 Solution: Demolish existing and construct new route
 Bar. Severity: 2 Recommended Cost Estimate: \$110,750.00 Status:
 Implementation Priority: 4 Facility Function:
 Implementation Phase: Implementation Date:
 Official Responsible:

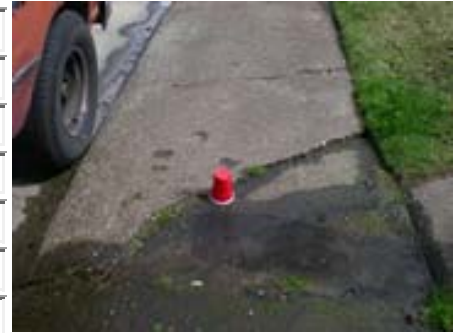
Field Date: 3/22/2011 Report Date: 3/22/2011 Barrier #: 6190B
 Location: Talbot Wy - South
 X Coordinate: -121.24655
 Y Coordinate: 38.71491
 Barrier Area: Sidewalks
 Barrier Type: Abrupt Change in Level - > 1/2"
 Code Ref: CBC 1133B.7.1 and ADA/ABA 303.3

As Built Meas: 4 Quantity: LF
 Description: Change in level greater than 1/2"
 As Built Desc: 1/2" lip in sidewalk surface
 Solution: Grind or repair sidewalk to remove trip hazard
 Bar. Severity: 1 Necessary Cost Estimate: \$1,000.00 Status:
 Implementation Priority: 4 Facility Function:
 Implementation Phase: Implementation Date:
 Official Responsible:

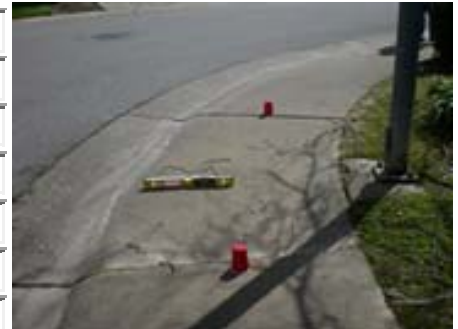
Field Date: 3/22/2011 Report Date: 3/22/2011 Barrier #: 6191
 Location: Talbot Wy - South
 X Coordinate: -121.24580
 Y Coordinate: 38.71498
 Barrier Area: Sidewalks
 Barrier Type: Elbow in Sidewalk - Cross Slope (5.0% or more)
 Code Ref: CBC 1133B.7.1.3 and ADA/ABA 403.3

As Built Meas: 6 Quantity: LF
 Description: Cross slope at elbow exceeds 2.0% (5.0% or more)
 As Built Desc: 7.8% cross slope
 Solution: Demolish existing and construct new sidewalk without curb ramp
 Bar. Severity: 1 Necessary Cost Estimate: \$750.00 Status:
 Implementation Priority: 4 Facility Function:
 Implementation Phase: Implementation Date:
 Official Responsible:
