**DRAFT ADA TRANSITION PLAN UPDATE
NEIGHBORHOOD AREA 8 CHASE
SEPTEMBER 20, 2011**

CITY OF CITRUS HEIGHTS

Conditions - CHASE Area 8

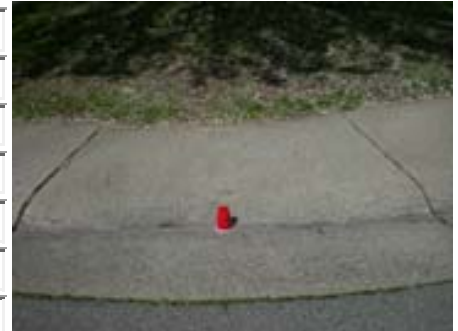
Field Date: 3/22/2011 Report Date: 3/22/2011 Barrier #: 6192
 Location: Talbot Wy and Silver Rock Ct - Corner A
 X Coordinate: -121.24583
 Y Coordinate: 38.71411
 Barrier Area: Curb Ramps
 Barrier Type: No Curb Ramp - Depressed Existing Curb
 Code Ref: CBC 1127B.5.1 and ADA/ABA 402.2

As Built Meas: 1 Quantity: EACH
 Description: No compliant curb cut at corner (intersection)
 As Built Desc: 12.2% running slope at depressed area
 Solution: Demolish existing and construct curb cut
 Bar. Severity: 1 Necessary Cost Estimate: \$2,500.00 Status:
 Implementation Priority: 4 Facility Function:
 Implementation Phase: Implementation Date:
 Official Responsible:

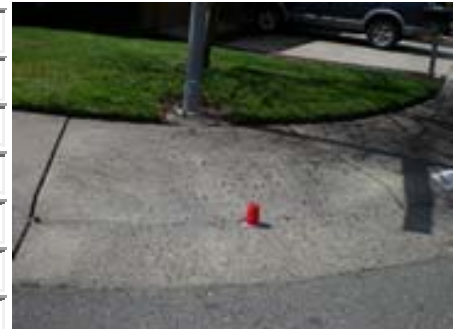
Field Date: 3/22/2011 Report Date: 3/22/2011 Barrier #: 6193
 Location: Talbot Wy and Silver Rock Ct - Corner D
 X Coordinate: -121.24583
 Y Coordinate: 38.71405
 Barrier Area: Curb Ramps
 Barrier Type: No Curb Ramp - Depressed Existing Curb
 Code Ref: CBC 1127B.5.1 and ADA/ABA 402.2

As Built Meas: 1 Quantity: EACH
 Description: No compliant curb cut at corner (intersection)
 As Built Desc: 9.5% running slope at depressed area
 Solution: Demolish existing and construct curb cut
 Bar. Severity: 1 Necessary Cost Estimate: \$2,500.00 Status:
 Implementation Priority: 4 Facility Function:
 Implementation Phase: Implementation Date:
 Official Responsible:

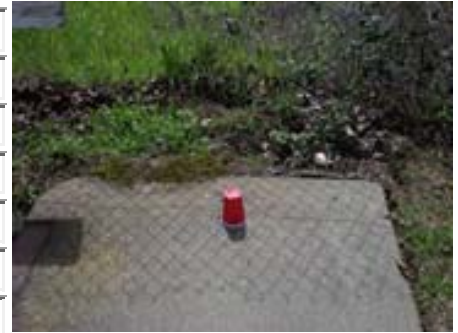
Field Date: 3/22/2011 Report Date: 3/22/2011 Barrier #: 6194
 Location: Talbot Wy - West
 X Coordinate: -121.24578
 Y Coordinate: 38.71372
 Barrier Area: Sidewalks
 Barrier Type: No Sidewalk - No Barricade
 Code Ref: MUTCD Section 6D.01

As Built Meas: 1 Quantity: JOB
 Description: No barricade provided where sidewalk ends in hazardous location
 As Built Desc: No barricade or other warning provided for the visually impaired at end of sidewalk
 Solution: Provide barricade with cane detectable warning at end of sidewalk
 Bar. Severity: 1 Necessary Cost Estimate: \$1,350.00 Status:
 Implementation Priority: 4 Facility Function:
 Implementation Phase: Implementation Date:
 Official Responsible:

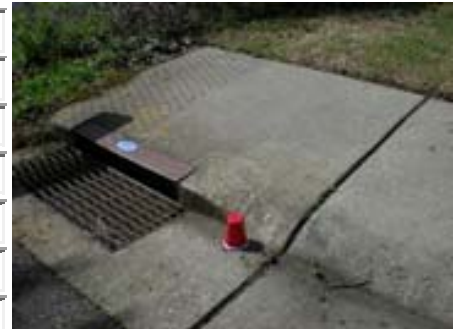
Field Date: 3/22/2011 Report Date: 3/22/2011 Barrier #: 6195
 Location: Talbot Wy - West
 X Coordinate: -121.24581
 Y Coordinate: 38.71374
 Barrier Area: Sidewalks
 Barrier Type: No Sidewalk - Transition to Shoulder
 Code Ref: CBC 1121B.2 and ADA/ABA 206.2.1

As Built Meas: 1 Quantity: JOB
 Description: Sidewalk ends and no ramp to pedestrian shoulder is provided
 As Built Desc: No ramp to shoulder to enable pedestrian travel onto existing shoulder
 Solution: Provide transition ramp to paved shoulder where no opposite sidewalk exists
 Bar. Severity: 1 Necessary Cost Estimate: \$2,500.00 Status:
 Implementation Priority: 4 Facility Function:
 Implementation Phase: Implementation Date:
 Official Responsible:

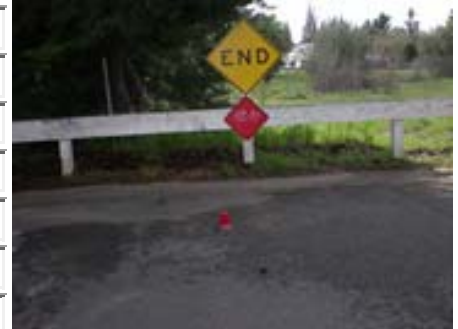
Field Date: 3/22/2011 Report Date: 3/22/2011 Barrier #: 6196
 Location: Talbot Wy - West
 X Coordinate: -121.24574
 Y Coordinate: 38.71369
 Barrier Area: Sidewalks
 Barrier Type: No Sidewalk - Cane Detectable Barricade
 Code Ref: CBC 1133B.8.6 and MUTCD Section 6D.02

As Built Meas: 60 Quantity: LF
 Description: No cane detectable warning on existing barricade
 As Built Desc: Existing barricade lacks warning for the visually impaired
 Solution: Provide cane detectable warning on barricade (max. 6" above ground)
 Bar. Severity: 1 Necessary Cost Estimate: \$6,000.00 Status:
 Implementation Priority: 4 Facility Function:
 Implementation Phase: Implementation Date:
 Official Responsible:

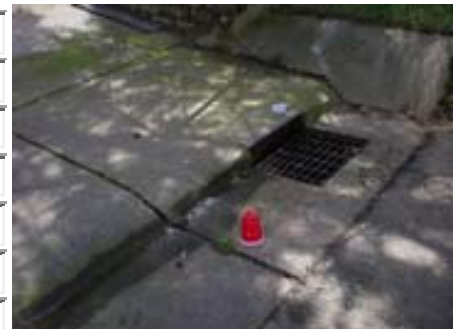
Field Date: 3/22/2011 Report Date: 3/22/2011 Barrier #: 6197
 Location: Talbot Wy - East
 X Coordinate: -121.24568
 Y Coordinate: 38.71375
 Barrier Area: Sidewalks
 Barrier Type: No Sidewalk - Transition to Shoulder
 Code Ref: CBC 1121B.2 and ADA/ABA 206.2.1

As Built Meas: 1 Quantity: JOB
 Description: Sidewalk ends and no ramp to pedestrian shoulder is provided
 As Built Desc: No ramp to shoulder to enable pedestrian travel onto existing shoulder
 Solution: Provide transition ramp to paved shoulder where no opposite sidewalk exists
 Bar. Severity: 1 Necessary Cost Estimate: \$2,500.00 Status:
 Implementation Priority: 4 Facility Function:
 Implementation Phase: Implementation Date:
 Official Responsible:

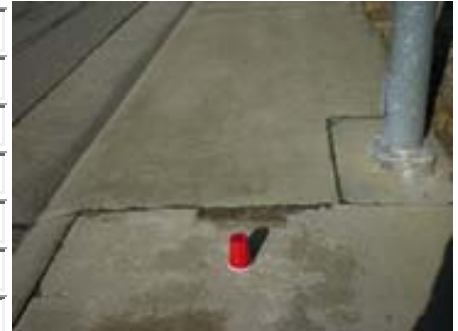
Field Date: 3/28/2011 Report Date: 3/28/2011 Barrier #: 6198
 Location: Oak Ave - North
 X Coordinate: -121.2458
 Y Coordinate: 38.7006
 Barrier Area: Sidewalks
 Barrier Type: Surface Condition - Damaged
 Code Ref: CBC 1133B.7.1 and ADA/ABA 302.1

As Built Meas: 6 Quantity: LF
 Description: Surface is not firm and stable (cracked, broken or loose soil, etc.)
 As Built Desc: Cracked concrete
 Solution: Repair surface to make firm and stable
 Bar. Severity: 1 Necessary Cost Estimate: \$750.00 Status:
 Implementation Priority: 1 Facility Function:
 Implementation Phase: Implementation Date:
 Official Responsible:

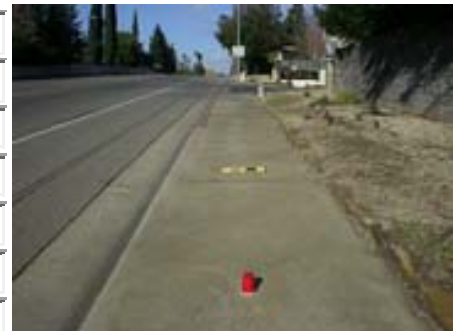
Field Date: 3/28/2011 Report Date: 3/28/2011 Barrier #: 6199
 Location: Oak Ave - North
 X Coordinate: -121.24588
 Y Coordinate: 38.70059
 Barrier Area: Sidewalks
 Barrier Type: Cross Slope - Existing (2.1% to 3.0%)
 Code Ref: CBC 1133B.7.1.3 and ADA/ABA 403.3

As Built Meas: 79 Quantity: LF
 Description: Cross slope exceeds 2.0% (2.1% to 3.0%)
 As Built Desc: 3.0% cross slope
 Solution: Low severity barrier - no remediation recommended
 Bar. Severity: 4 Low Severity Cost Estimate: \$0.00 Status:
 Implementation Priority: 1 Facility Function:
 Implementation Phase: Implementation Date:
 Official Responsible:

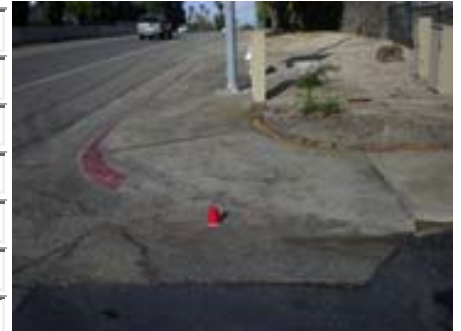
Field Date: 3/28/2011 Report Date: 3/28/2011 Barrier #: 6200
 Location: Oak Ave and Creekridge Ln - Corner A
 X Coordinate: -121.24637
 Y Coordinate: 38.70054
 Barrier Area: Curb Ramps
 Barrier Type: No Curb Ramp - Depressed Existing Curb
 Code Ref: CBC 1127B.5.1 and ADA/ABA 402.2

As Built Meas: 1 Quantity: EACH
 Description: No compliant curb cut at corner (intersection)
 As Built Desc: 8.2% running slope at depressed area
 Solution: Demolish existing and construct curb cut
 Bar. Severity: 1 Necessary Cost Estimate: \$2,500.00 Status:
 Implementation Priority: 1 Facility Function:
 Implementation Phase: Implementation Date:
 Official Responsible:

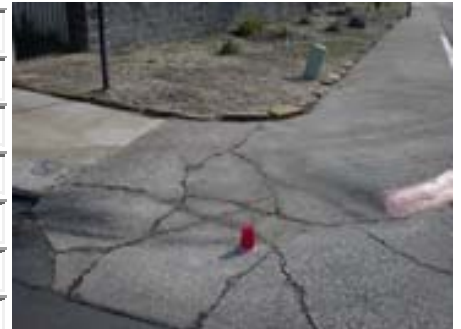
Field Date: 3/28/2011 Report Date: 3/28/2011 Barrier #: 6201
 Location: Oak Ave and Creekridge Ln - Corner B
 X Coordinate: -121.24613
 Y Coordinate: 38.70055
 Barrier Area: Curb Ramps
 Barrier Type: No Curb Ramp - Depressed Existing Curb
 Code Ref: CBC 1127B.5.1 and ADA/ABA 402.2

As Built Meas: 1 Quantity: EACH
 Description: No compliant curb cut at corner (intersection)
 As Built Desc: 8.5% running slope at depressed area
 Solution: Demolish existing and construct curb cut
 Bar. Severity: 1 Necessary Cost Estimate: \$2,500.00 Status:
 Implementation Priority: 1 Facility Function:
 Implementation Phase: Implementation Date:
 Official Responsible:

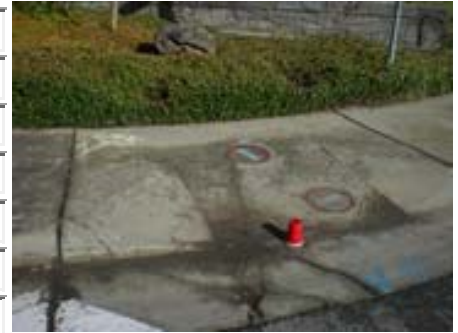
Field Date: 3/28/2011 Report Date: 3/28/2011 Barrier #: 6202A
 Location: Oak Ave and Bearded Iris Dr - Corner A
 X Coordinate: -121.24869
 Y Coordinate: 38.70057
 Barrier Area: Curb Ramps
 Barrier Type: 12" Grooves - Existing (>5.0%)
 Code Ref: CBC 1127B.5.6

As Built Meas: 1 Quantity: EACH
 Description: 12" grooves at top of curb ramp are not level (>5.0%)
 As Built Desc: 5.5% at 12" grooves
 Solution: Demolish existing and construct new curb ramp
 Bar. Severity: 1 Necessary Cost Estimate: \$2,500.00 Status:
 Implementation Priority: 1 Facility Function:
 Implementation Phase: Implementation Date:
 Official Responsible:

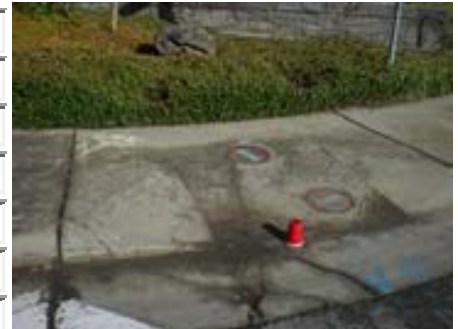
Field Date: 3/28/2011 Report Date: 3/28/2011 Barrier #: 6202B
 Location: Oak Ave and Bearded Iris Dr - Corner A
 X Coordinate: -121.24869
 Y Coordinate: 38.70057
 Barrier Area: Curb Ramps
 Barrier Type: Parallel Ramp Landing - Existing (4.1% to 4.9%)
 Code Ref: CBC 1127B.5.4 and ADA/ABA 406.4

As Built Meas: 1 Quantity: EACH
 Description: Curb ramp landing or pan not level(4.1% to 4.9%)
 As Built Desc: 4.6% landing slope
 Solution: Demolish existing and construct new transition
 Bar. Severity: 2 Recommended Cost Estimate: \$250.00 Status:
 Implementation Priority: 1 Facility Function:
 Implementation Phase: Implementation Date:
 Official Responsible:

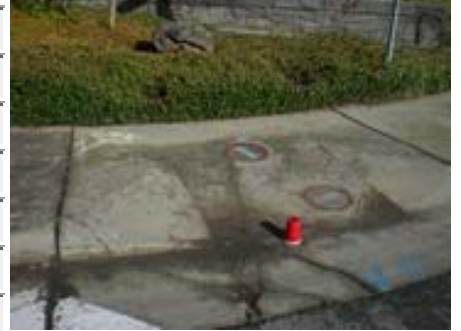
Field Date: 3/28/2011 Report Date: 3/28/2011 Barrier #: 6202C
 Location: Oak Ave and Bearded Iris Dr - Corner A
 X Coordinate: -121.24869
 Y Coordinate: 38.70057
 Barrier Area: Curb Ramps
 Barrier Type: Detectable Warnings - Truncated Domes
 Code Ref: CBC 1127B.5.7 and ADA/ABA 705.1.3

As Built Meas: 1 Quantity: EACH
 Description: No truncated domes provided at curb ramp
 As Built Desc: No detectable warnings at curb ramp
 Solution: Provide compliant truncated domes
 Bar. Severity: 2 Recommended Cost Estimate: \$1,400.00 Status:
 Implementation Priority: 1 Facility Function:
 Implementation Phase: Implementation Date:
 Official Responsible:

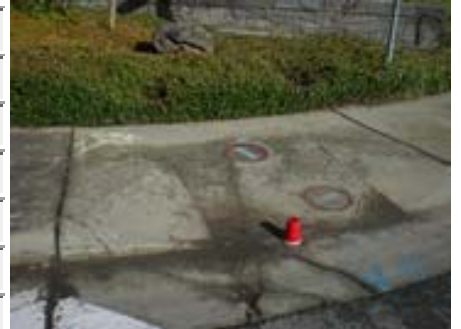
Field Date: 3/28/2011 Report Date: 3/28/2011 Barrier #: 6202D
 Location: Oak Ave and Bearded Iris Dr - Corner A
 X Coordinate: -121.24869
 Y Coordinate: 38.70057
 Barrier Area: Curb Ramps
 Barrier Type: Gutter Slope - Existing (6.6% to 8.2%)
 Code Ref: CBC 1127B.5.3 and ADA/ABA 406.2

As Built Meas: 6 Quantity: SF
 Description: Gutter slope exceeds 5.0% (6.6% to 8.2%)
 As Built Desc: 7.0% gutter slope
 Solution: Demolish existing and construct new gutter
 Bar. Severity: 2 Recommended Cost Estimate: \$750.00 Status:
 Implementation Priority: 1 Facility Function:
 Implementation Phase: Implementation Date:
 Official Responsible:

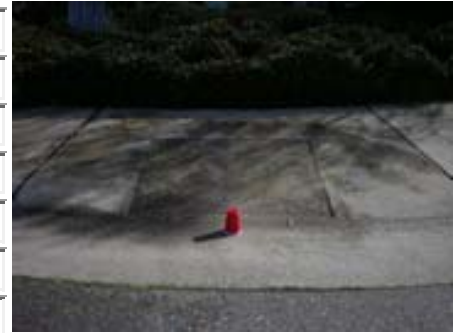
Field Date: 3/28/2011 Report Date: 3/28/2011 Barrier #: 6203A
 Location: Oak Ave and Bearded Iris Dr - Corner B
 X Coordinate: -121.24847
 Y Coordinate: 38.70057
 Barrier Area: Curb Ramps
 Barrier Type: 12" Grooves - Existing (>5.0%)
 Code Ref: CBC 1127B.5.6

As Built Meas: 1 Quantity: EACH
 Description: 12" grooves at top of curb ramp are not level (>5.0%)
 As Built Desc: 5.3% at 12" grooves
 Solution: Demolish existing and construct new curb ramp
 Bar. Severity: 1 Necessary Cost Estimate: \$2,500.00 Status:
 Implementation Priority: 1 Facility Function:
 Implementation Phase: Implementation Date:
 Official Responsible:

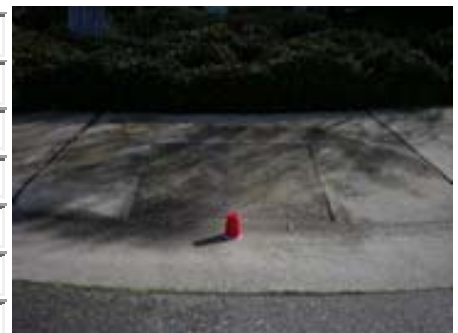
Field Date: 3/28/2011 Report Date: 3/28/2011 Barrier #: 6203B
 Location: Oak Ave and Bearded Iris Dr - Corner B
 X Coordinate: -121.24847
 Y Coordinate: 38.70057
 Barrier Area: Curb Ramps
 Barrier Type: Parallel Ramp Landing - Existing (>5.0% or more)
 Code Ref: CBC 1127B.5.4 and ADA/ABA 406.4

As Built Meas: 1 Quantity: EACH
 Description: Curb ramp landing or pan not level (>5.0% or more)
 As Built Desc: 7.6% landing slope
 Solution: Demolish existing and construct new transition
 Bar. Severity: 1 Necessary Cost Estimate: \$250.00 Status:
 Implementation Priority: 1 Facility Function:
 Implementation Phase: Implementation Date:
 Official Responsible:

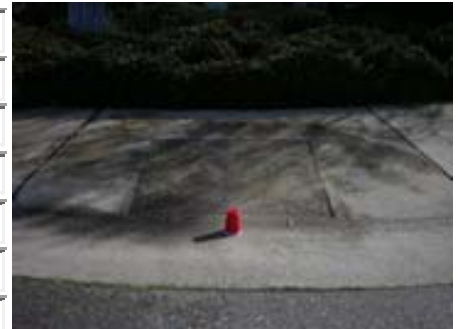
Field Date: 3/28/2011 Report Date: 3/28/2011 Barrier #: 6203D
 Location: Oak Ave and Bearded Iris Dr - Corner B
 X Coordinate: -121.24847
 Y Coordinate: 38.70057
 Barrier Area: Curb Ramps
 Barrier Type: Gutter Slope - Existing (5.1% - 5.8%)
 Code Ref: CBC 1127B.5.3 and ADA/ABA 406.2

As Built Meas: 6 Quantity: SF
 Description: Gutter slope exceeds 5.0% (5.1% - 5.8%)
 As Built Desc: 5.8% gutter slope
 Solution: Demolish existing and construct new gutter
 Bar. Severity: 4 Low Severity Cost Estimate: \$750.00 Status:
 Implementation Priority: 1 Facility Function:
 Implementation Phase: Implementation Date:
 Official Responsible:

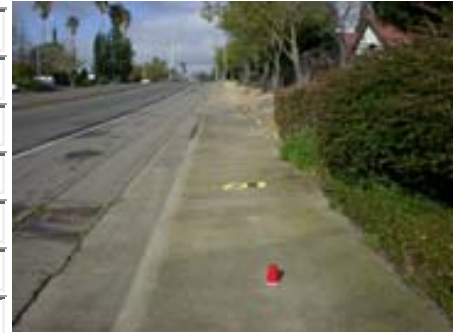
Field Date: 3/28/2011 Report Date: 3/28/2011 Barrier #: 6204
 Location: Oak Ave - North
 X Coordinate: -121.24885
 Y Coordinate: 38.70055
 Barrier Area: Sidewalks
 Barrier Type: Cross Slope - Existing (2.1% to 3.0%)
 Code Ref: CBC 1133B.7.1.3 and ADA/ABA 403.3

As Built Meas: 70 Quantity: LF
 Description: Cross slope exceeds 2.0% (2.1% to 3.0%)
 As Built Desc: 3.0% cross slope
 Solution: Low severity barrier - no remediation recommended
 Bar. Severity: 4 Low Severity Cost Estimate: \$0.00 Status:
 Implementation Priority: 1 Facility Function:
 Implementation Phase: Implementation Date:
 Official Responsible:

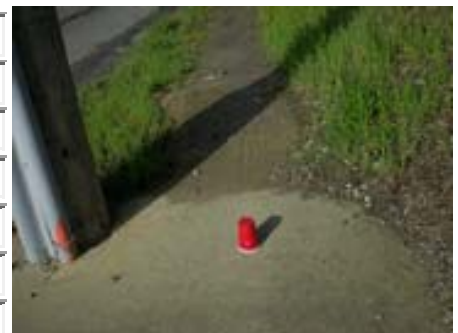
Field Date: 3/28/2011 Report Date: 3/28/2011 Barrier #: 6205
 Location: Oak Ave - North
 X Coordinate: -121.25059
 Y Coordinate: 38.70059
 Barrier Area: Sidewalks
 Barrier Type: No Sidewalk - No Barricade
 Code Ref: MUTCD Section 6D.01

As Built Meas: 1 Quantity: JOB
 Description: No barricade provided where sidewalk ends in hazardous location
 As Built Desc: No barricade or other warning provided for the visually impaired at end of sidewalk
 Solution: Provide barricade with cane detectable warning at end of sidewalk
 Bar. Severity: 1 Necessary Cost Estimate: \$1,350.00 Status:
 Implementation Priority: 1 Facility Function:
 Implementation Phase: Implementation Date:
 Official Responsible:

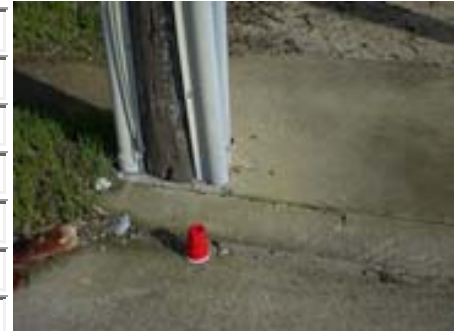
Field Date: 3/28/2011 Report Date: 3/28/2011 Barrier #: 6206
 Location: Oak Ave - North
 X Coordinate: -121.2506
 Y Coordinate: 38.70057
 Barrier Area: Sidewalks
 Barrier Type: Shoulder Cross Slope - Existing (4.1% to 4.9%)
 Code Ref: CBC 1133B.7.1.3 and ADA/ABA 403.3

As Built Meas: 375 Quantity: LF
 Description: Cross slope exceeds 2.0% (4.1% to 4.9%)
 As Built Desc: 4.2% cross slope
 Solution: Demolish existing and construct new pedestrian route
 Bar. Severity: 2 Recommended Cost Estimate: \$46,875.00 Status:
 Implementation Priority: 1 Facility Function:
 Implementation Phase: Implementation Date:
 Official Responsible:

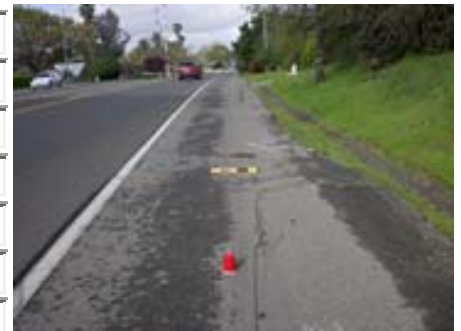
Field Date: 3/28/2011 Report Date: 3/28/2011 Barrier #: 6207
 Location: Oak Ave - North
 X Coordinate: -121.25076
 Y Coordinate: 38.70053
 Barrier Area: Sidewalks
 Barrier Type: No Sidewalk - Transition to Shoulder
 Code Ref: CBC 1121B.2 and ADA/ABA 206.2.1

As Built Meas: 1 Quantity: JOB
 Description: Sidewalk ends and no ramp to pedestrian shoulder is provided
 As Built Desc: No ramp to shoulder to enable pedestrian travel onto existing shoulder
 Solution: Provide transition ramp to paved shoulder where no opposite sidewalk exists
 Bar. Severity: 1 Necessary Cost Estimate: \$2,500.00 Status:
 Implementation Priority: 1 Facility Function:
 Implementation Phase: Implementation Date:
 Official Responsible:

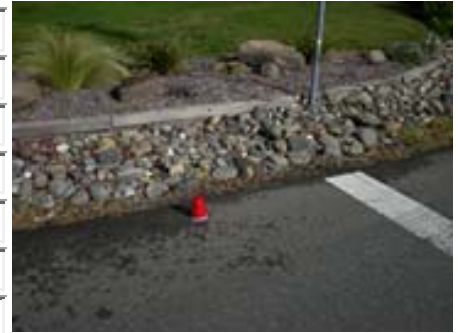
Field Date: 3/28/2011 Report Date: 3/28/2011 Barrier #: 6208
 Location: Oak Ave and Olivine Ave - Corner A
 X Coordinate: -121.25229
 Y Coordinate: 38.70051
 Barrier Area: Blended Transitions
 Barrier Type: Detectable Warnings - Truncated Domes
 Code Ref: CBC 1127B.5.3

As Built Meas: 1 Quantity: EACH
 Description: No truncated domes provided at transition into roadway
 As Built Desc: No detectable warning provided
 Solution: Provide compliant truncated domes
 Bar. Severity: 2 Recommended Cost Estimate: \$1,400.00 Status:
 Implementation Priority: 1 Facility Function:
 Implementation Phase: Implementation Date:
 Official Responsible:

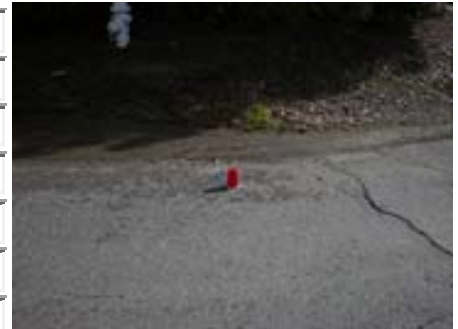
Field Date: 3/28/2011 Report Date: 3/28/2011 Barrier #: 6209
 Location: Oak Ave and Olivine Ave - Corner B
 X Coordinate: -121.25203
 Y Coordinate: 38.70052
 Barrier Area: Blended Transitions
 Barrier Type: Detectable Warnings - Truncated Domes
 Code Ref: CBC 1127B.5.3

As Built Meas: 1 Quantity: EACH
 Description: No truncated domes provided at transition into roadway
 As Built Desc: No detectable warning provided
 Solution: Provide compliant truncated domes
 Bar. Severity: 2 Recommended Cost Estimate: \$1,400.00 Status:
 Implementation Priority: 1 Facility Function:
 Implementation Phase: Implementation Date:
 Official Responsible:

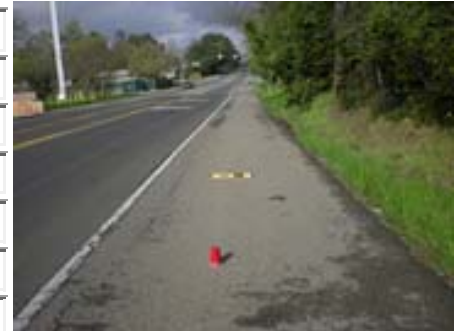
Field Date: 3/28/2011 Report Date: 3/28/2011 Barrier #: 6210
 Location: Oak Ave - North
 X Coordinate: -121.2525
 Y Coordinate: 38.70051
 Barrier Area: Sidewalks
 Barrier Type: Shoulder Cross Slope - Existing (4.1% to 4.9%)
 Code Ref: CBC 1133B.7.1.3 and ADA/ABA 403.3

As Built Meas: 150 Quantity: LF
 Description: Cross slope exceeds 2.0% (4.1% to 4.9%)
 As Built Desc: 4.6% cross slope
 Solution: Demolish existing and construct new pedestrian route
 Bar. Severity: 2 Recommended Cost Estimate: \$18,750.00 Status:
 Implementation Priority: 1 Facility Function:
 Implementation Phase: Implementation Date:
 Official Responsible:

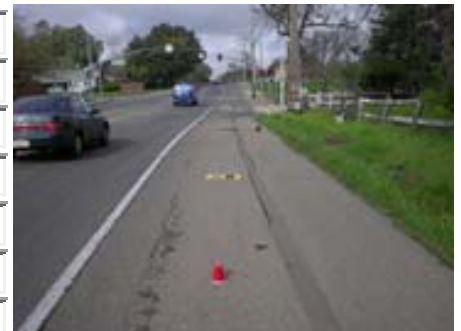
Field Date: 3/28/2011 Report Date: 3/28/2011 Barrier #: 6211
 Location: Oak Ave - North
 X Coordinate: -121.25341
 Y Coordinate: 38.70049
 Barrier Area: Sidewalks
 Barrier Type: Shoulder Cross Slope - Existing (3.1% to 4.0%)
 Code Ref: CBC 1133B.7.1.3 and ADA/ABA 403.3

As Built Meas: 96 Quantity: LF
 Description: Cross slope exceeds 2.0% (3.1% to 4.0%)
 As Built Desc: 3.8% cross slope
 Solution: Demolish existing and construct new pedestrian route
 Bar. Severity: 3 Hinderance Cost Estimate: \$12,000.00 Status:
 Implementation Priority: 1 Facility Function:
 Implementation Phase: Implementation Date:
 Official Responsible:

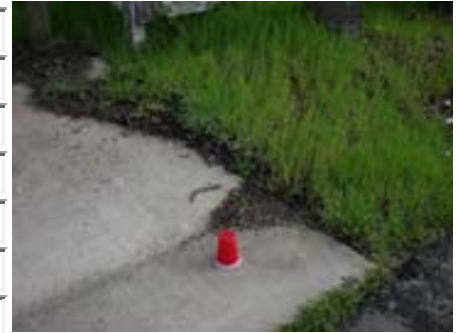
Field Date: 3/28/2011 Report Date: 3/28/2011 Barrier #: 6212
 Location: Oak Ave - North
 X Coordinate: -121.25366
 Y Coordinate: 38.70052
 Barrier Area: Sidewalks
 Barrier Type: No Sidewalk - Transition to Shoulder
 Code Ref: CBC 1121B.2 and ADA/ABA 206.2.1

As Built Meas: 1 Quantity: JOB
 Description: Sidewalk ends and no ramp to pedestrian shoulder is provided
 As Built Desc: No ramp to shoulder to enable pedestrian travel onto existing shoulder
 Solution: Provide transition ramp to paved shoulder where no opposite sidewalk exists
 Bar. Severity: 1 Necessary Cost Estimate: \$2,500.00 Status:
 Implementation Priority: 1 Facility Function:
 Implementation Phase: Implementation Date:
 Official Responsible:

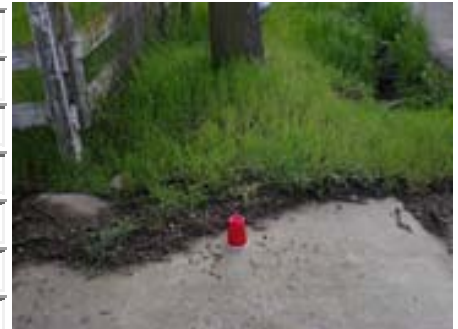
Field Date: 3/28/2011 Report Date: 3/28/2011 Barrier #: 6213
 Location: Oak Ave - North
 X Coordinate: -121.25365
 Y Coordinate: 38.70054
 Barrier Area: Sidewalks
 Barrier Type: No Sidewalk - No Barricade
 Code Ref: MUTCD Section 6D.01

As Built Meas: 1 Quantity: JOB
 Description: No barricade provided where sidewalk ends in hazardous location
 As Built Desc: No barricade or other warning provided for the visually impaired at end of sidewalk
 Solution: Provide barricade with cane detectable warning at end of sidewalk
 Bar. Severity: 1 Necessary Cost Estimate: \$1,350.00 Status:
 Implementation Priority: 1 Facility Function:
 Implementation Phase: Implementation Date:
 Official Responsible:

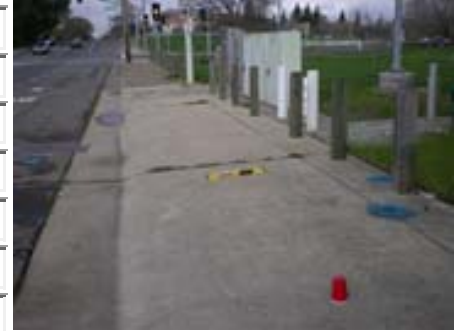
Field Date: 3/28/2011 Report Date: 3/28/2011 Barrier #: 6214
 Location: Oak Ave - North
 X Coordinate: -121.2537
 Y Coordinate: 38.70055
 Barrier Area: Sidewalks
 Barrier Type: Cross Slope - Existing (4.1% to 4.9%)
 Code Ref: CBC 1133B.7.1.3 and ADA/ABA 403.3

As Built Meas: 136 Quantity: LF
 Description: Cross slope exceeds 2.0% (4.1% to 4.9%)
 As Built Desc: 4.6% cross slope
 Solution: Demolish existing and construct new route
 Bar. Severity: 2 Recommended Cost Estimate: \$17,000.00 Status:
 Implementation Priority: 1 Facility Function:
 Implementation Phase: Implementation Date:
 Official Responsible:

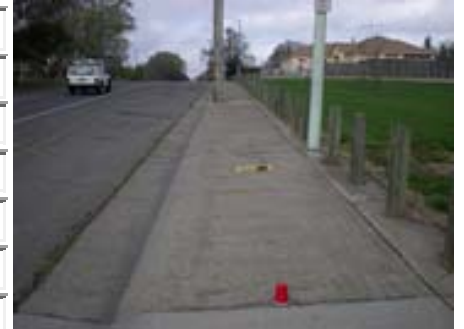
Field Date: 3/28/2011 Report Date: 3/28/2011 Barrier #: 6215
 Location: Oak Ave - North
 X Coordinate: -121.25459
 Y Coordinate: 38.70058
 Barrier Area: Sidewalks
 Barrier Type: Cross Slope - Existing (5.0% or more)
 Code Ref: CBC 1133B.7.1.3 and ADA/ABA 403.3

As Built Meas: 289 Quantity: LF
 Description: Cross slope exceeds 2.0% (5.0% or more)
 As Built Desc: 5.3% cross slope
 Solution: Demolish existing and construct new route
 Bar. Severity: 1 Necessary Cost Estimate: \$36,125.00 Status:
 Implementation Priority: 1 Facility Function:
 Implementation Phase: Implementation Date:
 Official Responsible:

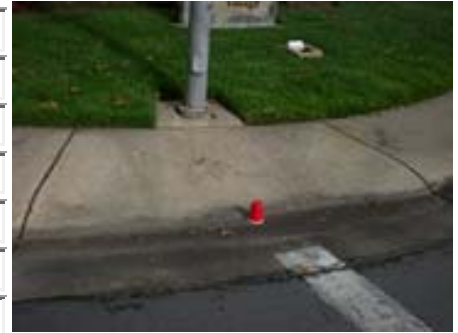
Field Date: 3/28/2011 Report Date: 3/28/2011 Barrier #: 6216
 Location: Oak Ave and Fox Meadow - Corner A
 X Coordinate: -121.25755
 Y Coordinate: 38.70059
 Barrier Area: Curb Ramps
 Barrier Type: No Curb Ramp - Depressed Existing Curb
 Code Ref: CBC 1127B.5.1 and ADA/ABA 402.2

As Built Meas: 1 Quantity: EACH
 Description: No compliant curb cut at corner (intersection)
 As Built Desc: 7.3% running slope at depressed area
 Solution: Demolish existing and construct curb cut
 Bar. Severity: 1 Necessary Cost Estimate: \$2,500.00 Status:
 Implementation Priority: 1 Facility Function:
 Implementation Phase: Implementation Date:
 Official Responsible:

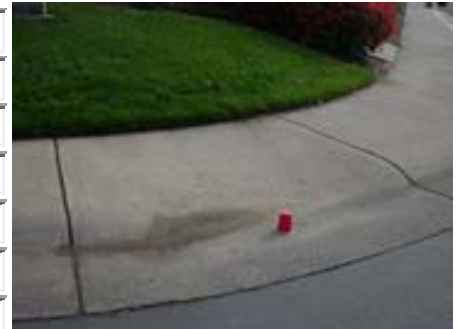
Field Date: 3/28/2011 Report Date: 3/28/2011 Barrier #: 6217
 Location: Oak Ave and Fox Meadow - Corner B
 X Coordinate: -121.25733
 Y Coordinate: 38.70058
 Barrier Area: Curb Ramps
 Barrier Type: No Curb Ramp - Depressed Existing Curb
 Code Ref: CBC 1127B.5.1 and ADA/ABA 402.2

As Built Meas: 1 Quantity: EACH
 Description: No compliant curb cut at corner (intersection)
 As Built Desc: 8.9% running slope at depressed area
 Solution: Demolish existing and construct curb cut
 Bar. Severity: 1 Necessary Cost Estimate: \$2,500.00 Status:
 Implementation Priority: 1 Facility Function:
 Implementation Phase: Implementation Date:
 Official Responsible:

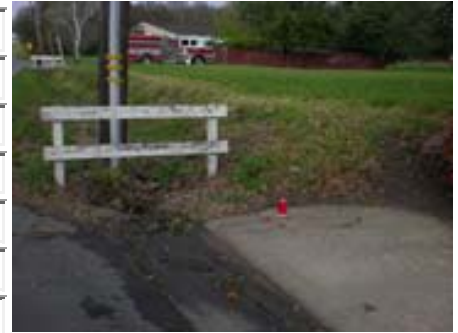
Field Date: 3/28/2011 Report Date: 3/28/2011 Barrier #: 6218
 Location: Oak Ave - North
 X Coordinate: -121.25767
 Y Coordinate: 38.7006
 Barrier Area: Sidewalks
 Barrier Type: No Sidewalk - No Barricade
 Code Ref: MUTCD Section 6D.01

As Built Meas: 1 Quantity: JOB
 Description: No barricade provided where sidewalk ends in hazardous location
 As Built Desc: No barricade or other warning provided for the visually impaired at end of sidewalk
 Solution: Provide barricade with cane detectable warning at end of sidewalk
 Bar. Severity: 1 Necessary Cost Estimate: \$1,350.00 Status:
 Implementation Priority: 1 Facility Function:
 Implementation Phase: Implementation Date:
 Official Responsible:

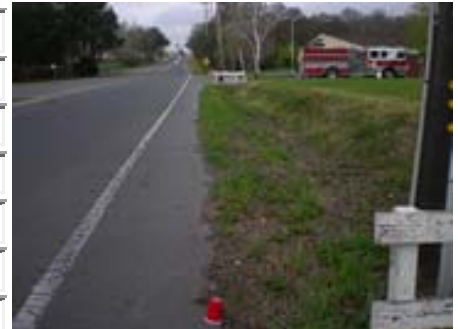
Field Date: 3/28/2011 Report Date: 3/28/2011 Barrier #: 6219A
 Location: Oak Ave - North
 X Coordinate: -121.25767
 Y Coordinate: 38.70059
 Barrier Area: Sidewalks
 Barrier Type: Drop-off Along Ped Route (> 4")
 Code Ref: CBC 1133B.8.1

As Built Meas: 50 Quantity: LF
 Description: Drop of more than 4" along pedestrian route lacks warning curb
 As Built Desc: 36" drop off creates hazardous condition for the visually impaired
 Solution: Provide curb projecting at least 6" above the walk or sidewalk surface to warn the blind of a potent
 Bar. Severity: 1 Necessary Cost Estimate: \$8,750.00 Status:
 Implementation Priority: 1 Facility Function:
 Implementation Phase: Implementation Date:
 Official Responsible:

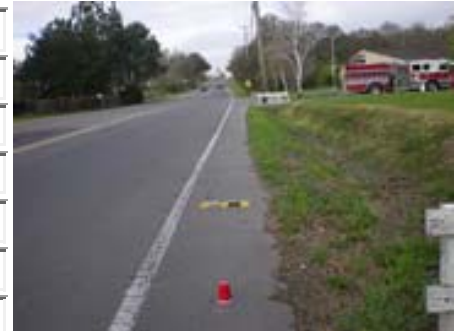
Field Date: 3/28/2011 Report Date: 3/28/2011 Barrier #: 6219B
 Location: Oak Ave - North
 X Coordinate: -121.25769
 Y Coordinate: 38.70059
 Barrier Area: Sidewalks
 Barrier Type: Cross Slope - Existing (4.1% to 4.9%)
 Code Ref: CBC 1133B.7.1.3 and ADA/ABA 403.3

As Built Meas: 110 Quantity: LF
 Description: Cross slope exceeds 2.0% (4.1% to 4.9%)
 As Built Desc: 4.3% cross slope
 Solution: Demolish existing and construct new route
 Bar. Severity: 2 Recommended Cost Estimate: \$13,750.00 Status:
 Implementation Priority: 1 Facility Function:
 Implementation Phase: Implementation Date:
 Official Responsible:

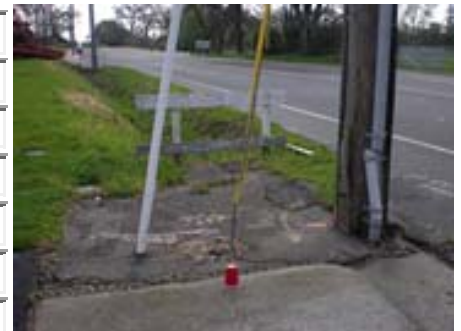
Field Date: 3/28/2011 Report Date: 3/28/2011 Barrier #: 6220
 Location: Oak Ave - North
 X Coordinate: -121.2581
 Y Coordinate: 38.7006
 Barrier Area: Sidewalks
 Barrier Type: No Sidewalk - No Barricade
 Code Ref: MUTCD Section 6D.01

As Built Meas: 1 Quantity: JOB
 Description: No barricade provided where sidewalk ends in hazardous location
 As Built Desc: No barricade or other warning provided for the visually impaired at end of sidewalk
 Solution: Provide barricade with cane detectable warning at end of sidewalk
 Bar. Severity: 1 Necessary Cost Estimate: \$1,350.00 Status:
 Implementation Priority: 1 Facility Function:
 Implementation Phase: Implementation Date:
 Official Responsible:

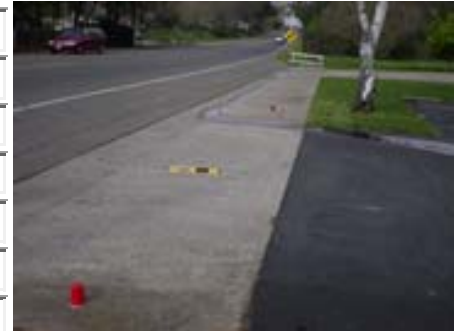
Field Date: 3/28/2011 Report Date: 3/28/2011 Barrier #: 6221
 Location: Oak Ave - North
 X Coordinate: -121.25816
 Y Coordinate: 38.70059
 Barrier Area: Sidewalks
 Barrier Type: Driveway - Existing (5.0% or more)
 Code Ref: CBC 1133B.7.1.3 and ADA/ABA 403.3

As Built Meas: 30 Quantity: LF
 Description: Driveway cross slope exceeds 2.0% (5.0% or more)
 As Built Desc: 6.2% cross slope
 Solution: Provide min. 48" wide level walkway through driveway
 Bar. Severity: 4 Low Severity Cost Estimate: \$3,750.00 Status:
 Implementation Priority: 1 Facility Function:
 Implementation Phase: Implementation Date:
 Official Responsible:

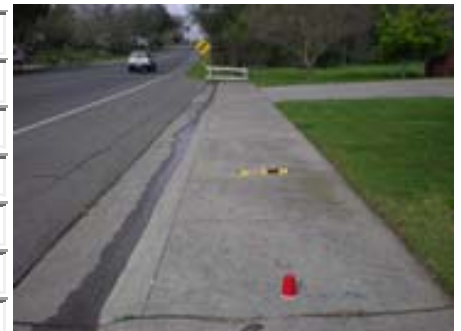
Field Date: 3/28/2011 Report Date: 3/28/2011 Barrier #: 6222
 Location: Oak Ave - North
 X Coordinate: -121.25822
 Y Coordinate: 38.70062
 Barrier Area: Sidewalks
 Barrier Type: Cross Slope - Existing (5.0% or more)
 Code Ref: CBC 1133B.7.1.3 and ADA/ABA 403.3

As Built Meas: 42 Quantity: LF
 Description: Cross slope exceeds 2.0% (5.0% or more)
 As Built Desc: 5.6% cross slope
 Solution: Demolish existing and construct new route
 Bar. Severity: 1 Necessary Cost Estimate: \$5,250.00 Status:
 Implementation Priority: 1 Facility Function:
 Implementation Phase: Implementation Date:
 Official Responsible:

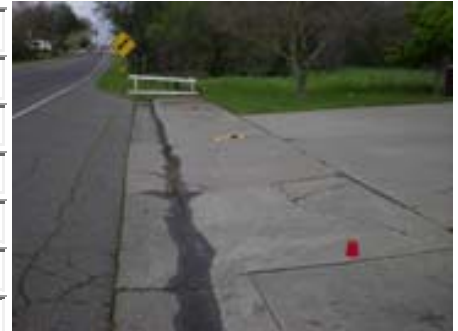
Field Date: 3/28/2011 Report Date: 3/28/2011 Barrier #: 6223
 Location: Oak Ave - North
 X Coordinate: -121.25848
 Y Coordinate: 38.70061
 Barrier Area: Sidewalks
 Barrier Type: Driveway - Existing (5.0% or more)
 Code Ref: CBC 1133B.7.1.3 and ADA/ABA 403.3

As Built Meas: 40 Quantity: LF
 Description: Driveway cross slope exceeds 2.0% (5.0% or more)
 As Built Desc: 9.4% cross slope, 8.6 running slope
 Solution: Provide min. 48" wide level walkway through driveway
 Bar. Severity: 1 Necessary Cost Estimate: \$5,000.00 Status:
 Implementation Priority: 1 Facility Function:
 Implementation Phase: Implementation Date:
 Official Responsible:

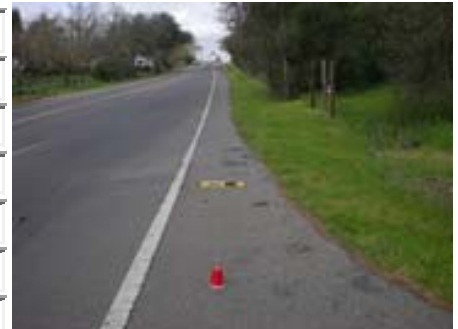
Field Date: 3/28/2011 Report Date: 3/28/2011 Barrier #: 6224
 Location: Oak Ave - North
 X Coordinate: -121.2586
 Y Coordinate: 38.70055
 Barrier Area: Sidewalks
 Barrier Type: Shoulder Cross Slope - Existing (5.0% or more)
 Code Ref: CBC 1133B.7.1.3 and ADA/ABA 403.3

As Built Meas: 514 Quantity: LF
 Description: Cross slope exceeds 2.0% (5.0% or more)
 As Built Desc: 4.7% cross slope
 Solution: Demolish existing and construct new pedestrian route
 Bar. Severity: 1 Necessary Cost Estimate: \$64,250.00 Status:
 Implementation Priority: 1 Facility Function:
 Implementation Phase: Implementation Date:
 Official Responsible:

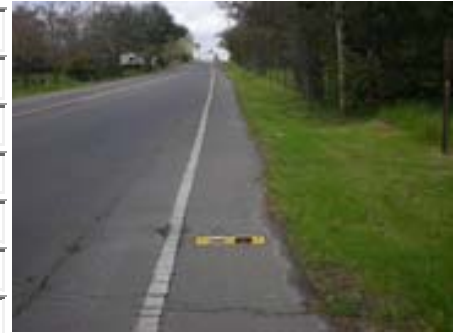
Field Date: 3/28/2011 Report Date: 3/28/2011 Barrier #: 6225
 Location: Oak Ave - North
 X Coordinate: -121.25875
 Y Coordinate: 38.70054
 Barrier Area: Sidewalks
 Barrier Type: Shoulder Clear Width - Existing ($\leq 31''$ or less)
 Code Ref: CBC 1133B.7.1

As Built Meas: 60 Quantity: LF
 Description: Pedestrian route is not min. 48" wide ($\leq 31''$ or less)
 As Built Desc: 29" clear width
 Solution: Demolish existing and construct new pedestrian route
 Bar. Severity: 1 Necessary Cost Estimate: \$7,500.00 Status:
 Implementation Priority: 1 Facility Function:
 Implementation Phase: Implementation Date:
 Official Responsible:

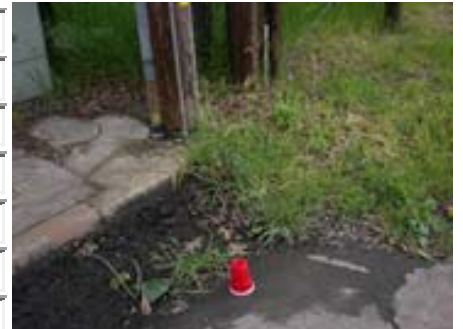
Field Date: 3/28/2011 Report Date: 3/28/2011 Barrier #: 6226
 Location: Oak Ave - North
 X Coordinate: -121.26127
 Y Coordinate: 38.7005
 Barrier Area: Sidewalks
 Barrier Type: No Sidewalk - Transition to Shoulder
 Code Ref: CBC 1121B.2 and ADA/ABA 206.2.1

As Built Meas: 1 Quantity: JOB
 Description: Sidewalk ends and no ramp to pedestrian shoulder is provided
 As Built Desc: No ramp to shoulder to enable pedestrian travel onto existing shoulder
 Solution: Provide transition ramp to paved shoulder where no opposite sidewalk exists
 Bar. Severity: 1 Necessary Cost Estimate: \$2,500.00 Status:
 Implementation Priority: 1 Facility Function:
 Implementation Phase: Implementation Date:
 Official Responsible:

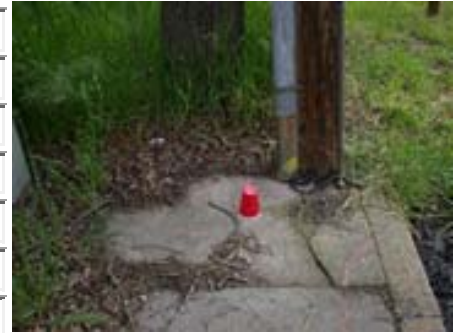
Field Date: 3/28/2011 Report Date: 3/28/2011 Barrier #: 6227
 Location: Oak Ave - North
 X Coordinate: -121.26128
 Y Coordinate: 38.70052
 Barrier Area: Sidewalks
 Barrier Type: No Sidewalk - No Barricade
 Code Ref: MUTCD Section 6D.01

As Built Meas: 1 Quantity: JOB
 Description: No barricade provided where sidewalk ends in hazardous location
 As Built Desc: No barricade or other warning provided for the visually impaired at end of sidewalk
 Solution: Provide barricade with cane detectable warning at end of sidewalk
 Bar. Severity: 1 Necessary Cost Estimate: \$1,350.00 Status:
 Implementation Priority: 1 Facility Function:
 Implementation Phase: Implementation Date:
 Official Responsible:

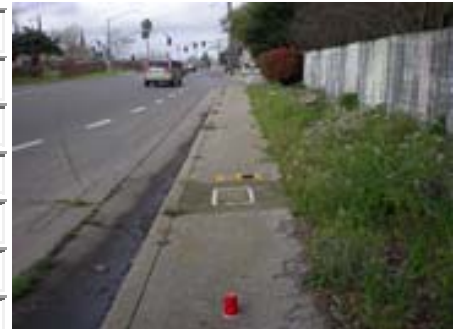
Field Date: 3/28/2011 Report Date: 3/28/2011 Barrier #: 6228
 Location: Oak Ave - North
 X Coordinate: -121.26133
 Y Coordinate: 38.70053
 Barrier Area: Sidewalks
 Barrier Type: Cross Slope - Existing (3.1% to 4.0%)
 Code Ref: CBC 1133B.7.1.3 and ADA/ABA 403.3

As Built Meas: 111 Quantity: LF
 Description: Cross slope exceeds 2.0% (3.1% to 4.0%)
 As Built Desc: 3.9% cross slope
 Solution: Demolish existing and construct new route
 Bar. Severity: 3 Hinderance Cost Estimate: \$13,875.00 Status:
 Implementation Priority: 1 Facility Function:
 Implementation Phase: Implementation Date:
 Official Responsible:

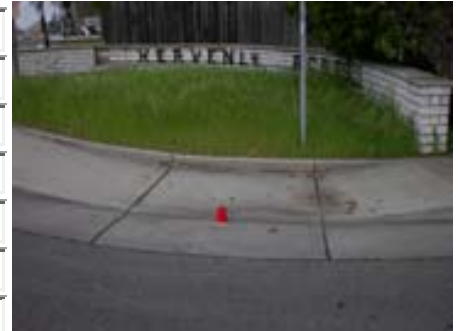
Field Date: 3/28/2011 Report Date: 3/28/2011 Barrier #: 6229A
 Location: Oak Ave and St Philomena Wy - Corner A
 X Coordinate: -121.2618
 Y Coordinate: 38.70057
 Barrier Area: Curb Ramps
 Barrier Type: 12" Grooves - Existing (3.1% to 4.0%)
 Code Ref: CBC 1127B.5.6

As Built Meas: 1 Quantity: EACH
 Description: 12" grooves at top of curb ramp are not level (3.1% to 4.0%)
 As Built Desc: 3.4% at 12" grooves
 Solution: Demolish existing and construct new curb ramp
 Bar. Severity: 3 Hindrance Cost Estimate: \$2,500.00 Status:
 Implementation Priority: 1 Facility Function:
 Implementation Phase: Implementation Date:
 Official Responsible:

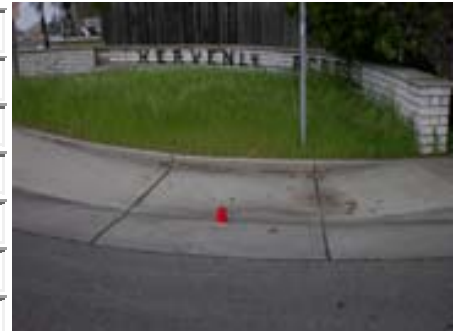
Field Date: 3/28/2011 Report Date: 3/28/2011 Barrier #: 6229B
 Location: Oak Ave and St Philomena Wy - Corner A
 X Coordinate: -121.2618
 Y Coordinate: 38.70057
 Barrier Area: Curb Ramps
 Barrier Type: Parallel Ramp Landing - Existing (4.1% to 4.9%)
 Code Ref: CBC 1127B.5.4 and ADA/ABA 406.4

As Built Meas: 1 Quantity: EACH
 Description: Curb ramp landing or pan not level(4.1% to 4.9%)
 As Built Desc: 4.1% landing slope
 Solution: Demolish existing and construct new transition
 Bar. Severity: 2 Recommended Cost Estimate: \$250.00 Status:
 Implementation Priority: 1 Facility Function:
 Implementation Phase: Implementation Date:
 Official Responsible:

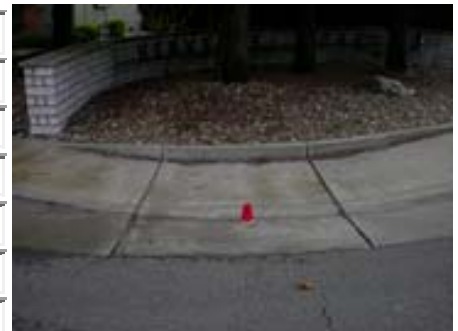
Field Date: 3/28/2011 Report Date: 3/28/2011 Barrier #: 6230A
 Location: Oak Ave and St Philomena Wy - Corner B
 X Coordinate: -121.26159
 Y Coordinate: 38.70054
 Barrier Area: Curb Ramps
 Barrier Type: 12" Grooves - Existing (3.1% to 4.0%)
 Code Ref: CBC 1127B.5.6

As Built Meas: 1 Quantity: EACH
 Description: 12" grooves at top of curb ramp are not level (3.1% to 4.0%)
 As Built Desc: 3.2% at 12" grooves
 Solution: Demolish existing and construct new curb ramp
 Bar. Severity: 3 Hindrance Cost Estimate: \$2,500.00 Status:
 Implementation Priority: 1 Facility Function:
 Implementation Phase: Implementation Date:
 Official Responsible:

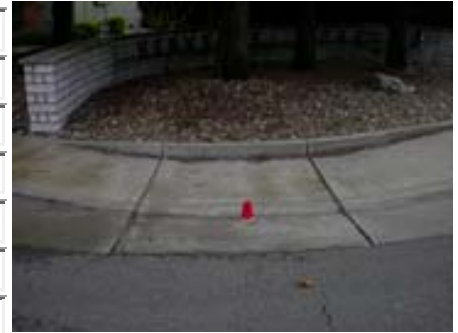
Field Date: 3/28/2011 Report Date: 3/28/2011 Barrier #: 6230B
 Location: Oak Ave and St Philomena Wy - Corner B
 X Coordinate: -121.26159
 Y Coordinate: 38.70054
 Barrier Area: Curb Ramps
 Barrier Type: Parallel Ramp Landing - Existing (3.1% to 4.0%)
 Code Ref: CBC 1127B.5.4 and ADA/ABA 406.4

As Built Meas: 1 Quantity: EACH
 Description: Curb ramp landing or pan not level (3.1% to 4.0%)
 As Built Desc: 3.1% landing slope
 Solution: Demolish existing and construct new transition
 Bar. Severity: 3 Hindrance Cost Estimate: \$250.00 Status:
 Implementation Priority: 1 Facility Function:
 Implementation Phase: Implementation Date:
 Official Responsible:

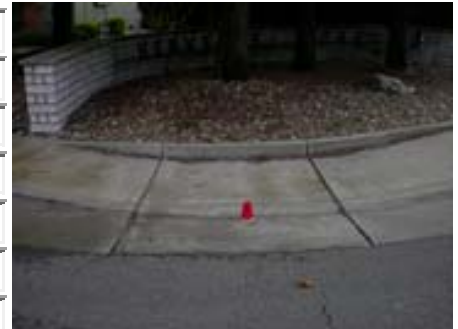
Field Date: 3/28/2011 Report Date: 3/28/2011 Barrier #: 6230C
 Location: Oak Ave and St Philomena Wy - Corner B
 X Coordinate: -121.26159
 Y Coordinate: 38.70054
 Barrier Area: Curb Ramps
 Barrier Type: Detectable Warnings - Truncated Domes
 Code Ref: CBC 1127B.5.7 and ADA/ABA 705.1.3

As Built Meas: 1 Quantity: EACH
 Description: No truncated domes provided at curb ramp
 As Built Desc: No detectable warnings at curb ramp
 Solution: Provide compliant truncated domes
 Bar. Severity: 2 Recommended Cost Estimate: \$1,400.00 Status:
 Implementation Priority: 1 Facility Function:
 Implementation Phase: Implementation Date:
 Official Responsible:

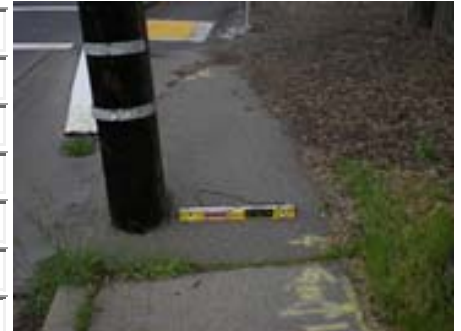
Field Date: 3/28/2011 Report Date: 3/28/2011 Barrier #: 6231C
 Location: Oak Ave - North
 X Coordinate: -121.26216
 Y Coordinate: 38.70054
 Barrier Area: Sidewalks
 Barrier Type: Clear Width - Existing ($\leq 31''$ or less)
 Code Ref: CBC 1133B.7.1

As Built Meas: 4 Quantity: LF
 Description: Pedestrian route is not min. 48" wide ($\leq 31''$ or less)
 As Built Desc: 24" clear width due to pole
 Solution: Demolish existing and construct new route
 Bar. Severity: 1 Necessary Cost Estimate: \$500.00 Status:
 Implementation Priority: 1 Facility Function:
 Implementation Phase: Implementation Date:
 Official Responsible:

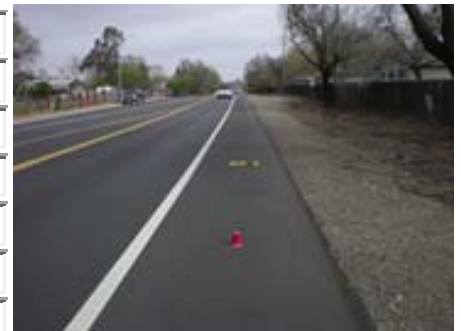
Field Date: 3/28/2011 Report Date: 3/28/2011 Barrier #: 6232
 Location: Fair Oaks Blvd - East
 X Coordinate: -121.26228
 Y Coordinate: 38.70147
 Barrier Area: Sidewalks
 Barrier Type: Shoulder Cross Slope - Existing (3.1% to 4.0%)
 Code Ref: CBC 1133B.7.1.3 and ADA/ABA 403.3

As Built Meas: 1240 Quantity: LF
 Description: Cross slope exceeds 2.0% (3.1% to 4.0%)
 As Built Desc: 3.5% cross slope
 Solution: Demolish existing and construct new pedestrian route
 Bar. Severity: 3 Hinderance Cost Estimate: \$155,000.00 Status:
 Implementation Priority: 1 Facility Function:
 Implementation Phase: Implementation Date:
 Official Responsible:

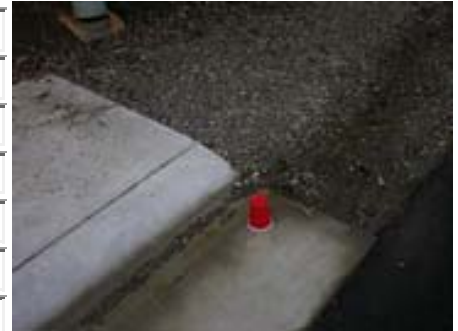
Field Date: 3/28/2011 Report Date: 3/28/2011 Barrier #: 6233
 Location: Fair Oaks Blvd - East
 X Coordinate: -121.26229
 Y Coordinate: 38.70483
 Barrier Area: Sidewalks
 Barrier Type: No Sidewalk - Transition to Shoulder
 Code Ref: CBC 1121B.2 and ADA/ABA 206.2.1

As Built Meas: 1 Quantity: JOB
 Description: Sidewalk ends and no ramp to pedestrian shoulder is provided
 As Built Desc: No ramp to shoulder to enable pedestrian travel onto existing shoulder
 Solution: Provide transition ramp to paved shoulder where no opposite sidewalk exists
 Bar. Severity: 1 Necessary Cost Estimate: \$2,500.00 Status:
 Implementation Priority: 1 Facility Function:
 Implementation Phase: Implementation Date:
 Official Responsible:

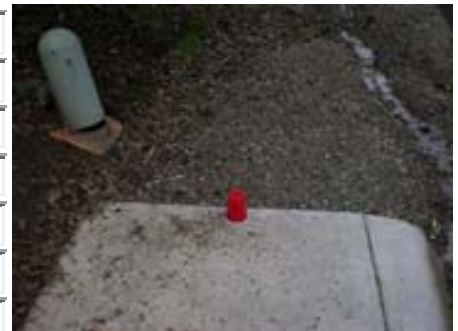
Field Date: 3/28/2011 Report Date: 3/28/2011 Barrier #: 6234
 Location: Fair Oaks Blvd - East
 X Coordinate: -121.26227
 Y Coordinate: 38.70482
 Barrier Area: Sidewalks
 Barrier Type: No Sidewalk - No Barricade
 Code Ref: MUTCD Section 6D.01

As Built Meas: 1 Quantity: JOB
 Description: No barricade provided where sidewalk ends in hazardous location
 As Built Desc: No barricade or other warning provided for the visually impaired at end of sidewalk
 Solution: Provide barricade with cane detectable warning at end of sidewalk
 Bar. Severity: 1 Necessary Cost Estimate: \$1,350.00 Status:
 Implementation Priority: 1 Facility Function:
 Implementation Phase: Implementation Date:
 Official Responsible:

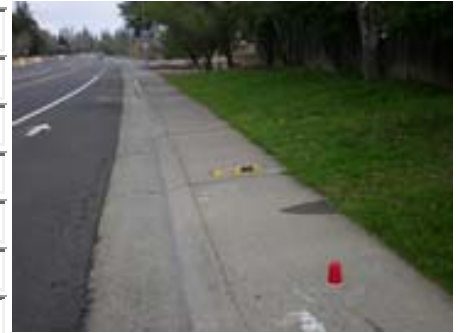
Field Date: 3/28/2011 Report Date: 3/28/2011 Barrier #: 6235
 Location: Fair Oaks Blvd - East
 X Coordinate: -121.2623
 Y Coordinate: 38.70523
 Barrier Area: Sidewalks
 Barrier Type: Cross Slope - Existing (5.0% or more)
 Code Ref: CBC 1133B.7.1.3 and ADA/ABA 403.3

As Built Meas: 209 Quantity: LF
 Description: Cross slope exceeds 2.0% (5.0% or more)
 As Built Desc: 5.4% cross slope
 Solution: Demolish existing and construct new route
 Bar. Severity: 1 Necessary Cost Estimate: \$26,125.00 Status:
 Implementation Priority: 1 Facility Function:
 Implementation Phase: Implementation Date:
 Official Responsible:

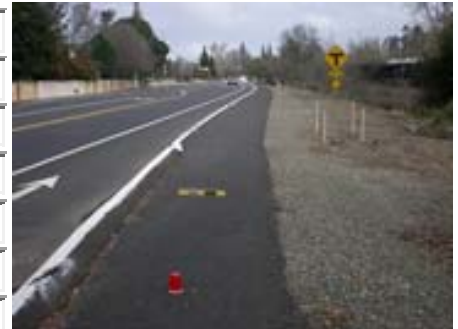
Field Date: 3/28/2011 Report Date: 3/28/2011 Barrier #: 6236
 Location: Fair Oaks Blvd - East
 X Coordinate: -121.26239
 Y Coordinate: 38.70609
 Barrier Area: Sidewalks
 Barrier Type: Cross Slope - Existing (5.0% or more)
 Code Ref: CBC 1133B.7.1.3 and ADA/ABA 403.3

As Built Meas: 595 Quantity: LF
 Description: Cross slope exceeds 2.0% (5.0% or more)
 As Built Desc: 5.6% cross slope
 Solution: Demolish existing and construct new route
 Bar. Severity: 1 Necessary Cost Estimate: \$74,375.00 Status:
 Implementation Priority: 1 Facility Function:
 Implementation Phase: Implementation Date:
 Official Responsible:

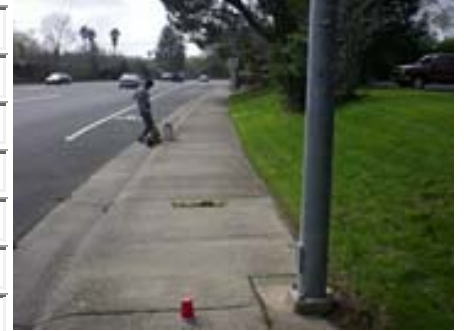
Field Date: 3/28/2011 Report Date: 3/28/2011 Barrier #: 6237
 Location: Fair Oaks Blvd - West
 X Coordinate: -121.26305
 Y Coordinate: 38.70756
 Barrier Area: Sidewalks
 Barrier Type: Cross Slope - Existing (3.1% to 4.0%)
 Code Ref: CBC 1133B.7.1.3 and ADA/ABA 403.3

As Built Meas: 142 Quantity: LF
 Description: Cross slope exceeds 2.0% (3.1% to 4.0%)
 As Built Desc: 3.3% cross slope
 Solution: Demolish existing and construct new route
 Bar. Severity: 3 Hinderance Cost Estimate: \$17,750.00 Status:
 Implementation Priority: 1 Facility Function:
 Implementation Phase: Implementation Date:
 Official Responsible:

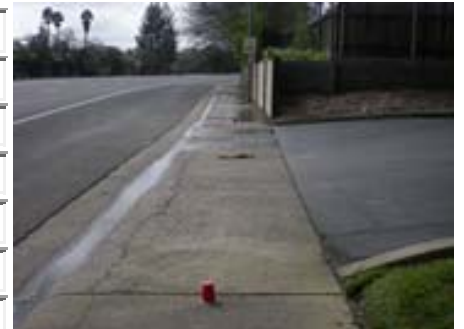
Field Date: 3/28/2011 Report Date: 3/28/2011 Barrier #: 6238
 Location: Fair Oaks Blvd - West
 X Coordinate: -121.26288
 Y Coordinate: 38.70716
 Barrier Area: Sidewalks
 Barrier Type: Cross Slope - Existing (5.0% or more)
 Code Ref: CBC 1133B.7.1.3 and ADA/ABA 403.3

As Built Meas: 38 Quantity: LF
 Description: Cross slope exceeds 2.0% (5.0% or more)
 As Built Desc: 6.1% cross slope
 Solution: Demolish existing and construct new route
 Bar. Severity: 1 Necessary Cost Estimate: \$4,750.00 Status:
 Implementation Priority: 1 Facility Function:
 Implementation Phase: Implementation Date:
 Official Responsible:

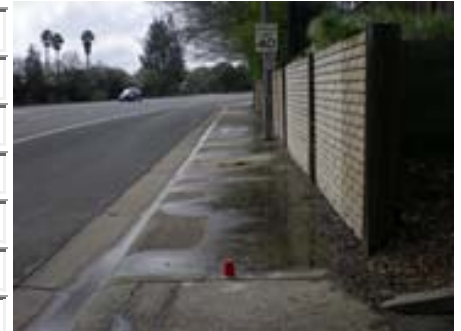
Field Date: 3/28/2011 Report Date: 3/28/2011 Barrier #: 6239
 Location: Fair Oaks Blvd - West
 X Coordinate: -121.26286
 Y Coordinate: 38.70708
 Barrier Area: Sidewalks
 Barrier Type: Cross Slope - Existing (3.1% to 4.0%)
 Code Ref: CBC 1133B.7.1.3 and ADA/ABA 403.3

As Built Meas: 942 Quantity: LF
 Description: Cross slope exceeds 2.0% (3.1% to 4.0%)
 As Built Desc: 4.0% cross slope
 Solution: Demolish existing and construct new route
 Bar. Severity: 3 Hinderance Cost Estimate: \$117,750.00 Status:
 Implementation Priority: 1 Facility Function:
 Implementation Phase: Implementation Date:
 Official Responsible:

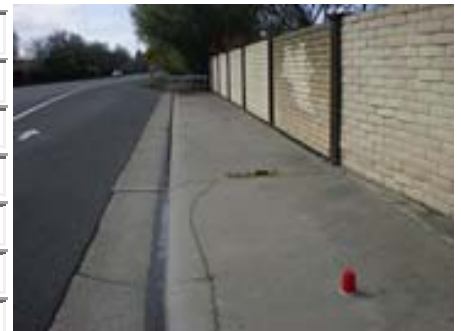
Field Date: 3/28/2011 Report Date: 3/28/2011 Barrier #: 6240
 Location: Fair Oaks Blvd - West
 X Coordinate: -121.26253
 Y Coordinate: 38.70425
 Barrier Area: Sidewalks
 Barrier Type: Cross Slope - Existing (2.1% to 3.0%)
 Code Ref: CBC 1133B.7.1.3 and ADA/ABA 403.3

As Built Meas: 40 Quantity: LF
 Description: Cross slope exceeds 2.0% (2.1% to 3.0%)
 As Built Desc: 3.0% cross slope
 Solution: Low severity barrier - no remediation recommended
 Bar. Severity: 4 Low Severity Cost Estimate: \$0.00 Status:
 Implementation Priority: 1 Facility Function:
 Implementation Phase: Implementation Date:
 Official Responsible:

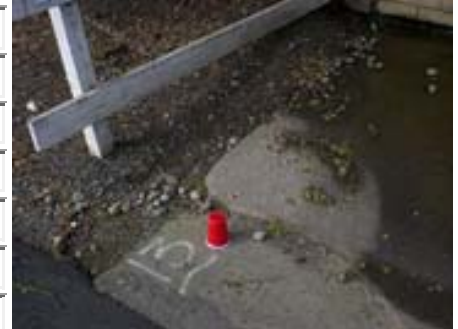
Field Date: 3/28/2011 Report Date: 3/28/2011 Barrier #: 6241
 Location: Fair Oaks Blvd - West
 X Coordinate: -121.26254
 Y Coordinate: 38.70403
 Barrier Area: Sidewalks
 Barrier Type: No Sidewalk - Transition to Shoulder
 Code Ref: CBC 1121B.2 and ADA/ABA 206.2.1

As Built Meas: 1 Quantity: JOB
 Description: Sidewalk ends and no ramp to pedestrian shoulder is provided
 As Built Desc: No ramp to shoulder to enable pedestrian travel onto existing shoulder
 Solution: Provide transition ramp to paved shoulder where no opposite sidewalk exists
 Bar. Severity: 1 Necessary Cost Estimate: \$2,500.00 Status:
 Implementation Priority: 1 Facility Function:
 Implementation Phase: Implementation Date:
 Official Responsible:

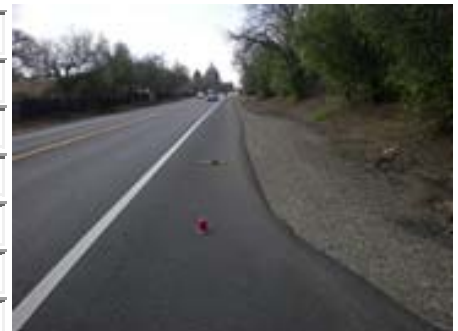
Field Date: 3/28/2011 Report Date: 3/28/2011 Barrier #: 6242
 Location: Fair Oaks Blvd - West
 X Coordinate: -121.26247
 Y Coordinate: 38.70383
 Barrier Area: Sidewalks
 Barrier Type: Shoulder Cross Slope - Existing (4.1% to 4.9%)
 Code Ref: CBC 1133B.7.1.3 and ADA/ABA 403.3

As Built Meas: 600 Quantity: LF
 Description: Cross slope exceeds 2.0% (4.1% to 4.9%)
 As Built Desc: 4.3% cross slope
 Solution: Demolish existing and construct new pedestrian route
 Bar. Severity: 2 Recommended Cost Estimate: \$75,000.00 Status:
 Implementation Priority: 1 Facility Function:
 Implementation Phase: Implementation Date:
 Official Responsible:

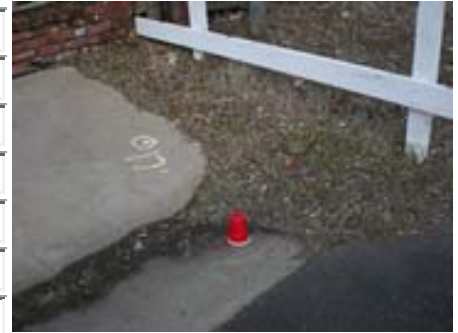
Field Date: 3/28/2011 Report Date: 3/28/2011 Barrier #: 6243
 Location: Fair Oaks Blvd - West
 X Coordinate: -121.26251
 Y Coordinate: 38.70222
 Barrier Area: Sidewalks
 Barrier Type: No Sidewalk - Transition to Shoulder
 Code Ref: CBC 1121B.2 and ADA/ABA 206.2.1

As Built Meas: 1 Quantity: JOB
 Description: Sidewalk ends and no ramp to pedestrian shoulder is provided
 As Built Desc: No ramp to shoulder to enable pedestrian travel onto existing shoulder
 Solution: Provide transition ramp to paved shoulder where no opposite sidewalk exists
 Bar. Severity: 1 Necessary Cost Estimate: \$2,500.00 Status:
 Implementation Priority: 1 Facility Function:
 Implementation Phase: Implementation Date:
 Official Responsible:

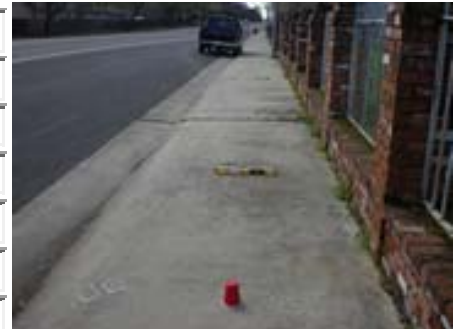
Field Date: 3/28/2011 Report Date: 3/28/2011 Barrier #: 6244
 Location: Fair Oaks Blvd - West
 X Coordinate: -121.26252
 Y Coordinate: 38.70219
 Barrier Area: Sidewalks
 Barrier Type: Cross Slope - Existing (4.1% to 4.9%)
 Code Ref: CBC 1133B.7.1.3 and ADA/ABA 403.3

As Built Meas: 440 Quantity: LF
 Description: Cross slope exceeds 2.0% (4.1% to 4.9%)
 As Built Desc: 4.3% cross slope
 Solution: Demolish existing and construct new route
 Bar. Severity: 2 Recommended Cost Estimate: \$55,000.00 Status:
 Implementation Priority: 1 Facility Function:
 Implementation Phase: Implementation Date:
 Official Responsible:

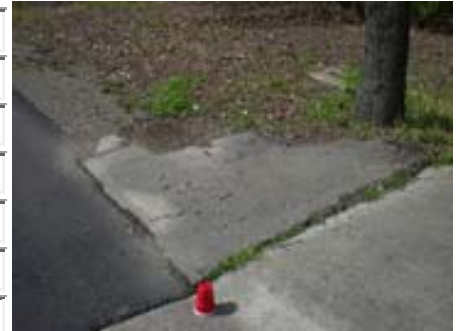
Field Date: 3/28/2011 Report Date: 3/28/2011 Barrier #: 6245
 Location: Oak Ave - North
 X Coordinate: -121.26255
 Y Coordinate: 38.70098
 Barrier Area: Sidewalks
 Barrier Type: No Sidewalk - Transition to Shoulder
 Code Ref: CBC 1121B.2 and ADA/ABA 206.2.1

As Built Meas: 1 Quantity: JOB
 Description: Sidewalk ends and no ramp to pedestrian shoulder is provided
 As Built Desc: No ramp to shoulder to enable pedestrian travel onto existing shoulder
 Solution: Provide transition ramp to paved shoulder where no opposite sidewalk exists
 Bar. Severity: 1 Necessary Cost Estimate: \$2,500.00 Status:
 Implementation Priority: 1 Facility Function:
 Implementation Phase: Implementation Date:
 Official Responsible:

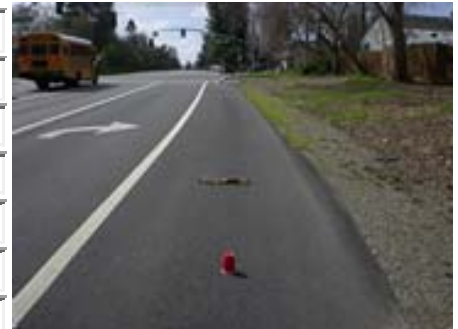
Field Date: 3/28/2011 Report Date: 3/28/2011 Barrier #: 6246
 Location: Oak Ave - North
 X Coordinate: -121.26257
 Y Coordinate: 38.70096
 Barrier Area: Sidewalks
 Barrier Type: Shoulder Cross Slope - Existing (3.1% to 4.0%)
 Code Ref: CBC 1133B.7.1.3 and ADA/ABA 403.3

As Built Meas: 112 Quantity: LF
 Description: Cross slope exceeds 2.0% (3.1% to 4.0%)
 As Built Desc: 3.2% cross slope
 Solution: Demolish existing and construct new pedestrian route
 Bar. Severity: 3 Hinderance Cost Estimate: \$14,000.00 Status:
 Implementation Priority: 1 Facility Function:
 Implementation Phase: Implementation Date:
 Official Responsible:

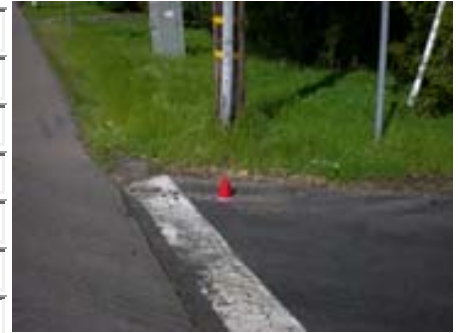
Field Date: 3/28/2011 Report Date: 3/28/2011 Barrier #: 6247
 Location: Oak Ave and Minnesota Dr - Corner A
 X Coordinate: -121.26361
 Y Coordinate: 38.70049
 Barrier Area: Blended Transitions
 Barrier Type: Detectable Warnings - Truncated Domes
 Code Ref: CBC 1127B.5.3

As Built Meas: 1 Quantity: EACH
 Description: No truncated domes provided at transition into roadway
 As Built Desc: No detectable warning provided
 Solution: Provide compliant truncated domes
 Bar. Severity: 2 Recommended Cost Estimate: \$1,400.00 Status:
 Implementation Priority: 1 Facility Function:
 Implementation Phase: Implementation Date:
 Official Responsible:
