**DRAFT ADA TRANSITION PLAN UPDATE
NEIGHBORHOOD AREA 8 CHASE
SEPTEMBER 20, 2011**

CITY OF CITRUS HEIGHTS

Conditions - CHASE Area 8

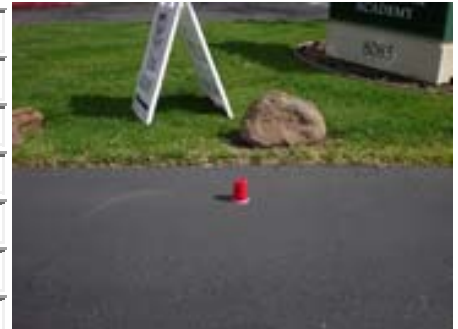
Field Date: 3/28/2011 Report Date: 3/28/2011 Barrier #: 6248
 Location: Oak Ave and Minnesota Dr - Corner B
 X Coordinate: -121.26339
 Y Coordinate: 38.70052
 Barrier Area: Blended Transitions
 Barrier Type: Detectable Warnings - Truncated Domes
 Code Ref: CBC 1127B.5.3

As Built Meas: 1 Quantity: EACH
 Description: No truncated domes provided at transition into roadway
 As Built Desc: No detectable warning provided
 Solution: Provide compliant truncated domes
 Bar. Severity: 2 Recommended Cost Estimate: \$1,400.00 Status:
 Implementation Priority: 1 Facility Function:
 Implementation Phase: Implementation Date:
 Official Responsible:

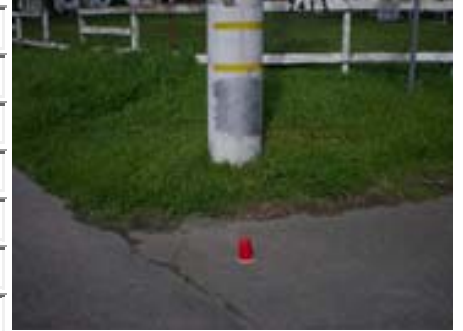
Field Date: 3/28/2011 Report Date: 3/28/2011 Barrier #: 6249
 Location: Oak Ave and Andersen Ln - Corner A
 X Coordinate: -121.26465
 Y Coordinate: 38.70047
 Barrier Area: Blended Transitions
 Barrier Type: Detectable Warnings - Truncated Domes
 Code Ref: CBC 1127B.5.3

As Built Meas: 1 Quantity: EACH
 Description: No truncated domes provided at transition into roadway
 As Built Desc: No detectable warning provided
 Solution: Provide compliant truncated domes
 Bar. Severity: 2 Recommended Cost Estimate: \$1,400.00 Status:
 Implementation Priority: 1 Facility Function:
 Implementation Phase: Implementation Date:
 Official Responsible:

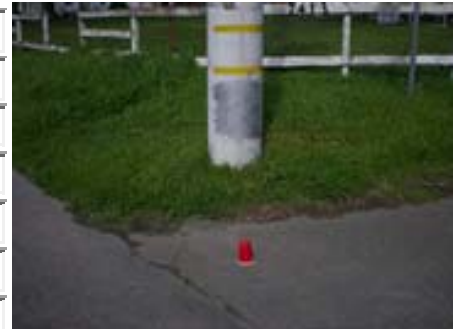
Field Date: 3/28/2011 Report Date: 3/28/2011 Barrier #: 6250
 Location: Oak Ave and Andersen Ln - Corner B
 X Coordinate: -121.26481
 Y Coordinate: 38.70048
 Barrier Area: Blended Transitions
 Barrier Type: Detectable Warnings - Truncated Domes
 Code Ref: CBC 1127B.5.3

As Built Meas: 1 Quantity: EACH
 Description: No truncated domes provided at transition into roadway
 As Built Desc: No detectable warning provided
 Solution: Provide compliant truncated domes
 Bar. Severity: 2 Recommended Cost Estimate: \$1,400.00 Status:
 Implementation Priority: 1 Facility Function:
 Implementation Phase: Implementation Date:
 Official Responsible:

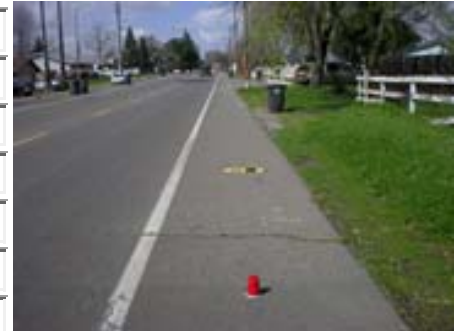
Field Date: 3/28/2011 Report Date: 3/28/2011 Barrier #: 6251
 Location: Oak Ave - North
 X Coordinate: -121.26557
 Y Coordinate: 38.7005
 Barrier Area: Sidewalks
 Barrier Type: Shoulder Cross Slope - Existing (3.1% to 4.0%)
 Code Ref: CBC 1133B.7.1.3 and ADA/ABA 403.3

As Built Meas: 127 Quantity: LF
 Description: Cross slope exceeds 2.0% (3.1% to 4.0%)
 As Built Desc: 3.5% cross slope
 Solution: Demolish existing and construct new pedestrian route
 Bar. Severity: 3 Hinderance Cost Estimate: \$15,875.00 Status:
 Implementation Priority: 1 Facility Function:
 Implementation Phase: Implementation Date:
 Official Responsible:

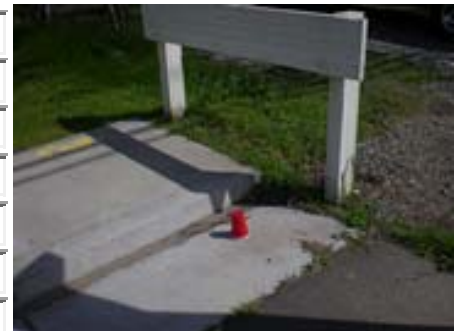
Field Date: 3/28/2011 Report Date: 3/28/2011 Barrier #: 6252
 Location: Oak Ave - North
 X Coordinate: -121.26557
 Y Coordinate: 38.7005
 Barrier Area: Sidewalks
 Barrier Type: No Sidewalk - Transition to Shoulder
 Code Ref: CBC 1121B.2 and ADA/ABA 206.2.1

As Built Meas: 1 Quantity: JOB
 Description: Sidewalk ends and no ramp to pedestrian shoulder is provided
 As Built Desc: No ramp to shoulder to enable pedestrian travel onto existing shoulder
 Solution: Provide transition ramp to paved shoulder where no opposite sidewalk exists
 Bar. Severity: 1 Necessary Cost Estimate: \$2,500.00 Status:
 Implementation Priority: 1 Facility Function:
 Implementation Phase: Implementation Date:
 Official Responsible:

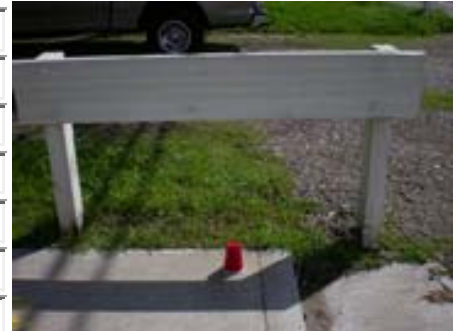
Field Date: 3/28/2011 Report Date: 3/28/2011 Barrier #: 6253
 Location: Oak Ave - North
 X Coordinate: -121.2659
 Y Coordinate: 38.70052
 Barrier Area: Sidewalks
 Barrier Type: No Sidewalk - Cane Detectable Barricade
 Code Ref: CBC 1133B.8.6 and MUTCD Section 6D.02

As Built Meas: 4 Quantity: LF
 Description: No cane detectable warning on existing barricade
 As Built Desc: Existing barricade lacks warning for the visually impaired
 Solution: Provide cane detectable warning on barricade (max. 6" above ground)
 Bar. Severity: 1 Necessary Cost Estimate: \$400.00 Status:
 Implementation Priority: 1 Facility Function:
 Implementation Phase: Implementation Date:
 Official Responsible:

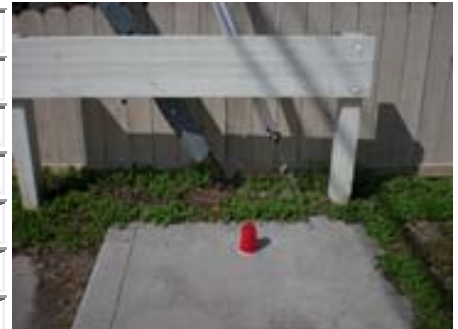
Field Date: 3/28/2011 Report Date: 3/28/2011 Barrier #: 6254
 Location: Oak Ave - North
 X Coordinate: -121.2659
 Y Coordinate: 38.70051
 Barrier Area: Sidewalks
 Barrier Type: No Sidewalk - Cane Detectable Barricade
 Code Ref: CBC 1133B.8.6 and MUTCD Section 6D.02

As Built Meas: 4 Quantity: LF
 Description: No cane detectable warning on existing barricade
 As Built Desc: Existing barricade lacks warning for the visually impaired
 Solution: Provide cane detectable warning on barricade (max. 6" above ground)
 Bar. Severity: 1 Necessary Cost Estimate: \$400.00 Status:
 Implementation Priority: 1 Facility Function:
 Implementation Phase: Implementation Date:
 Official Responsible:

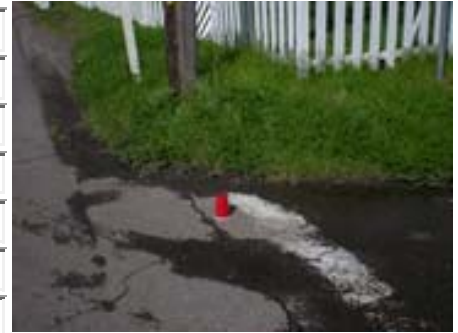
Field Date: 3/28/2011 Report Date: 3/28/2011 Barrier #: 6255
 Location: Oak Ave and Canady Ln - Corner A
 X Coordinate: -121.26659
 Y Coordinate: 38.70045
 Barrier Area: Blended Transitions
 Barrier Type: Detectable Warnings - Truncated Domes
 Code Ref: CBC 1127B.5.3

As Built Meas: 1 Quantity: EACH
 Description: No truncated domes provided at transition into roadway
 As Built Desc: No detectable warning provided
 Solution: Provide compliant truncated domes
 Bar. Severity: 2 Recommended Cost Estimate: \$1,400.00 Status:
 Implementation Priority: 1 Facility Function:
 Implementation Phase: Implementation Date:
 Official Responsible:

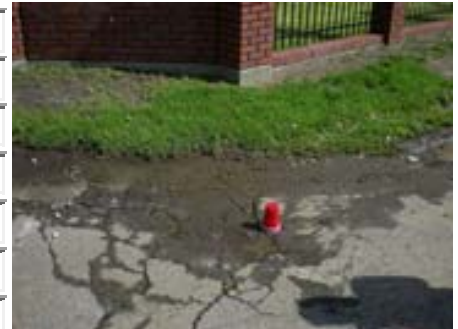
Field Date: 3/28/2011 Report Date: 3/28/2011 Barrier #: 6256
 Location: Oak Ave and Canady Ln - Corner B
 X Coordinate: -121.26648
 Y Coordinate: 38.70046
 Barrier Area: Blended Transitions
 Barrier Type: Detectable Warnings - Truncated Domes
 Code Ref: CBC 1127B.5.3

As Built Meas: 1 Quantity: EACH
 Description: No truncated domes provided at transition into roadway
 As Built Desc: No detectable warning provided
 Solution: Provide compliant truncated domes
 Bar. Severity: 2 Recommended Cost Estimate: \$1,400.00 Status:
 Implementation Priority: 1 Facility Function:
 Implementation Phase: Implementation Date:
 Official Responsible:

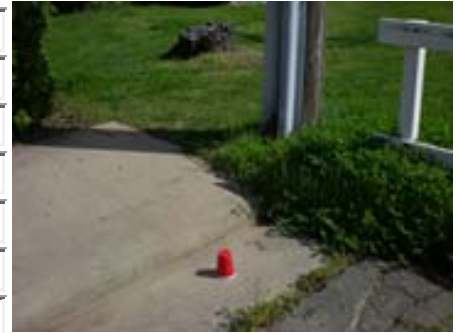
Field Date: 3/28/2011 Report Date: 3/28/2011 Barrier #: 6257
 Location: Oak Ave - North
 X Coordinate: -121.26795
 Y Coordinate: 38.70042
 Barrier Area: Sidewalks
 Barrier Type: No Sidewalk - Transition to Shoulder
 Code Ref: CBC 1121B.2 and ADA/ABA 206.2.1

As Built Meas: 1 Quantity: JOB
 Description: Sidewalk ends and no ramp to pedestrian shoulder is provided
 As Built Desc: No ramp to shoulder to enable pedestrian travel onto existing shoulder
 Solution: Provide transition ramp to paved shoulder where no opposite sidewalk exists
 Bar. Severity: 1 Necessary Cost Estimate: \$2,500.00 Status:
 Implementation Priority: 1 Facility Function:
 Implementation Phase: Implementation Date:
 Official Responsible:

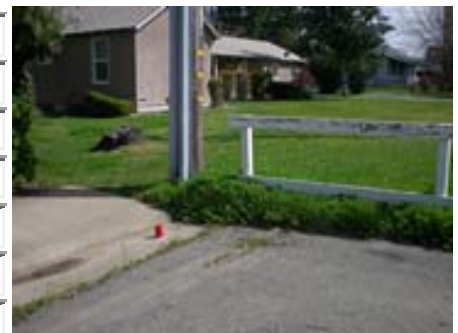
Field Date: 3/28/2011 Report Date: 3/28/2011 Barrier #: 6258
 Location: Oak Ave - North
 X Coordinate: -121.26789
 Y Coordinate: 38.70045
 Barrier Area: Sidewalks
 Barrier Type: No Sidewalk - No Barricade
 Code Ref: MUTCD Section 6D.01

As Built Meas: 1 Quantity: JOB
 Description: No barricade provided where sidewalk ends in hazardous location
 As Built Desc: No barricade or other warning provided for the visually impaired at end of sidewalk
 Solution: Provide barricade with cane detectable warning at end of sidewalk
 Bar. Severity: 1 Necessary Cost Estimate: \$1,350.00 Status:
 Implementation Priority: 1 Facility Function:
 Implementation Phase: Implementation Date:
 Official Responsible:

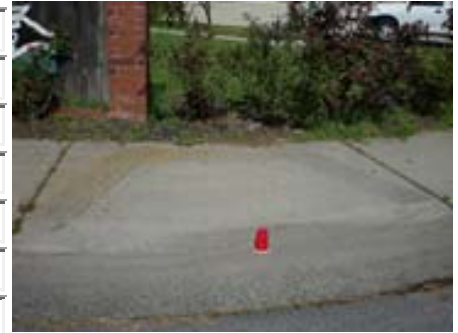
Field Date: 3/28/2011 Report Date: 3/28/2011 Barrier #: 6259
 Location: Oak Ave and Foxhills Dr - Corner A
 X Coordinate: -121.26848
 Y Coordinate: 38.70047
 Barrier Area: Blended Transitions
 Barrier Type: Detectable Warnings - Truncated Domes
 Code Ref: CBC 1127B.5.3

As Built Meas: 1 Quantity: EACH
 Description: No truncated domes provided at transition into roadway
 As Built Desc: No detectable warning provided
 Solution: Provide compliant truncated domes
 Bar. Severity: 2 Recommended Cost Estimate: \$1,400.00 Status:
 Implementation Priority: 1 Facility Function:
 Implementation Phase: Implementation Date:
 Official Responsible:

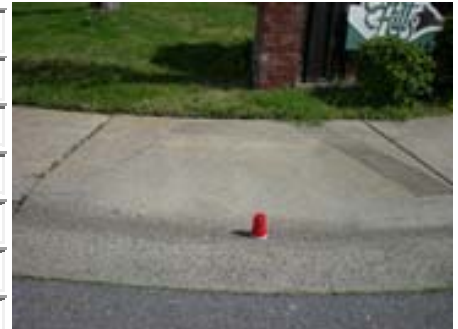
Field Date: 3/28/2011 Report Date: 3/28/2011 Barrier #: 6260
 Location: Oak Ave and Foxhills Dr - Corner B
 X Coordinate: -121.26829
 Y Coordinate: 38.70048
 Barrier Area: Blended Transitions
 Barrier Type: Detectable Warnings - Truncated Domes
 Code Ref: CBC 1127B.5.3

As Built Meas: 1 Quantity: EACH
 Description: No truncated domes provided at transition into roadway
 As Built Desc: No detectable warning provided
 Solution: Provide compliant truncated domes
 Bar. Severity: 2 Recommended Cost Estimate: \$1,400.00 Status:
 Implementation Priority: 1 Facility Function:
 Implementation Phase: Implementation Date:
 Official Responsible:

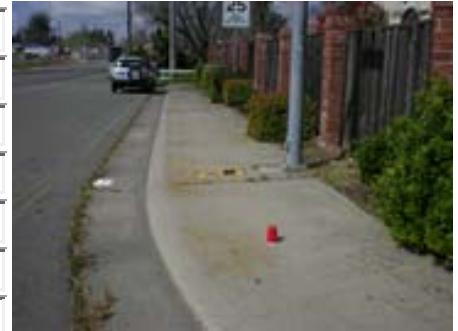
Barrier Type: Cross Slope - Existing (4.1% to 4.9%)

Code Ref: CBC 1133B.7.1.3 and ADA/ABA 403.3

As Built Meas: 110 Quantity: LF

Description: Cross slope exceeds 2.0% (4.1% to 4.9%)

Bar. Severity: 2 Recommended Cost Estimate: \$13,750.00 Status:

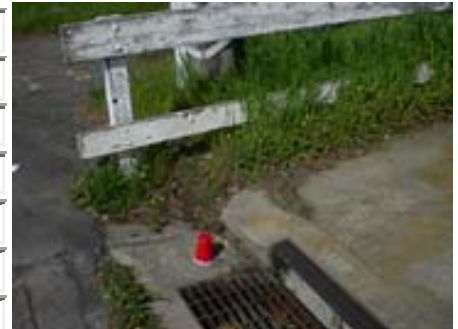
Barrier Type: No Sidewalk - Transition to Shoulder

Code Ref: CBC 1121B.2 and ADA/ABA 206.2.1

As Built Meas: 1 Quantity: JOB

Description: Sidewalk ends and no ramp to pedestrian shoulder is provided

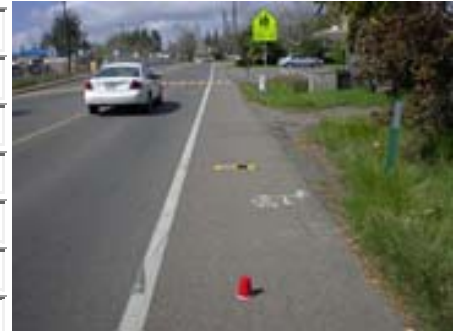
Field Date: 3/28/2011 Report Date: 3/28/2011 Barrier #: 6263
 Location: Oak Ave - North
 X Coordinate: -121.26915
 Y Coordinate: 38.70042
 Barrier Area: Sidewalks
 Barrier Type: Shoulder Cross Slope - Existing (4.1% to 4.9%)
 Code Ref: CBC 1133B.7.1.3 and ADA/ABA 403.3

As Built Meas: 580 Quantity: LF
 Description: Cross slope exceeds 2.0% (4.1% to 4.9%)
 As Built Desc: 4.5% cross slope
 Solution: Demolish existing and construct new pedestrian route
 Bar. Severity: 2 Recommended Cost Estimate: \$72,500.00 Status:
 Implementation Priority: 1 Facility Function:
 Implementation Phase: Implementation Date:
 Official Responsible:

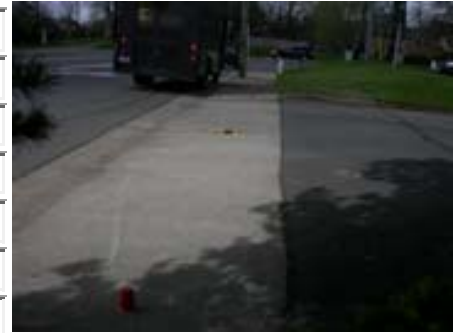
Field Date: 3/28/2011 Report Date: 3/28/2011 Barrier #: 6265
 Location: Oak Ave - North
 X Coordinate: -121.27129
 Y Coordinate: 38.70048
 Barrier Area: Sidewalks
 Barrier Type: Driveway - Existing (5.0% or more)
 Code Ref: CBC 1133B.7.1.3 and ADA/ABA 403.3

As Built Meas: 40 Quantity: LF
 Description: Driveway cross slope exceeds 2.0% (5.0% or more)
 As Built Desc: 5.5% cross slope
 Solution: Provide min. 48" wide level walkway through driveway
 Bar. Severity: 4 Low Severity Cost Estimate: \$5,000.00 Status:
 Implementation Priority: 1 Facility Function:
 Implementation Phase: Implementation Date:
 Official Responsible:

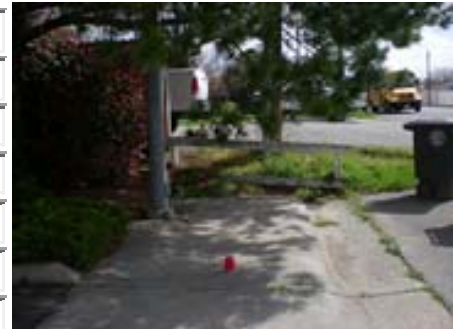
Field Date: 3/28/2011 Report Date: 3/28/2011 Barrier #: 6266
 Location: Oak Ave - North
 X Coordinate: -121.27124
 Y Coordinate: 38.70046
 Barrier Area: Sidewalks
 Barrier Type: Protruding Hazard
 Code Ref: CBC 1133B.8.6.1 and ADA/ABA 307.2

As Built Meas: 1 Quantity: JOB
 Description: Protruding object in route of travel between 27" and 80" high
 As Built Desc: 32" at tree branch
 Solution: Remove object or provide detectable warning
 Bar. Severity: 1 Necessary Cost Estimate: \$1,400.00 Status:
 Implementation Priority: 1 Facility Function:
 Implementation Phase: Implementation Date:
 Official Responsible:

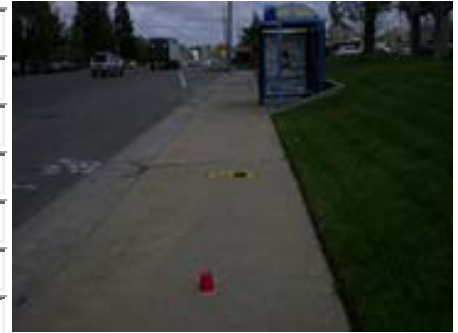
Field Date: 3/28/2011 Report Date: 3/28/2011 Barrier #: 6267
 Location: Sunrise Blvd -East
 X Coordinate: -121.27163
 Y Coordinate: 38.70061
 Barrier Area: Sidewalks
 Barrier Type: Cross Slope - Existing (3.1% to 4.0%)
 Code Ref: CBC 1133B.7.1.3 and ADA/ABA 403.3

As Built Meas: 118 Quantity: LF
 Description: Cross slope exceeds 2.0% (3.1% to 4.0%)
 As Built Desc: 3.1% cross slope
 Solution: Demolish existing and construct new route
 Bar. Severity: 3 Hinderance Cost Estimate: \$14,750.00 Status:
 Implementation Priority: 1 Facility Function:
 Implementation Phase: Implementation Date:
 Official Responsible:

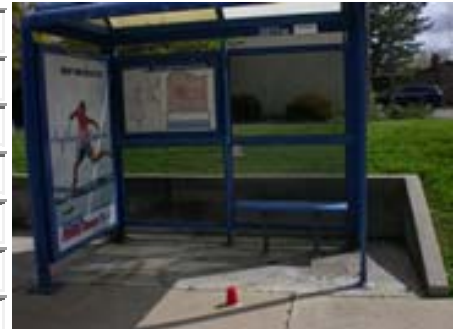
Field Date: 3/28/2011 Report Date: 3/28/2011 Barrier #: 6268A
 Location: Sunrise Blvd - East
 X Coordinate: -121.27162
 Y Coordinate: 38.70072
 Barrier Area: Bus Stops and Shelters
 Barrier Type: Bench Seat Depth
 Code Ref: ADAAG 4.37.1 and ADA/ABA 903.4

As Built Meas: 1 Quantity: EACH
 Description: Bench seat depth not 20" - 24" deep
 As Built Desc: 8" depth
 Solution: Provide min. 1 accessible bench at bench stop
 Bar. Severity: 3 Hindrance Cost Estimate: \$775.00 Status:
 Implementation Priority: 1 Facility Function:
 Implementation Phase: Implementation Date:
 Official Responsible:

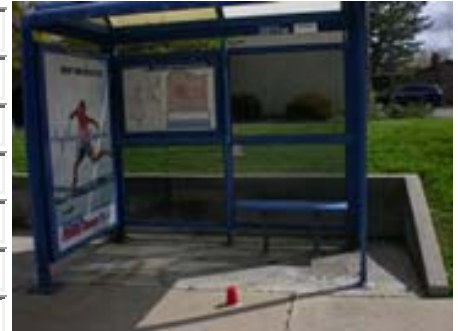
Field Date: 3/28/2011 Report Date: 3/28/2011 Barrier #: 6268B
 Location: Sunrise Blvd - East
 X Coordinate: -121.27162
 Y Coordinate: 38.70072
 Barrier Area: Bus Stops and Shelters
 Barrier Type: Bench Seat Height
 Code Ref: ADAAG 4.37.3* and ADA/ABA 903.4

As Built Meas: 1 Quantity: EACH
 Description: Bench seat height not between 17" - 19"
 As Built Desc: 19" high
 Solution: Provide new compliant bench or remount at compliant height where possible
 Bar. Severity: 3 Hindrance Cost Estimate: \$0.00 Status:
 Implementation Priority: 1 Facility Function:
 Implementation Phase: Implementation Date:
 Official Responsible:

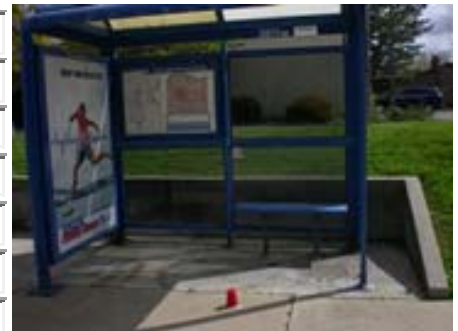
Field Date: 3/28/2011 Report Date: 3/28/2011 Barrier #: 6268C
 Location: Sunrise Blvd - East
 X Coordinate: -121.27162
 Y Coordinate: 38.70072
 Barrier Area: Bus Stops and Shelters
 Barrier Type: Bench Back Support
 Code Ref: ADAAG 4.37.4 and ADA/ABA 903.4

As Built Meas: 1 Quantity: EACH
 Description: Bench has no back support of at least 18" high
 As Built Desc: No back support provided
 Solution: Provide min. 1 accessible bench at bench stop or shelter
 Bar. Severity: 3 Hindrance Cost Estimate: \$0.00 Status:
 Implementation Priority: 1 Facility Function:
 Implementation Phase: Implementation Date:
 Official Responsible:

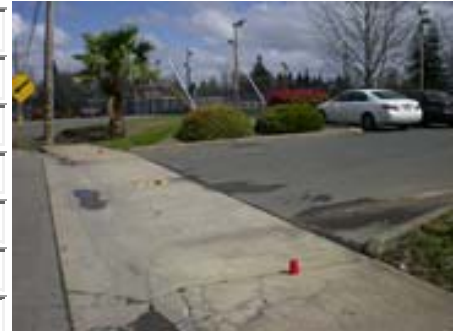
Field Date: 3/28/2011 Report Date: 3/28/2011 Barrier #: 6269
 Location: Sunrise Blvd - East
 X Coordinate: -121.27165
 Y Coordinate: 38.70099
 Barrier Area: Sidewalks
 Barrier Type: Driveway - Existing (5.0% or more)
 Code Ref: CBC 1133B.7.1.3 and ADA/ABA 403.3

As Built Meas: 40 Quantity: LF
 Description: Driveway cross slope exceeds 2.0% (5.0% or more)
 As Built Desc: 5.7% cross slope
 Solution: Provide min. 48" wide level walkway through driveway
 Bar. Severity: 4 Low Severity Cost Estimate: \$5,000.00 Status:
 Implementation Priority: 1 Facility Function:
 Implementation Phase: Implementation Date:
 Official Responsible:

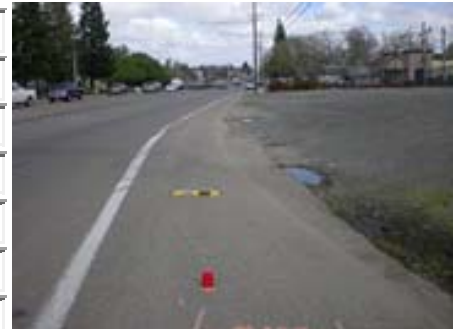
Field Date: 3/28/2011 Report Date: 3/28/2011 Barrier #: 6270
 Location: Sunrise Blvd - East
 X Coordinate: -121.27172
 Y Coordinate: 38.70111
 Barrier Area: Sidewalks
 Barrier Type: Shoulder Cross Slope - Existing (5.0% or more)
 Code Ref: CBC 1133B.7.1.3 and ADA/ABA 403.3

As Built Meas: 244 Quantity: LF
 Description: Cross slope exceeds 2.0% (5.0% or more)
 As Built Desc: 6.2% cross slope
 Solution: Demolish existing and construct new pedestrian route
 Bar. Severity: 1 Necessary Cost Estimate: \$30,500.00 Status:
 Implementation Priority: 1 Facility Function:
 Implementation Phase: Implementation Date:
 Official Responsible:

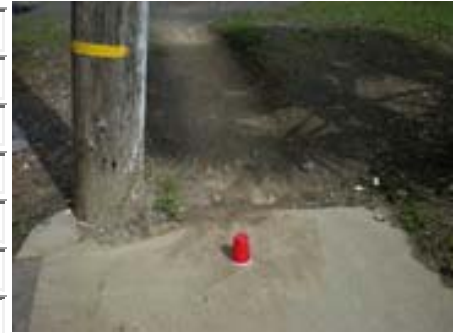
Field Date: 3/28/2011 Report Date: 3/28/2011 Barrier #: 6271
 Location: Sunrise Blvd - East
 X Coordinate: -121.27168
 Y Coordinate: 38.70106
 Barrier Area: Sidewalks
 Barrier Type: No Sidewalk - No Barricade
 Code Ref: MUTCD Section 6D.01

As Built Meas: 1 Quantity: JOB
 Description: No barricade provided where sidewalk ends in hazardous location
 As Built Desc: No barricade or other warning provided for the visually impaired at end of sidewalk
 Solution: Provide barricade with cane detectable warning at end of sidewalk
 Bar. Severity: 1 Necessary Cost Estimate: \$1,350.00 Status:
 Implementation Priority: 1 Facility Function:
 Implementation Phase: Implementation Date:
 Official Responsible:

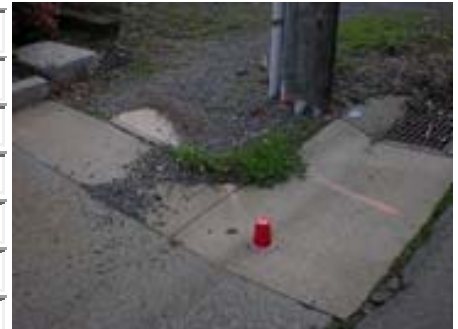
Field Date: 3/28/2011 Report Date: 3/28/2011 Barrier #: 6272
 Location: Sunrise Blvd - East
 X Coordinate: -121.27172
 Y Coordinate: 38.70176
 Barrier Area: Sidewalks
 Barrier Type: No Sidewalk - Transition to Shoulder
 Code Ref: CBC 1121B.2 and ADA/ABA 206.2.1

As Built Meas: 1 Quantity: JOB
 Description: Sidewalk ends and no ramp to pedestrian shoulder is provided
 As Built Desc: No ramp to shoulder to enable pedestrian travel onto existing shoulder
 Solution: Provide transition ramp to paved shoulder where no opposite sidewalk exists
 Bar. Severity: 1 Necessary Cost Estimate: \$2,500.00 Status:
 Implementation Priority: 1 Facility Function:
 Implementation Phase: Implementation Date:
 Official Responsible:

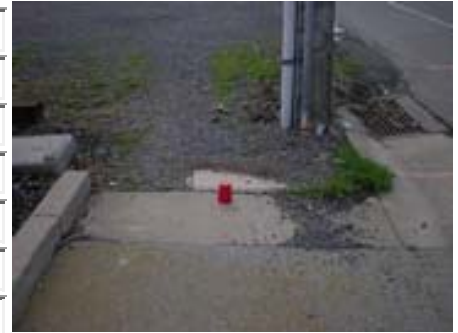
Field Date: 3/28/2011 Report Date: 3/28/2011 Barrier #: 6273
 Location: Sunrise Blvd - East
 X Coordinate: -121.2717
 Y Coordinate: 38.70175
 Barrier Area: Sidewalks
 Barrier Type: No Sidewalk - No Barricade
 Code Ref: MUTCD Section 6D.01

As Built Meas: 1 Quantity: JOB
 Description: No barricade provided where sidewalk ends in hazardous location
 As Built Desc: No barricade or other warning provided for the visually impaired at end of sidewalk
 Solution: Provide barricade with cane detectable warning at end of sidewalk
 Bar. Severity: 1 Necessary Cost Estimate: \$1,350.00 Status:
 Implementation Priority: 1 Facility Function:
 Implementation Phase: Implementation Date:
 Official Responsible:

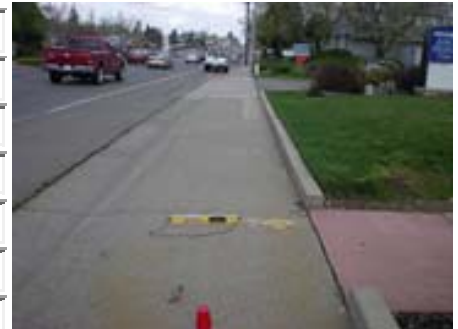
Field Date: 3/28/2011 Report Date: 3/28/2011 Barrier #: 6274
 Location: Sunrise Blvd - East
 X Coordinate: -121.2717
 Y Coordinate: 38.70177
 Barrier Area: Sidewalks
 Barrier Type: Cross Slope - Existing (5.0% or more)
 Code Ref: CBC 1133B.7.1.3 and ADA/ABA 403.3

As Built Meas: 48 Quantity: LF
 Description: Cross slope exceeds 2.0% (5.0% or more)
 As Built Desc: 6.6% cross slope
 Solution: Demolish existing and construct new route
 Bar. Severity: 1 Necessary Cost Estimate: \$6,000.00 Status:
 Implementation Priority: 1 Facility Function:
 Implementation Phase: Implementation Date:
 Official Responsible:

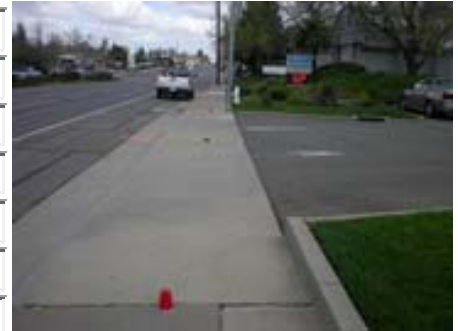
Field Date: 3/28/2011 Report Date: 3/28/2011 Barrier #: 6275
 Location: Sunrise Blvd - East
 X Coordinate: -121.27172
 Y Coordinate: 38.70199
 Barrier Area: Sidewalks
 Barrier Type: Driveway - Existing (5.0% or more)
 Code Ref: CBC 1133B.7.1.3 and ADA/ABA 403.3

As Built Meas: 54 Quantity: LF
 Description: Driveway cross slope exceeds 2.0% (5.0% or more)
 As Built Desc: 5.5% cross slope
 Solution: Provide min. 48" wide level walkway through driveway
 Bar. Severity: 4 Low Severity Cost Estimate: \$6,750.00 Status:
 Implementation Priority: 1 Facility Function:
 Implementation Phase: Implementation Date:
 Official Responsible:

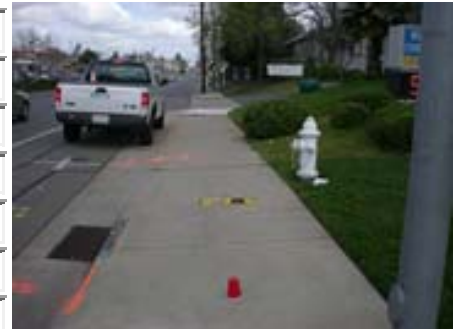
Field Date: 3/28/2011 Report Date: 3/28/2011 Barrier #: 6276
 Location: Sunrise Blvd - East
 X Coordinate: -121.27171
 Y Coordinate: 38.70207
 Barrier Area: Sidewalks
 Barrier Type: Cross Slope - Existing (5.0% or more)
 Code Ref: CBC 1133B.7.1.3 and ADA/ABA 403.3

As Built Meas: 81 Quantity: LF
 Description: Cross slope exceeds 2.0% (5.0% or more)
 As Built Desc: 5.4% cross slope
 Solution: Demolish existing and construct new route
 Bar. Severity: 1 Necessary Cost Estimate: \$10,125.00 Status:
 Implementation Priority: 1 Facility Function:
 Implementation Phase: Implementation Date:
 Official Responsible:

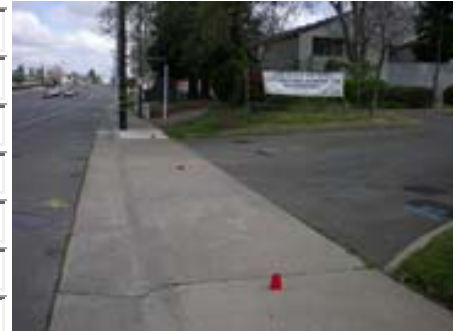
Field Date: 3/28/2011 Report Date: 3/28/2011 Barrier #: 6277
 Location: Sunrise Blvd - East
 X Coordinate: -121.2717
 Y Coordinate: 38.70232
 Barrier Area: Sidewalks
 Barrier Type: Cross Slope - Existing (4.1% to 4.9%)
 Code Ref: CBC 1133B.7.1.3 and ADA/ABA 403.3

As Built Meas: 44 Quantity: LF
 Description: Cross slope exceeds 2.0% (4.1% to 4.9%)
 As Built Desc: 4.4% cross slope
 Solution: Demolish existing and construct new route
 Bar. Severity: 2 Recommended Cost Estimate: \$5,500.00 Status:
 Implementation Priority: 1 Facility Function:
 Implementation Phase: Implementation Date:
 Official Responsible:

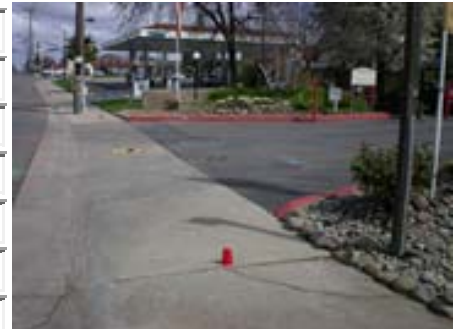
Field Date: 3/28/2011 Report Date: 3/28/2011 Barrier #: 6278
 Location: Sunrise Blvd - East
 X Coordinate: -121.2717
 Y Coordinate: 38.70301
 Barrier Area: Sidewalks
 Barrier Type: Driveway - Existing (4.1% to 4.9%)
 Code Ref: CBC 1133B.7.1.3 and ADA/ABA 403.3

As Built Meas: 52 Quantity: LF
 Description: Driveway cross slope exceeds 2.0% (4.1% to 4.9%)
 As Built Desc: 4.5% cross slope
 Solution: Provide min. 48" wide level walkway through driveway
 Bar. Severity: 3 Hinderance Cost Estimate: \$6,500.00 Status:
 Implementation Priority: 1 Facility Function:
 Implementation Phase: Implementation Date:
 Official Responsible:

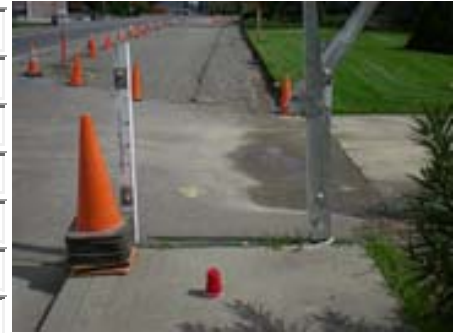
Field Date: 3/28/2011 Report Date: 3/28/2011 Barrier #: 6279
 Location: Old Auburn Rd - South
 X Coordinate: -121.27077
 Y Coordinate: 38.7043
 Barrier Area: Sidewalks
 Barrier Type: No Sidewalk - No Barricade
 Code Ref: MUTCD Section 6D.01

As Built Meas: 1 Quantity: JOB
 Description: No barricade provided where sidewalk ends in hazardous location
 As Built Desc: No barricade or other warning provided for the visually impaired at end of sidewalk
 Solution: Provide barricade with cane detectable warning at end of sidewalk
 Bar. Severity: 1 Necessary Cost Estimate: \$1,350.00 Status:
 Implementation Priority: 1 Facility Function:
 Implementation Phase: Implementation Date:
 Official Responsible:

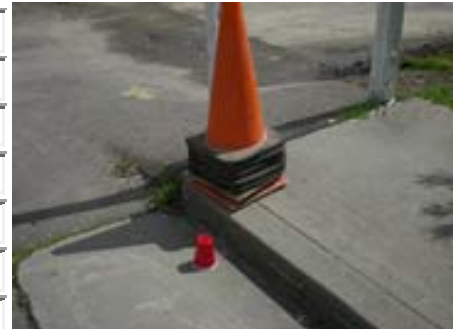
Field Date: 3/28/2011 Report Date: 3/28/2011 Barrier #: 6280
 Location: Old Auburn Rd - South
 X Coordinate: -121.27078
 Y Coordinate: 38.70431
 Barrier Area: Sidewalks
 Barrier Type: No Sidewalk - Transition to Shoulder
 Code Ref: CBC 1121B.2 and ADA/ABA 206.2.1

As Built Meas: 1 Quantity: JOB
 Description: Sidewalk ends and no ramp to pedestrian shoulder is provided
 As Built Desc: No ramp to shoulder to enable pedestrian travel onto existing shoulder
 Solution: Provide transition ramp to paved shoulder where no opposite sidewalk exists
 Bar. Severity: 1 Necessary Cost Estimate: \$2,500.00 Status:
 Implementation Priority: 1 Facility Function:
 Implementation Phase: Implementation Date:
 Official Responsible:

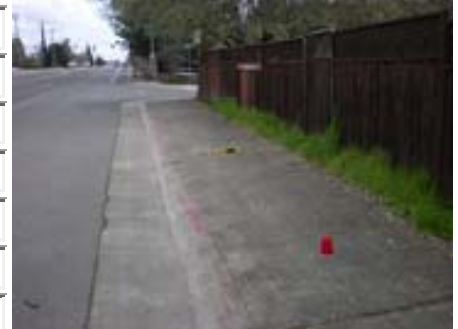
Field Date: 3/28/2011 Report Date: 3/28/2011 Barrier #: 6281
 Location: Old Auburn Rd - South
 X Coordinate: -121.26886
 Y Coordinate: 38.70526
 Barrier Area: Sidewalks
 Barrier Type: Cross Slope - Existing (3.1% to 4.0%)
 Code Ref: CBC 1133B.7.1.3 and ADA/ABA 403.3

As Built Meas: 55 Quantity: LF
 Description: Cross slope exceeds 2.0% (3.1% to 4.0%)
 As Built Desc: 3.3% cross slope
 Solution: Demolish existing and construct new route
 Bar. Severity: 3 Hindrance Cost Estimate: \$6,875.00 Status:
 Implementation Priority: 1 Facility Function:
 Implementation Phase: Implementation Date:
 Official Responsible:

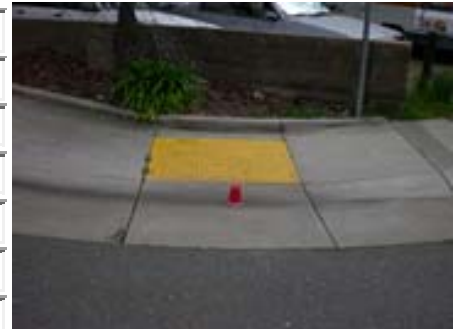
Field Date: 3/28/2011 Report Date: 3/28/2011 Barrier #: 6282A
 Location: Old Auburn Rd and Soquel Wy - Corner C
 X Coordinate: -121.26853
 Y Coordinate: 38.70539
 Barrier Area: Curb Ramps
 Barrier Type: 12" Grooves - Existing (3.1% to 4.0%)
 Code Ref: CBC 1127B.5.6

As Built Meas: 1 Quantity: EACH
 Description: 12" grooves at top of curb ramp are not level (3.1% to 4.0%)
 As Built Desc: 3.7% at 12" grooves
 Solution: Demolish existing and construct new curb ramp
 Bar. Severity: 3 Hindrance Cost Estimate: \$2,500.00 Status:
 Implementation Priority: 1 Facility Function:
 Implementation Phase: Implementation Date:
 Official Responsible:

Notes: Two - way intersection corners C,D. Corner D compliant

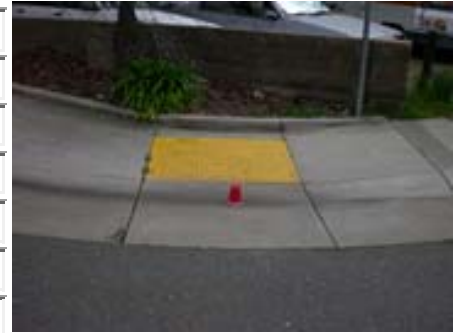
Field Date: 3/28/2011 Report Date: 3/28/2011 Barrier #: 6282B
 Location: Old Auburn Rd and Soquel Wy - Corner C
 X Coordinate: -121.26853
 Y Coordinate: 38.70539
 Barrier Area: Curb Ramps
 Barrier Type: Perpendicular Ramp Landing (3.1% to 4.0%)
 Code Ref: CBC 1127B.5.4 and ADA/ABA 406.4

As Built Meas: 1 Quantity: EACH
 Description: Curb ramp top landing not level (3.1% to 4.0%)
 As Built Desc: 4.0% landing slope
 Solution: Demolish existing and construct new transition
 Bar. Severity: 3 Hindrance Cost Estimate: \$250.00 Status:
 Implementation Priority: 1 Facility Function:
 Implementation Phase: Implementation Date:
 Official Responsible:

Notes: Two - way intersection corners C,D. Corner D compliant

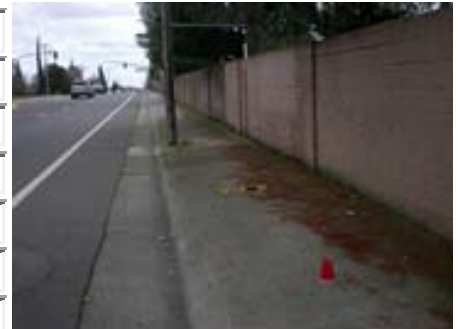
Field Date: 3/28/2011 Report Date: 3/28/2011 Barrier #: 6283
 Location: Old Auburn Rd - South
 X Coordinate: -121.26845
 Y Coordinate: 38.70543
 Barrier Area: Sidewalks
 Barrier Type: Cross Slope - Existing (3.1% to 4.0%)
 Code Ref: CBC 1133B.7.1.3 and ADA/ABA 403.3

As Built Meas: 272 Quantity: LF
 Description: Cross slope exceeds 2.0% (3.1% to 4.0%)
 As Built Desc: 4.0% cross slope
 Solution: Demolish existing and construct new route
 Bar. Severity: 3 Hinderance Cost Estimate: \$34,000.00 Status:
 Implementation Priority: 1 Facility Function:
 Implementation Phase: Implementation Date:
 Official Responsible:

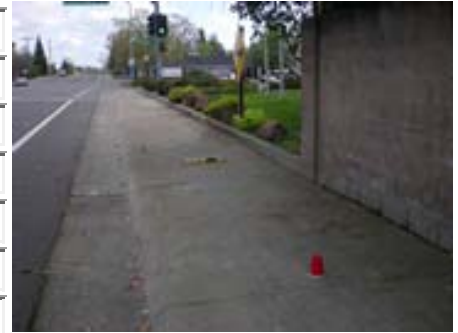
Field Date: 3/28/2011 Report Date: 3/28/2011 Barrier #: 6284
 Location: Old Auburn Rd - South
 X Coordinate: -121.26753
 Y Coordinate: 38.70583
 Barrier Area: Sidewalks
 Barrier Type: Cross Slope - Existing (4.1% to 4.9%)
 Code Ref: CBC 1133B.7.1.3 and ADA/ABA 403.3

As Built Meas: 71 Quantity: LF
 Description: Cross slope exceeds 2.0% (4.1% to 4.9%)
 As Built Desc: 4.2% cross slope
 Solution: Demolish existing and construct new route
 Bar. Severity: 2 Recommended Cost Estimate: \$8,875.00 Status:
 Implementation Priority: 1 Facility Function:
 Implementation Phase: Implementation Date:
 Official Responsible:

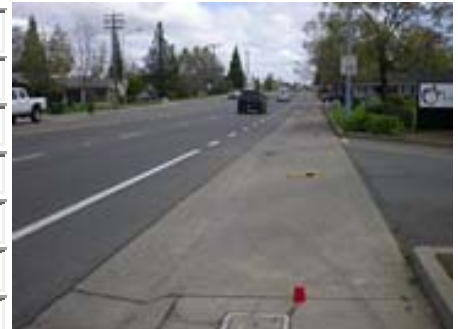
Field Date: 3/28/2011 Report Date: 3/28/2011 Barrier #: 6285
 Location: Old Auburn Rd - South
 X Coordinate: -121.26709
 Y Coordinate: 38.70602
 Barrier Area: Sidewalks
 Barrier Type: Cross Slope - Existing (5.0% or more)
 Code Ref: CBC 1133B.7.1.3 and ADA/ABA 403.3

As Built Meas: 47 Quantity: LF
 Description: Cross slope exceeds 2.0% (5.0% or more)
 As Built Desc: 6.0% cross slope
 Solution: Demolish existing and construct new route
 Bar. Severity: 1 Necessary Cost Estimate: \$5,875.00 Status:
 Implementation Priority: 1 Facility Function:
 Implementation Phase: Implementation Date:
 Official Responsible:

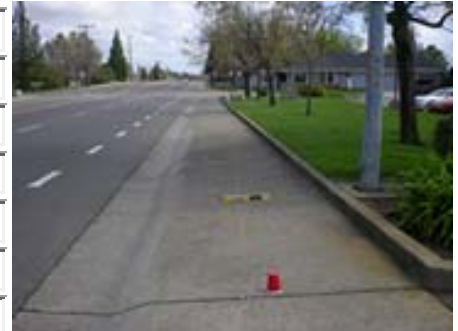
Field Date: 3/28/2011 Report Date: 3/28/2011 Barrier #: 6286
 Location: Old Auburn Rd - South
 X Coordinate: -121.26699
 Y Coordinate: 38.70606
 Barrier Area: Sidewalks
 Barrier Type: Cross Slope - Existing (3.1% to 4.0%)
 Code Ref: CBC 1133B.7.1.3 and ADA/ABA 403.3

As Built Meas: 151 Quantity: LF
 Description: Cross slope exceeds 2.0% (3.1% to 4.0%)
 As Built Desc: 3.5% cross slope
 Solution: Demolish existing and construct new route
 Bar. Severity: 3 Hinderance Cost Estimate: \$18,875.00 Status:
 Implementation Priority: 1 Facility Function:
 Implementation Phase: Implementation Date:
 Official Responsible:

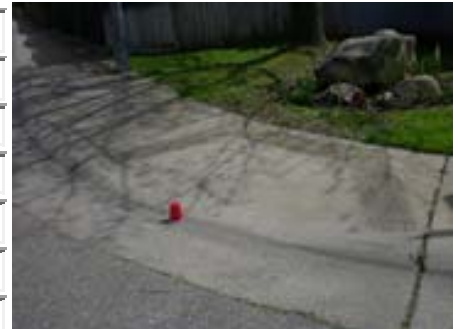
Field Date: 3/28/2011 Report Date: 3/28/2011 Barrier #: 6287
 Location: Old Auburn Rd and Glenn Tree Dr - Corner C
 X Coordinate: -121.26633
 Y Coordinate: 38.70633
 Barrier Area: Curb Ramps
 Barrier Type: No Curb Ramp - Depressed Existing Curb
 Code Ref: CBC 1127B.5.1 and ADA/ABA 402.2

As Built Meas: 1 Quantity: EACH
 Description: No compliant curb cut at corner (intersection)
 As Built Desc: 11.7% running slope at depressed area
 Solution: Demolish existing and construct curb cut
 Bar. Severity: 1 Necessary Cost Estimate: \$2,500.00 Status:
 Implementation Priority: 1 Facility Function:
 Implementation Phase: Implementation Date:
 Official Responsible:

Notes: Two - way intersection corners C,D

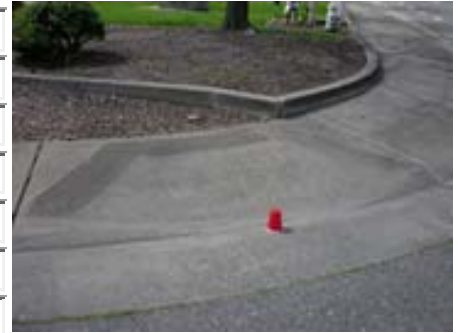
Field Date: 3/28/2011 Report Date: 3/28/2011 Barrier #: 6288
 Location: Old Auburn Rd and Glenn Tree Dr - Corner D
 X Coordinate: -121.2665
 Y Coordinate: 38.70625
 Barrier Area: Curb Ramps
 Barrier Type: No Curb Ramp - Depressed Existing Curb
 Code Ref: CBC 1127B.5.1 and ADA/ABA 402.2

As Built Meas: 1 Quantity: EACH
 Description: No compliant curb cut at corner (intersection)
 As Built Desc: 8.6% running slope at depressed area
 Solution: Demolish existing and construct curb cut
 Bar. Severity: 1 Necessary Cost Estimate: \$2,500.00 Status:
 Implementation Priority: 1 Facility Function:
 Implementation Phase: Implementation Date:
 Official Responsible:

Notes: Two - way intersection corners C,D

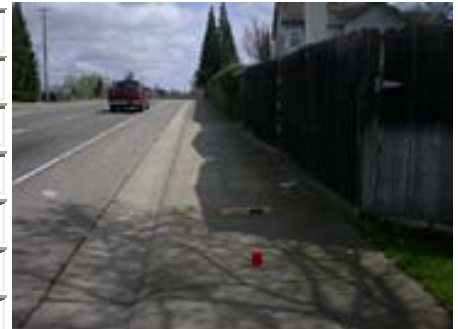
Field Date: 3/28/2011 Report Date: 3/28/2011 Barrier #: 6289
 Location: Old Auburn Rd - South
 X Coordinate: -121.26628
 Y Coordinate: 38.70633
 Barrier Area: Sidewalks
 Barrier Type: Cross Slope - Existing (3.1% to 4.0%)
 Code Ref: CBC 1133B.7.1.3 and ADA/ABA 403.3

As Built Meas: 156 Quantity: LF
 Description: Cross slope exceeds 2.0% (3.1% to 4.0%)
 As Built Desc: 4.0% cross slope
 Solution: Demolish existing and construct new route
 Bar. Severity: 3 Hinderance Cost Estimate: \$19,500.00 Status:
 Implementation Priority: 1 Facility Function:
 Implementation Phase: Implementation Date:
 Official Responsible:

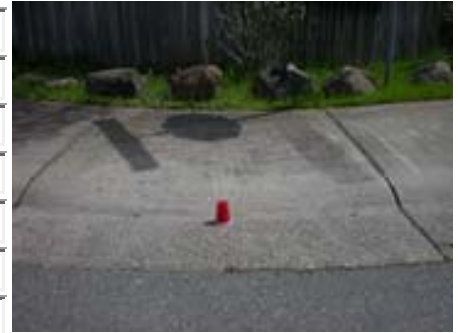
Field Date: 3/28/2011 Report Date: 3/28/2011 Barrier #: 6290
 Location: Old Auburn Rd and Chipmunk Wy - Corner C
 X Coordinate: -121.26492
 Y Coordinate: 38.70689
 Barrier Area: Curb Ramps
 Barrier Type: No Curb Ramp - Depressed Existing Curb
 Code Ref: CBC 1127B.5.1 and ADA/ABA 402.2

As Built Meas: 1 Quantity: EACH
 Description: No compliant curb cut at corner (intersection)
 As Built Desc: 8.3% running slope at depressed area
 Solution: Demolish existing and construct curb cut
 Bar. Severity: 1 Necessary Cost Estimate: \$2,500.00 Status:
 Implementation Priority: 1 Facility Function:
 Implementation Phase: Implementation Date:
 Official Responsible:

Notes: Two - way intersection corners C,D

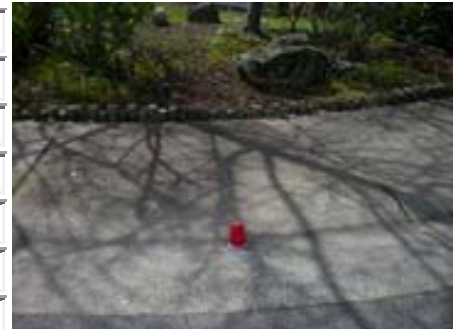
Field Date: 3/28/2011 Report Date: 3/28/2011 Barrier #: 6291
 Location: Old Auburn Rd and Chipmunk Wy - Corner D
 X Coordinate: -121.26507
 Y Coordinate: 38.70683
 Barrier Area: Curb Ramps
 Barrier Type: No Curb Ramp - Depressed Existing Curb
 Code Ref: CBC 1127B.5.1 and ADA/ABA 402.2

As Built Meas: 1 Quantity: EACH
 Description: No compliant curb cut at corner (intersection)
 As Built Desc: 8.3% running slope at depressed area
 Solution: Demolish existing and construct curb cut
 Bar. Severity: 1 Necessary Cost Estimate: \$2,500.00 Status:
 Implementation Priority: 1 Facility Function:
 Implementation Phase: Implementation Date:
 Official Responsible:

Notes: Two - way intersection corners C,D

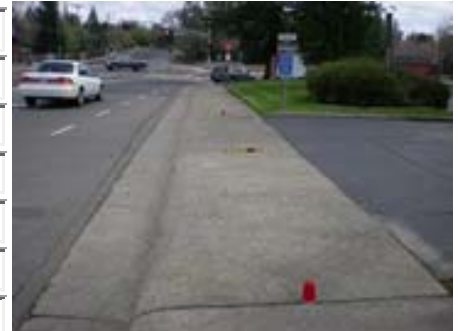
Field Date: 3/28/2011 Report Date: 3/28/2011 Barrier #: 6294
 Location: Old Auburn Rd - South
 X Coordinate: -121.26341
 Y Coordinate: 38.7075
 Barrier Area: Sidewalks
 Barrier Type: Cross Slope - Existing (4.1% to 4.9%)
 Code Ref: CBC 1133B.7.1.3 and ADA/ABA 403.3

As Built Meas: 38 Quantity: LF
 Description: Cross slope exceeds 2.0% (4.1% to 4.9%)
 As Built Desc: 4.6% cross slope
 Solution: Demolish existing and construct new route
 Bar. Severity: 2 Recommended Cost Estimate: \$4,750.00 Status:
 Implementation Priority: 1 Facility Function:
 Implementation Phase: Implementation Date:
 Official Responsible:

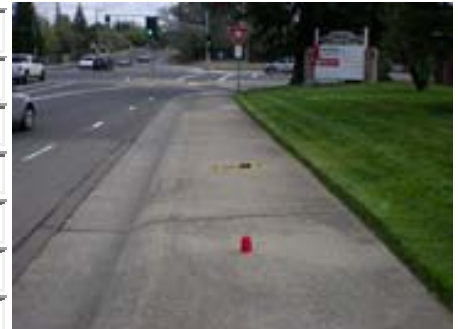
Field Date: 3/28/2011 Report Date: 3/28/2011 Barrier #: 6295
 Location: Old Auburn Rd - South
 X Coordinate: -121.26336
 Y Coordinate: 38.70753
 Barrier Area: Sidewalks
 Barrier Type: Cross Slope - Existing (3.1% to 4.0%)
 Code Ref: CBC 1133B.7.1.3 and ADA/ABA 403.3

As Built Meas: 73 Quantity: LF
 Description: Cross slope exceeds 2.0% (3.1% to 4.0%)
 As Built Desc: 3.4% cross slope
 Solution: Demolish existing and construct new route
 Bar. Severity: 3 Hinderance Cost Estimate: \$9,125.00 Status:
 Implementation Priority: 1 Facility Function:
 Implementation Phase: Implementation Date:
 Official Responsible:

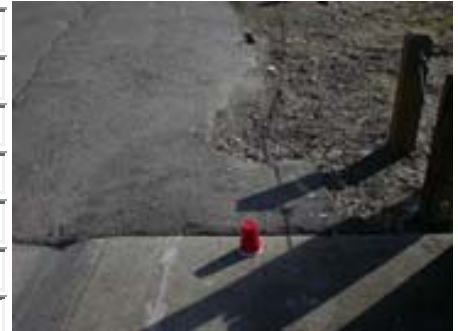
Field Date: 3/29/2011 Report Date: 3/29/2011 Barrier #: 6296
 Location: Old Auburn Rd - South
 X Coordinate: -121.26264
 Y Coordinate: 38.70785
 Barrier Area: Sidewalks
 Barrier Type: No Sidewalk - Transition to Shoulder
 Code Ref: CBC 1121B.2 and ADA/ABA 206.2.1

As Built Meas: 1 Quantity: JOB
 Description: Sidewalk ends and no ramp to pedestrian shoulder is provided
 As Built Desc: No ramp to shoulder to enable pedestrian travel onto existing shoulder
 Solution: Provide transition ramp to paved shoulder where no opposite sidewalk exists
 Bar. Severity: 1 Necessary Cost Estimate: \$2,500.00 Status:
 Implementation Priority: 1 Facility Function:
 Implementation Phase: Implementation Date:
 Official Responsible:

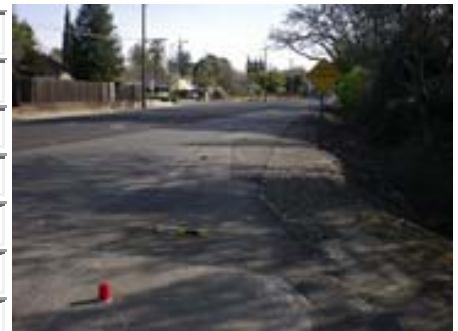
Field Date: 3/29/2011 Report Date: 3/29/2011 Barrier #: 6297
 Location: Old Auburn Rd - South
 X Coordinate: -121.26256
 Y Coordinate: 38.70796
 Barrier Area: Sidewalks
 Barrier Type: Shoulder Cross Slope - Existing (2.1% to 3.0%)
 Code Ref: CBC 1133B.7.1.3 and ADA/ABA 403.3

As Built Meas: 427 Quantity: LF
 Description: Cross slope exceeds 2.0% (2.1% to 3.0%)
 As Built Desc: 3.0% cross slope
 Solution: Low severity barrier - no remediation recommended
 Bar. Severity: 4 Low Severity Cost Estimate: \$0.00 Status:
 Implementation Priority: 1 Facility Function:
 Implementation Phase: Implementation Date:
 Official Responsible:

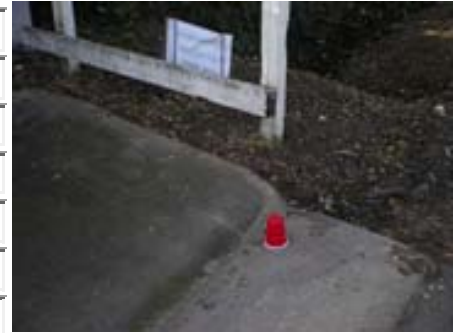
Field Date: 3/29/2011 Report Date: 3/29/2011 Barrier #: 6298
 Location: Old Auburn Rd - South
 X Coordinate: -121.26131
 Y Coordinate: 38.70844
 Barrier Area: Sidewalks
 Barrier Type: No Sidewalk - Transition to Shoulder
 Code Ref: CBC 1121B.2 and ADA/ABA 206.2.1

As Built Meas: 1 Quantity: JOB
 Description: Sidewalk ends and no ramp to pedestrian shoulder is provided
 As Built Desc: No ramp to shoulder to enable pedestrian travel onto existing shoulder
 Solution: Provide transition ramp to paved shoulder where no opposite sidewalk exists
 Bar. Severity: 1 Necessary Cost Estimate: \$2,500.00 Status:
 Implementation Priority: 1 Facility Function:
 Implementation Phase: Implementation Date:
 Official Responsible:

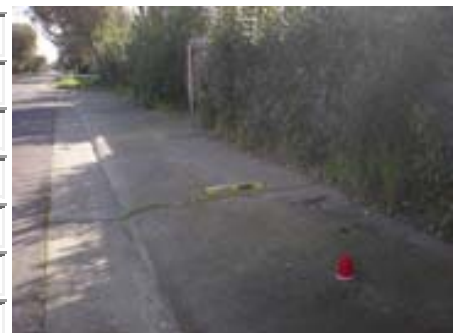
Field Date: 3/29/2011 Report Date: 3/29/2011 Barrier #: 6299
 Location: Old Auburn Rd - South
 X Coordinate: -121.26127
 Y Coordinate: 38.70848
 Barrier Area: Sidewalks
 Barrier Type: Cross Slope - Existing (3.1% to 4.0%)
 Code Ref: CBC 1133B.7.1.3 and ADA/ABA 403.3

As Built Meas: 104 Quantity: LF
 Description: Cross slope exceeds 2.0% (3.1% to 4.0%)
 As Built Desc: 3.4% cross slope
 Solution: Demolish existing and construct new route
 Bar. Severity: 3 Hinderance Cost Estimate: \$13,000.00 Status:
 Implementation Priority: 1 Facility Function:
 Implementation Phase: Implementation Date:
 Official Responsible:

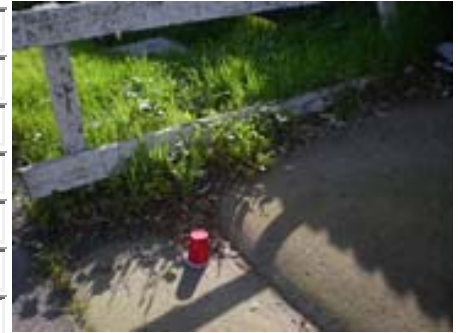
Field Date: 3/29/2011 Report Date: 3/29/2011 Barrier #: 6300
 Location: Old Auburn Rd - South
 X Coordinate: -121.26102
 Y Coordinate: 38.70857
 Barrier Area: Sidewalks
 Barrier Type: No Sidewalk - Transition to Shoulder
 Code Ref: CBC 1121B.2 and ADA/ABA 206.2.1

As Built Meas: 1 Quantity: JOB
 Description: Sidewalk ends and no ramp to pedestrian shoulder is provided
 As Built Desc: No ramp to shoulder to enable pedestrian travel onto existing shoulder
 Solution: Provide transition ramp to paved shoulder where no opposite sidewalk exists
 Bar. Severity: 1 Necessary Cost Estimate: \$2,500.00 Status:
 Implementation Priority: 1 Facility Function:
 Implementation Phase: Implementation Date:
 Official Responsible:

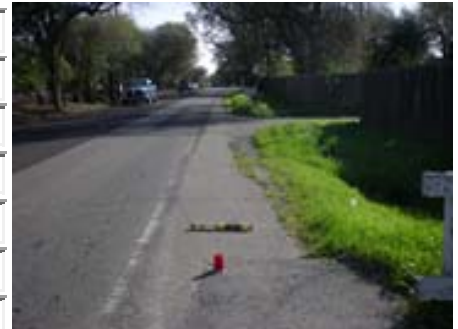
Field Date: 3/29/2011 Report Date: 3/29/2011 Barrier #: 6301A
 Location: Old Auburn Rd - South
 X Coordinate: -121.26098
 Y Coordinate: 38.70861
 Barrier Area: Sidewalks
 Barrier Type: Shoulder Clear Width - Existing ($\leq 31''$ or less)
 Code Ref: CBC 1133B.7.1

As Built Meas: 1 Quantity: LF
 Description: Pedestrian route is not min. 48" wide ($\leq 31''$ or less)
 As Built Desc: 24" clear width due to foliage
 Solution: Trim foliage to provide min. 48" clear width
 Bar. Severity: 1 Necessary Cost Estimate: \$125.00 Status:
 Implementation Priority: 1 Facility Function:
 Implementation Phase: Implementation Date:
 Official Responsible:

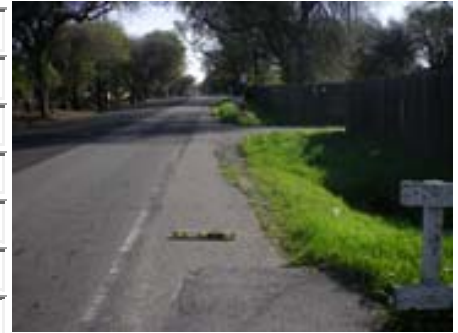
Field Date: 3/29/2011 Report Date: 3/29/2011 Barrier #: 6301B
 Location: Old Auburn Rd - South
 X Coordinate: -121.26098
 Y Coordinate: 38.70861
 Barrier Area: Sidewalks
 Barrier Type: Shoulder Cross Slope - Existing (5.0% or more)
 Code Ref: CBC 1133B.7.1.3 and ADA/ABA 403.3

As Built Meas: 185 Quantity: LF
 Description: Cross slope exceeds 2.0% (5.0% or more)
 As Built Desc: 5.0% cross slope
 Solution: Demolish existing and construct new pedestrian route
 Bar. Severity: 1 Necessary Cost Estimate: \$23,125.00 Status:
 Implementation Priority: 1 Facility Function:
 Implementation Phase: Implementation Date:
 Official Responsible:

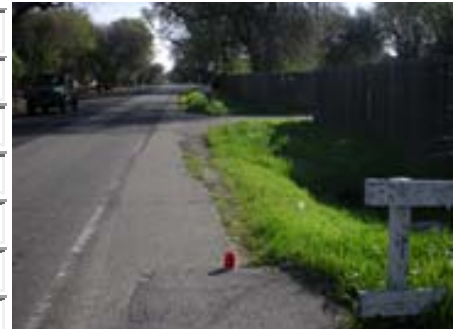
Field Date: 3/29/2011 Report Date: 3/29/2011 Barrier #: 6301C
 Location: Old Auburn Rd - South
 X Coordinate: -121.26098
 Y Coordinate: 38.70861
 Barrier Area: Sidewalks
 Barrier Type: Drop-off Along Ped Route (> 4")
 Code Ref: CBC 1133B.8.1

As Built Meas: 50 Quantity: LF
 Description: Drop of more than 4" along pedestrian route lacks warning curb
 As Built Desc: 3" drop off creates hazardous condition for the visually impaired
 Solution: Provide curb projecting at least 6" above the walk or sidewalk surface to warn the blind of a potent
 Bar. Severity: 1 Necessary Cost Estimate: \$8,750.00 Status:
 Implementation Priority: 1 Facility Function:
 Implementation Phase: Implementation Date:
 Official Responsible:

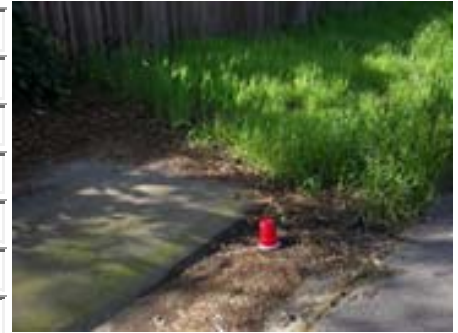
Field Date: 3/29/2011 Report Date: 3/29/2011 Barrier #: 6302
 Location: Old Auburn Rd - South
 X Coordinate: -121.26041
 Y Coordinate: 38.70883
 Barrier Area: Sidewalks
 Barrier Type: No Sidewalk - Transition to Shoulder
 Code Ref: CBC 1121B.2 and ADA/ABA 206.2.1

As Built Meas: 1 Quantity: JOB
 Description: Sidewalk ends and no ramp to pedestrian shoulder is provided
 As Built Desc: No ramp to shoulder to enable pedestrian travel onto existing shoulder
 Solution: Provide transition ramp to paved shoulder where no opposite sidewalk exists
 Bar. Severity: 1 Necessary Cost Estimate: \$2,500.00 Status:
 Implementation Priority: 1 Facility Function:
 Implementation Phase: Implementation Date:
 Official Responsible:

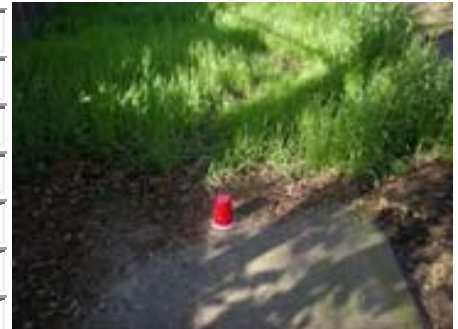
Field Date: 3/29/2011 Report Date: 3/29/2011 Barrier #: 6303
 Location: Old Auburn Rd - South
 X Coordinate: -121.26038
 Y Coordinate: 38.70883
 Barrier Area: Sidewalks
 Barrier Type: No Sidewalk - No Barricade
 Code Ref: MUTCD Section 6D.01

As Built Meas: 1 Quantity: JOB
 Description: No barricade provided where sidewalk ends in hazardous location
 As Built Desc: No barricade or other warning provided for the visually impaired at end of sidewalk
 Solution: Provide barricade with cane detectable warning at end of sidewalk
 Bar. Severity: 1 Necessary Cost Estimate: \$1,350.00 Status:
 Implementation Priority: 1 Facility Function:
 Implementation Phase: Implementation Date:
 Official Responsible:

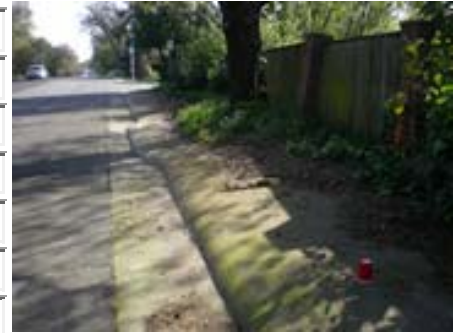
Field Date: 3/29/2011 Report Date: 3/29/2011 Barrier #: 6304
 Location: Old Auburn Rd - South
 X Coordinate: -121.26036
 Y Coordinate: 38.70887
 Barrier Area: Sidewalks
 Barrier Type: Cross Slope - Existing (3.1% to 4.0%)
 Code Ref: CBC 1133B.7.1.3 and ADA/ABA 403.3

As Built Meas: 93 Quantity: LF
 Description: Cross slope exceeds 2.0% (3.1% to 4.0%)
 As Built Desc: 3.8% cross slope
 Solution: Demolish existing and construct new route
 Bar. Severity: 3 Hinderance Cost Estimate: \$11,625.00 Status:
 Implementation Priority: 1 Facility Function:
 Implementation Phase: Implementation Date:
 Official Responsible:

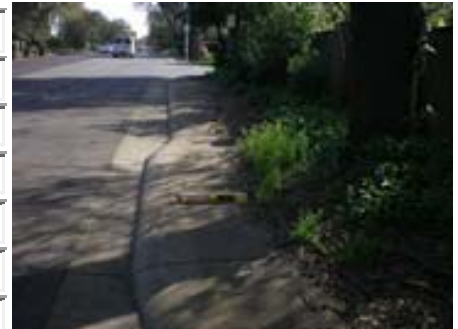
Field Date: 3/29/2011 Report Date: 3/29/2011 Barrier #: 6305
 Location: Old Auburn Rd - South
 X Coordinate: -121.26029
 Y Coordinate: 38.70895
 Barrier Area: Sidewalks
 Barrier Type: Clear Width - Existing ($\leq 31''$ or less)
 Code Ref: CBC 1133B.7.1

As Built Meas: 1 Quantity: LF
 Description: Pedestrian route is not min. 48" wide ($\leq 31''$ or less)
 As Built Desc: 24" clear width due to foliage
 Solution: Trim foliage to provide min. 48" clear width
 Bar. Severity: 1 Necessary Cost Estimate: \$125.00 Status:
 Implementation Priority: 1 Facility Function:
 Implementation Phase: Implementation Date:
 Official Responsible:

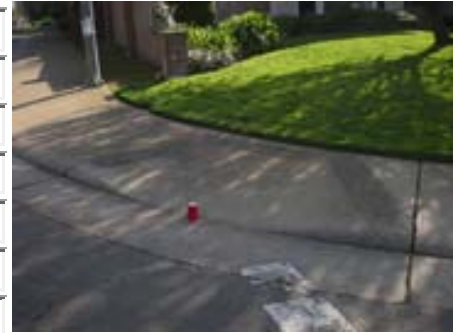
Field Date: 3/29/2011 Report Date: 3/29/2011 Barrier #: 6306
 Location: Old Auburn Rd and Auburn Woods Dr - Corner C
 X Coordinate: -121.25988
 Y Coordinate: 38.70904
 Barrier Area: Curb Ramps
 Barrier Type: No Curb Ramp - Depressed Existing Curb
 Code Ref: CBC 1127B.5.1 and ADA/ABA 402.2

As Built Meas: 1 Quantity: EACH
 Description: No compliant curb cut at corner (intersection)
 As Built Desc: 7.5% running slope at depressed area
 Solution: Demolish existing and construct curb cut
 Bar. Severity: 1 Necessary Cost Estimate: \$2,500.00 Status:
 Implementation Priority: 1 Facility Function:
 Implementation Phase: Implementation Date:
 Official Responsible:

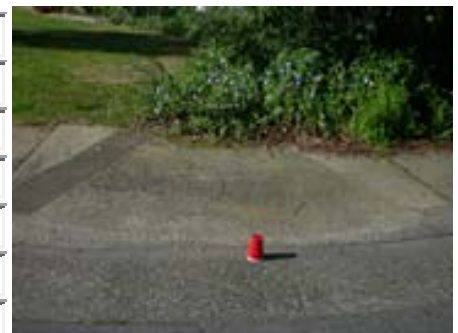
Field Date: 3/29/2011 Report Date: 3/29/2011 Barrier #: 6307
 Location: Old Auburn Rd and Auburn Woods Dr - Corner D
 X Coordinate: -121.26001
 Y Coordinate: 38.70898
 Barrier Area: Curb Ramps
 Barrier Type: No Curb Ramp - Depressed Existing Curb
 Code Ref: CBC 1127B.5.1 and ADA/ABA 402.2

As Built Meas: 1 Quantity: EACH
 Description: No compliant curb cut at corner (intersection)
 As Built Desc: 8.5% running slope at depressed area
 Solution: Demolish existing and construct curb cut
 Bar. Severity: 1 Necessary Cost Estimate: \$2,500.00 Status:
 Implementation Priority: 1 Facility Function:
 Implementation Phase: Implementation Date:
 Official Responsible:

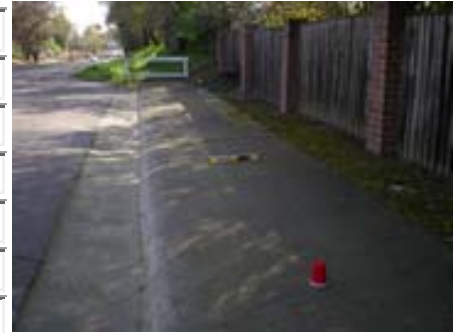
Field Date: 3/29/2011 Report Date: 3/29/2011 Barrier #: 6308
 Location: Old Auburn Rd - South
 X Coordinate: -121.25964
 Y Coordinate: 38.70914
 Barrier Area: Sidewalks
 Barrier Type: Cross Slope - Existing (3.1% to 4.0%)
 Code Ref: CBC 1133B.7.1.3 and ADA/ABA 403.3

As Built Meas: 56 Quantity: LF
 Description: Cross slope exceeds 2.0% (3.1% to 4.0%)
 As Built Desc: 3.8% cross slope
 Solution: Demolish existing and construct new route
 Bar. Severity: 3 Hinderance Cost Estimate: \$7,000.00 Status:
 Implementation Priority: 1 Facility Function:
 Implementation Phase: Implementation Date:
 Official Responsible:

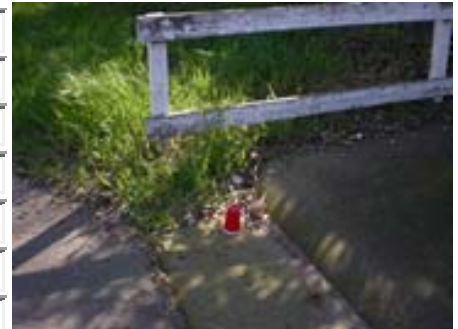
Field Date: 3/29/2011 Report Date: 3/29/2011 Barrier #: 6309
 Location: Old Auburn Rd - South
 X Coordinate: -121.2595
 Y Coordinate: 38.70919
 Barrier Area: Sidewalks
 Barrier Type: No Sidewalk - Transition to Shoulder
 Code Ref: CBC 1121B.2 and ADA/ABA 206.2.1

As Built Meas: 1 Quantity: JOB
 Description: Sidewalk ends and no ramp to pedestrian shoulder is provided
 As Built Desc: No ramp to shoulder to enable pedestrian travel onto existing shoulder
 Solution: Provide transition ramp to paved shoulder where no opposite sidewalk exists
 Bar. Severity: 1 Necessary Cost Estimate: \$2,500.00 Status:
 Implementation Priority: 1 Facility Function:
 Implementation Phase: Implementation Date:
 Official Responsible:

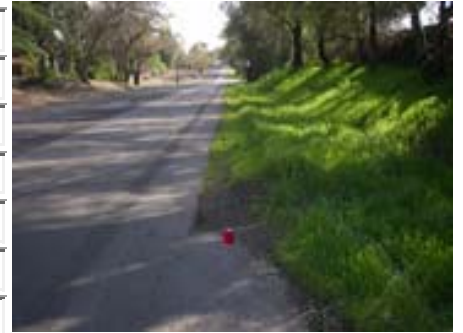
Field Date: 3/29/2011 Report Date: 3/29/2011 Barrier #: 6310
 Location: Old Auburn Rd - South
 X Coordinate: -121.25945
 Y Coordinate: 38.70926
 Barrier Area: Sidewalks
 Barrier Type: No sidewalk
 Code Ref: CBC 1127B.1 and ADA/ABA 206.2.1

As Built Meas: 433 Quantity: LF
 Description: No pedestrian route provided
 As Built Desc: No sidewalk provided
 Solution: Construct new firm and stable pedestrian route
 Bar. Severity: 1 Necessary Cost Estimate: \$43,300.00 Status:
 Implementation Priority: 1 Facility Function:
 Implementation Phase: Implementation Date:
 Official Responsible:

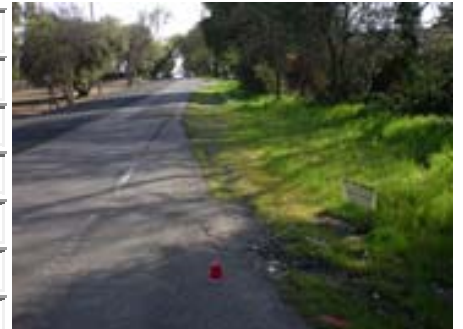
Field Date: 3/29/2011 Report Date: 3/29/2011 Barrier #: 6311
 Location: Old Auburn Rd - South
 X Coordinate: -121.25767
 Y Coordinate: 38.71005
 Barrier Area: Sidewalks
 Barrier Type: No sidewalk
 Code Ref: CBC 1127B.1 and ADA/ABA 206.2.1

As Built Meas: 259 Quantity: LF
 Description: No pedestrian route provided
 As Built Desc: No sidewalk provided
 Solution: Construct new firm and stable pedestrian route
 Bar. Severity: 1 Necessary Cost Estimate: \$25,900.00 Status:
 Implementation Priority: 1 Facility Function:
 Implementation Phase: Implementation Date:
 Official Responsible:
