**DRAFT ADA TRANSITION PLAN UPDATE
NEIGHBORHOOD AREA 8 CHASE
SEPTEMBER 20, 2011**

CITY OF CITRUS HEIGHTS

Conditions - CHASE Area 8

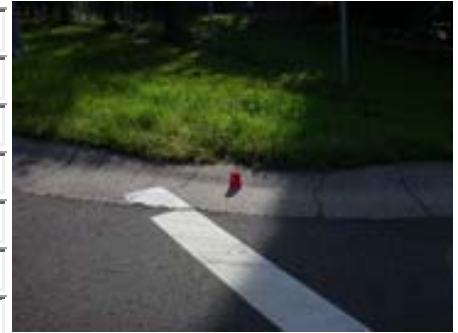
Field Date: 3/29/2011 Report Date: 3/29/2011 Barrier #: 6312
 Location: Old Auburn Rd and Daffodil Wy - Corner C
 X Coordinate: -121.25683
 Y Coordinate: 38.71036
 Barrier Area: Blended Transitions
 Barrier Type: Detectable Warnings - Truncated Domes
 Code Ref: CBC 1127B.5.3

As Built Meas: 1 Quantity: EACH
 Description: No truncated domes provided at transition into roadway
 As Built Desc: No detectable warning provided
 Solution: Provide compliant truncated domes
 Bar. Severity: 2 Recommended Cost Estimate: \$1,400.00 Status:
 Implementation Priority: 1 Facility Function:
 Implementation Phase: Implementation Date:
 Official Responsible:

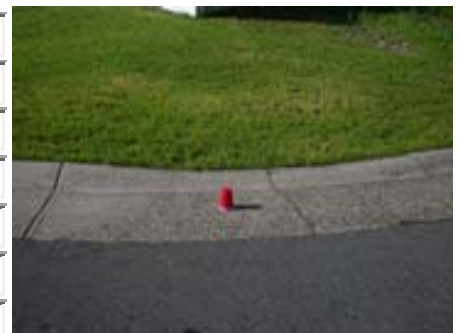
Field Date: 3/29/2011 Report Date: 3/29/2011 Barrier #: 6313
 Location: Old Auburn Rd and Daffodil Wy - Corner D
 X Coordinate: -121.25695
 Y Coordinate: 38.7103
 Barrier Area: Blended Transitions
 Barrier Type: Detectable Warnings - Truncated Domes
 Code Ref: CBC 1127B.5.3

As Built Meas: 1 Quantity: EACH
 Description: No truncated domes provided at transition into roadway
 As Built Desc: No detectable warning provided
 Solution: Provide compliant truncated domes
 Bar. Severity: 2 Recommended Cost Estimate: \$1,400.00 Status:
 Implementation Priority: 1 Facility Function:
 Implementation Phase: Implementation Date:
 Official Responsible:

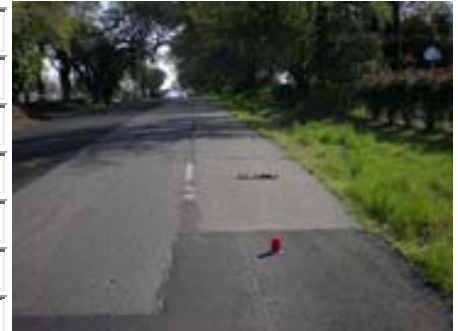
Field Date: 3/29/2011 Report Date: 3/29/2011 Barrier #: 6314
 Location: Old Auburn Rd - South
 X Coordinate: -121.25677
 Y Coordinate: 38.7104
 Barrier Area: Sidewalks
 Barrier Type: Shoulder Cross Slope - Existing (4.1% to 4.9%)
 Code Ref: CBC 1133B.7.1.3 and ADA/ABA 403.3

As Built Meas: 121 Quantity: LF
 Description: Cross slope exceeds 2.0% (4.1% to 4.9%)
 As Built Desc: 4.8% cross slope
 Solution: Demolish existing and construct new pedestrian route
 Bar. Severity: 2 Recommended Cost Estimate: \$15,125.00 Status:
 Implementation Priority: 1 Facility Function:
 Implementation Phase: Implementation Date:
 Official Responsible:

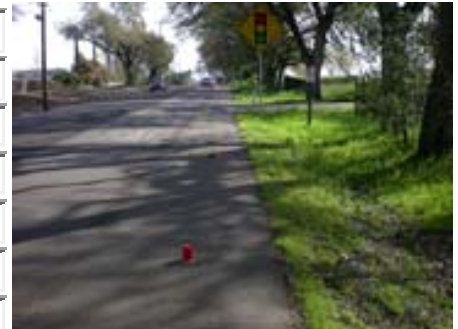
Field Date: 3/29/2011 Report Date: 3/29/2011 Barrier #: 6315
 Location: Old Auburn Rd - South
 X Coordinate: -121.2562
 Y Coordinate: 38.71069
 Barrier Area: Sidewalks
 Barrier Type: Shoulder Cross Slope - Existing (5.0% or more)
 Code Ref: CBC 1133B.7.1.3 and ADA/ABA 403.3

As Built Meas: 603 Quantity: LF
 Description: Cross slope exceeds 2.0% (5.0% or more)
 As Built Desc: 7.0% cross slope
 Solution: Demolish existing and construct new pedestrian route
 Bar. Severity: 1 Necessary Cost Estimate: \$75,375.00 Status:
 Implementation Priority: 1 Facility Function:
 Implementation Phase: Implementation Date:
 Official Responsible:

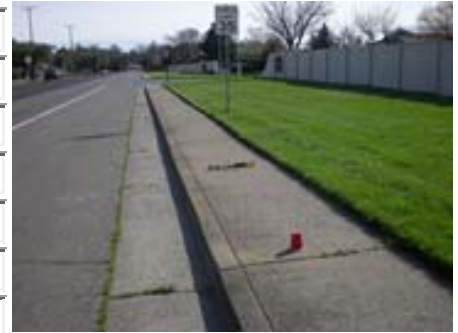
Field Date: 3/29/2011 Report Date: 3/29/2011 Barrier #: 6316
 Location: Old Auburn Rd - South
 X Coordinate: -121.25312
 Y Coordinate: 38.71208
 Barrier Area: Sidewalks
 Barrier Type: Cross Slope - Existing (3.1% to 4.0%)
 Code Ref: CBC 1133B.7.1.3 and ADA/ABA 403.3

As Built Meas: 129 Quantity: LF
 Description: Cross slope exceeds 2.0% (3.1% to 4.0%)
 As Built Desc: 3.7% cross slope
 Solution: Demolish existing and construct new route
 Bar. Severity: 3 Hinderance Cost Estimate: \$16,125.00 Status:
 Implementation Priority: 1 Facility Function:
 Implementation Phase: Implementation Date:
 Official Responsible:

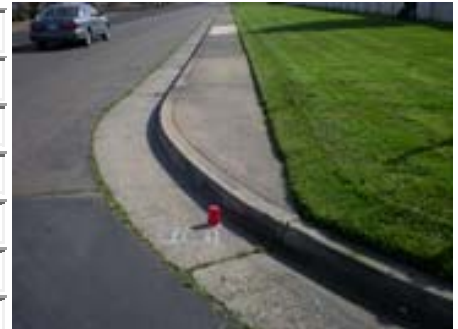
Field Date: 3/29/2011 Report Date: 3/29/2011 Barrier #: 6317
 Location: Old Auburn Rd and Big Oak Park Entrance - Corner C
 X Coordinate: -121.25254
 Y Coordinate: 38.71236
 Barrier Area: Curb Ramps
 Barrier Type: No Curb Ramp
 Code Ref: CBC 1127B.5.1 and ADA/ABA 402.2

As Built Meas: 1 Quantity: EACH
 Description: No curb cut at corner (intersection)
 As Built Desc: No curb ramp at corner
 Solution: Demolish existing and construct curb cut
 Bar. Severity: 1 Necessary Cost Estimate: \$2,500.00 Status:
 Implementation Priority: 1 Facility Function:
 Implementation Phase: Implementation Date:
 Official Responsible:

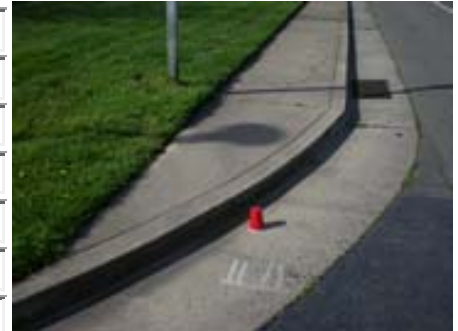
Field Date: 3/29/2011 Report Date: 3/29/2011 Barrier #: 6318
 Location: Old Auburn Rd and Big Oak Park Entrance - Corner D
 X Coordinate: -121.25279
 Y Coordinate: 38.71225
 Barrier Area: Curb Ramps
 Barrier Type: No Curb Ramp
 Code Ref: CBC 1127B.5.1 and ADA/ABA 402.2

As Built Meas: 1 Quantity: EACH
 Description: No curb cut at corner (intersection)
 As Built Desc: No curb ramp at corner
 Solution: Demolish existing and construct curb cut
 Bar. Severity: 1 Necessary Cost Estimate: \$2,500.00 Status:
 Implementation Priority: 1 Facility Function:
 Implementation Phase: Implementation Date:
 Official Responsible:

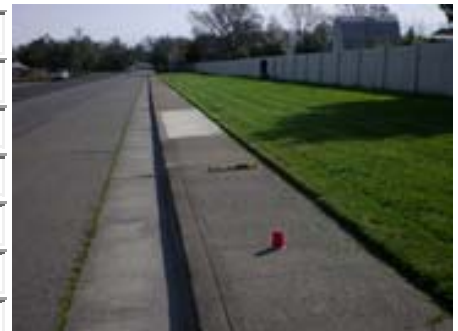
Field Date: 3/29/2011 Report Date: 3/29/2011 Barrier #: 6319
 Location: Old Auburn Rd - South
 X Coordinate: -121.25246
 Y Coordinate: 38.7124
 Barrier Area: Sidewalks
 Barrier Type: Cross Slope - Existing (3.1% to 4.0%)
 Code Ref: CBC 1133B.7.1.3 and ADA/ABA 403.3

As Built Meas: 72 Quantity: LF
 Description: Cross slope exceeds 2.0% (3.1% to 4.0%)
 As Built Desc: 3.6% cross slope
 Solution: Demolish existing and construct new route
 Bar. Severity: 3 Hinderance Cost Estimate: \$9,000.00 Status:
 Implementation Priority: 1 Facility Function:
 Implementation Phase: Implementation Date:
 Official Responsible:

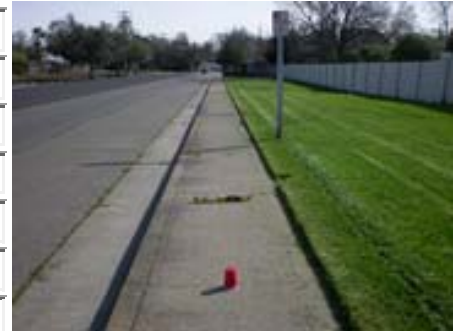
Field Date: 3/29/2011 Report Date: 3/29/2011 Barrier #: 6320
 Location: Old Auburn Rd - South
 X Coordinate: -121.25216
 Y Coordinate: 38.71255
 Barrier Area: Sidewalks
 Barrier Type: Cross Slope - Existing (4.1% to 4.9%)
 Code Ref: CBC 1133B.7.1.3 and ADA/ABA 403.3

As Built Meas: 258 Quantity: LF
 Description: Cross slope exceeds 2.0% (4.1% to 4.9%)
 As Built Desc: 4.1% cross slope
 Solution: Demolish existing and construct new route
 Bar. Severity: 2 Recommended Cost Estimate: \$32,250.00 Status:
 Implementation Priority: 1 Facility Function:
 Implementation Phase: Implementation Date:
 Official Responsible:

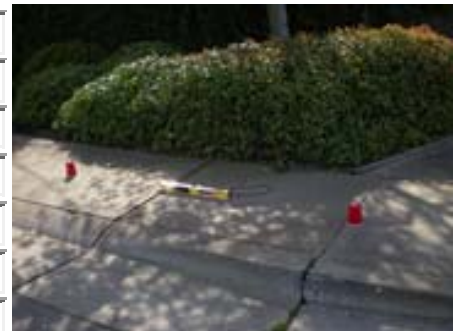
Field Date: 3/29/2011 Report Date: 3/29/2011 Barrier #: 6321
 Location: Old Auburn Rd - South
 X Coordinate: -121.25141
 Y Coordinate: 38.71292
 Barrier Area: Sidewalks
 Barrier Type: Running Slope (Existing)
 Code Ref: CBC 1133B.7.3 and ADA/ABA 403.3

As Built Meas: 4 Quantity: LF
 Description: Running slope exceeds 5.0%
 As Built Desc: 6.6% running slope
 Solution: No remediation where sidewalk sloped as roadway
 Bar. Severity: 5 Technically Infeasible Cost Estimate: \$0.00 Status:
 Implementation Priority: 1 Facility Function:
 Implementation Phase: Implementation Date:
 Official Responsible:

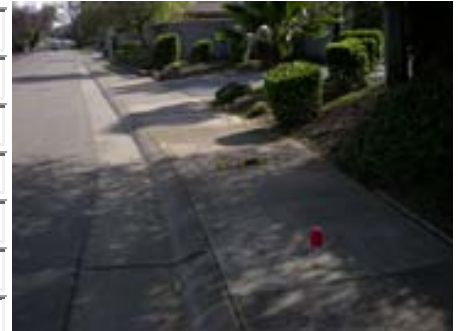
Field Date: 3/29/2011 Report Date: 3/29/2011 Barrier #: 6322
 Location: Old Auburn Rd - South
 X Coordinate: -121.25134
 Y Coordinate: 38.71295
 Barrier Area: Sidewalks
 Barrier Type: Cross Slope - Existing (3.1% to 4.0%)
 Code Ref: CBC 1133B.7.1.3 and ADA/ABA 403.3

As Built Meas: 191 Quantity: LF
 Description: Cross slope exceeds 2.0% (3.1% to 4.0%)
 As Built Desc: 3.8% cross slope
 Solution: Demolish existing and construct new route
 Bar. Severity: 3 Hinderance Cost Estimate: \$23,875.00 Status:
 Implementation Priority: 1 Facility Function:
 Implementation Phase: Implementation Date:
 Official Responsible:

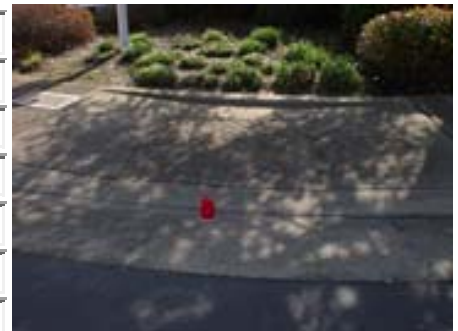
Field Date: 3/29/2011 Report Date: 3/29/2011 Barrier #: 6323A
 Location: Old Auburn Rd and Auburn Oak Village Ln - Corner C
 X Coordinate: -121.2505
 Y Coordinate: 38.71338
 Barrier Area: Curb Ramps
 Barrier Type: Cross Slope - Existing (2.1% to 3.0%)
 Code Ref: CBC 1127B.5.3 and ADA/ABA 406.2

As Built Meas: 1 Quantity: EACH
 Description: Ramp run cross slope exceeds 2.0% (2.1% to 3.0%)
 As Built Desc: 2.8% cross slope
 Solution: Demolish existing and construct new curb ramp
 Bar. Severity: 4 Low Severity Cost Estimate: \$2,500.00 Status:
 Implementation Priority: 1 Facility Function:
 Implementation Phase: Implementation Date:
 Official Responsible:

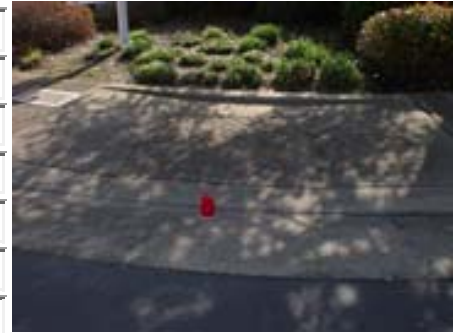
Field Date: 3/29/2011 Report Date: 3/29/2011 Barrier #: 6323B
 Location: Old Auburn Rd and Auburn Oak Village Ln - Corner C
 X Coordinate: -121.2505
 Y Coordinate: 38.71338
 Barrier Area: Curb Ramps
 Barrier Type: Detectable Warnings - Truncated Domes
 Code Ref: CBC 1127B.5.7 and ADA/ABA 705.1.3

As Built Meas: 1 Quantity: EACH
 Description: No truncated domes provided at curb ramp
 As Built Desc: No detectable warnings at curb ramp
 Solution: Provide compliant truncated domes
 Bar. Severity: 2 Recommended Cost Estimate: \$1,400.00 Status:
 Implementation Priority: 1 Facility Function:
 Implementation Phase: Implementation Date:
 Official Responsible:

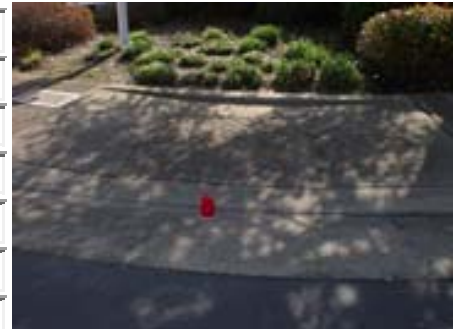
Field Date: 3/29/2011 Report Date: 3/29/2011 Barrier #: 6323C
 Location: Old Auburn Rd and Auburn Oak Village Ln - Corner C
 X Coordinate: -121.2505
 Y Coordinate: 38.71338
 Barrier Area: Curb Ramps
 Barrier Type: Gutter Slope - Existing (5.9% - 6.5%)
 Code Ref: CBC 1127B.5.3 and ADA/ABA 406.2

As Built Meas: 6 Quantity: SF
 Description: Gutter slope exceeds 5.0% (5.9% - 6.5%)
 As Built Desc: 6.2% gutter slope
 Solution: Demolish existing and construct new gutter
 Bar. Severity: 3 Hindrance Cost Estimate: \$750.00 Status:
 Implementation Priority: 1 Facility Function:
 Implementation Phase: Implementation Date:
 Official Responsible:

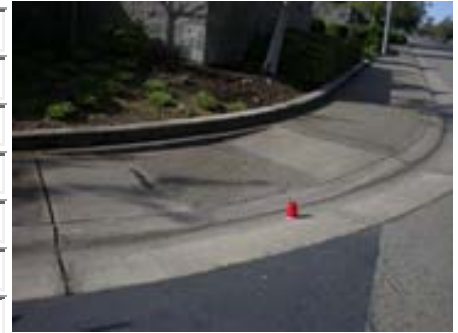
Field Date: 3/29/2011 Report Date: 3/29/2011 Barrier #: 6324A
 Location: Old Auburn Rd and Auburn Oak Village Ln - Corner D
 X Coordinate: -121.25074
 Y Coordinate: 38.71327
 Barrier Area: Curb Ramps
 Barrier Type: 12" Grooves - Existing (2.1% to 3.0%)
 Code Ref: CBC 1127B.5.6

As Built Meas: 1 Quantity: EACH
 Description: 12" grooves at top of curb ramp are not level (2.1% to 3.0%)
 As Built Desc: 2.4% at 12" grooves
 Solution: Demolish existing and construct new curb ramp
 Bar. Severity: 4 Low Severity Cost Estimate: \$2,500.00 Status:
 Implementation Priority: 1 Facility Function:
 Implementation Phase: Implementation Date:
 Official Responsible:

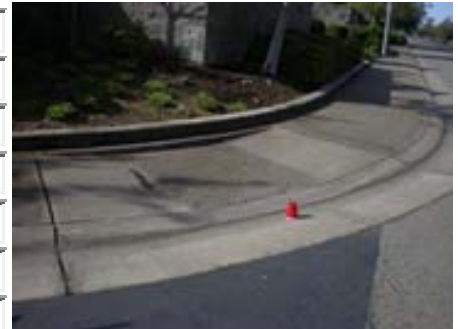
Field Date: 3/29/2011 Report Date: 3/29/2011 Barrier #: 6324B
 Location: Old Auburn Rd and Auburn Oak Village Ln - Corner D
 X Coordinate: -121.25074
 Y Coordinate: 38.71327
 Barrier Area: Curb Ramps
 Barrier Type: Detectable Warnings - Truncated Domes
 Code Ref: CBC 1127B.5.7 and ADA/ABA 705.1.3

As Built Meas: 1 Quantity: EACH
 Description: No truncated domes provided at curb ramp
 As Built Desc: No detectable warnings at curb ramp
 Solution: Provide compliant truncated domes
 Bar. Severity: 2 Recommended Cost Estimate: \$1,400.00 Status:
 Implementation Priority: 1 Facility Function:
 Implementation Phase: Implementation Date:
 Official Responsible:

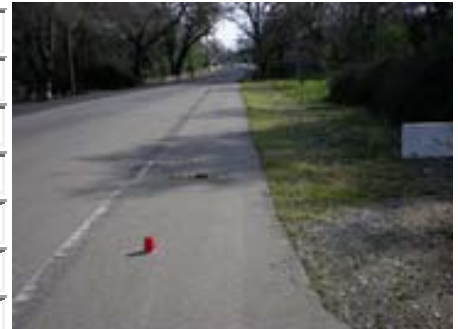
Field Date: 3/29/2011 Report Date: 3/29/2011 Barrier #: 6325
 Location: Old Auburn Rd - South
 X Coordinate: -121.25043
 Y Coordinate: 38.71344
 Barrier Area: Sidewalks
 Barrier Type: Shoulder Cross Slope - Existing (4.1% to 4.9%)
 Code Ref: CBC 1133B.7.1.3 and ADA/ABA 403.3

As Built Meas: 665 Quantity: LF
 Description: Cross slope exceeds 2.0% (4.1% to 4.9%)
 As Built Desc: 4.7% cross slope
 Solution: Demolish existing and construct new pedestrian route
 Bar. Severity: 2 Recommended Cost Estimate: \$83,125.00 Status:
 Implementation Priority: 1 Facility Function:
 Implementation Phase: Implementation Date:
 Official Responsible:

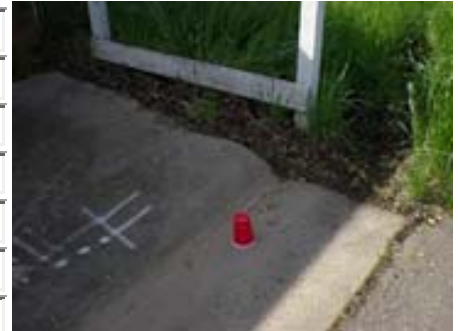
Field Date: 3/29/2011 Report Date: 3/29/2011 Barrier #: 6326
 Location: Old Auburn Rd - South
 X Coordinate: -121.24842
 Y Coordinate: 38.71435
 Barrier Area: Sidewalks
 Barrier Type: No Sidewalk - Transition to Shoulder
 Code Ref: CBC 1121B.2 and ADA/ABA 206.2.1

As Built Meas: 1 Quantity: JOB
 Description: Sidewalk ends and no ramp to pedestrian shoulder is provided
 As Built Desc: No ramp to shoulder to enable pedestrian travel onto existing shoulder
 Solution: Provide transition ramp to paved shoulder where no opposite sidewalk exists
 Bar. Severity: 1 Necessary Cost Estimate: \$2,500.00 Status:
 Implementation Priority: 1 Facility Function:
 Implementation Phase: Implementation Date:
 Official Responsible:

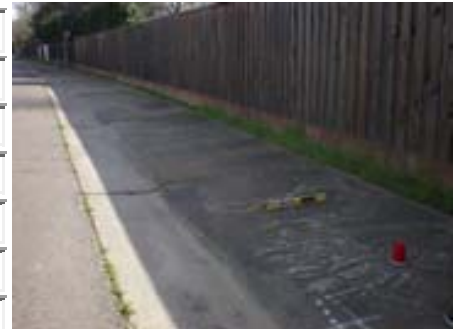
Field Date: 3/29/2011 Report Date: 3/29/2011 Barrier #: 6327A
 Location: Old Auburn Rd - South
 X Coordinate: -121.2473
 Y Coordinate: 38.71499
 Barrier Area: Sidewalks
 Barrier Type: Cross Slope - Existing (5.0% or more)
 Code Ref: CBC 1133B.7.1.3 and ADA/ABA 403.3

As Built Meas: 444 Quantity: LF
 Description: Cross slope exceeds 2.0% (5.0% or more)
 As Built Desc: 7.1% cross slope
 Solution: Demolish existing and construct new route
 Bar. Severity: 1 Necessary Cost Estimate: \$55,500.00 Status:
 Implementation Priority: 1 Facility Function:
 Implementation Phase: Implementation Date:
 Official Responsible:

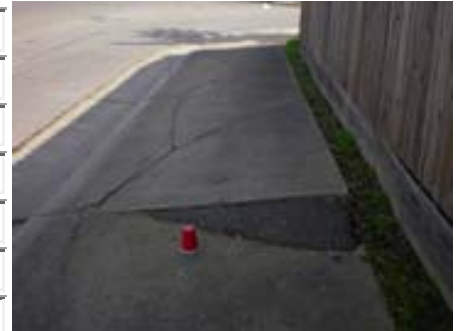
Field Date: 3/29/2011 Report Date: 3/29/2011 Barrier #: 6327B
 Location: Old Auburn Rd - South
 X Coordinate: -121.24694
 Y Coordinate: 38.71516
 Barrier Area: Sidewalks
 Barrier Type: Abrupt Change in Level - > 1/2"
 Code Ref: CBC 1133B.7.1 and ADA/ABA 303.3

As Built Meas: 8 Quantity: LF
 Description: Change in level greater than 1/2"
 As Built Desc: 6" lip in sidewalk surface
 Solution: Grind or repair sidewalk to remove trip hazard
 Bar. Severity: 1 Necessary Cost Estimate: \$2,000.00 Status:
 Implementation Priority: 1 Facility Function:
 Implementation Phase: Implementation Date:
 Official Responsible:

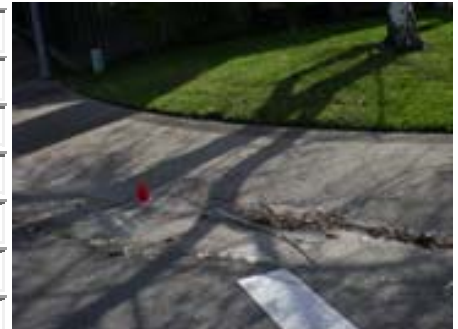
Field Date: 3/29/2011 Report Date: 3/29/2011 Barrier #: 6328
 Location: Old Auburn Rd and Argo Wy - Corner C
 X Coordinate: -121.2471
 Y Coordinate: 38.71504
 Barrier Area: Curb Ramps
 Barrier Type: No Curb Ramp - Depressed Existing Curb
 Code Ref: CBC 1127B.5.1 and ADA/ABA 402.2

As Built Meas: 1 Quantity: EACH
 Description: No compliant curb cut at corner (intersection)
 As Built Desc: 10.4% running slope at depressed area
 Solution: Demolish existing and construct curb cut
 Bar. Severity: 1 Necessary Cost Estimate: \$2,500.00 Status:
 Implementation Priority: 1 Facility Function:
 Implementation Phase: Implementation Date:
 Official Responsible:

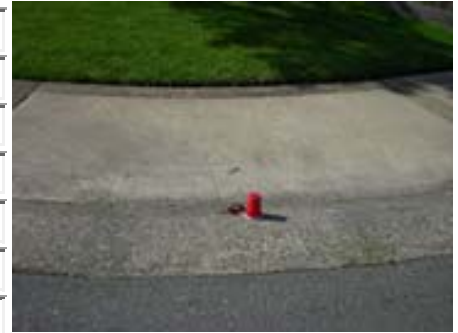
Field Date: 3/29/2011 Report Date: 3/29/2011 Barrier #: 6329
 Location: Old Auburn Rd and Argo Wy - Corner D
 X Coordinate: -121.24711
 Y Coordinate: 38.71505
 Barrier Area: Curb Ramps
 Barrier Type: No Curb Ramp - Depressed Existing Curb
 Code Ref: CBC 1127B.5.1 and ADA/ABA 402.2

As Built Meas: 1 Quantity: EACH
 Description: No compliant curb cut at corner (intersection)
 As Built Desc: 10.7% running slope at depressed area
 Solution: Demolish existing and construct curb cut
 Bar. Severity: 1 Necessary Cost Estimate: \$2,500.00 Status:
 Implementation Priority: 1 Facility Function:
 Implementation Phase: Implementation Date:
 Official Responsible:

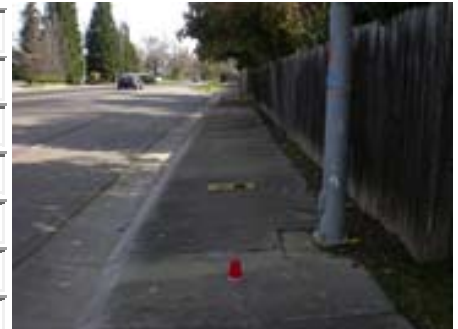
Field Date: 3/29/2011 Report Date: 3/29/2011 Barrier #: 6330
 Location: Old Auburn Rd - South
 X Coordinate: -121.24691
 Y Coordinate: 38.7152
 Barrier Area: Sidewalks
 Barrier Type: Cross Slope - Existing (5.0% or more)
 Code Ref: CBC 1133B.7.1.3 and ADA/ABA 403.3

As Built Meas: 178 Quantity: LF
 Description: Cross slope exceeds 2.0% (5.0% or more)
 As Built Desc: 6.8% cross slope
 Solution: Demolish existing and construct new route
 Bar. Severity: 1 Necessary Cost Estimate: \$22,250.00 Status:
 Implementation Priority: 1 Facility Function:
 Implementation Phase: Implementation Date:
 Official Responsible:

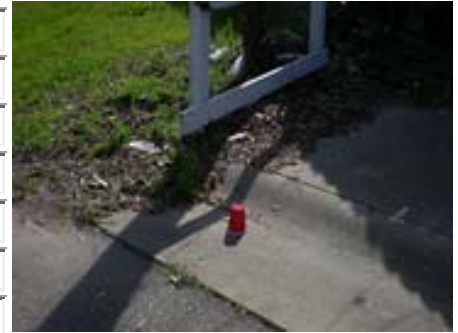
Barrier Type: No Sidewalk - Transition to Shoulder

Description: Sidewalk ends and no ramp to pedestrian shoulder is provided

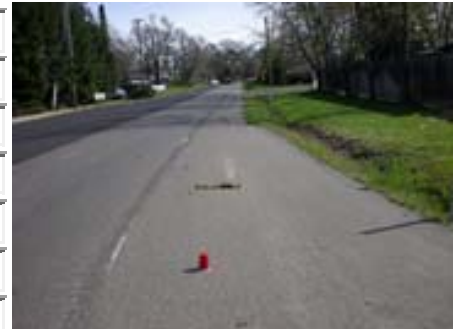
Barrier Type: Shoulder Cross Slope - Existing (4.1% to 4.9%)

Description: Cross slope exceeds 2.0% (4.1% to 4.9%)

Bar. Severity: 2 Recommended Cost Estimate: \$77,500.00 Status:

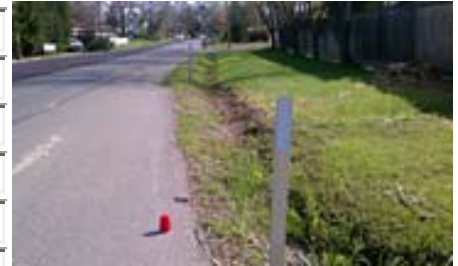
Field Date: 3/29/2011 Report Date: 3/29/2011 Barrier #: 6332B
 Location: Old Auburn Rd - South
 X Coordinate: -121.24643
 Y Coordinate: 38.71556
 Barrier Area: Sidewalks
 Barrier Type: Drop-off Along Ped Route (> 4")
 Code Ref: CBC 1133B.8.1

As Built Meas: 144 Quantity: LF
 Description: Drop of more than 4" along pedestrian route lacks warning curb
 As Built Desc: 1" drop off creates hazardous condition for the visually impaired
 Solution: Provide curb projecting at least 6" above the walk or sidewalk surface to warn the blind of a potent
 Bar. Severity: 1 Necessary Cost Estimate: \$25,200.00 Status:
 Implementation Priority: 1 Facility Function:
 Implementation Phase: Implementation Date:
 Official Responsible:

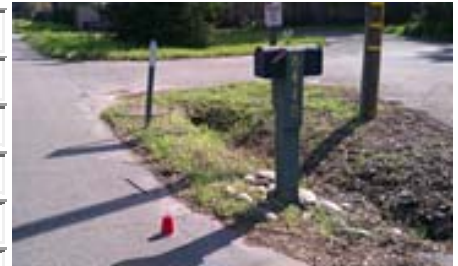
Field Date: 3/29/2011 Report Date: 3/29/2011 Barrier #: 6332C
 Location: Old Auburn Rd - South
 X Coordinate: -121.24592
 Y Coordinate: 38.71585
 Barrier Area: Sidewalks
 Barrier Type: Drop-off Along Ped Route (> 4")
 Code Ref: CBC 1133B.8.1

As Built Meas: 25 Quantity: LF
 Description: Drop of more than 4" along pedestrian route lacks warning curb
 As Built Desc: 1" drop off creates hazardous condition for the visually impaired
 Solution: Provide curb projecting at least 6" above the walk or sidewalk surface to warn the blind of a potent
 Bar. Severity: 1 Necessary Cost Estimate: \$4,375.00 Status:
 Implementation Priority: 1 Facility Function:
 Implementation Phase: Implementation Date:
 Official Responsible:

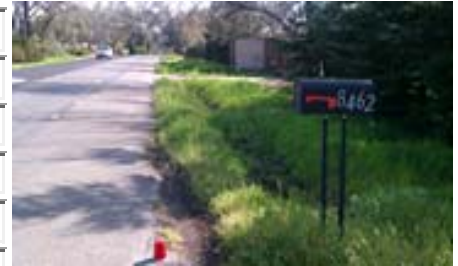
Field Date: 3/29/2011 Report Date: 3/29/2011 Barrier #: 6332D
 Location: Old Auburn Rd - South
 X Coordinate: -121.24458
 Y Coordinate: 38.71654
 Barrier Area: Sidewalks
 Barrier Type: Drop-off Along Ped Route (> 4")
 Code Ref: CBC 1133B.8.1

As Built Meas: 1 Quantity: LF
 Description: Drop of more than 4" along pedestrian route lacks warning curb
 As Built Desc: 70" drop off creates hazardous condition for the visually impaired
 Solution: Provide curb projecting at least 6" above the walk or sidewalk surface to warn the blind of a potent
 Bar. Severity: 1 Necessary Cost Estimate: \$525.00 Status:
 Implementation Priority: 1 Facility Function:
 Implementation Phase: Implementation Date:
 Official Responsible:

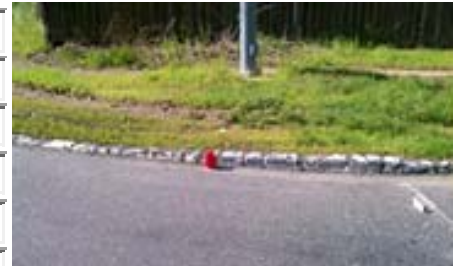
Field Date: 3/29/2011 Report Date: 3/29/2011 Barrier #: 6333
 Location: Old Auburn Rd And Wachtel Wy - Corner D
 X Coordinate: -121.24451
 Y Coordinate: 38.71645
 Barrier Area: Blended Transitions
 Barrier Type: Detectable Warnings - Truncated Domes
 Code Ref: CBC 1127B.5.3

As Built Meas: 1 Quantity: EACH
 Description: No truncated domes provided at transition into roadway
 As Built Desc: No detectable warning provided
 Solution: Provide compliant truncated domes
 Bar. Severity: 2 Recommended Cost Estimate: \$1,400.00 Status:
 Implementation Priority: 1 Facility Function:
 Implementation Phase: Implementation Date:
 Official Responsible:

Notes: Two-way intersection corners C, D. Corner C in Roseville CA

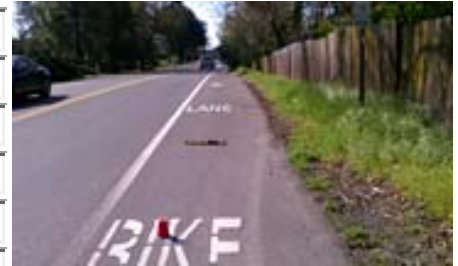
Field Date: 3/29/2011 Report Date: 3/29/2011 Barrier #: 6334
 Location: Wachtel Wy - West
 X Coordinate: -121.24448
 Y Coordinate: 38.71604
 Barrier Area: Sidewalks
 Barrier Type: Shoulder Cross Slope - Existing (2.1% to 3.0%)
 Code Ref: CBC 1133B.7.1.3 and ADA/ABA 403.3

As Built Meas: 89 Quantity: LF
 Description: Cross slope exceeds 2.0% (2.1% to 3.0%)
 As Built Desc: 3.0% cross slope
 Solution: Low severity barrier - no remediation recommended
 Bar. Severity: 4 Low Severity Cost Estimate: \$0.00 Status:
 Implementation Priority: 2 Facility Function:
 Implementation Phase: Implementation Date:
 Official Responsible:

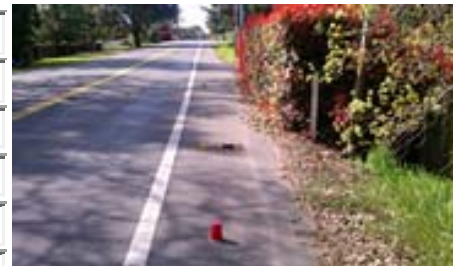
Field Date: 3/29/2011 Report Date: 3/29/2011 Barrier #: 6335
 Location: Wachtel Wy - West
 X Coordinate: -121.24456
 Y Coordinate: 38.71521
 Barrier Area: Sidewalks
 Barrier Type: Shoulder Cross Slope - Existing (4.1% to 4.9%)
 Code Ref: CBC 1133B.7.1.3 and ADA/ABA 403.3

As Built Meas: 320 Quantity: LF
 Description: Cross slope exceeds 2.0% (4.1% to 4.9%)
 As Built Desc: 4.7% cross slope
 Solution: Demolish existing and construct new pedestrian route
 Bar. Severity: 2 Recommended Cost Estimate: \$40,000.00 Status:
 Implementation Priority: 2 Facility Function:
 Implementation Phase: Implementation Date:
 Official Responsible:

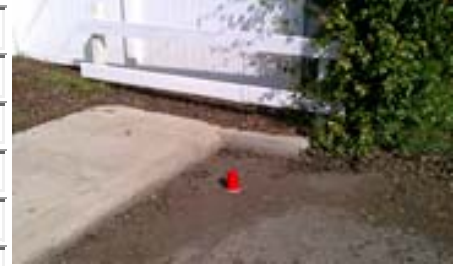
Field Date: 3/29/2011 Report Date: 3/29/2011 Barrier #: 6336
 Location: Wachtel Wy - West
 X Coordinate: -121.24456
 Y Coordinate: 38.7152
 Barrier Area: Sidewalks
 Barrier Type: No Sidewalk - Transition to Shoulder
 Code Ref: CBC 1121B.2 and ADA/ABA 206.2.1

As Built Meas: 1 Quantity: JOB
 Description: Sidewalk ends and no ramp to pedestrian shoulder is provided
 As Built Desc: No ramp to shoulder to enable pedestrian travel onto existing shoulder
 Solution: Provide transition ramp to paved shoulder where no opposite sidewalk exists
 Bar. Severity: 1 Necessary Cost Estimate: \$2,500.00 Status:
 Implementation Priority: 2 Facility Function:
 Implementation Phase: Implementation Date:
 Official Responsible:

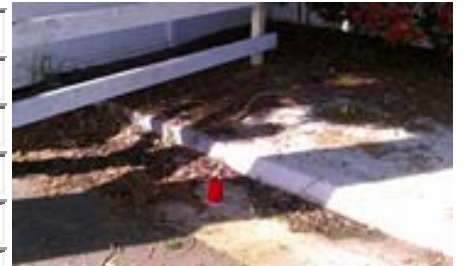
Field Date: 3/29/2011 Report Date: 3/29/2011 Barrier #: 6337
 Location: Wachtel Wy - West
 X Coordinate: -121.24457
 Y Coordinate: 38.71461
 Barrier Area: Sidewalks
 Barrier Type: No Sidewalk - Transition to Shoulder
 Code Ref: CBC 1121B.2 and ADA/ABA 206.2.1

As Built Meas: 1 Quantity: JOB
 Description: Sidewalk ends and no ramp to pedestrian shoulder is provided
 As Built Desc: No ramp to shoulder to enable pedestrian travel onto existing shoulder
 Solution: Provide transition ramp to paved shoulder where no opposite sidewalk exists
 Bar. Severity: 1 Necessary Cost Estimate: \$2,500.00 Status:
 Implementation Priority: 2 Facility Function:
 Implementation Phase: Implementation Date:
 Official Responsible:

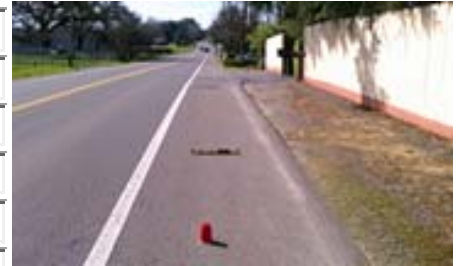
Field Date: 3/29/2011 Report Date: 3/29/2011 Barrier #: 6338
 Location: Wachtel Wy - West
 X Coordinate: -121.2445
 Y Coordinate: 38.71457
 Barrier Area: Sidewalks
 Barrier Type: Shoulder Cross Slope - Existing (5.0% or more)
 Code Ref: CBC 1133B.7.1.3 and ADA/ABA 403.3

As Built Meas: 742 Quantity: LF
 Description: Cross slope exceeds 2.0% (5.0% or more)
 As Built Desc: 5.3% cross slope
 Solution: Demolish existing and construct new pedestrian route
 Bar. Severity: 1 Necessary Cost Estimate: \$92,750.00 Status:
 Implementation Priority: 2 Facility Function:
 Implementation Phase: Implementation Date:
 Official Responsible:

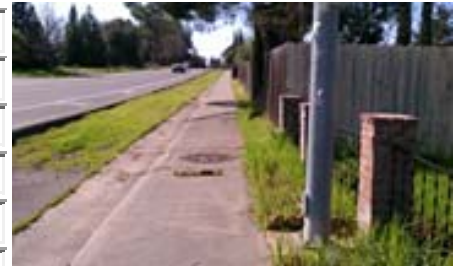
Field Date: 3/29/2011 Report Date: 3/29/2011 Barrier #: 6339
 Location: Wachtel Wy - West
 X Coordinate: -121.24467
 Y Coordinate: 38.7123
 Barrier Area: Sidewalks
 Barrier Type: Cross Slope - Existing (5.0% or more)
 Code Ref: CBC 1133B.7.1.3 and ADA/ABA 403.3

As Built Meas: 1317 Quantity: LF
 Description: Cross slope exceeds 2.0% (5.0% or more)
 As Built Desc: 5.7% cross slope
 Solution: Demolish existing and construct new route
 Bar. Severity: 1 Necessary Cost Estimate: \$164,625.00 Status:
 Implementation Priority: 2 Facility Function:
 Implementation Phase: Implementation Date:
 Official Responsible:

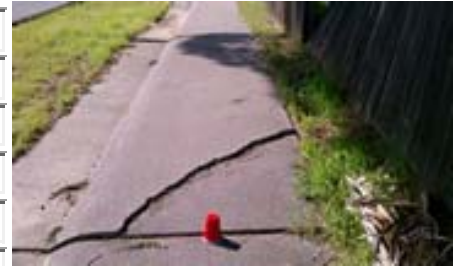
Field Date: 3/29/2011 Report Date: 3/29/2011 Barrier #: 6340
 Location: Wachtel Wy - West
 X Coordinate: -121.24465
 Y Coordinate: 38.71225
 Barrier Area: Sidewalks
 Barrier Type: Abrupt Change in Level - > 1/2"
 Code Ref: CBC 1133B.7.1 and ADA/ABA 303.3

As Built Meas: 10 Quantity: LF
 Description: Change in level greater than 1/2"
 As Built Desc: 1/2" lip in sidewalk surface
 Solution: Grind or repair sidewalk to remove trip hazard
 Bar. Severity: 1 Necessary Cost Estimate: \$2,500.00 Status:
 Implementation Priority: 2 Facility Function:
 Implementation Phase: Implementation Date:
 Official Responsible:

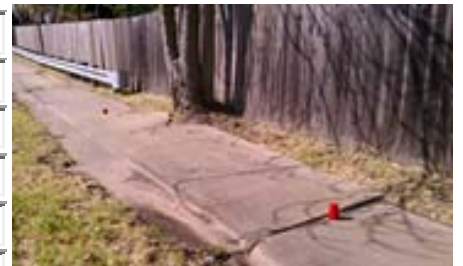
Field Date: 3/29/2011 Report Date: 3/29/2011 Barrier #: 6341
 Location: Wachtel Wy - West
 X Coordinate: -121.2447
 Y Coordinate: 38.70945
 Barrier Area: Sidewalks
 Barrier Type: Abrupt Change in Level - > 1/2"
 Code Ref: CBC 1133B.7.1 and ADA/ABA 303.3

As Built Meas: 25 Quantity: LF
 Description: Change in level greater than 1/2"
 As Built Desc: 1/2" lip in sidewalk surface
 Solution: Grind or repair sidewalk to remove trip hazard
 Bar. Severity: 1 Necessary Cost Estimate: \$6,250.00 Status:
 Implementation Priority: 2 Facility Function:
 Implementation Phase: Implementation Date:
 Official Responsible:

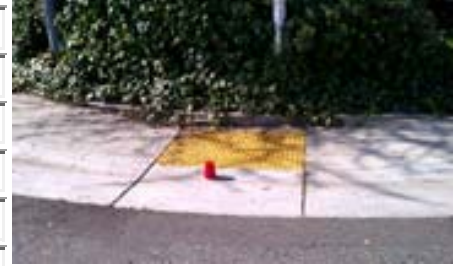
Field Date: 3/29/2011 Report Date: 3/29/2011 Barrier #: 6342A
 Location: Wachtel Wy and Pitalo Wy - Corner D
 X Coordinate: -121.24471
 Y Coordinate: 38.70859
 Barrier Area: Curb Ramps
 Barrier Type: 12" Grooves - Existing (>5.0%)
 Code Ref: CBC 1127B.5.6

As Built Meas: 1 Quantity: EACH
 Description: 12" grooves at top of curb ramp are not level (>5.0%)
 As Built Desc: 9.2% at 12" grooves
 Solution: Demolish existing and construct new curb ramp
 Bar. Severity: 1 Necessary Cost Estimate: \$2,500.00 Status:
 Implementation Priority: 2 Facility Function:
 Implementation Phase: Implementation Date:
 Official Responsible:

Notes: Two - way intersection corners A,D. Corner A compliant

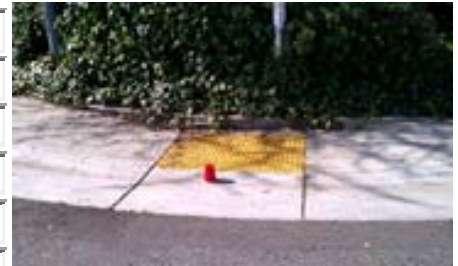
Field Date: 3/29/2011 Report Date: 3/29/2011 Barrier #: 6342B
 Location: Wachtel Wy and Pitalo Wy - Corner D
 X Coordinate: -121.24471
 Y Coordinate: 38.70859
 Barrier Area: Curb Ramps
 Barrier Type: Running Slope - Existing (9.5% or more)
 Code Ref: CBC 1127B.5.3 and ADA/ABA 406.1

As Built Meas: 1 Quantity: EACH
 Description: Ramp run cross slope exceeds 2.0% (9.5% or more)
 As Built Desc: 9.6% running slope
 Solution: Demolish existing and construct new curb ramp
 Bar. Severity: 1 Necessary Cost Estimate: \$2,500.00 Status:
 Implementation Priority: 2 Facility Function:
 Implementation Phase: Implementation Date:
 Official Responsible:

Notes: Two - way intersection corners A,D. Corner A compliant

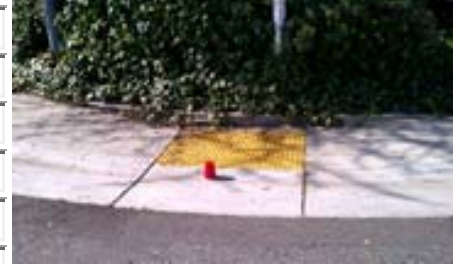
Field Date: 3/29/2011 Report Date: 3/29/2011 Barrier #: 6342C
 Location: Wachtel Wy and Pitalo Wy - Corner D
 X Coordinate: -121.24471
 Y Coordinate: 38.70859
 Barrier Area: Curb Ramps
 Barrier Type: Parallel Ramp Landing - Existing (>5.0% or more)
 Code Ref: CBC 1127B.5.4 and ADA/ABA 406.4

As Built Meas: 1 Quantity: EACH
 Description: Curb ramp landing or pan not level (>5.0% or more)
 As Built Desc: 7.3% landing slope
 Solution: Demolish existing and construct new transition
 Bar. Severity: 1 Necessary Cost Estimate: \$250.00 Status:
 Implementation Priority: 2 Facility Function:
 Implementation Phase: Implementation Date:
 Official Responsible:

Notes: Two - way intersection corners A,D. Corner A compliant

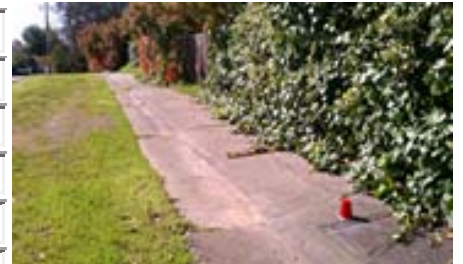
Field Date: 3/29/2011 Report Date: 3/29/2011 Barrier #: 6343A
 Location: Wachtel Wy - West
 X Coordinate: -121.2447
 Y Coordinate: 38.70857
 Barrier Area: Sidewalks
 Barrier Type: Cross Slope - Existing (5.0% or more)
 Code Ref: CBC 1133B.7.1.3 and ADA/ABA 403.3

As Built Meas: 281 Quantity: LF
 Description: Cross slope exceeds 2.0% (5.0% or more)
 As Built Desc: 5.8% cross slope
 Solution: Demolish existing and construct new route
 Bar. Severity: 1 Necessary Cost Estimate: \$35,125.00 Status:
 Implementation Priority: 2 Facility Function:
 Implementation Phase: Implementation Date:
 Official Responsible:

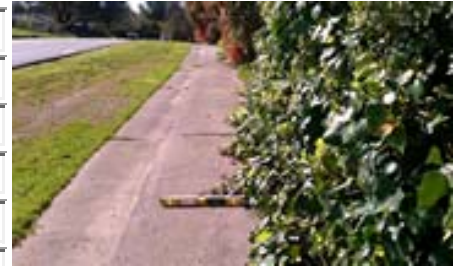
Field Date: 3/29/2011 Report Date: 3/29/2011 Barrier #: 6343B
 Location: Wachtel Wy - West
 X Coordinate: -121.2447
 Y Coordinate: 38.70857
 Barrier Area: Sidewalks
 Barrier Type: Clear Width - Existing ($\leq 31''$ or less)
 Code Ref: CBC 1133B.7.1

As Built Meas: 1 Quantity: LF
 Description: Pedestrian route is not min. 48" wide ($\leq 31''$ or less)
 As Built Desc: 24" clear width due to foliage
 Solution: Trim foliage to provide min. 48" clear width
 Bar. Severity: 1 Necessary Cost Estimate: \$125.00 Status:
 Implementation Priority: 2 Facility Function:
 Implementation Phase: Implementation Date:
 Official Responsible:

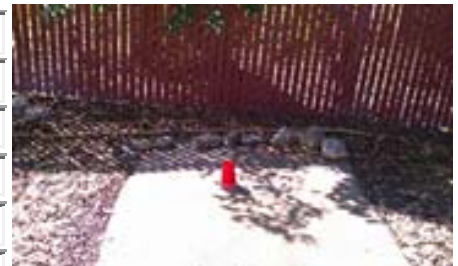
Field Date: 3/29/2011 Report Date: 3/29/2011 Barrier #: 6344
 Location: Wachtel Wy - West
 X Coordinate: -121.24452
 Y Coordinate: 38.70783
 Barrier Area: Sidewalks
 Barrier Type: No Sidewalk - No Barricade
 Code Ref: MUTCD Section 6D.01

As Built Meas: 1 Quantity: JOB
 Description: No barricade provided where sidewalk ends in hazardous location
 As Built Desc: No barricade or other warning provided for the visually impaired at end of sidewalk
 Solution: Provide barricade with cane detectable warning at end of sidewalk
 Bar. Severity: 1 Necessary Cost Estimate: \$1,350.00 Status:
 Implementation Priority: 2 Facility Function:
 Implementation Phase: Implementation Date:
 Official Responsible:

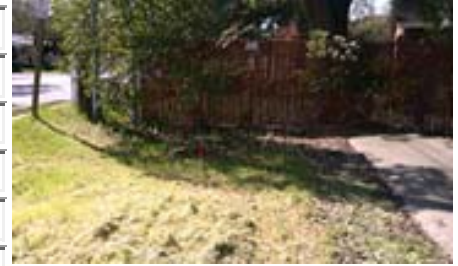
Field Date: 3/29/2011 Report Date: 3/29/2011 Barrier #: 6345
 Location: Wachtel Wy - West
 X Coordinate: -121.24445
 Y Coordinate: 38.70661
 Barrier Area: Sidewalks
 Barrier Type: No Sidewalk - Transition to Shoulder
 Code Ref: CBC 1121B.2 and ADA/ABA 206.2.1

As Built Meas: 1 Quantity: JOB
 Description: Sidewalk ends and no ramp to pedestrian shoulder is provided
 As Built Desc: No ramp to shoulder to enable pedestrian travel onto existing shoulder
 Solution: Provide transition ramp to paved shoulder where no opposite sidewalk exists
 Bar. Severity: 1 Necessary Cost Estimate: \$2,500.00 Status:
 Implementation Priority: 2 Facility Function:
 Implementation Phase: Implementation Date:
 Official Responsible:

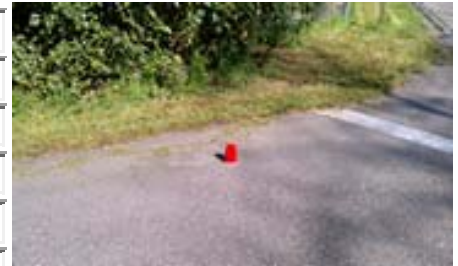
Field Date: 3/29/2011 Report Date: 3/29/2011 Barrier #: 6346
 Location: Wachtel Wy and Olivine Ave - Corner A
 X Coordinate: -121.24444
 Y Coordinate: 38.7066
 Barrier Area: Blended Transitions
 Barrier Type: Detectable Warnings - Truncated Domes
 Code Ref: CBC 1127B.5.3

As Built Meas: 1 Quantity: EACH
 Description: No truncated domes provided at transition into roadway
 As Built Desc: No detectable warning provided
 Solution: Provide compliant truncated domes
 Bar. Severity: 2 Recommended Cost Estimate: \$1,400.00 Status:
 Implementation Priority: 2 Facility Function:
 Implementation Phase: Implementation Date:
 Official Responsible:

Notes: Two - way intersection corners A,D

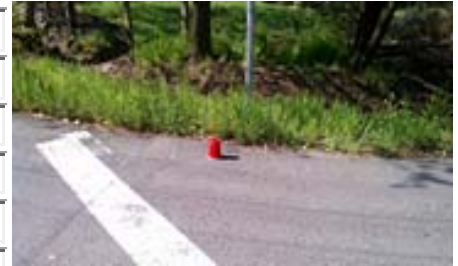
Field Date: 3/29/2011 Report Date: 3/29/2011 Barrier #: 6347
 Location: Wachtel Wy and Olivine Ave - Corner D
 X Coordinate: -121.24442
 Y Coordinate: 38.70645
 Barrier Area: Blended Transitions
 Barrier Type: Detectable Warnings - Truncated Domes
 Code Ref: CBC 1127B.5.3

As Built Meas: 1 Quantity: EACH
 Description: No truncated domes provided at transition into roadway
 As Built Desc: No detectable warning provided
 Solution: Provide compliant truncated domes
 Bar. Severity: 2 Recommended Cost Estimate: \$1,400.00 Status:
 Implementation Priority: 2 Facility Function:
 Implementation Phase: Implementation Date:
 Official Responsible:

Notes: Two - way intersection corners A,D

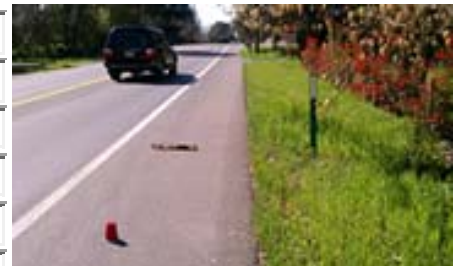
Field Date: 3/29/2011 Report Date: 3/29/2011 Barrier #: 6348
 Location: Wachtel Wy - West
 X Coordinate: -121.2444
 Y Coordinate: 38.70643
 Barrier Area: Sidewalks
 Barrier Type: Shoulder Cross Slope - Existing (4.1% to 4.9%)
 Code Ref: CBC 1133B.7.1.3 and ADA/ABA 403.3

As Built Meas: 183 Quantity: LF
 Description: Cross slope exceeds 2.0% (4.1% to 4.9%)
 As Built Desc: 4.2% cross slope
 Solution: Demolish existing and construct new pedestrian route
 Bar. Severity: 2 Recommended Cost Estimate: \$22,875.00 Status:
 Implementation Priority: 2 Facility Function:
 Implementation Phase: Implementation Date:
 Official Responsible:

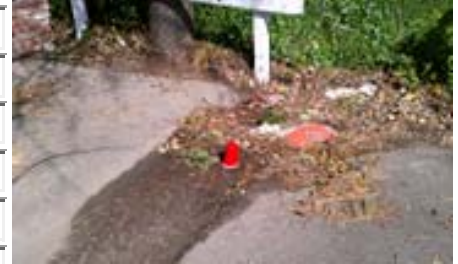
Field Date: 3/29/2011 Report Date: 3/29/2011 Barrier #: 6349
 Location: Wachtel Wy - West
 X Coordinate: -121.24448
 Y Coordinate: 38.70595
 Barrier Area: Sidewalks
 Barrier Type: No Sidewalk - Transition to Shoulder
 Code Ref: CBC 1121B.2 and ADA/ABA 206.2.1

As Built Meas: 1 Quantity: JOB
 Description: Sidewalk ends and no ramp to pedestrian shoulder is provided
 As Built Desc: No ramp to shoulder to enable pedestrian travel onto existing shoulder
 Solution: Provide transition ramp to paved shoulder where no opposite sidewalk exists
 Bar. Severity: 1 Necessary Cost Estimate: \$2,500.00 Status:
 Implementation Priority: 2 Facility Function:
 Implementation Phase: Implementation Date:
 Official Responsible:

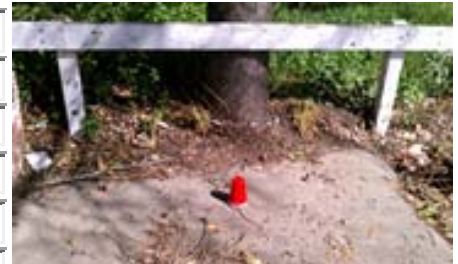
Field Date: 3/29/2011 Report Date: 3/29/2011 Barrier #: 6350
 Location: Wachtel Wy - West
 X Coordinate: -121.24449
 Y Coordinate: 38.70595
 Barrier Area: Sidewalks
 Barrier Type: No Sidewalk - Cane Detectable Barricade
 Code Ref: CBC 1133B.8.6 and MUTCD Section 6D.02

As Built Meas: 4 Quantity: LF
 Description: No cane detectable warning on existing barricade
 As Built Desc: Existing barricade lacks warning for the visually impaired
 Solution: Provide cane detectable warning on barricade (max. 6" above ground)
 Bar. Severity: 1 Necessary Cost Estimate: \$400.00 Status:
 Implementation Priority: 2 Facility Function:
 Implementation Phase: Implementation Date:
 Official Responsible:

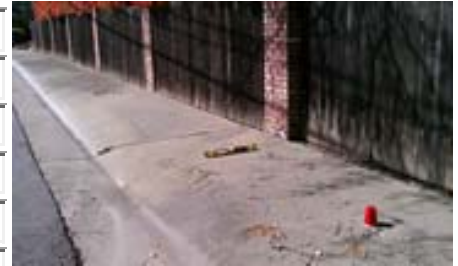
Field Date: 3/29/2011 Report Date: 3/29/2011 Barrier #: 6351
 Location: Wachtel Wy - West
 X Coordinate: -121.24448
 Y Coordinate: 38.70592
 Barrier Area: Sidewalks
 Barrier Type: Cross Slope - Existing (3.1% to 4.0%)
 Code Ref: CBC 1133B.7.1.3 and ADA/ABA 403.3

As Built Meas: 129 Quantity: LF
 Description: Cross slope exceeds 2.0% (3.1% to 4.0%)
 As Built Desc: 3.5% cross slope
 Solution: Demolish existing and construct new route
 Bar. Severity: 3 Hinderance Cost Estimate: \$16,125.00 Status:
 Implementation Priority: 2 Facility Function:
 Implementation Phase: Implementation Date:
 Official Responsible:

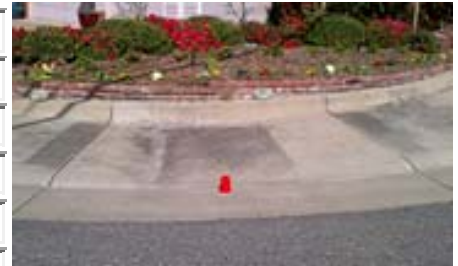
Field Date: 3/29/2011 Report Date: 3/29/2011 Barrier #: 6352A
 Location: Wachtel Wy and Andre Ct - Corner A
 X Coordinate: -121.2445
 Y Coordinate: 38.70554
 Barrier Area: Curb Ramps
 Barrier Type: Detectable Warnings - Truncated Domes
 Code Ref: CBC 1127B.5.7 and ADA/ABA 705.1.3

As Built Meas: 1 Quantity: EACH
 Description: No truncated domes provided at curb ramp
 As Built Desc: No detectable warnings at curb ramp
 Solution: Provide compliant truncated domes
 Bar. Severity: 2 Recommended Cost Estimate: \$1,400.00 Status:
 Implementation Priority: 2 Facility Function:
 Implementation Phase: Implementation Date:
 Official Responsible:

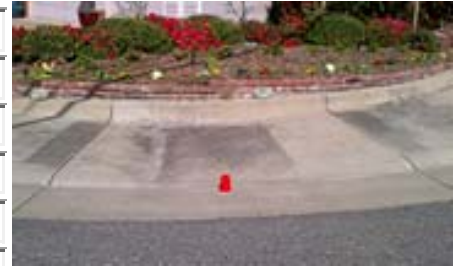
Field Date: 3/29/2011 Report Date: 3/29/2011 Barrier #: 6352B
 Location: Wachtel Wy and Andre Ct - Corner A
 X Coordinate: -121.2445
 Y Coordinate: 38.70554
 Barrier Area: Curb Ramps
 Barrier Type: Gutter Slope - Existing (8.3% or more)
 Code Ref: CBC 1127B.5.3 and ADA/ABA 406.2

As Built Meas: 6 Quantity: SF
 Description: Gutter slope exceeds 5.0% (8.3% or more)
 As Built Desc: 8.3% gutter slope
 Solution: Demolish existing and construct new gutter
 Bar. Severity: 1 Necessary Cost Estimate: \$750.00 Status:
 Implementation Priority: 2 Facility Function:
 Implementation Phase: Implementation Date:
 Official Responsible:

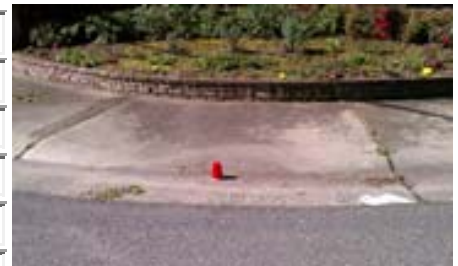
Field Date: 3/29/2011 Report Date: 3/29/2011 Barrier #: 6353A
 Location: Wachtel Wy and Andre Ct - Corner D
 X Coordinate: -121.24448
 Y Coordinate: 38.70539
 Barrier Area: Curb Ramps
 Barrier Type: Parallel Ramp Landing - Existing (>5.0% or more)
 Code Ref: CBC 1127B.5.4 and ADA/ABA 406.4

As Built Meas: 1 Quantity: EACH
 Description: Curb ramp landing or pan not level (>5.0% or more)
 As Built Desc: 6.4% landing slope
 Solution: Demolish existing and construct new transition
 Bar. Severity: 1 Necessary Cost Estimate: \$250.00 Status:
 Implementation Priority: 2 Facility Function:
 Implementation Phase: Implementation Date:
 Official Responsible:

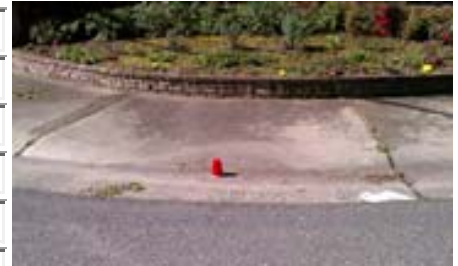
Field Date: 3/29/2011 Report Date: 3/29/2011 Barrier #: 6353B
 Location: Wachtel Wy and Andre Ct - Corner D
 X Coordinate: -121.24448
 Y Coordinate: 38.70539
 Barrier Area: Curb Ramps
 Barrier Type: Detectable Warnings - Truncated Domes
 Code Ref: CBC 1127B.5.7 and ADA/ABA 705.1.3

As Built Meas: 1 Quantity: EACH
 Description: No truncated domes provided at curb ramp
 As Built Desc: No detectable warnings at curb ramp
 Solution: Provide compliant truncated domes
 Bar. Severity: 2 Recommended Cost Estimate: \$1,400.00 Status:
 Implementation Priority: 2 Facility Function:
 Implementation Phase: Implementation Date:
 Official Responsible:

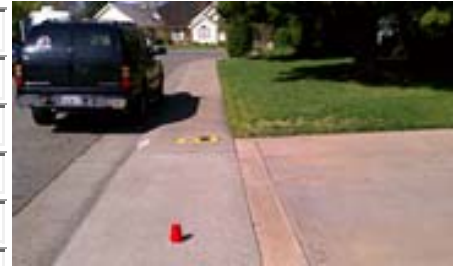
Barrier Type: Cross Slope - Existing (2.1% to 3.0%)

Code Ref: CBC 1133B.7.1.3 and ADA/ABA 403.3

As Built Meas: 88 Quantity: LF

Description: Cross slope exceeds 2.0% (2.1% to 3.0%)

Solution: Low severity barrier - no remediation recommended

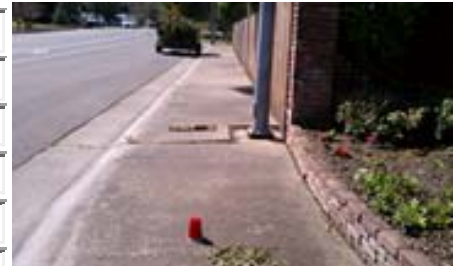
Barrier Type: Cross Slope - Existing (5.0% or more)

Code Ref: CBC 1133B.7.1.3 and ADA/ABA 403.3

As Built Meas: 133 Quantity: LF

Description: Cross slope exceeds 2.0% (5.0% or more)

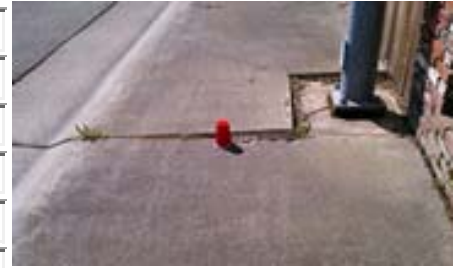
Field Date: 3/29/2011 Report Date: 3/29/2011 Barrier #: 6355B
 Location: Wachtel Wy - West
 X Coordinate: -121.24446
 Y Coordinate: 38.70537
 Barrier Area: Sidewalks
 Barrier Type: Abrupt Change in Level - > 1/2"
 Code Ref: CBC 1133B.7.1 and ADA/ABA 303.3

As Built Meas: 4 Quantity: LF
 Description: Change in level greater than 1/2"
 As Built Desc: 1/2" lip in sidewalk surface
 Solution: Grind or repair sidewalk to remove trip hazard
 Bar. Severity: 1 Necessary Cost Estimate: \$1,000.00 Status:
 Implementation Priority: 2 Facility Function:
 Implementation Phase: Implementation Date:
 Official Responsible:

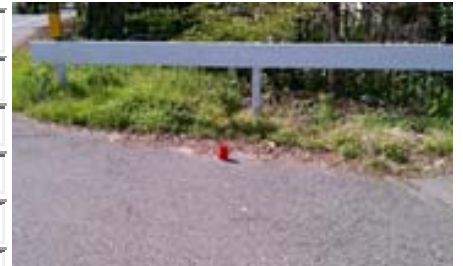
Field Date: 3/29/2011 Report Date: 3/29/2011 Barrier #: 6356
 Location: Wachtel Wy - West
 X Coordinate: -121.24444
 Y Coordinate: 38.705
 Barrier Area: Sidewalks
 Barrier Type: No Sidewalk - Cane Detectable Barricade
 Code Ref: CBC 1133B.8.6 and MUTCD Section 6D.02

As Built Meas: 1 Quantity: LF
 Description: No cane detectable warning on existing barricade
 As Built Desc: Existing barricade lacks warning for the visually impaired
 Solution: Provide cane detectable warning on barricade (max. 6" above ground)
 Bar. Severity: 1 Necessary Cost Estimate: \$100.00 Status:
 Implementation Priority: 2 Facility Function:
 Implementation Phase: Implementation Date:
 Official Responsible:

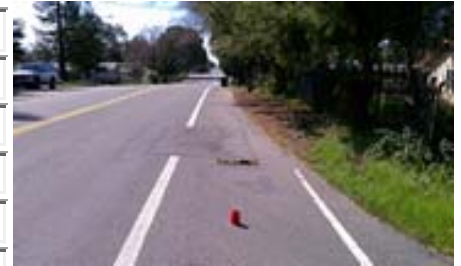
Field Date: 3/29/2011 Report Date: 3/29/2011 Barrier #: 6357
 Location: Wachtel Wy - West
 X Coordinate: -121.24439
 Y Coordinate: 38.70492
 Barrier Area: Sidewalks
 Barrier Type: Shoulder Cross Slope - Existing (4.1% to 4.9%)
 Code Ref: CBC 1133B.7.1.3 and ADA/ABA 403.3

As Built Meas: 306 Quantity: LF
 Description: Cross slope exceeds 2.0% (4.1% to 4.9%)
 As Built Desc: 4.6% cross slope
 Solution: Demolish existing and construct new pedestrian route
 Bar. Severity: 2 Recommended Cost Estimate: \$38,250.00 Status:
 Implementation Priority: 2 Facility Function:
 Implementation Phase: Implementation Date:
 Official Responsible:

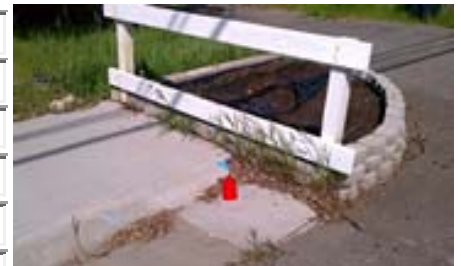
Field Date: 3/29/2011 Report Date: 3/29/2011 Barrier #: 6358
 Location: Wachtel Wy - West
 X Coordinate: -121.24446
 Y Coordinate: 38.70409
 Barrier Area: Sidewalks
 Barrier Type: No Sidewalk - Transition to Shoulder
 Code Ref: CBC 1121B.2 and ADA/ABA 206.2.1

As Built Meas: 1 Quantity: JOB
 Description: Sidewalk ends and no ramp to pedestrian shoulder is provided
 As Built Desc: No ramp to shoulder to enable pedestrian travel onto existing shoulder
 Solution: Provide transition ramp to paved shoulder where no opposite sidewalk exists
 Bar. Severity: 1 Necessary Cost Estimate: \$2,500.00 Status:
 Implementation Priority: 2 Facility Function:
 Implementation Phase: Implementation Date:
 Official Responsible:

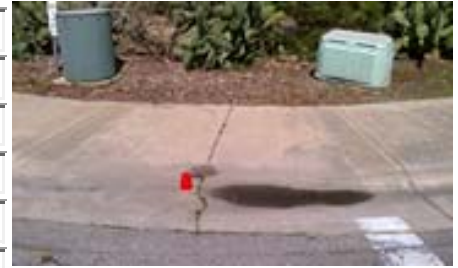
Field Date: 3/29/2011 Report Date: 3/29/2011 Barrier #: 6359A
 Location: Wachtel Wy and Oak Ave - Corner A
 X Coordinate: -121.24456
 Y Coordinate: 38.70064
 Barrier Area: Curb Ramps
 Barrier Type: 12" Grooves - Existing (3.1% to 4.0%)
 Code Ref: CBC 1127B.5.6

As Built Meas: 1 Quantity: EACH
 Description: 12" grooves at top of curb ramp are not level (3.1% to 4.0%)
 As Built Desc: 3.1% at 12" grooves
 Solution: Demolish existing and construct new curb ramp
 Bar. Severity: 3 Hindrance Cost Estimate: \$2,500.00 Status:
 Implementation Priority: 2 Facility Function:
 Implementation Phase: Implementation Date:
 Official Responsible:

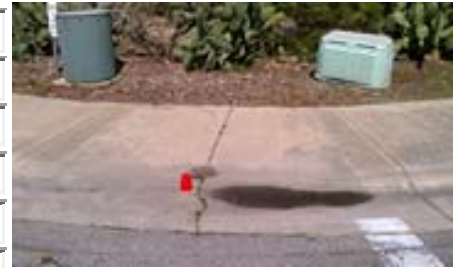
Field Date: 3/29/2011 Report Date: 3/29/2011 Barrier #: 6359B
 Location: Wachtel Wy and Oak Ave - Corner A
 X Coordinate: -121.24456
 Y Coordinate: 38.70064
 Barrier Area: Curb Ramps
 Barrier Type: Cross Slope - Existing (5.0% or more)
 Code Ref: CBC 1127B.5.3 and ADA/ABA 406.2

As Built Meas: 1 Quantity: EACH
 Description: Ramp run cross slope exceeds 2.0% (5.0% or more)
 As Built Desc: 5.6% cross slope
 Solution: Demolish existing and construct new curb ramp
 Bar. Severity: 1 Necessary Cost Estimate: \$2,500.00 Status:
 Implementation Priority: 2 Facility Function:
 Implementation Phase: Implementation Date:
 Official Responsible:

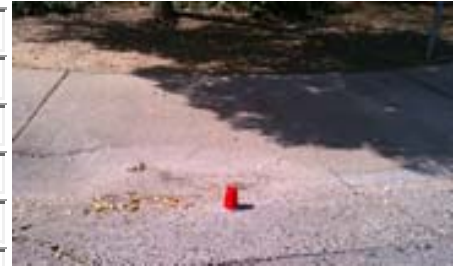
Field Date: 3/29/2011 Report Date: 3/29/2011 Barrier #: 6360
 Location: Wachtel Wy and Oak Ave - Corner D
 X Coordinate: -121.24455
 Y Coordinate: 38.70033
 Barrier Area: Curb Ramps
 Barrier Type: No Curb Ramp - Depressed Existing Curb
 Code Ref: CBC 1127B.5.1 and ADA/ABA 402.2

As Built Meas: 1 Quantity: EACH
 Description: No compliant curb cut at corner (intersection)
 As Built Desc: 9.4% running slope at depressed area
 Solution: Demolish existing and construct curb cut
 Bar. Severity: 1 Necessary Cost Estimate: \$2,500.00 Status:
 Implementation Priority: 2 Facility Function:
 Implementation Phase: Implementation Date:
 Official Responsible:
